Evaluation of Rigid Hazards Placed in the Zone of Intrusion

EVALUATION OF RIGID HAZARDS PLACED IN THE ZONE OF INTRUSION

1. Report No. TRP-03-151-08	2.	3. Recipient's Accession No.	
4. Title and Subtitle Evaluation of Rigid Hazards Placed in the Zone of Intrusion		5. Report Date January 3, 2008

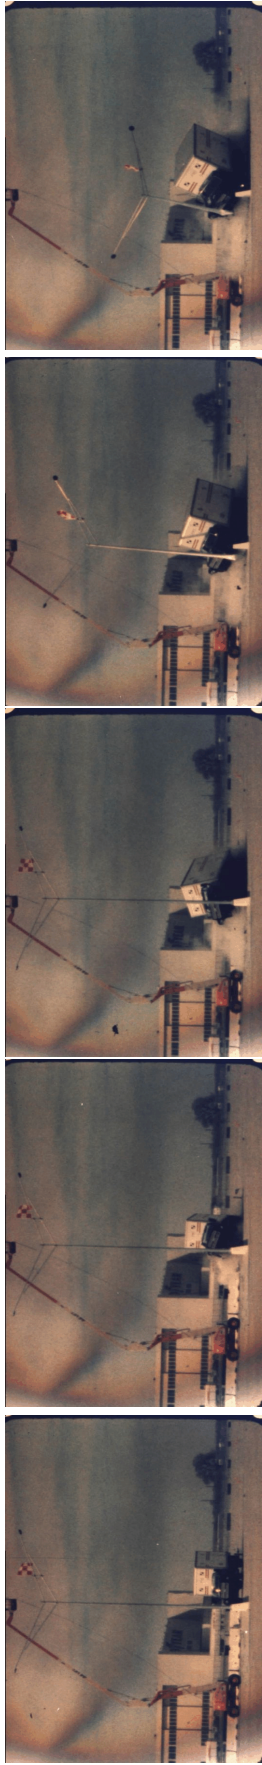
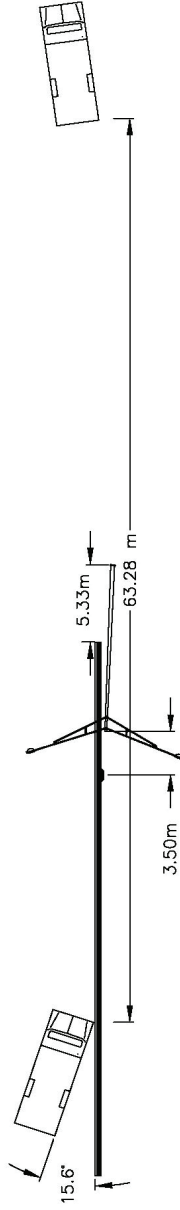
Figure 24. Summary of Test Results and Sequential Photographs, Test No. ZOI-1

A 7,985-kg (17,605-lbs) single-unit truck impacted the single-slope concrete barrier with a luminaire pole attached to the top of the barrier at a speed of 80.8 km/h (50.4 mph) and at an angle of 15.6 degrees. A summary of the test results and sequential photographs are shown in Figure 24. The summary of the test results and sequential photographs in English units are shown in Appendix D. Additional sequential photographs are shown in Figures 25 and 26. Documentary photographs of the crash test are shown in Figures 27 through 32.

The analysis of the test results for test no. ZOI-1 showed that the single-slope concrete barrier with an attached luminaire pole impacted with the 8000S vehicle adequately contained and redirected the vehicle with controlled lateral displacements of the barrier system. There were no detached elements nor fragments which showed potential for penetrating the occupant compartment nor presented undue hazard to other traffic as the pole landed behind the barrier and parallel to it. Deformations, or intrusion, into the occupant compartment that could have caused serious injury did not occur. The test vehicle did not penetrate nor ride over the barrier system and remained upright during and after the collision. Vehicle roll, pitch, and yaw angular displacements were noted, but they were deemed acceptable because they did not adversely influence occupant risk safety criteria nor cause rollover. After the collision, the vehicle's trajectory did not intrude into adjacent traffic lanes. In addition, the vehicle's exit angle was less than 60 percent of the impact angle. Therefore, test no. ZOI-1 conducted on the single-slope concrete barrier with an attached luminaire pole was determined to be acceptable according to the TL-4 safety performance criteria of test designation no. 4-12 found in NCHRP Report No. 350.

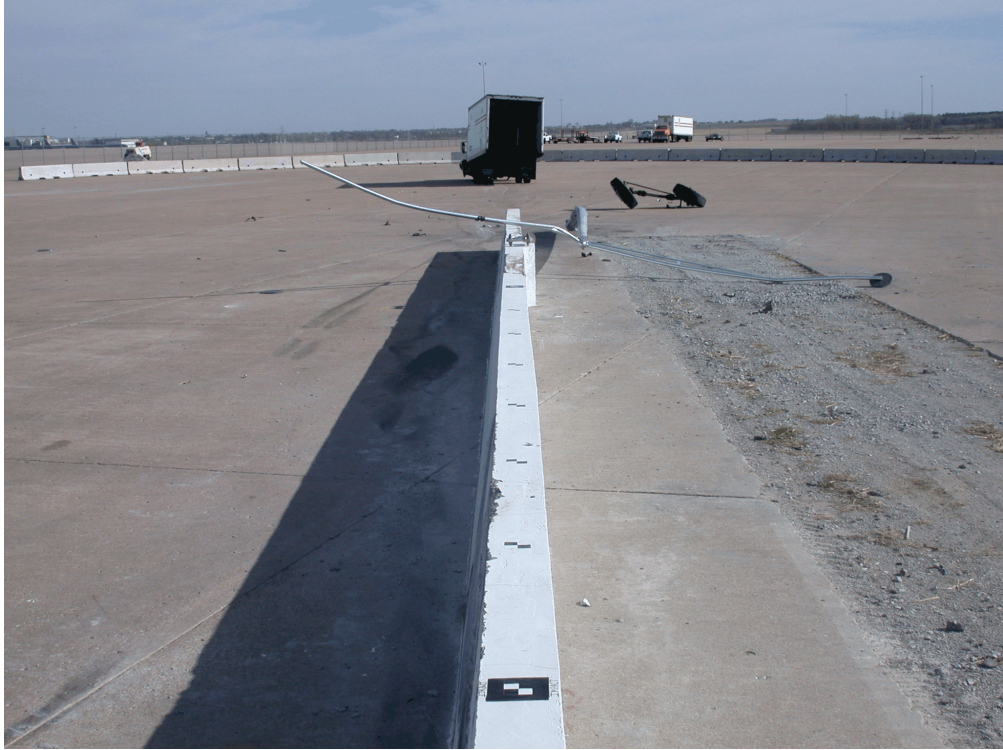
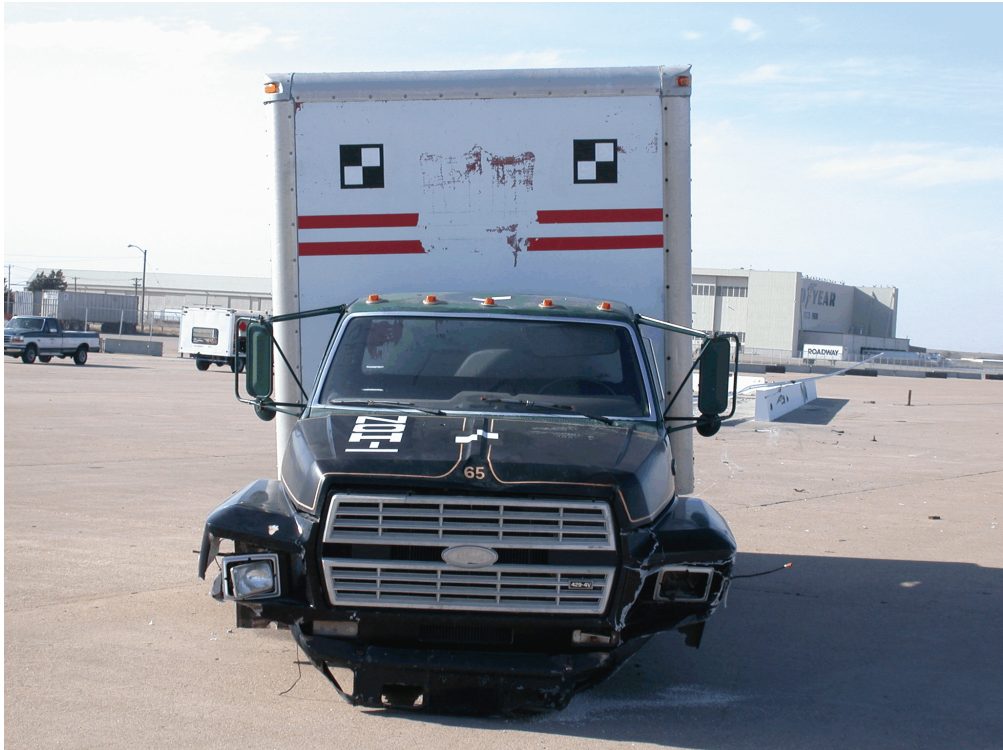
Figure 33. Impact Location, Test No. ZOI-1

Initial vehicle impact was to occur 16.8 m (55 ft) upstream of the centerline of the luminaire pole, as shown in Figure 33. Actual vehicle impact occurred 356 mm (14 in.) upstream of the targeted impact. At 0.078 sec after impact, the right-front corner of the cab rose upward. At 0.133 sec, the truck began to redirect. At 0.191 sec, the front of the truck continued to rise upward and rolled clockwise. At 0.311 sec, the truck became parallel to the barrier at a speed of 63.4 km/h (39.4 mph). At 0.320 sec, the truck rolled counter-clockwise. At this same time, the rear of the truck rose up, and the left-front tire disengaged. At 0.394 sec, the left-rear tire became airborne. At 0.830 sec, the front of the truck contacted the pole. At 0.880 sec, the pole disengaged from the barrier and rotated downward toward the truck. At 1.135 sec, the cab rolled counter-clockwise, and the box continued to roll clockwise. At this same time, the pole descended down and traversed the truck. At 1.204 sec, the cab rolled clockwise. At 1.411 sec, the pole was no longer in contact with the truck. At 1.984 sec, the truck rolled to a 40 degree angle, and the left-front corner of the truck contacted the ground. At 2.050 sec, the truck rolled counter-clockwise as it exited the end of the

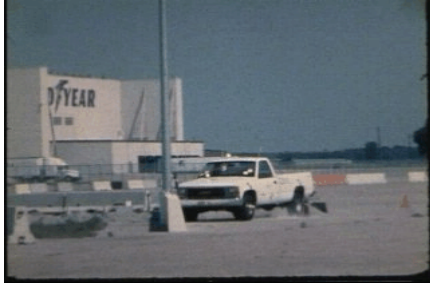
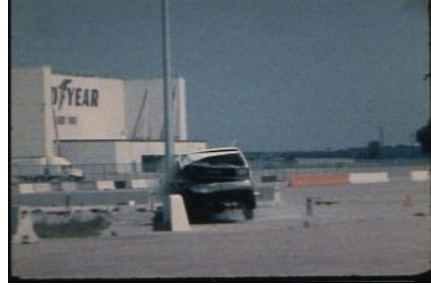
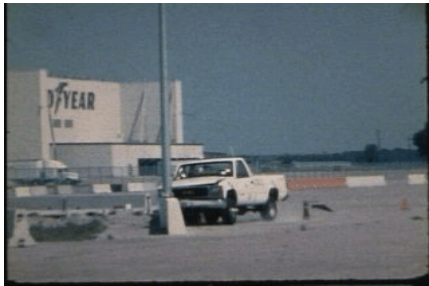
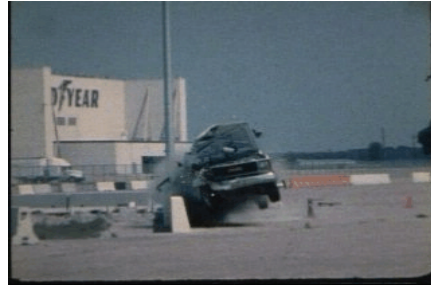
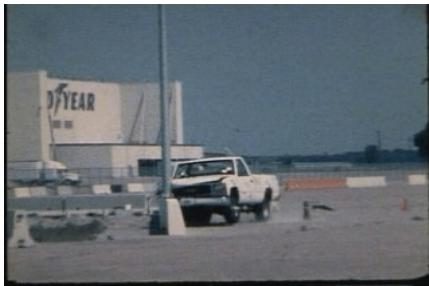
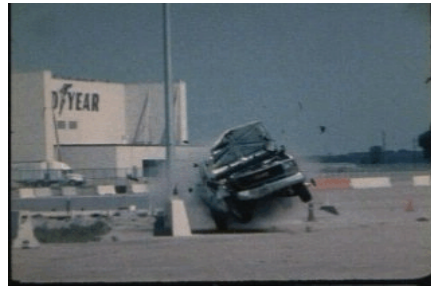
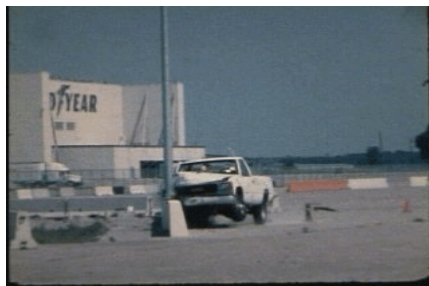
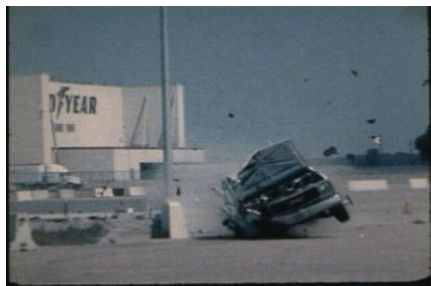
Figure 41. Summary of Test Results and Sequential Photographs, Test No. ZOI-2

A 2,009-kg (4,430-lbs) pickup truck impacted the single-slope concrete barrier with a luminaire pole attached to the top of the barrier at a speed of 99.3 km/h (61.7 mph) and at an angle of 23.4 degrees. A summary of the test results and sequential photographs are shown in Figure 41. The summary of the test results and sequential photographs in English units are shown in Appendix D. Additional sequential photographs are shown in Figures 42 through 44. Documentary photographs of the crash test are shown in Figures 45 through 47.
