Design and Evaluation of an Open Combination Traffic/Bicycle Bridge Railing System

DESIGN AND EVALUATION OF AN OPEN COMBINATION TRAFFIC/BICYCLE BRIDGE RAILING SYSTEM

MwRSF Research Report No. TRP-03-162-07

February 9, 2007

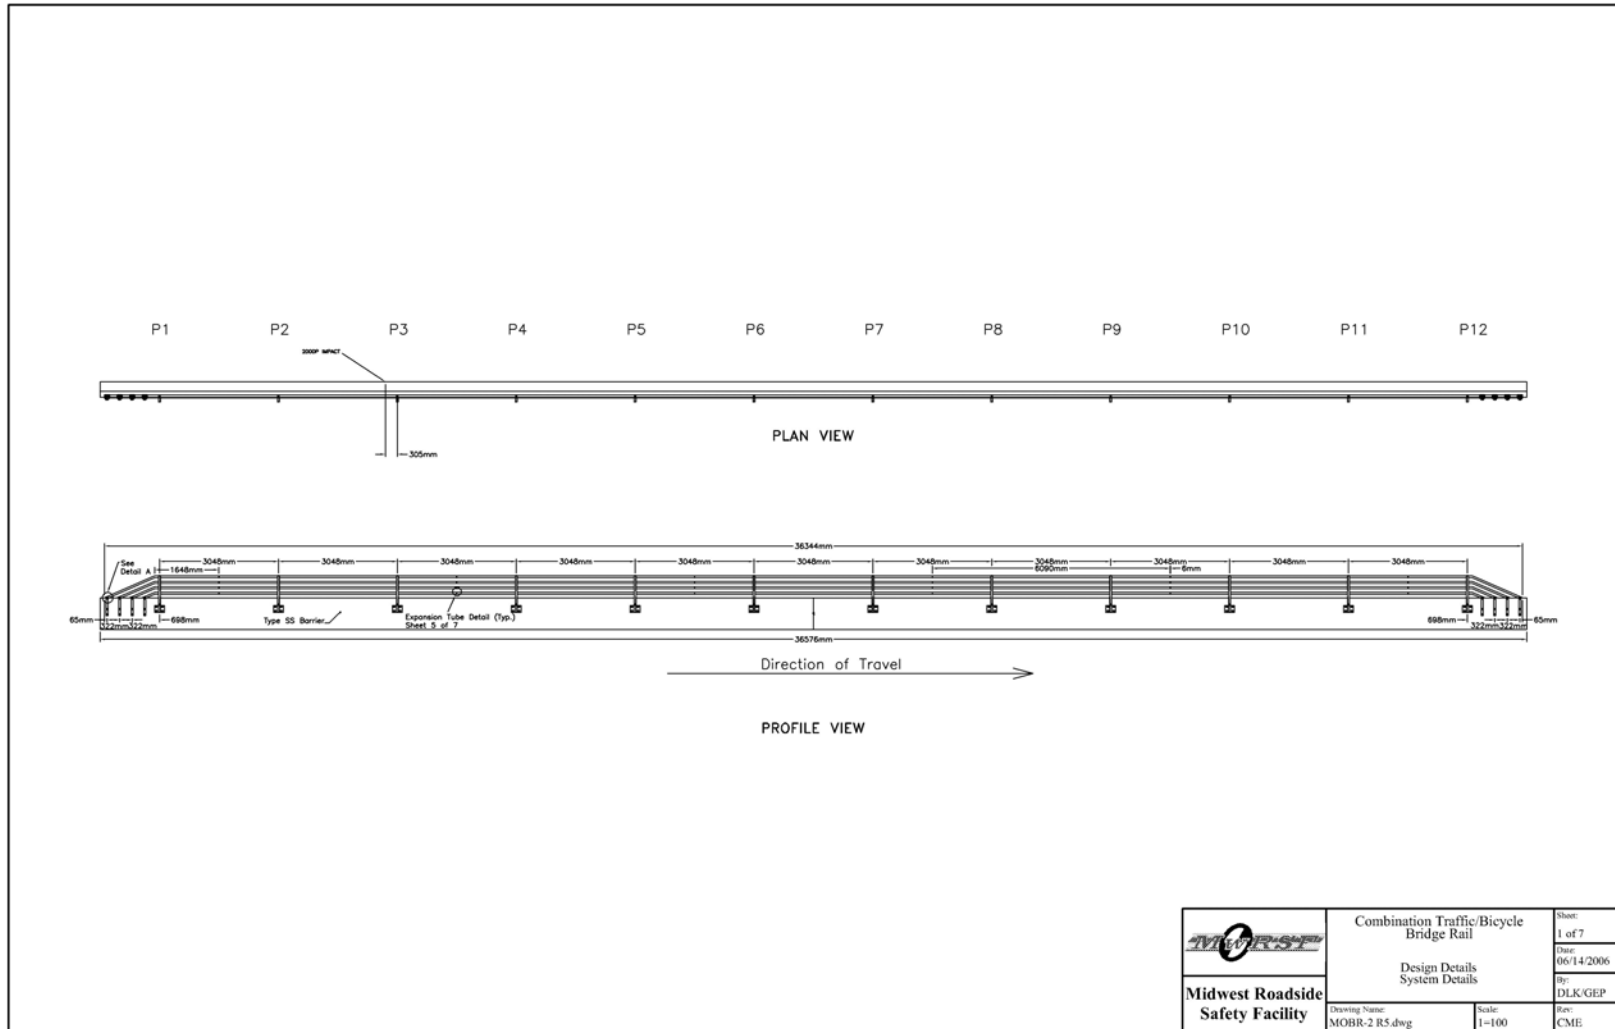
Figure 34. Modified Combination Traffic/Bicycle Bridge Rail - System Details

Again, the system was terminated by sloping the ends of the four longitudinal tubes down to the top of the barrier. The bottom sloped end rail was 335 mm (13 3/16 in.) long and ended 376 mm (14 7/8 in.) away from the centerline of the first and last posts. The lower-middle sloped end rail was 686 mm (27 in.) long and ended 699 mm (2 ft - 3 1/2 in.) away from the centerline of the first and last posts. The upper-middle sloped end rail was 1,038 mm (40 7/8 in.) long and ended 1,021 mm (3 ft - 4 3/16 in.) away from the centerline of the first and last posts. The top sloped end rail was 1,389 mm (54 11/16 in.) long and ended 1,343 mm (4 ft 4 7/8 in.) away from the centerline of the first and last posts. The sloped end rails were bolted to both the top and back sides of the concrete parapet, as shown in Figures 34 and 36.

After the initial design was deemed unsuccessful, modifications were made to the system in an attempt to improve the impact performance. From the film analysis, the deflection of the rails and subsequent protrusion of the right-front corner of the vehicle held the vehicle from experiencing the normal vaulting behavior shown previously with impacts on a single slope barrier, in turn causing the vehicle to roll. It was then determined that reducing the space between the rails and repositioning the rail would potentially reduce the amount of vehicle intrusion between the rails. Therefore, in the modified system, the number of longitudinal rails was increased from three to four, with the top of the tops of the rails mounted at 1,375 mm (54 1/8 in.), 1,235 mm (48 5/8 in.), 1,095 mm (43 1/8 in.), and 995 mm (39 1/8 in.) from the ground. System details are shown in Figures 34 through 40 with photographs shown in Figure 41. Corresponding English-unit system details are presented in Appendix D.
