# SAFETY PERFORMANCE EVALUATION ON THE NEBRASKA TURNED-DOWN APPROACH TERMINAL SECTION

Project RES 1 (0099) P464  
TRANSPORTATION RESEARCH REPORT TRP-03-32-92

October 1992

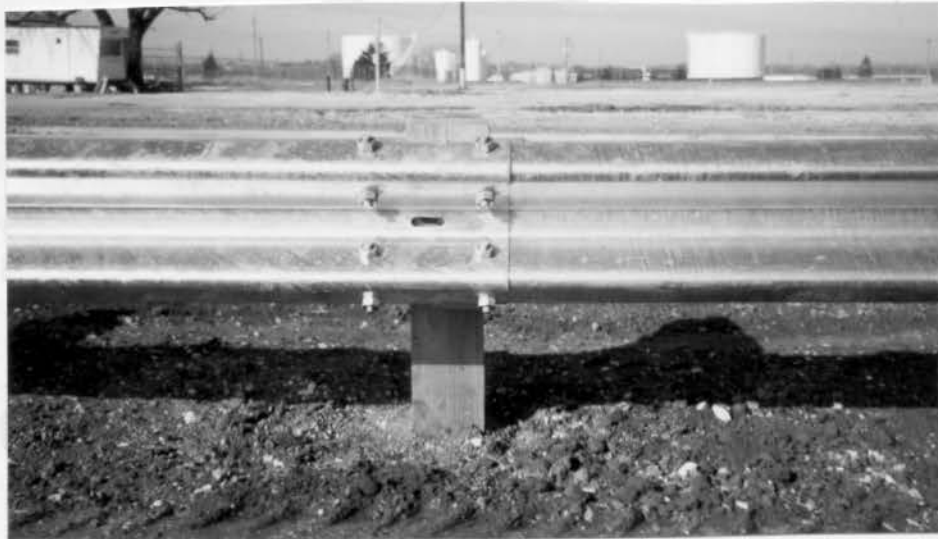
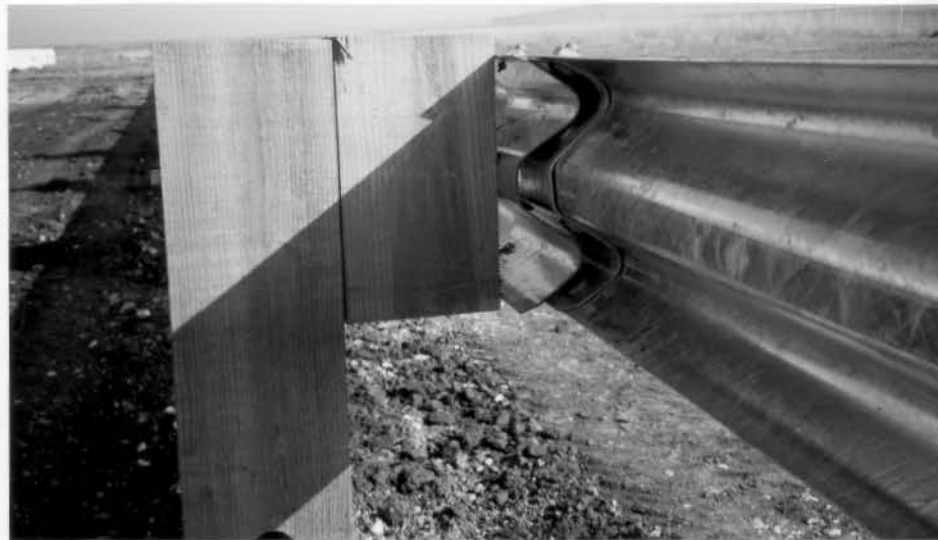
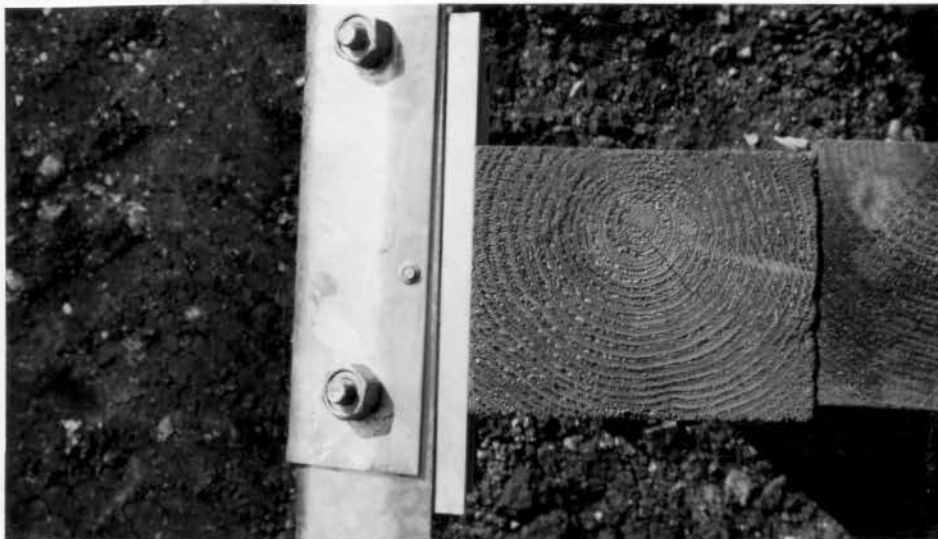
FIGURE 6. Guardrail Connection Detail, Post No. 3

Twelve gauge W-beam guardrail sections were used at all remaining locations of the installation. W-section backup plates were mounted on Post Nos. 1 through 8 and Post Nos. 10 and 11 (Figure 5). A 6-in. long backup plate was placed at Post No. 5, while all remaining backup plates were 12-in. long. The W-beam guardrail was not connected to Post Nos. 1 through 5. The guardrail was bolted to the backup plates at Post Nos. 1 and 3 with a No. 10 bolt (Figure 3 and 6).

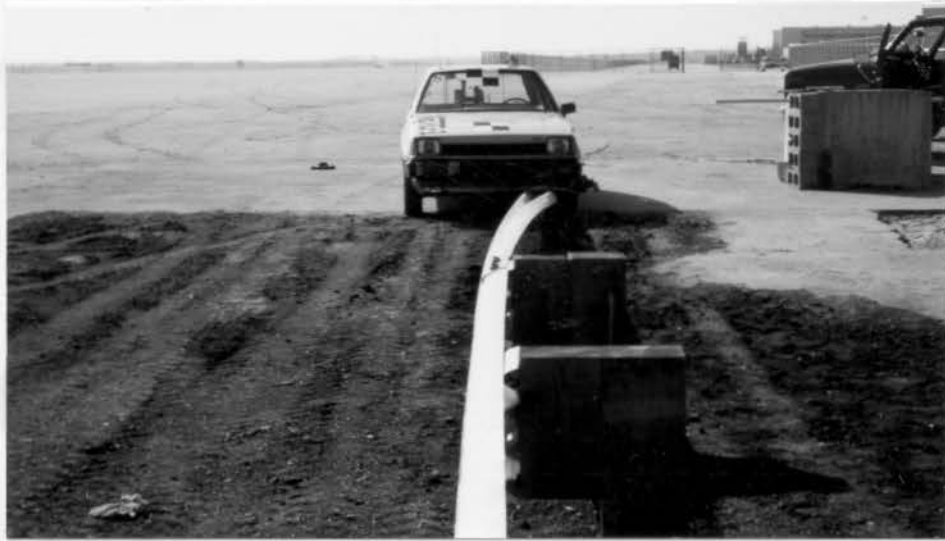
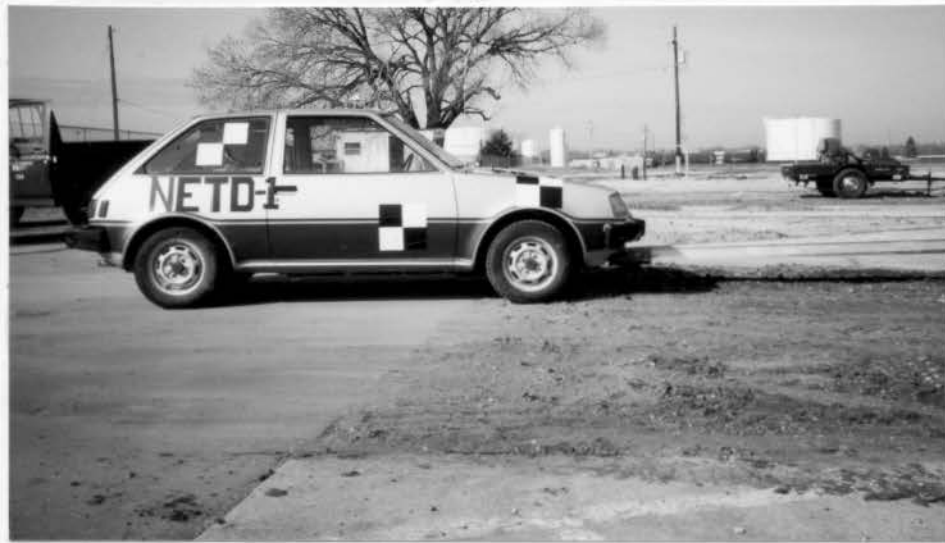
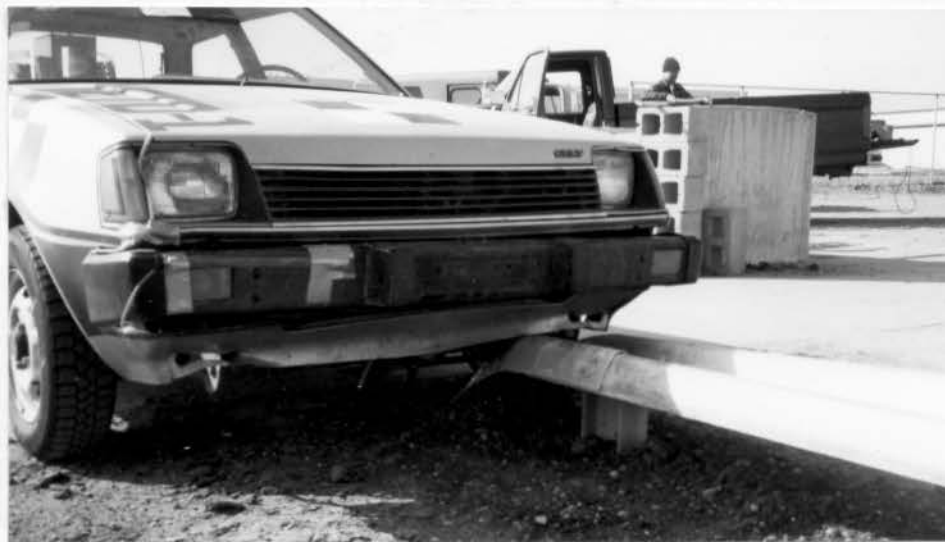
FIGURE 11. Impact Location, Test NETD-1

Test NETD-1 was conducted with 1984 Dodge Colt under the impact conditions of 59.0 mph and 0 degrees (head-on) with respect to a line parallel to the roadway and offset 1.25-ft toward the roadway (Figure 11). A summary of the test results and sequential photographs are shown in Figure 12. Additional sequential photographs are shown in Figures 13 through 16.

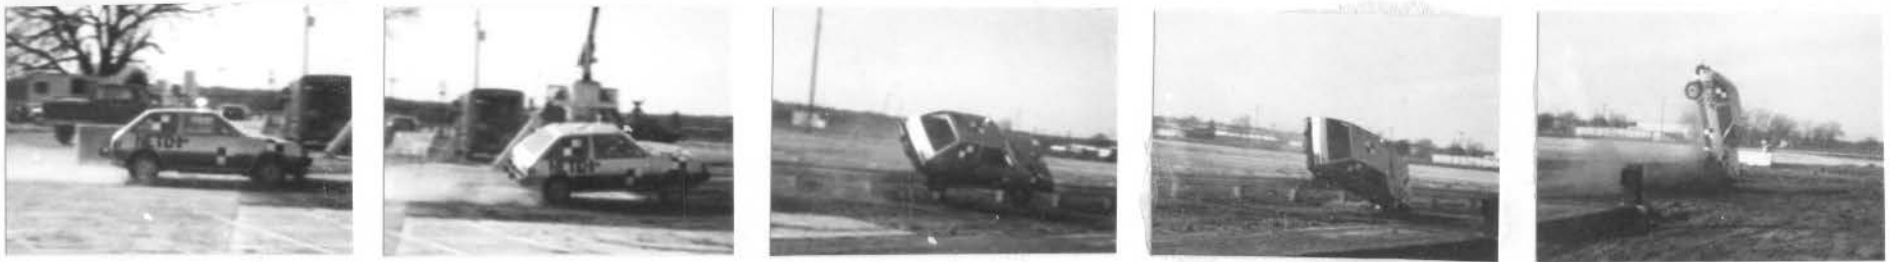
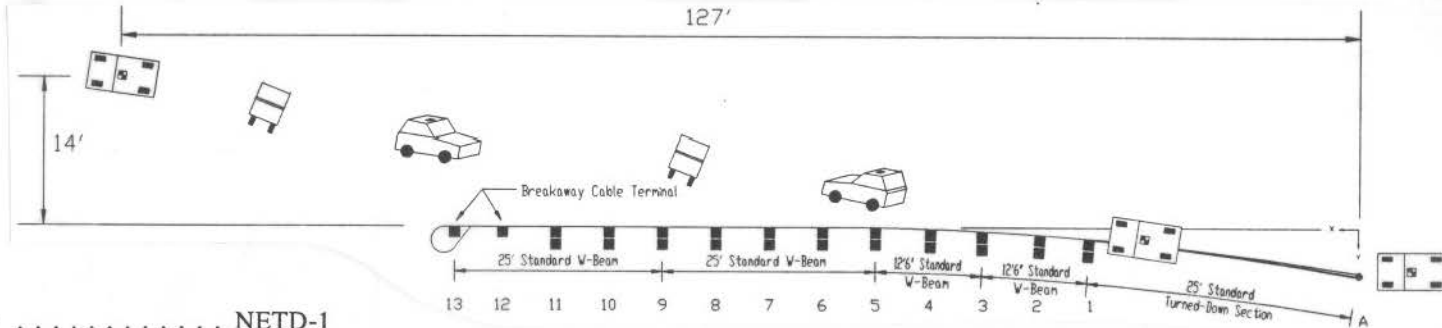
FIGURE 12. Test Results and Sequential Photographs, Test NETD-1

- Test Number ..... NETD-1
- Date ..... 3/13/92
- Appurtenance ..... Nebraska Turned-Down Approach Terminal Section and Guardrail
- Total Length ..... 100-ft
- Steel W-beam Guardrail
  - Mounting Height ..... 27-in.
  - Length-of-Need ..... 75-ft
  - Material Size ..... 12 Gauge
  - Terminal Section ..... 25-ft
  - Material Size ..... 12 Gauge
- Timber Posts
  - Post No.'s 1 - 11 ..... 6-in. x 8-in. x 6-ft
  - Post No.'s 12 - 13 ..... 5 1/2-in. x 7 1/2-in. x 3-ft 7-in.
- Timber Spacer Blocks
  - Post No.'s 1 - 11 ..... 6-in. x 8-in. x 1-ft 2-in.
- Soil Type ..... Silty-Clay (SL) (Dry)
- Vehicle
  - Model ..... 1984 Dodge Colt
  - Weight
    - Curb ..... 1,830-lb
    - Test Inertial ..... 1,887-lb
    - Gross Static ..... 1,887-lb

- Vehicle Speed
  - Impact ..... 59.0 mph
  - Exit ..... 50.0 mph
- Vehicle Angle
  - Impact ..... 0 deg
  - Exit ..... 13 deg
- Vehicle Snagging ..... Left-front undercarriage and tires at Post No. 1
- Vehicle Stability ..... Vehicle Rollover
- Occupant Ridedown Deceleration
  - Longitudinal ..... 16.7 g's > 15
  - Lateral ..... 22.5 g's > 15
- Occupant Impact Velocity
  - Longitudinal ..... 10.1 fps < 30
  - Lateral ..... 13.4 fps < 20
- Vehicle Damage ..... Extensive
  - TAD ..... RFQ-3, LBQ-6
  - VDI ..... RFE02, LBA06
- Vehicle Stopping Distance
  - Lateral ..... 14-ft
  - Longitudinal ..... 127-ft
- Guardrail Damage ..... Minor
