SAFETY PERFORMANCE EVALUATION OF THE STEEL-BACKED LOG RAIL

Midwest Roadside Safety Facility
Civil Engineering Department
University of Nebraska-Lincoln
1901 "Y" St.
P.O. Box 880601
Lincoln, Nebraska 68588-0601
(402) 472-6864

Federal Highway Administration Eastern Federal Lands Highway Division 21400 Ridgetop Circle Sterling, Virginia 22170

Transportation Research Report No. TRP-03-35-92

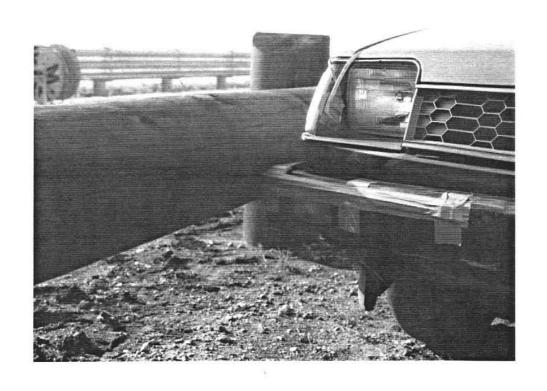
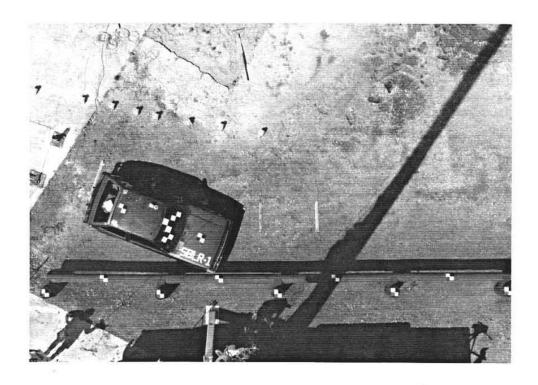
FIGURE 10. Vehicle Impact Location, Test SBLR-1

The 1984 Dodge Colt was directed into the Steel-Backed Log Rail using a reverse tow and cable guidance system (4). The vehicle was released from the tow cable and guidance system and was free wheeling at impact. The speed of the vehicle at impact was 50.6 mph and the angle of impact was 19.2 degrees. The impact point, shown in Figure 10, was located midspan between Post Nos. 2 and 3, or 15 ft from the upstream end of the installation. A summary of the test results and sequential photographs is shown in Figure 11. Additional sequential photographs are shown in Figures 12 through 14.

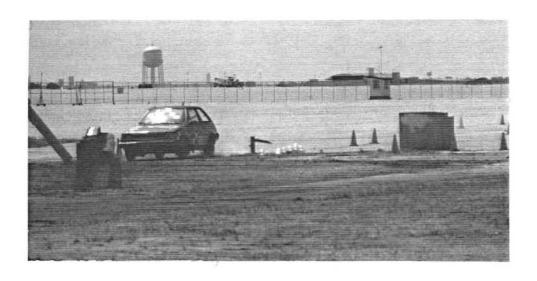
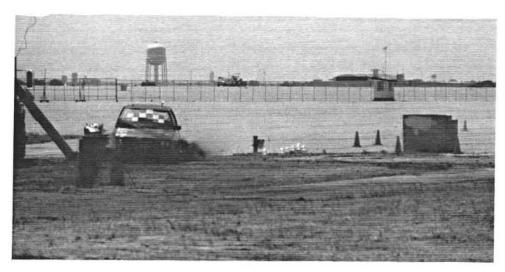
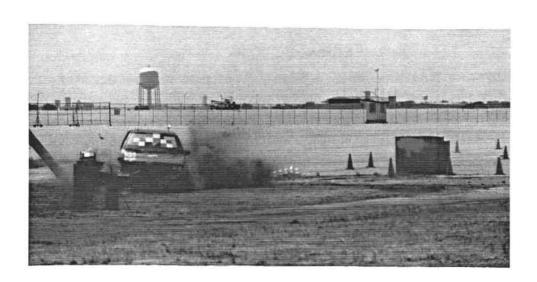
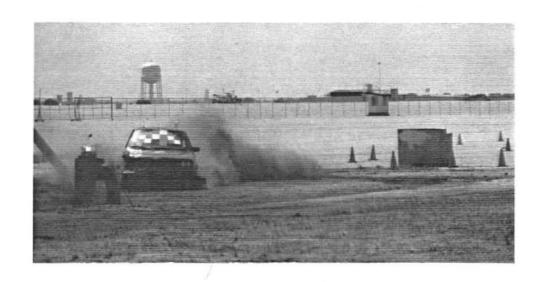
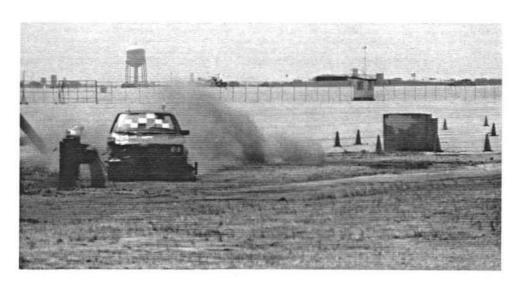
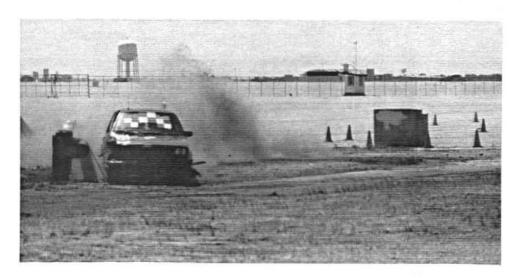
FIGURE 12. Downstream Sequential Photographs, Test SBLR-1

Upon impact with the log rail, the front bumper slipped under the rail, and the front right corner of the vehicle began to crush inward. The vehicle slid along the log rail and reached Post No. 3 approximately 64 ms after impact. 216 ms after impact the vehicle reached Post No. 4 and became parallel to the rail at approximately 352 ms. The vehicle exited the rail at an angle of 2 degrees approximately 503 ms after impact. After exiting the rail, the vehicle continued to travel downstream and to the left, coming to a rest 240 ft downstream from impact and 153 ft to the left of a line parallel to the railing face. This vehicle trajectory is shown in Figure 15.

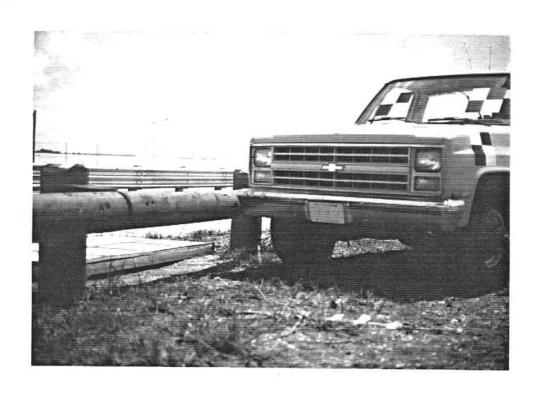
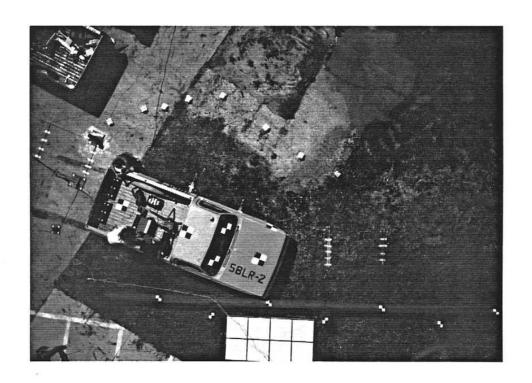
FIGURE 19. Vehicle Impact Location, Test SBLR-2

A 1986 3/4 ton Chevrolet Pickup was directed into the steel-backed log rail using a reverse tow and cable guidance system (4). The vehicle was released from the tow cable and guidance system and was free wheeling at impact. The speed of the vehicle at impact was 46.1 mph and the angle of impact was 20.9 degrees. The impact point, shown in Figure 19, was located midspan between Post Nos. 2 and 3, or 15 ft from the upstream end of the rail. A summary of the test results and sequential photographs is shown in Figure 20. Additional sequential photographs are shown in Figures 21 and 22.

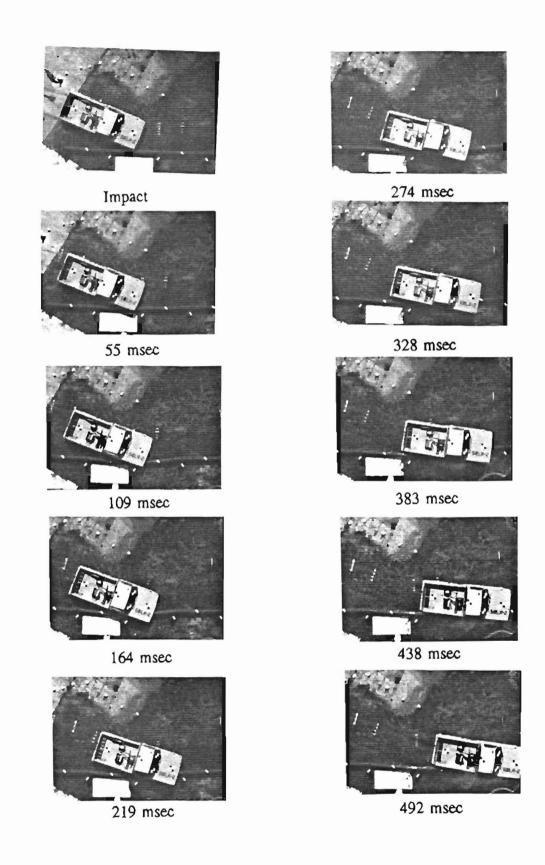
FIGURE 21. Overhead Sequential Photographs, Test SBLR-2

Upon impact, the bumper of the test vehicle began to ride up onto the log rail. The vehicle traveled along the top of the log rail until it reached Post No. 5 approximately 448 ms after impact. After impacting Post No. 5, the vehicle began to rotate clockwise, coming to rest perpendicular to the rail, 45 ft downstream from impact. The vehicle trajectory is shown in Figure 23.
