# Safety Performance Evaluation of the George Washington Memorial Parkway Bridge Rail

Transportation Research Report TRP-03-45-94

**FHWA Contract No. DTFH71-90-C-00035**

June, 1995

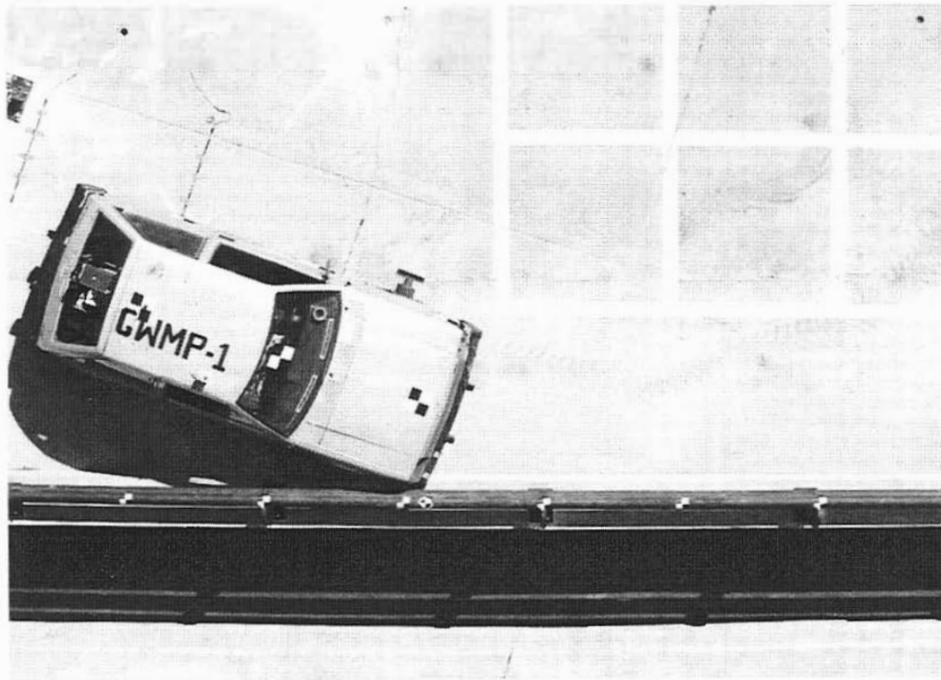
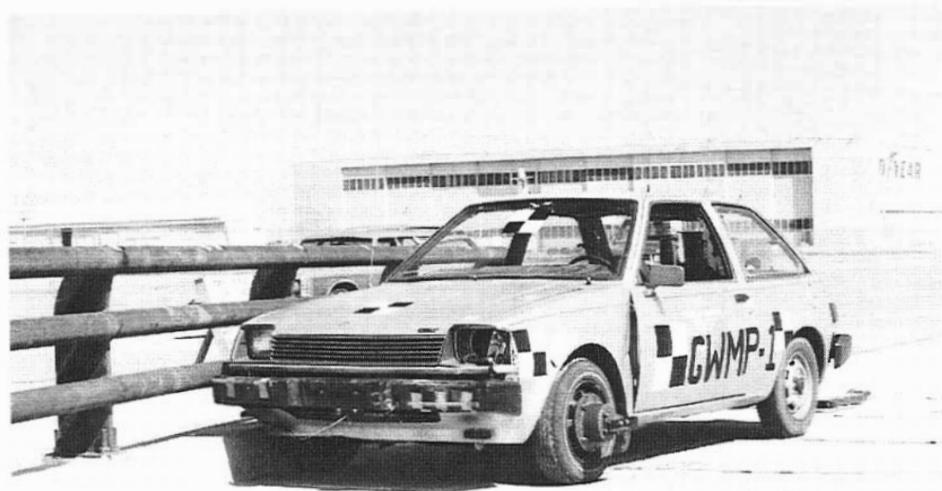
Figure 13. Impact Location. Test GWMP-1.

Upon impact with the steel bridge rail, the right front quarter panel was crushed inward and the bumper was pulled to the right and pushed back causing the front end of the vehicle to bend toward the right side of its longitudinal centerline. 42 ms after impact the bumper began to contact post number 4 and was crushed into the front right tire. With the bumper pushing the tire into the firewall, the vehicle began to buckle at the door post. This caused the windshield frame and roof to buckle. At 116 ms the car lost contact with post number 4 and continued down the rail with no further snagging. There was no rolling motion detected throughout the collision, and the vehicle was redirected, coming to rest 170 ft. (51.8 m) downstream and 90 ft. (27.4 m) behind a line parallel to the rail face, as shown in Figure 16.

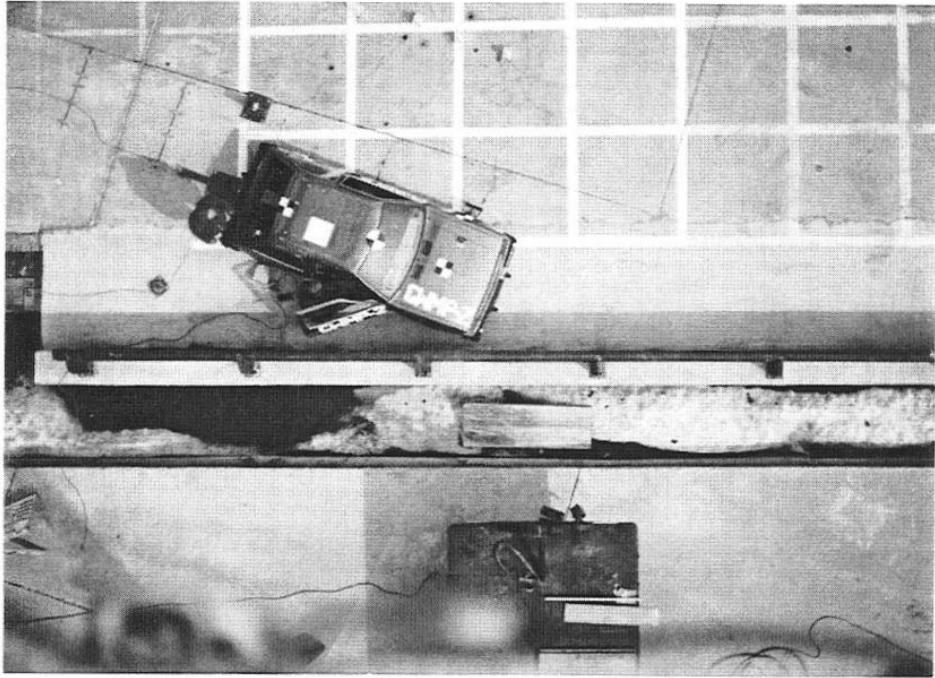
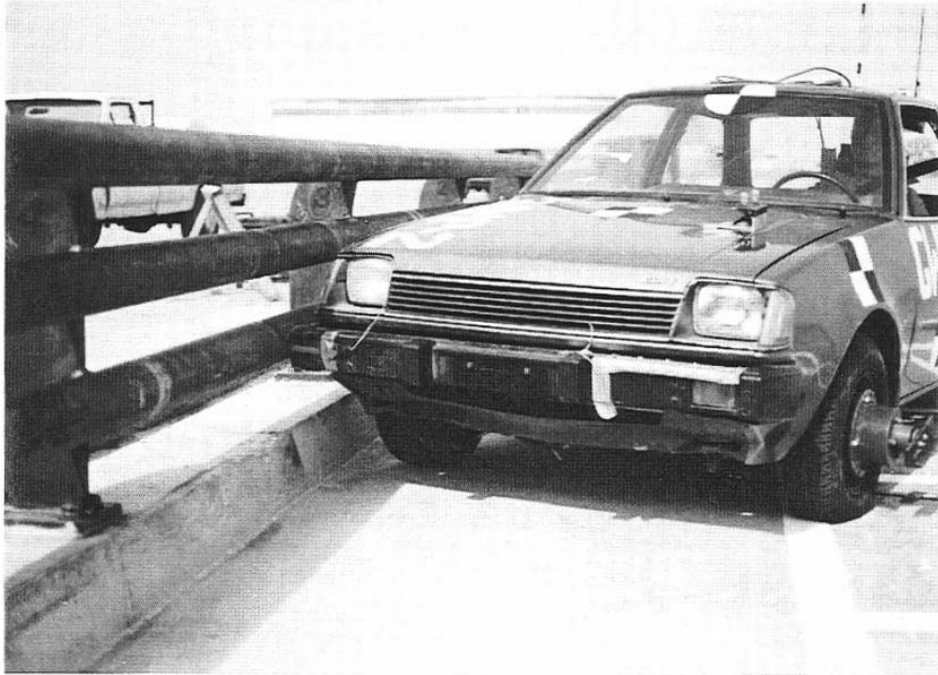
**Figure 21.** Impact Location, Test GWMP-2.

The 1984 Dodge Colt was directed into the George Washington Memorial Parkway Bridge Rail using a reverse tow and cable guidance system (5). The vehicle was released from the tow cable and guidance system and was free wheeling at impact. The speed of the vehicle at impact was 52.6 mph (84.65 km/h) and the angle of impact was 22.6 degrees. The impact point was located midway between the 3rd and 4th posts from the upstream end of the installation as shown in Figure 21. A summary of the test results and sequential photographs is shown in Figure 22.

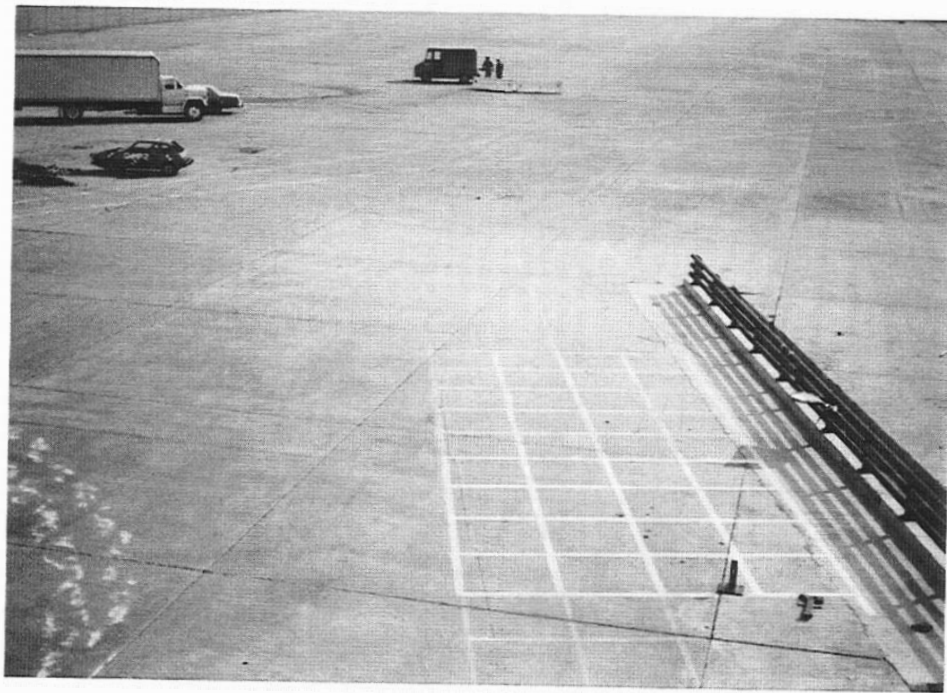
**Figure 23.** Vehicle Trajectory, Test GWMP-2.

Upon impact with the bridge rail system, the right front corner of the car was crushed inward. 68 ms after impact, the right front corner of the hood contacted post 4 causing the hood to rotate about its right front mount in a clockwise manner, approximately 90 degrees. The vehicle continued down the rail without the tire mounting the curb. When the vehicle approached post 5, 174 ms after impact, the left front corner of the hood contacted post 5 separating it from the vehicle. The hood remained at post 5 between the upper and middle rails as the vehicle proceeded down the rail. The hood then made contact with right front windshield support and the lower right corner of the windshield and was forced up and over the vehicle. The vehicle came to rest 120 ft. (36.5 m) downstream of impact and 61 ft. (18.6 m) In front of a line parallel with the front face of the bridge rail as seen in Figure 23.

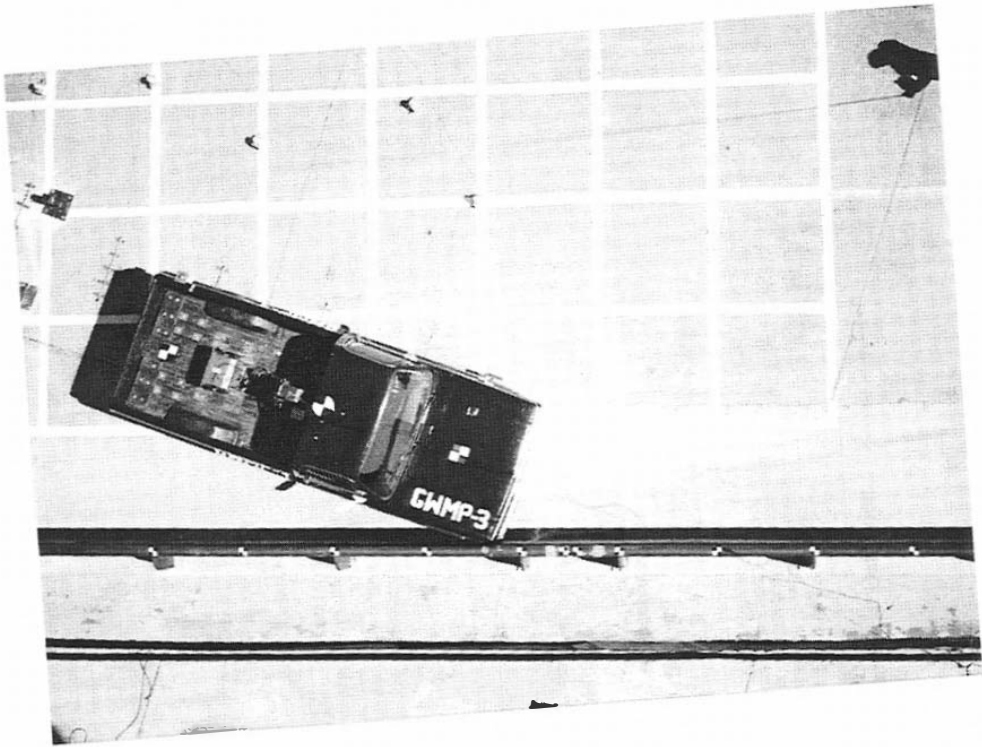
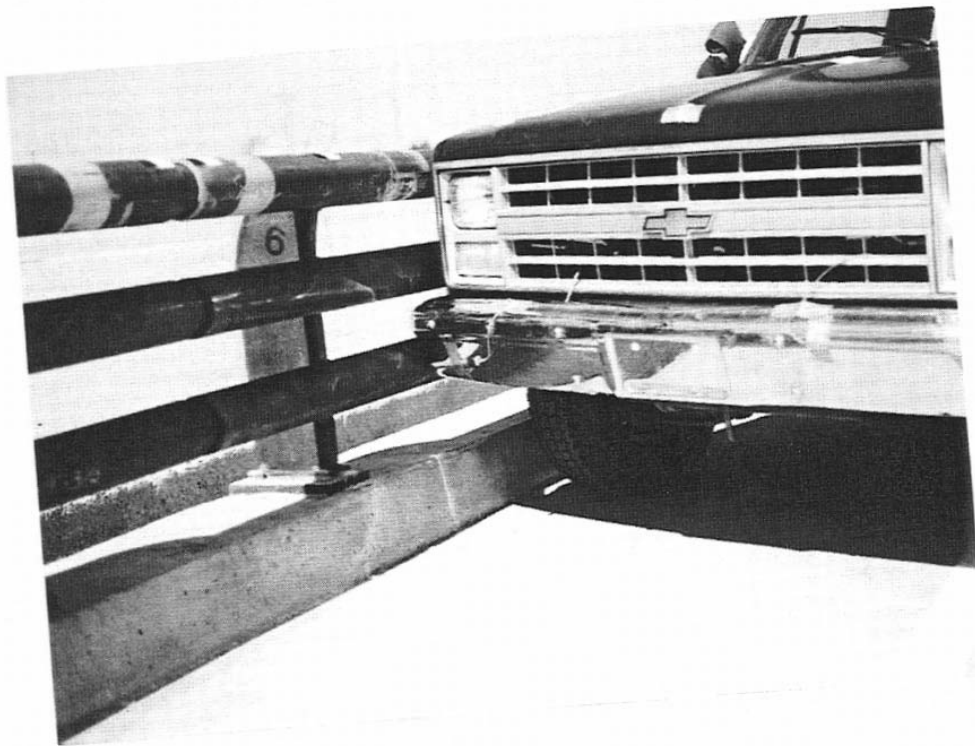
Figure 28. Impact Location, Test GWMP-3.

The 1985 Chevrolet 3/4 ton pickup was directed into the George Washington Memorial Parkway Bridge Rail using a reverse tow and cable guidance system (5). The vehicle was released from the tow cable and guidance system and was free wheeling at impact. The speed of the vehicle at impact was 46.6 mph (75.0 km/h) and the angle of impact was 22.7 degrees. The impact point was located 3 ft. - 3.5 in. (1.0 m) upstream of the expansion joint, just before post 6 from the upstream end of the installation as shown in Figure 28. A summary of the test results and sequential photographs is shown in Figure 29.

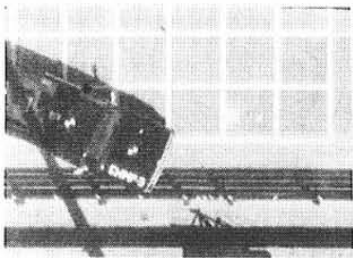
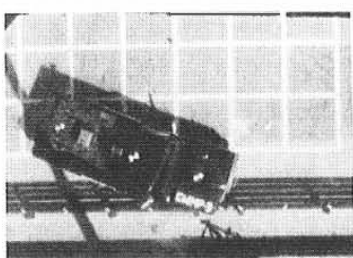
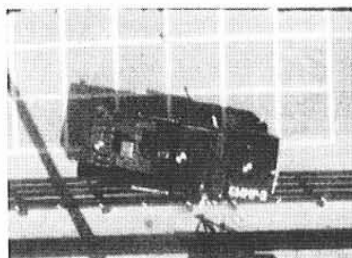
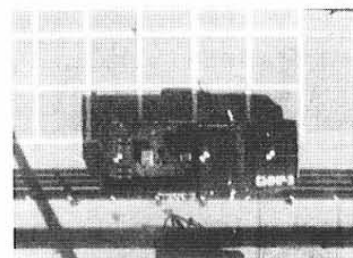
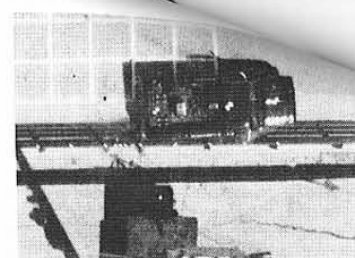
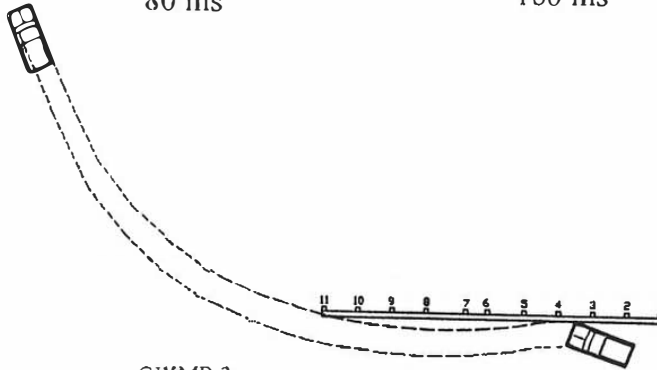
Figure 29. Summary of Test GWMP-3.

The longitudinal and lateral occupant impact velocities as determined from accelerometer data analysis were 9.6 fps (2.93 m/s) and 21.3 fps (6.49 m/s), respectively. The maximum occupant ridedown decelerations were 2.0 g's (longitudinal), and 8.0 g's (lateral). The results of this analysis are summarized in Figure 29 and Table 1.

It was determined that the performance of this test was acceptable according to the AASHTO (3) PL-1 guidelines.

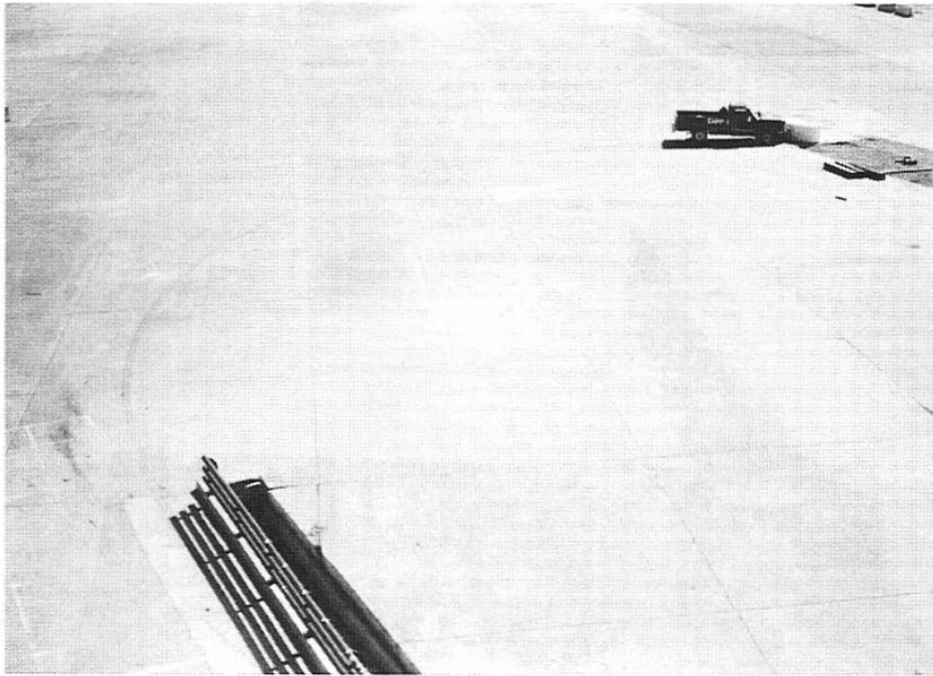
**Figure 30.** Vehicle Trajectory, Test GWMP-3.

The vehicle was smoothly redirected by the bridge railing, with a relatively small amount of damage to the vehicle. At 140 ms, tail slap occurred between the passenger side rear quarter panel of the vehicle and the rail. The tail slap caused cracking of the curb and deck at post 6. There was no snagging of the vehicle. There was a maximum permanent set deflection of 0.125 in. (0.32 cm) in the bridge rail. The vehicle came to rest 135 ft. (41.1 m) downstream and 110 ft. (33.5 m) to the back side of a line parallel with the front face of the bridge rail, as can be seen in Figure 30.

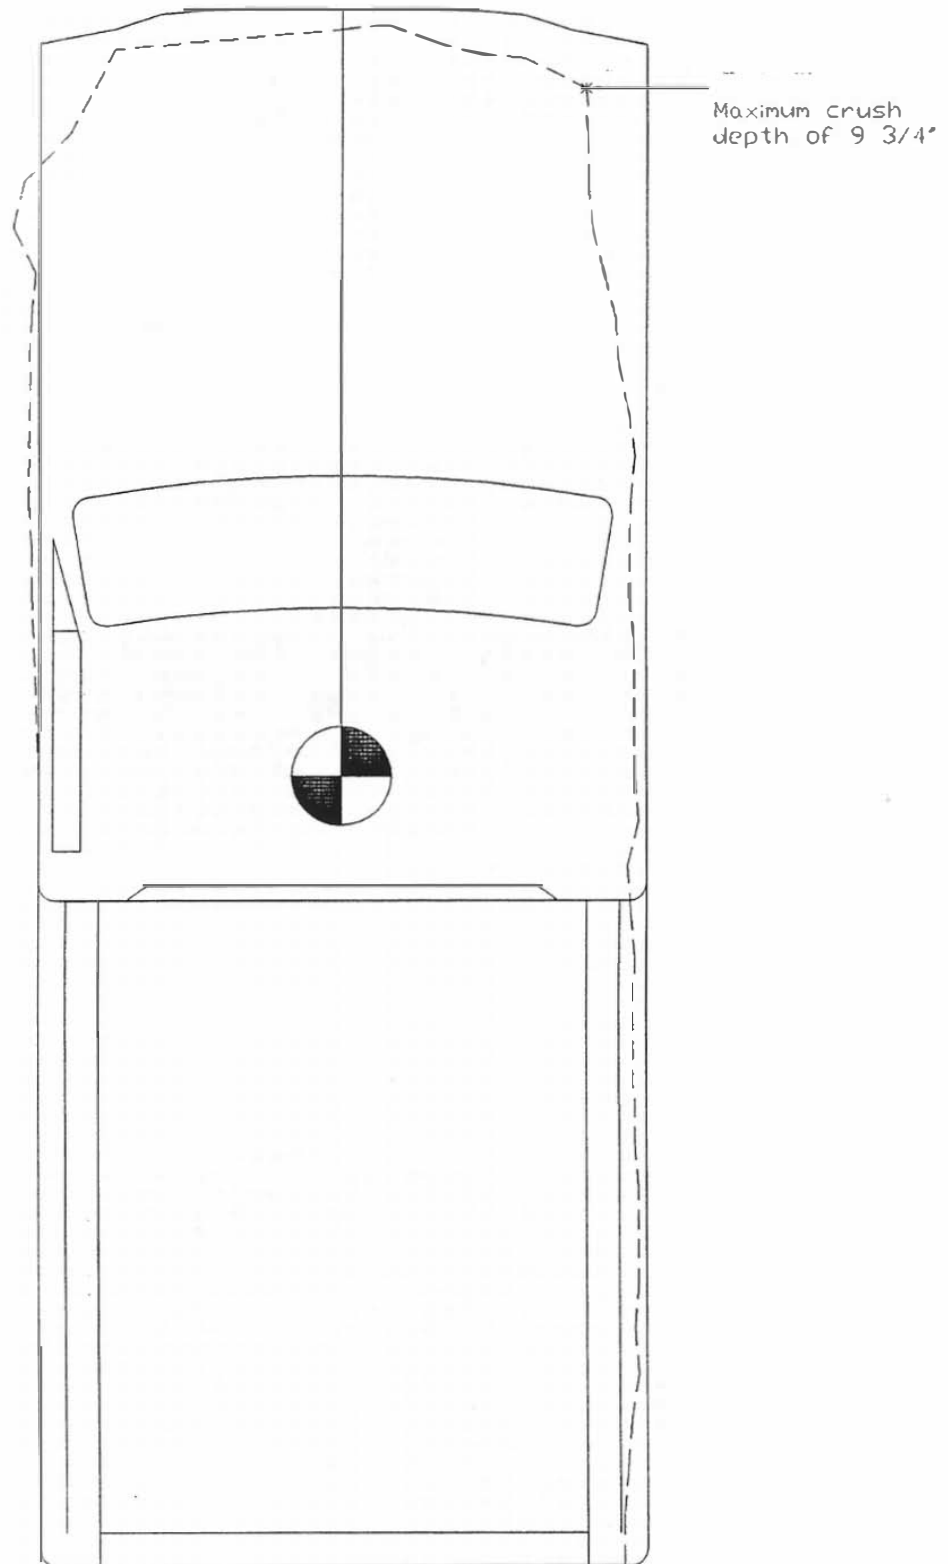
**Figure 32.** Vehicle Crush Measurements, Test GWMP-3.

The vehicle damage, shown in Figure 31, included the crushing of the right front corner of the vehicle, and scrapes and dents along the length of the passenger side. The right front tire was blown out and the rim was deformed. The maximum crush deformation of 9.75 in. (24.8 cm) is shown in Figure 32. All damage to the vehicle on the drivers side of the longitudinal centerline occurred after impact with the bridge rail. During the vehicle's run out, it struck an obstacle on the testing grounds, which resulted in damage to the left front corner of the vehicle..
