Determination of the Maximum MGS Mounting Height -- Phase I Crash Testing

*Midwest States Regional Pooled Fund Research Program
Fiscal Year 2009-2010 (Year 20)
Research Project Number TPF-5(193)
NDOR Sponsoring Agency Code RFPF-10-MGS*

DETERMINATION OF THE MAXIMUM MGS MOUNTING HEIGHT – PHASE I CRASH TESTING

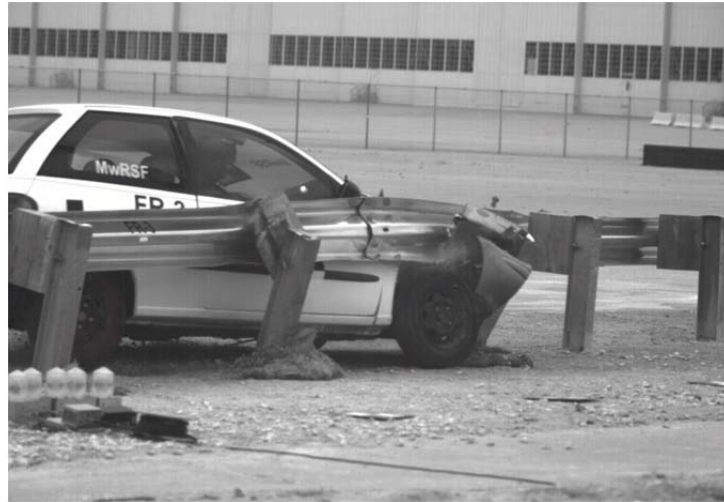
Figure 1. Test No. FR-3, Potential for Wheel Snag

Two concerns arise when wheel snag occurs: (1) the wheel is pushed rearward against the wheel well, which could deform the floorpan and (2) the longitudinal forces on the wheel increase the occupant risk values. Test no. FR-3 showed the propensity for wheel snag, as shown in Figure 1. Additionally, the small car utilized in test no. FR-5 encountered wheel snag on post no. 15, as shown in Figure 2. These flare rate tests, however, were more severe than a standard W-beam test, as the small car impacted at a higher effective angle of 31.8 degrees. As stated before, both of these tests passed the NCHRP Report No. 350 test criteria, and experienced acceptable floorpan deflections and occupant risk values. Thus, wheel snag may not pose a critical risk to the small car at higher rail heights. In test no. 2214MG-3, slight wheel snag occurred that did not abruptly stop the vehicle but caused it to yaw toward the barrier, as shown in Figures 3 and 4.

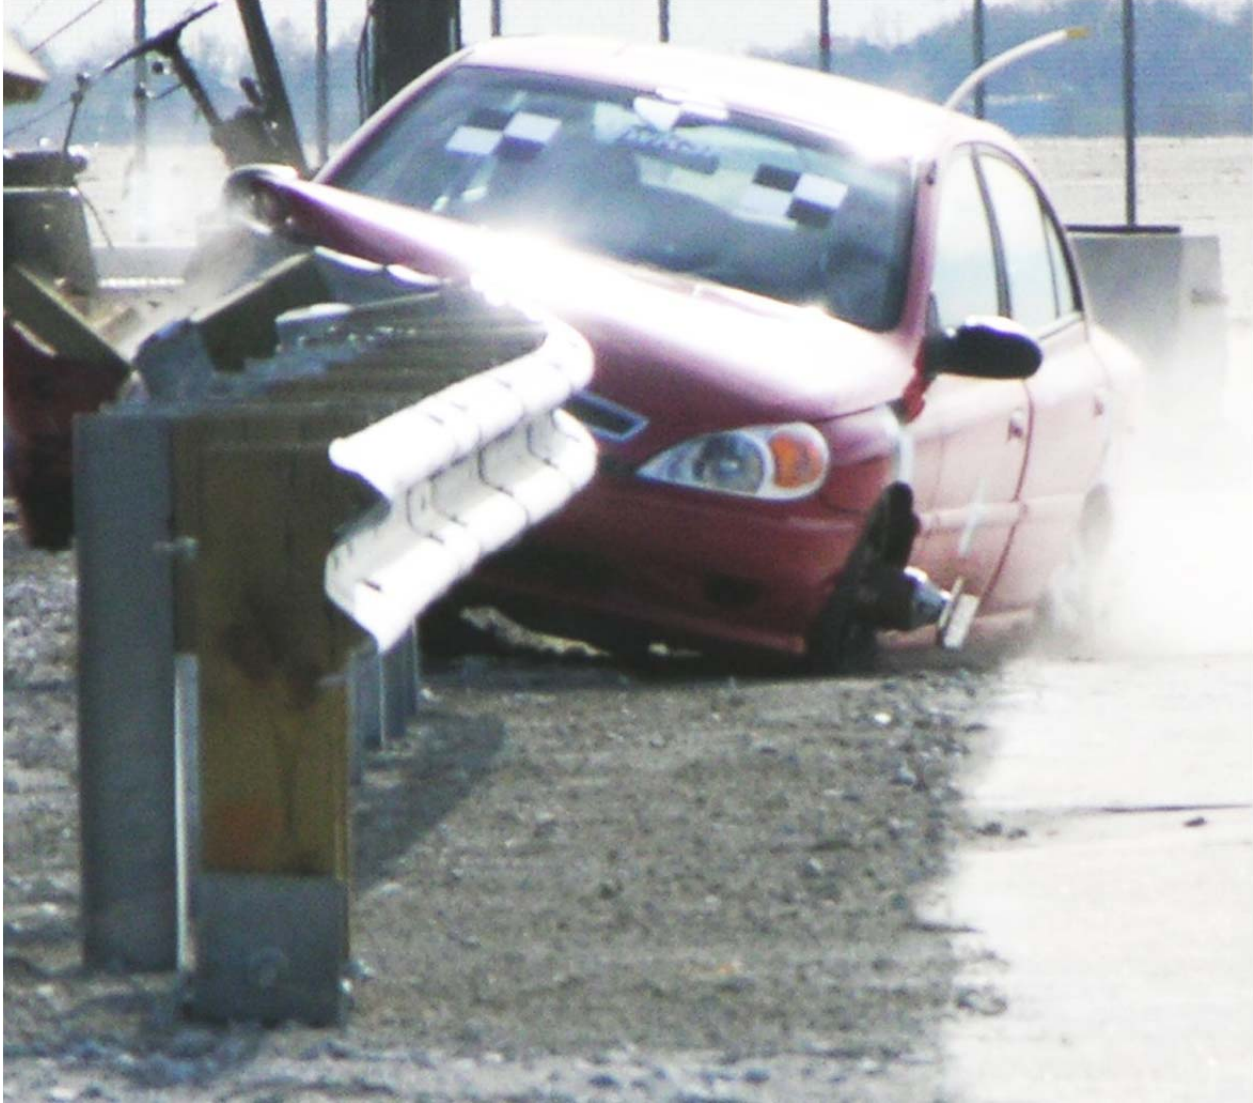
Figure 5. Test No. 2214MG-3, Rail Snags Under the Hood

The potential for barrier underride was seen in several tests. In some tests, the rail contacted the front of the vehicle and began to slide upward, but snagged under the hood and the quarter panel, as shown in Figure 5. The hood snag did not pose a threat to the occupants of the vehicle, but the rail may not be caught under the hood at higher rail heights, which would allow underride to occur.

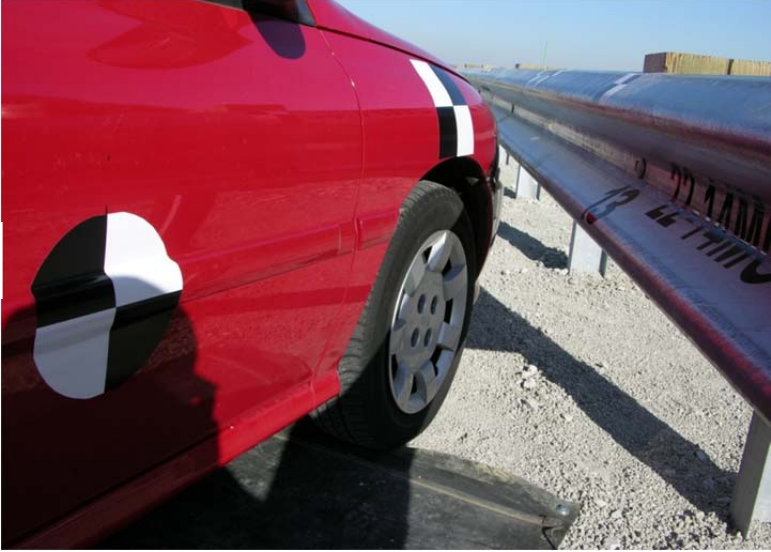
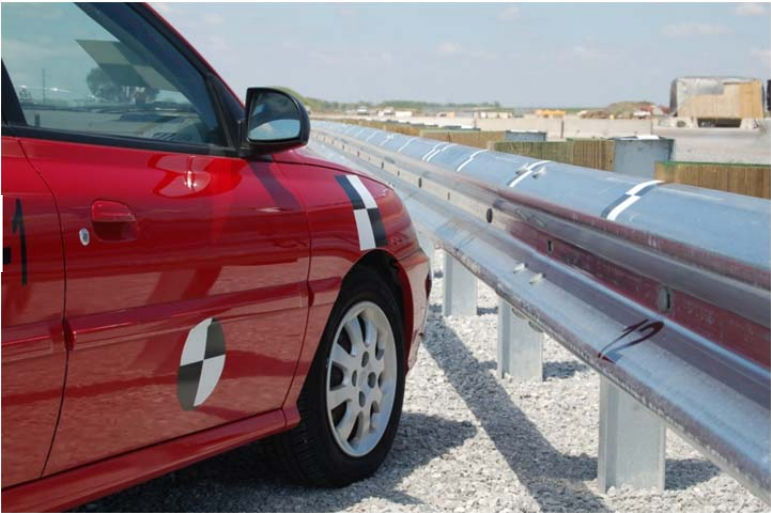
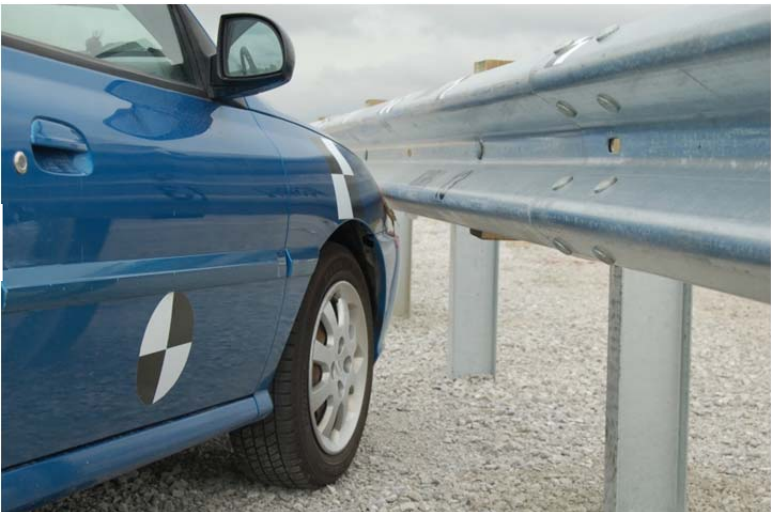
Figure 8. 1100C Next to 32-, 34-, and 36-in. (813-, 864-, and 914-mm) MGS – Rear View

Another key geometric factor is the vehicle to rail relationship, as shown in Figures 8 and 9. When the rail is mounted at a height of 32 in. (813 mm), the rail no longer contacts the bumper—its contact is primarily with the hood and side quarter panel of the vehicle. Because several tests have successfully passed with that type of contact, the height of the rail may be increased several inches and still successfully capture the vehicle. As shown in Figure 6, the distance between the top of the bumper and the upper edge of the side panel is approximately

Rail snag under the hood did not occur for either test. For the 32-in. (813-mm) tall MGS, the corner of the 1100C vehicle hood was located above the top corrugation of the rail. In test nos. MGSMRH-1 and MGSMRH-2, the corner of the hood was located between the corrugations of the rail, as shown in Figures 8 and 9. As a result, the corner of the hood slid into the valley of the W-beam and crumpled, jarring the hood open.

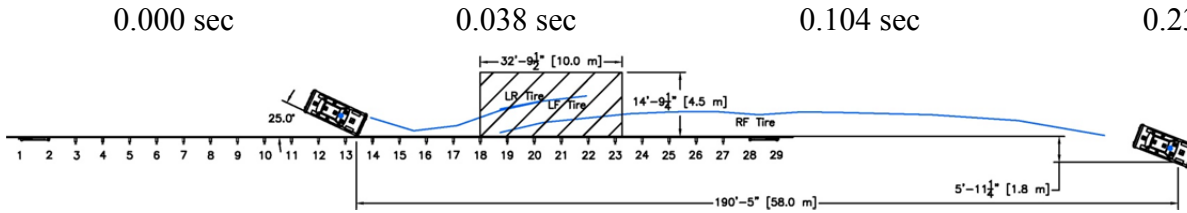
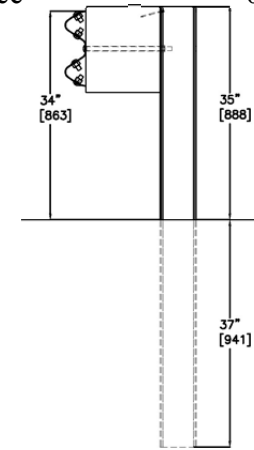
Figure 29. Summary of Test Results and Sequential Photographs, Test No. MGSMRH-1

The analysis of the test results for test no. MGSMRH-1 showed that the 34-in. (864-mm) tall MGS adequately contained and redirected the 1100C vehicle with controlled lateral displacements of the barrier. There were no detached elements nor fragments which showed potential for penetrating the occupant compartment nor presented undue hazard to other traffic. Deformations of, or intrusions into, the occupant compartment that could have caused serious injury did not occur. The test vehicle did not penetrate nor underide the barrier and remained upright during and after the collision. Vehicle roll, pitch, and yaw angular displacements were deemed acceptable because they did not adversely influence occupant risk safety criteria nor

- Vehicle Damage Moderate
 - VDS^[34] 01-RFQ-5
 - CDC^[35] 01-RYAW-5
 - Maximum Interior Deformation 3/4 in. (19 mm)
- Test Article Damage Moderate

Evaluation Criteria		Transducer		MASH Limit
		EDR-3	DTS	
OIV ft/s (m/s)	Longitudinal	-15.56 (-4.74)	-15.84 (-4.83)	≤ 40 (12.2)
	Lateral	-17.65 (-5.38)	-19.03 (-5.80)	≤ 40 (12.2)
ORA g's	Longitudinal	-8.45	-8.41	≤ 20.49
	Lateral	-8.17	-9.19	≤ 20.49
THIV – ft/s (m/s)		NA	22.94 (6.99)	not required
PHD – g's		NA	11.29	not required
ASI		0.90	0.90	not required

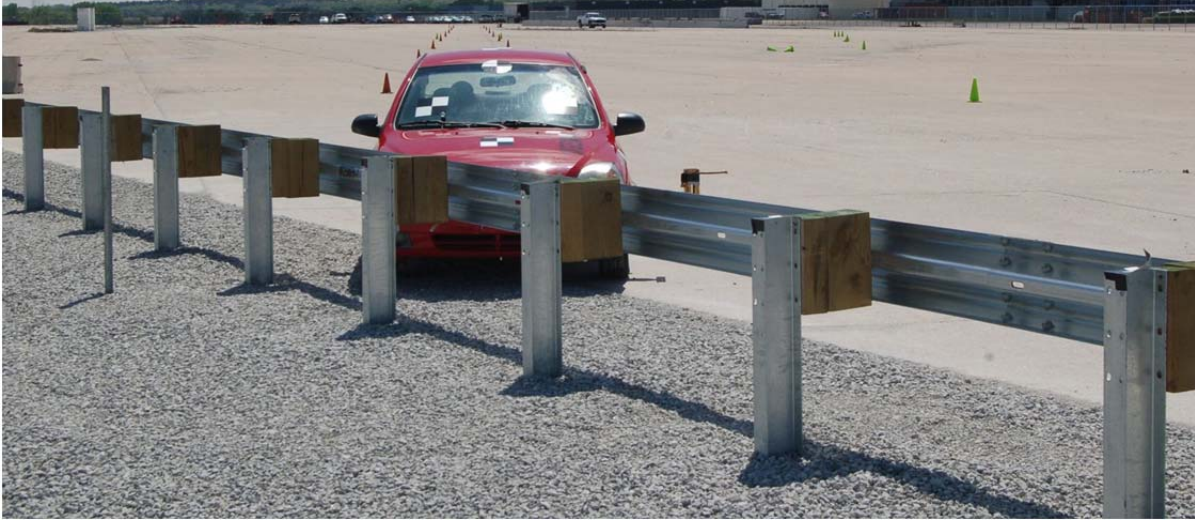
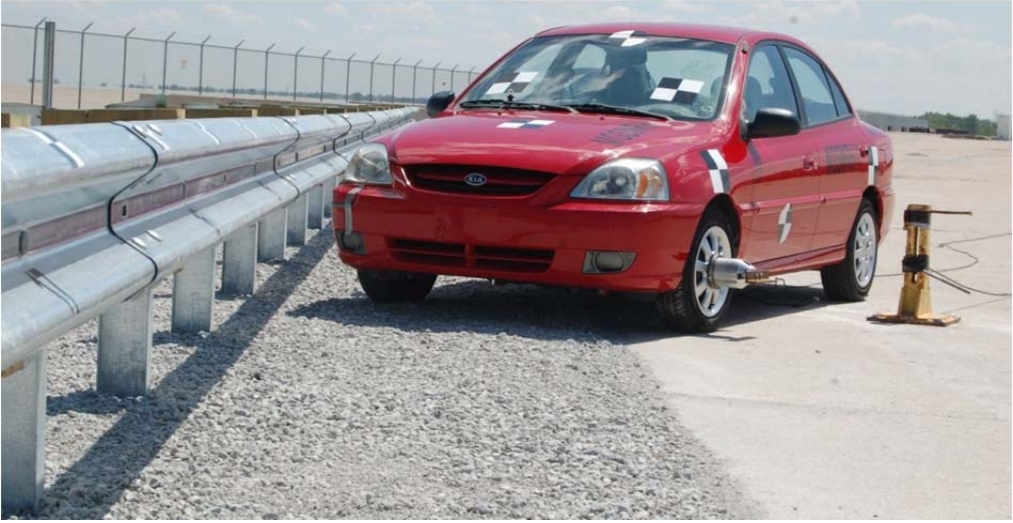
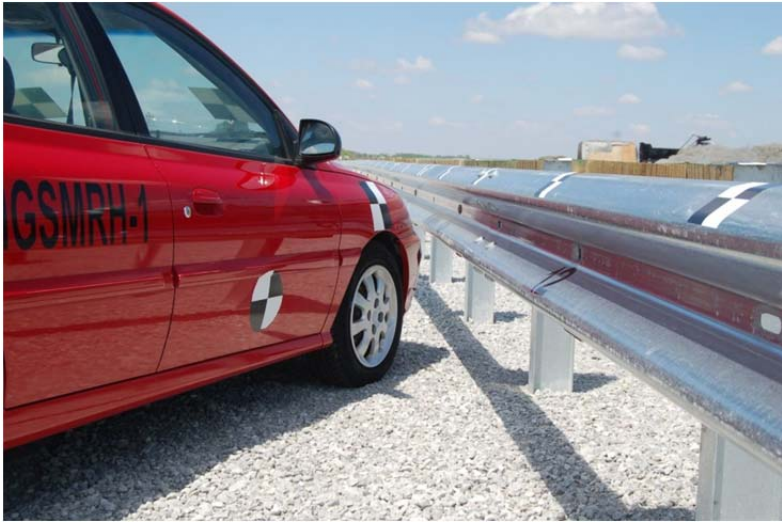
Figure 34. Impact Location, Test No. MGSMRH-1

Initial vehicle impact was to occur 10 ft (3.0 m) upstream of the centerline of post no. 15, as shown in Figure 34, which was selected using the critical impact point (CIP) plots found in Section 2.3 of MASH. The actual point of impact was 10 ft – 1 in. (3.1 m) upstream from the centerline of post no. 15. A sequential description of the impact events is contained in Table 6. The vehicle came to rest facing downstream, located 190 ft – 5 in. (58.0 m) downstream from impact and 5 ft – 11¼ in. (1.8 m) laterally behind the front face of the guardrail. The vehicle trajectory and final position are shown in Figures 29 and 35.

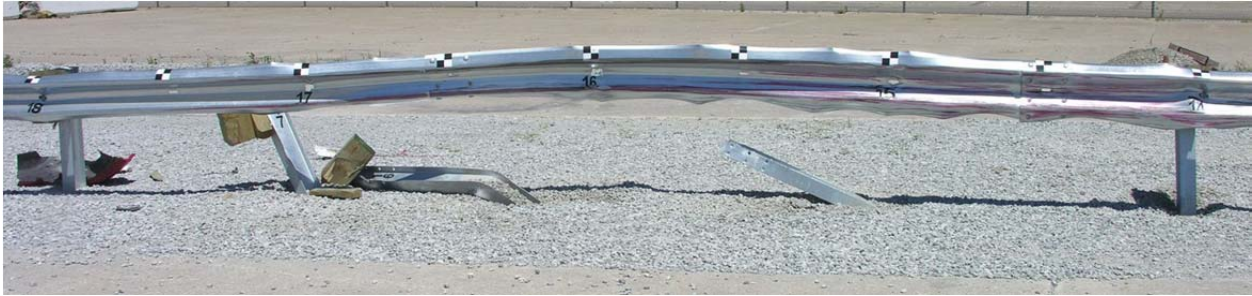
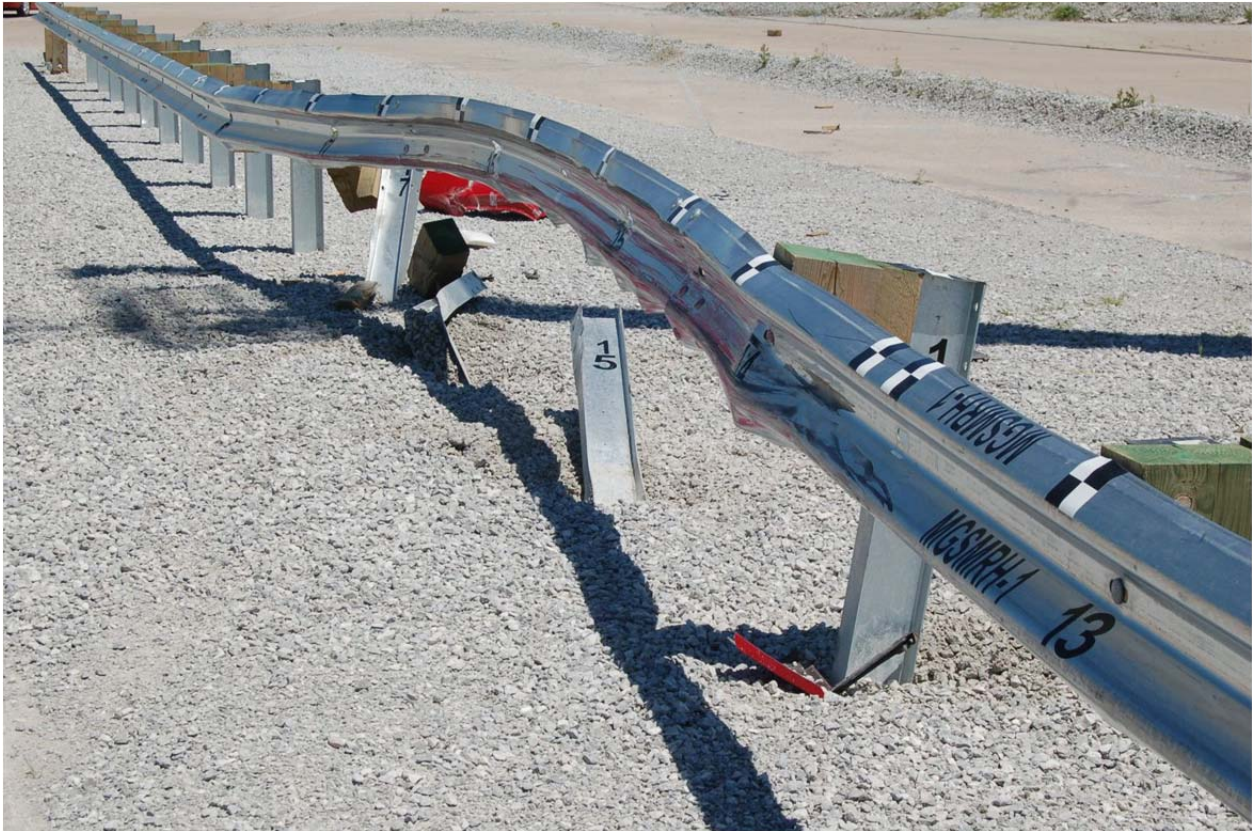
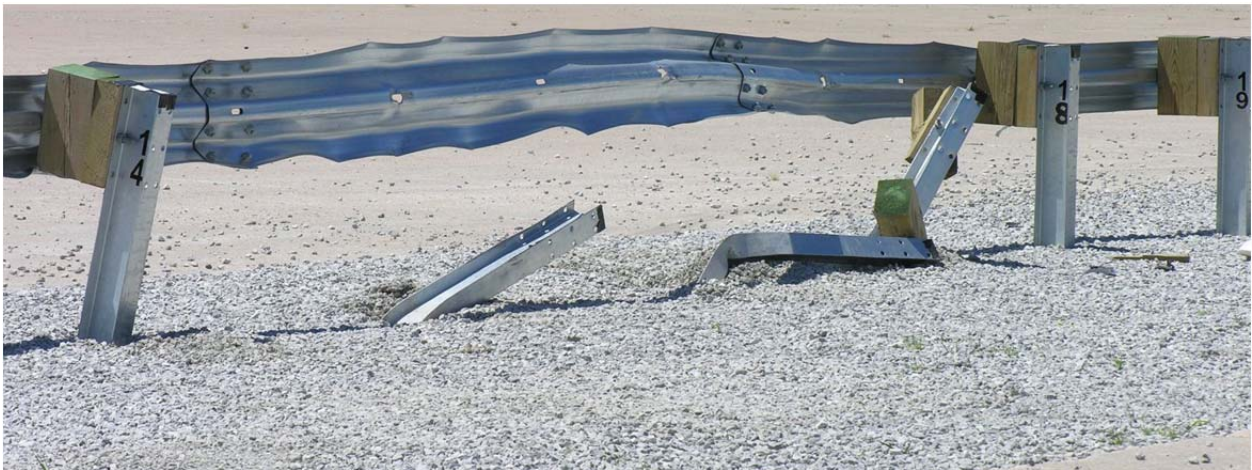
Figure 38. System Damage, Test No. MGSMRH-1

Red paint transfer was found on the rail between the impact location and post no. 18. Minor kinks in the top and bottom corrugations of the rail were found between post nos. 12 and 19, as shown in Figure 38. Flattening and deformation of the rail occurred between post nos. 13 and 18. The bottom corrugation was flattened between post nos. 14 and 16. The bottom edge of the rail was folded upward at post no. 14.

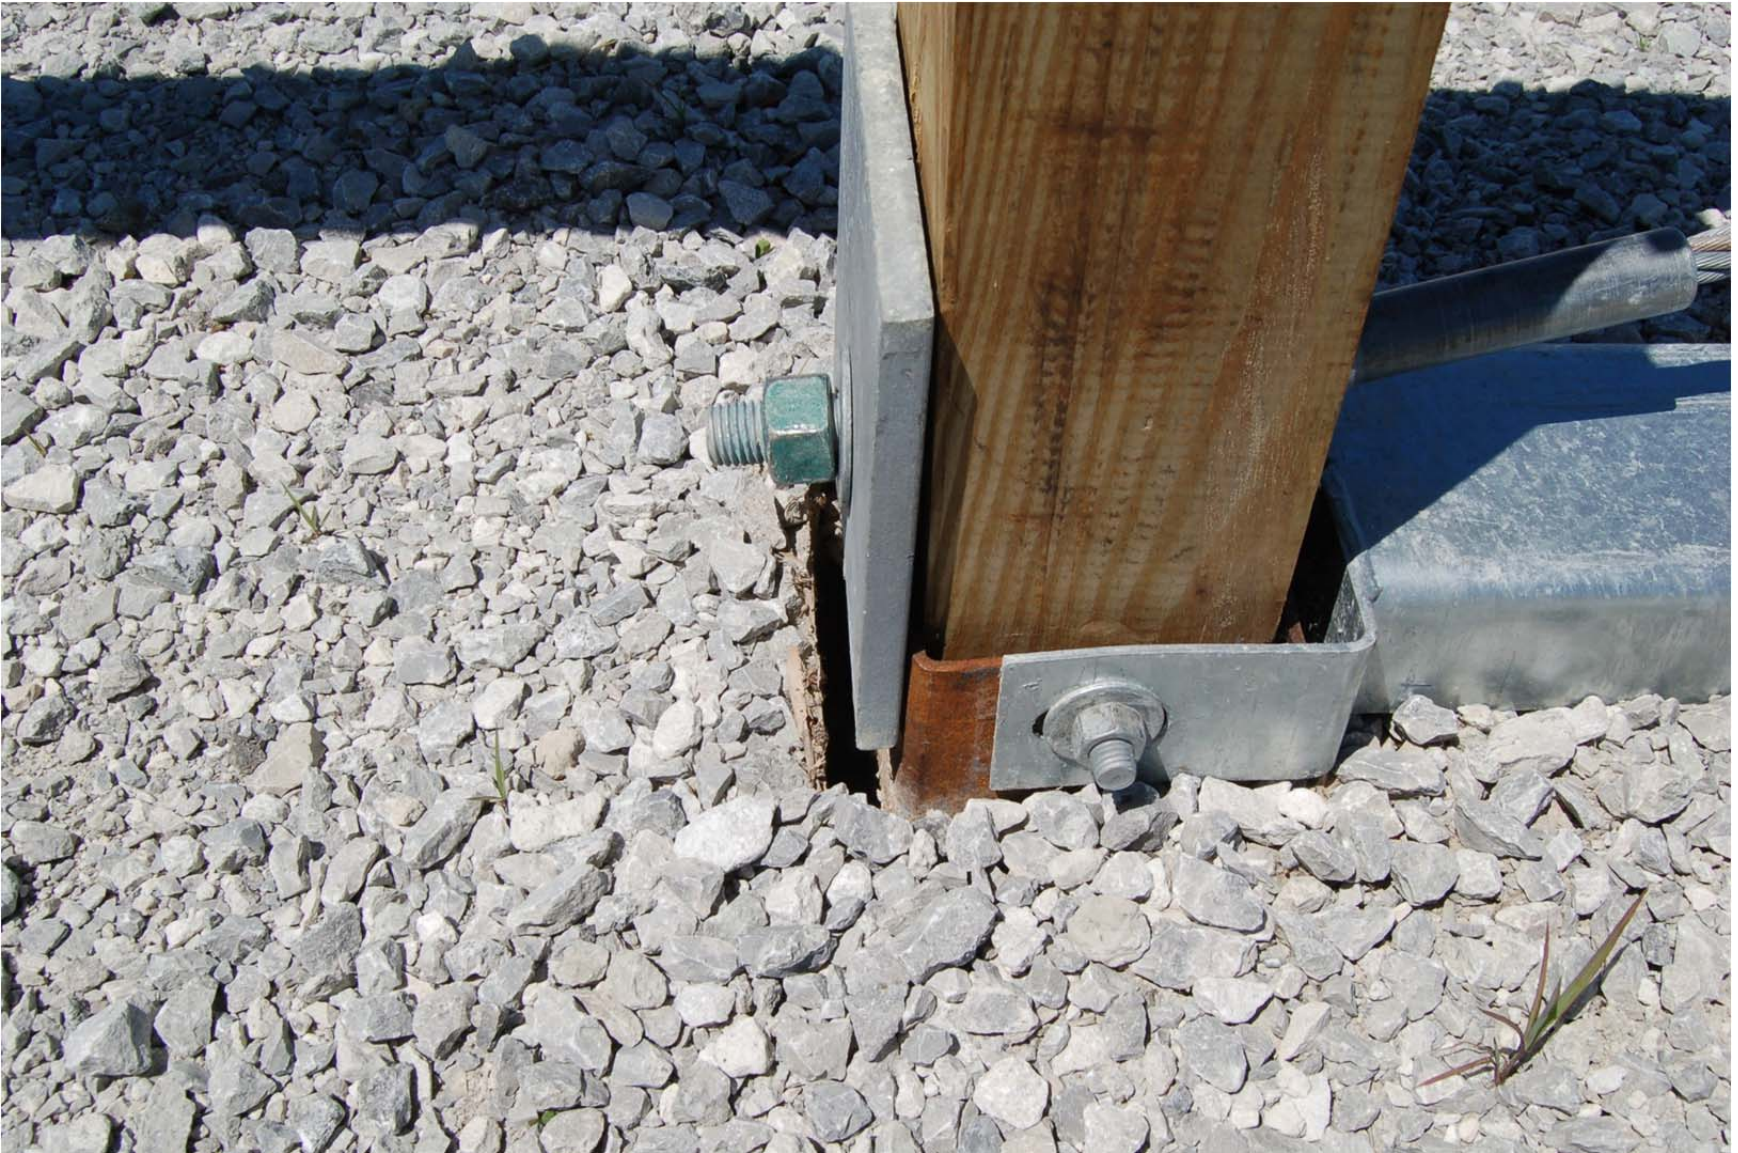
Figure 40. Soil Gap at Upstream End Anchor, Test No. MGSMRH-1

A soil gap measuring $1\frac{1}{2}$ in. (38 mm) was present on the upstream side of post no. 1, as shown in Figure 40. A soil gap measuring $\frac{3}{8}$ in. (10-mm) was present on the downstream side of post no. 2. A $\frac{1}{16}$ -in. (2-mm) soil gap was present on the front face of post nos. 12 and 18. A $1\frac{1}{4}$ -

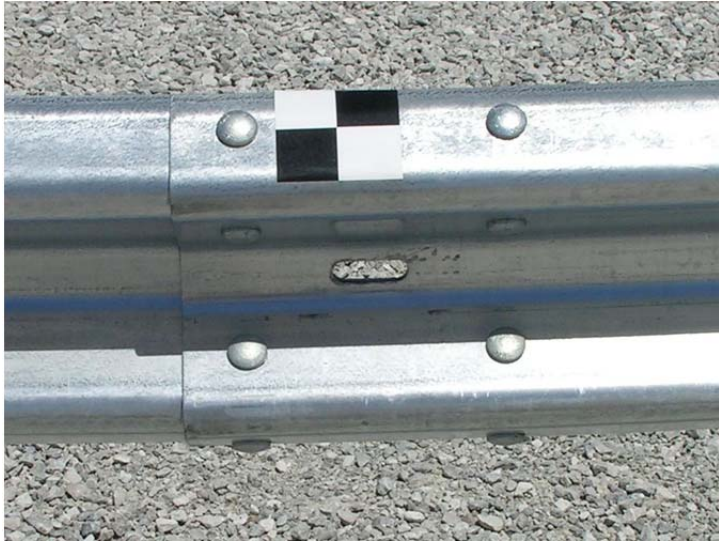
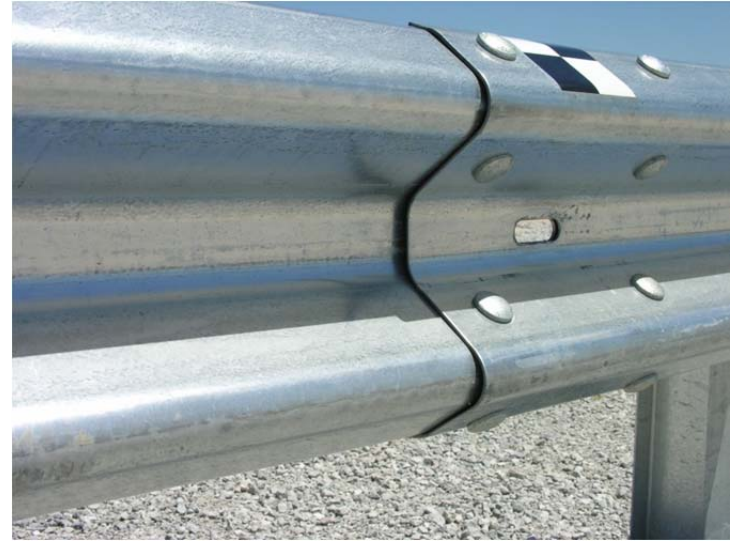
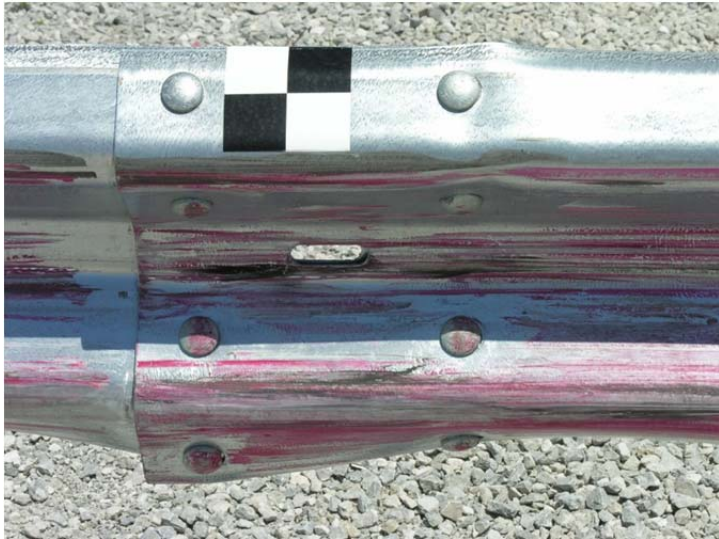
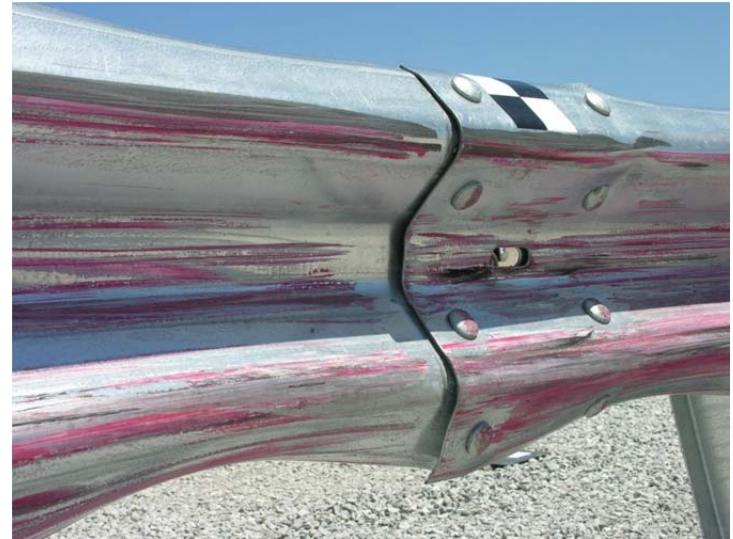
Figure 41. Splice Damage, Test No. MGSMRH-1

The post bolt pulled through the slots in the rail at post nos. 15 through 17. There was a $\frac{3}{4}$ -in. (19-mm) long tear in the bolt slot at post no. 15. There was a $2\frac{1}{4}$ -in. (57-mm) long tear and a $1\frac{1}{2}$ -in. (38-mm) long tear on the upstream and downstream sides, respectively, of the bolt slot on post no. 16. There was a $1\frac{1}{4}$ -in. (32-mm) long tear and a 1-in. (25-mm) long tear on the upstream and downstream sides, respectively, of the bolt slot on post no. 17. There was a $\frac{3}{8}$ -in. (10-mm) lateral separation between the W-beam sections in the splices between post nos. 12 and 13 and between post nos. 14 and 15. The splices between post nos. 14 and 15, 16 and 17, and 18 and 19 were extended $\frac{1}{8}$ in. (3 mm) longitudinally. The splice damage is shown in Figures 41 and 42.

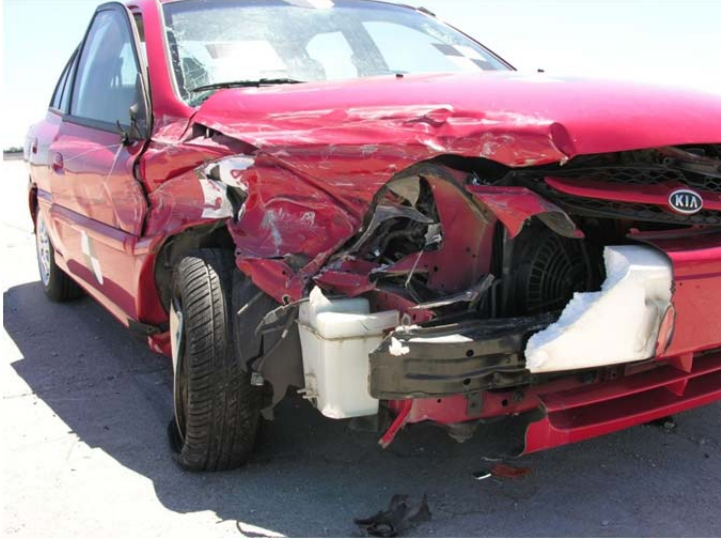
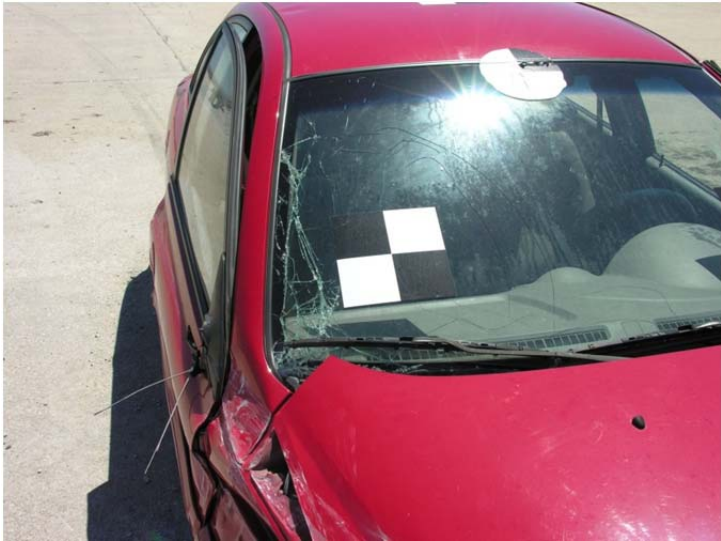
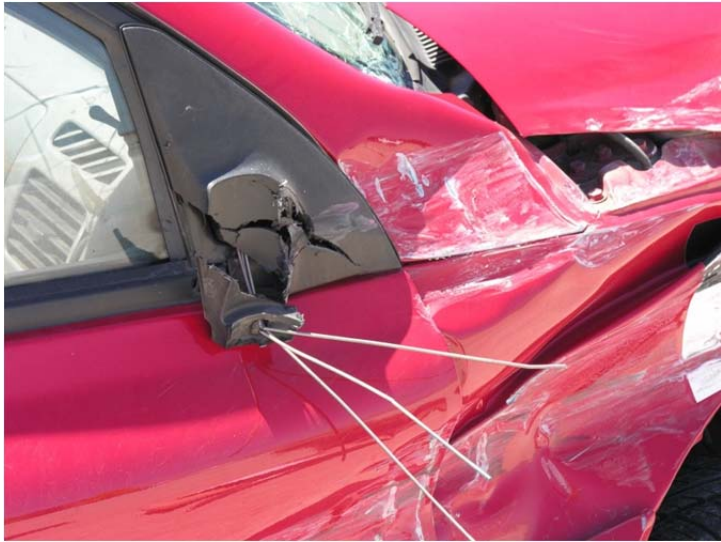
Figure 47. Vehicle Damage, Test No. MGSMRH-1

The damage to the vehicle was moderate, as shown in Figures 46 through 49. The maximum occupant compartment deformations are listed in Table 7 alongside the deformation limits established in MASH for various areas of the occupant compartment. It should be noted that none of the MASH established deformation limits were violated. Complete occupant compartment and vehicle deformations and the corresponding locations are provided in Appendix D.

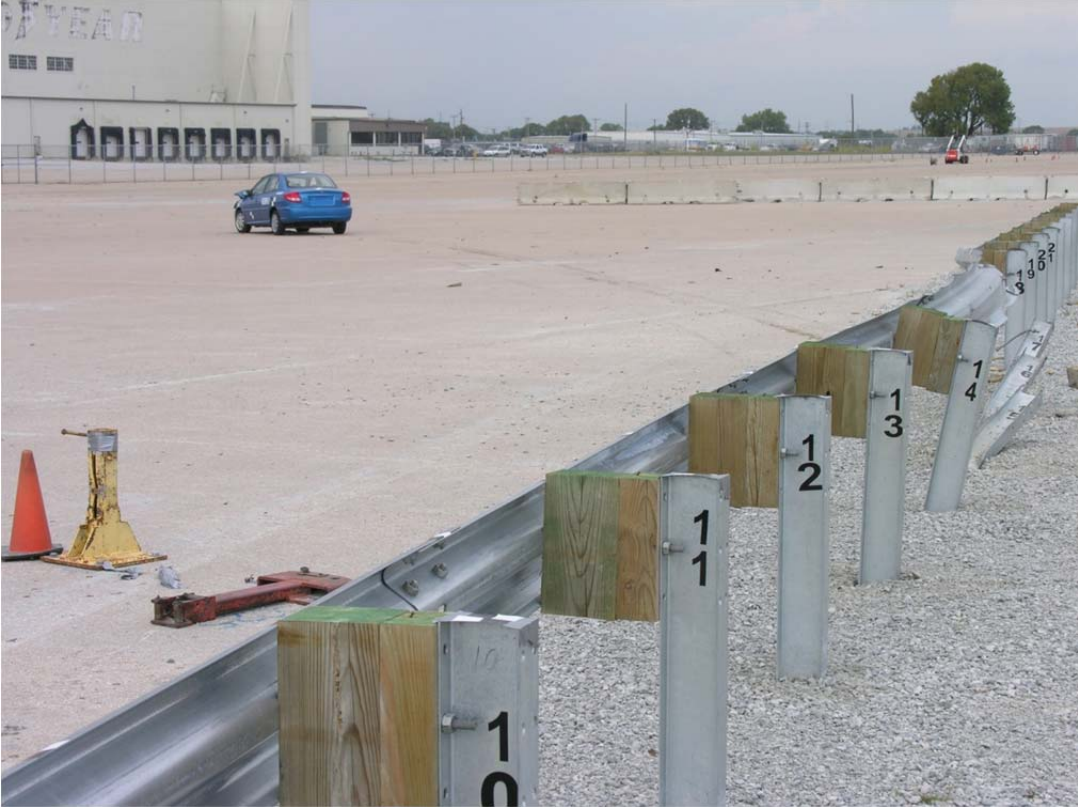
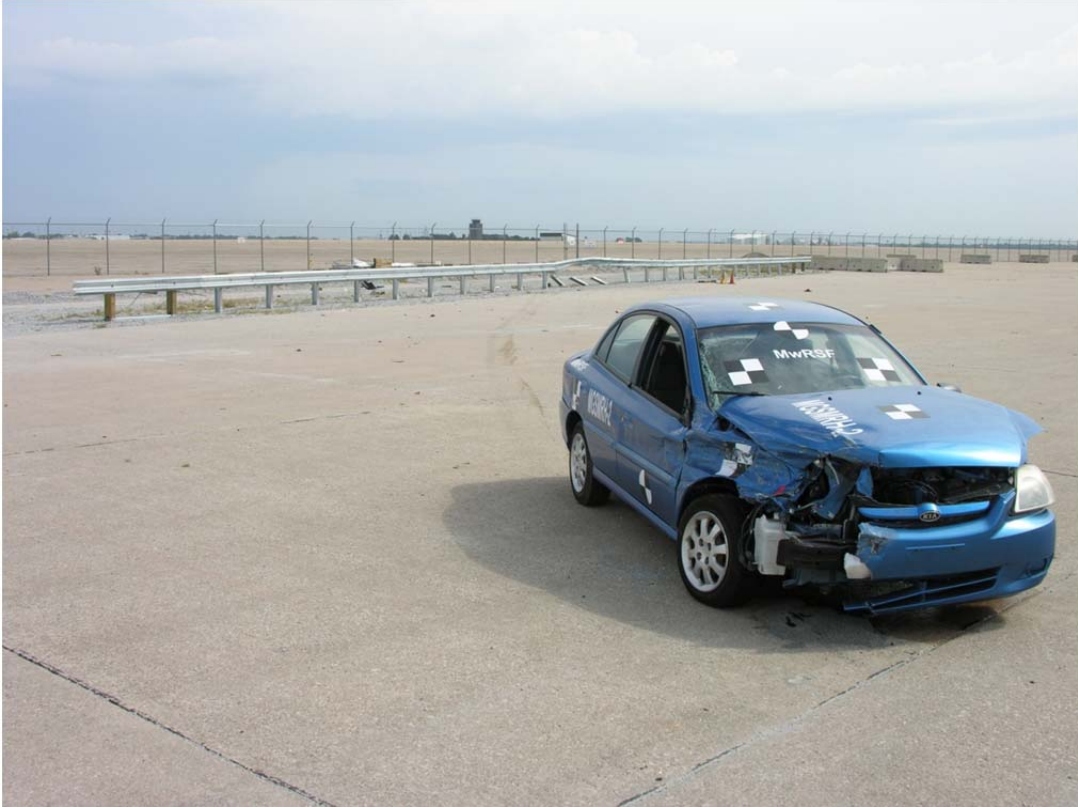
Figure 60. Vehicle Final Position and Trajectory Marks, Test No. MGSMRH-2

Initial vehicle impact was to occur 10 ft (3.0 m) upstream of the centerline of post no. 15, as shown in Figure 59, which was selected using the CIP plots found in Section 2.3 of MASH. The actual point of impact was 9 ft – 8 in. (2.9 m) upstream of post no. 15. A sequential description of the impact events is contained in Table 10. The vehicle came to rest facing downstream at 129 ft – 9 in. (39.5 m) downstream of the initial impact point and 61 ft – 1 in. (18.6 m) laterally away from the front of the rail. The vehicle trajectory and final position are shown in Figures 54 and 60.

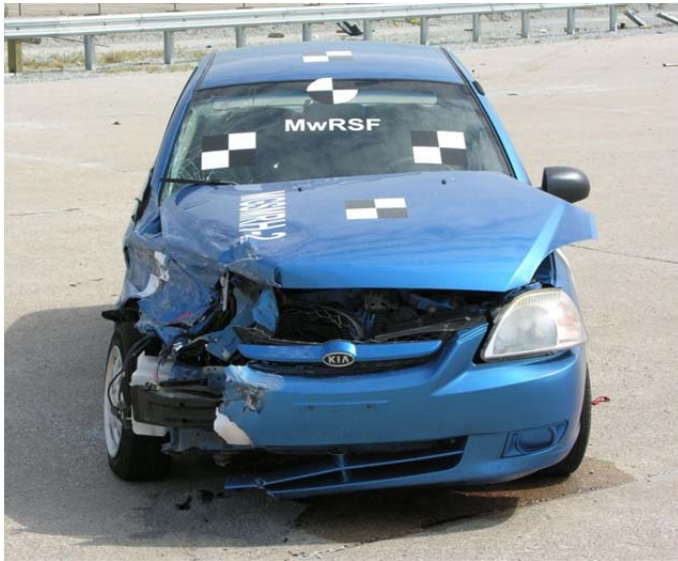
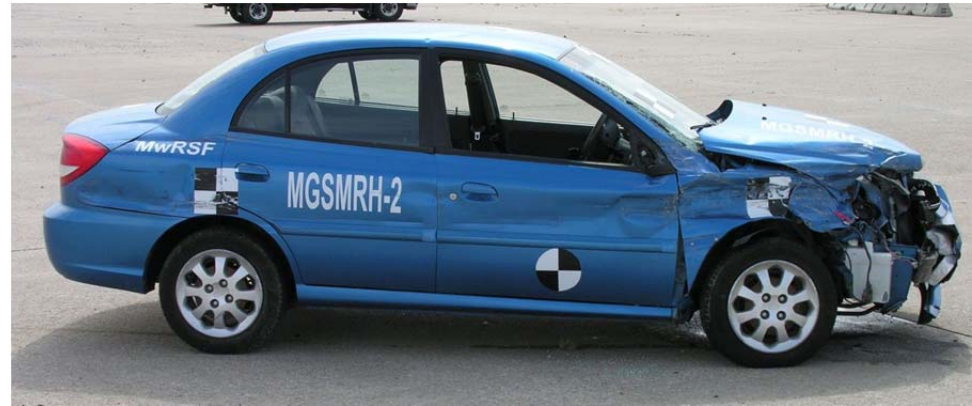
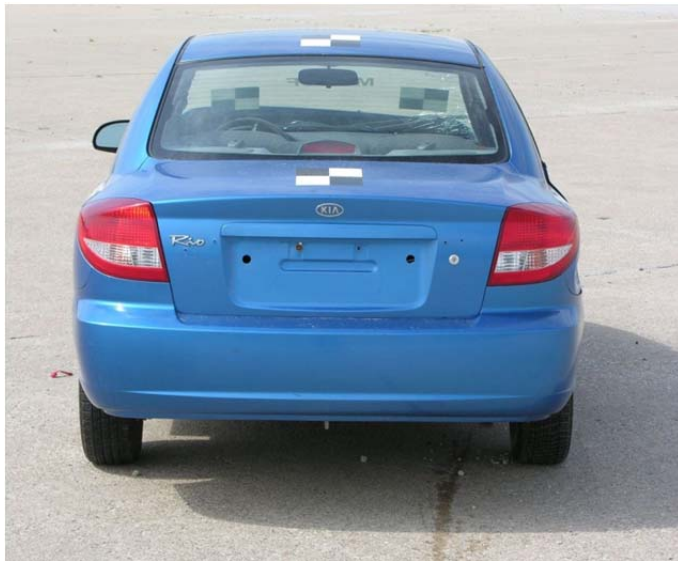
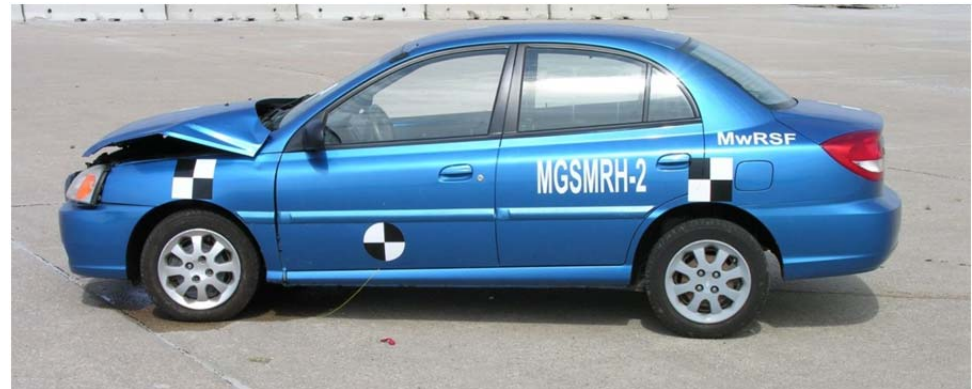
Figure 68. Vehicle Damage, Test No. MGSMRH-2

The damage to the vehicle was moderate, as shown in Figures 68 through 71. The maximum occupant compartment deformations are listed in Table 11 with the deformation limits established in MASH for various areas of the occupant compartment. It should be noted that none of the MASH established deformation limits were violated. Complete occupant compartment and vehicle deformations and the corresponding locations are provided in Appendix D.

The majority of the damage was concentrated on the right-front corner and right side of the vehicle where the impact occurred. The right fender was crushed back and inward. A fold was present in the right fender above the wheel. The right-front wheel was scuffed. The right-

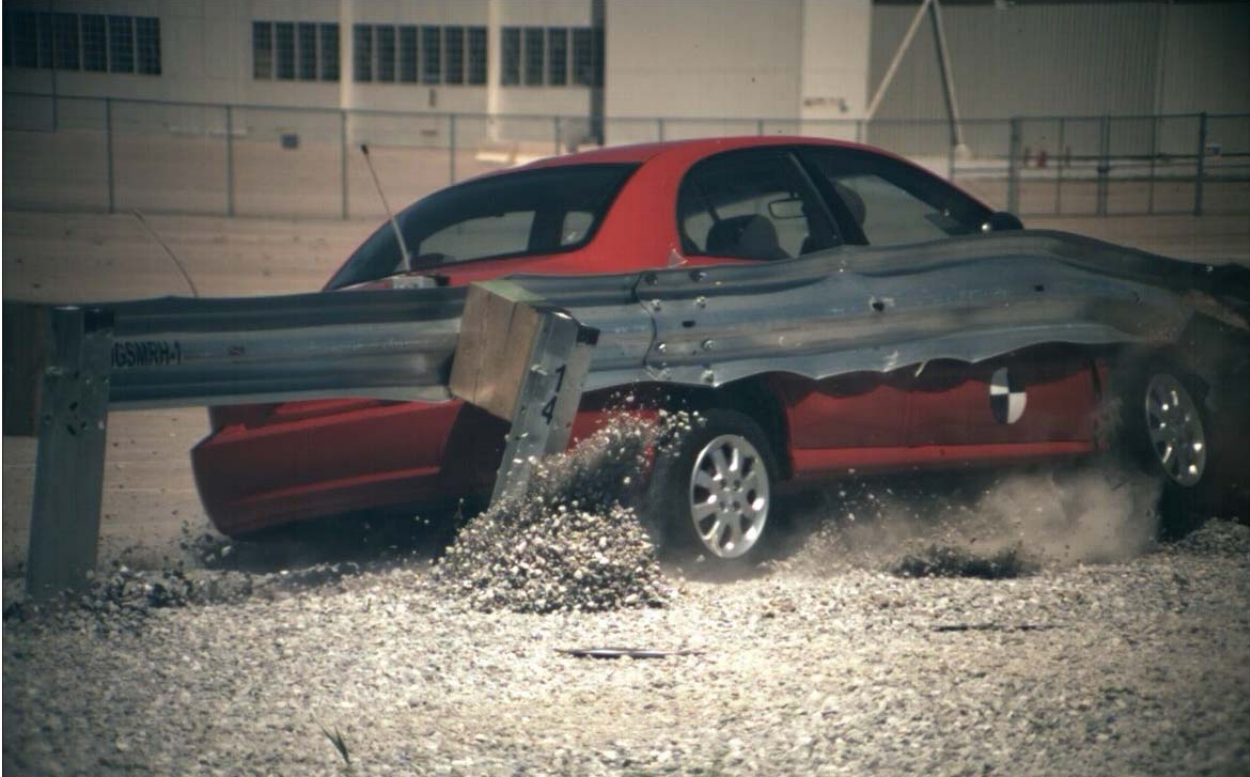
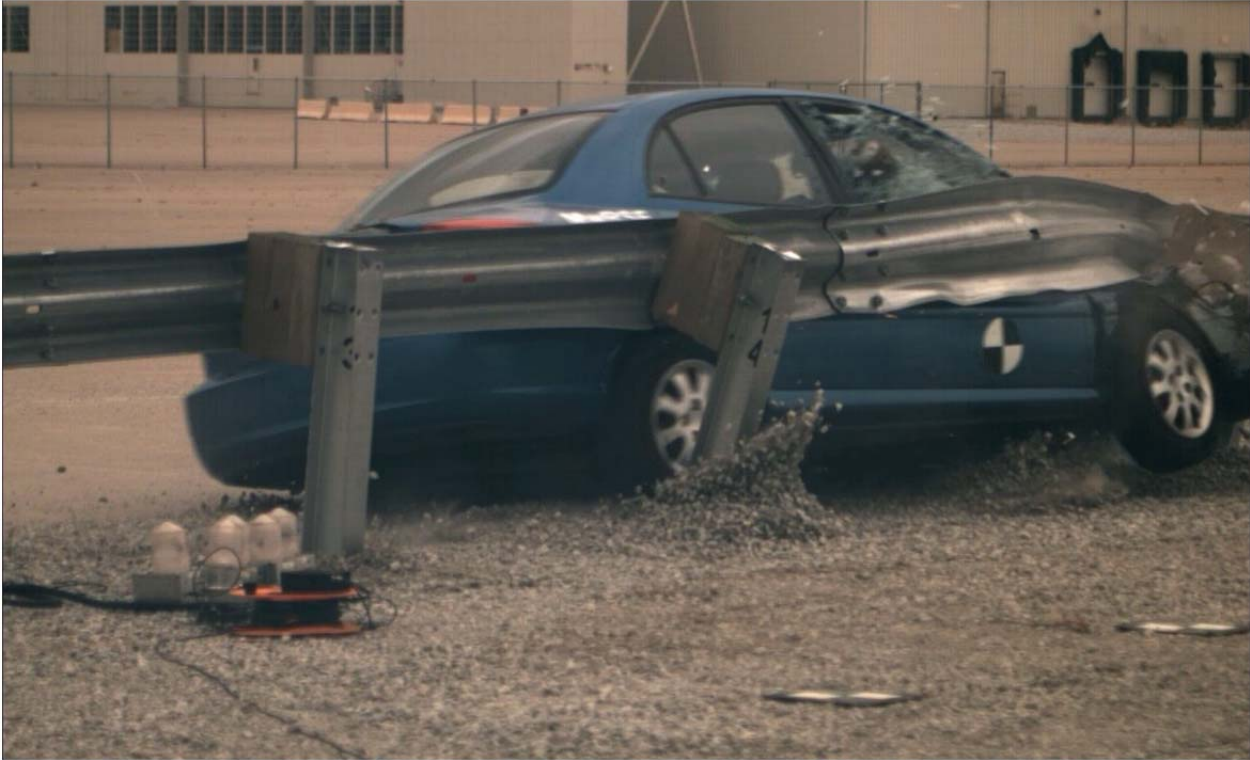
Figure 72. Vehicle-to-Rail Interaction

During redirection, the rail deflected upward as it released from the posts and slid up the side of the vehicle. The vehicle contacted the detached posts and overrode them, which caused the vehicle to pitch upward and roll away from the barrier, as shown in Figures 72 and 73. In both tests, the vehicle reached a maximum roll angle of about 11 degrees and pitched upward about 2 degrees. As the vehicle rolled away from the barrier, the right side of the vehicle that was in contact with the rail moved upward. As a consequence, the rail slid up the vehicle, contacted the base of the A-pillar, and did not slide any higher. At this same time, the rail was applying a downward force on the vehicle which counteracted the vehicle roll.

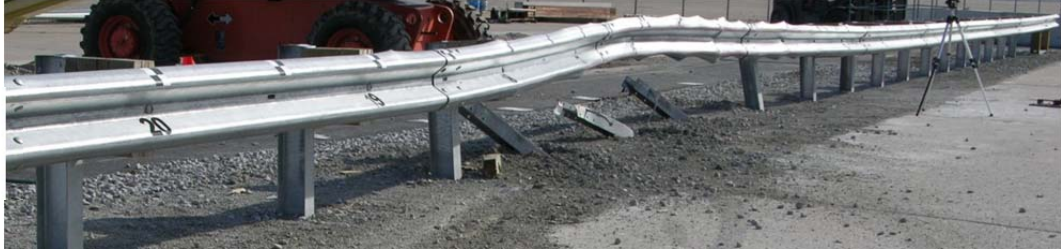
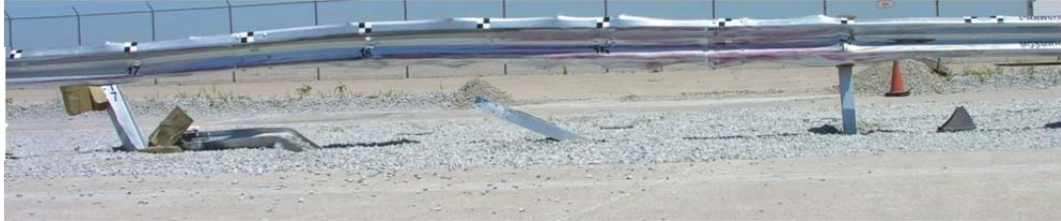
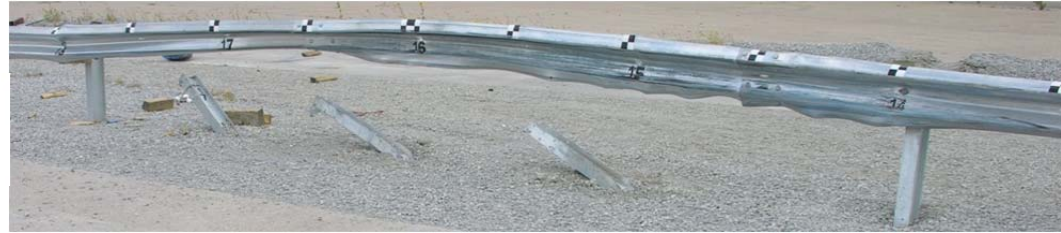
Figure 74. System Damage Comparison

System damage differed between the 32-, 34-, and 36-in. (813-, 864-, and 914-mm) tall MGS, as shown in Figure 74. In test no. 2214MG-3, the 32-in. (813-mm) tall MGS rail did not fully flatten, although rail kinking occurred between post nos. 13 and 17 and the rail lifted approximately 1½ in. (38 mm). In test no. MGSMRH-1, the 34-in. (864-mm) MGS rail was not fully flattened, but the corrugations were compressed between post nos. 14 and 17, and the rail lifted approximately 2½ in. (64 mm). In test no. MGSMRH-2, the lower corrugation of the 36-in. (914-mm) tall MGS was flattened beginning at the splice between post nos. 14 and 15 and ending at the splice between post nos. 16 and 17. The rail was lifted approximately 3 in. (76 mm), and the degree of rail twist was greater than the twist in the 32- and 34-in. (813- and 864-mm) tall MGS.

The post-soil interaction also differed between the systems. Soil comparisons cannot be made between test no. 2214MG-3 and test nos. MGSMRH-1 and MGSMRH-2, as the soil compaction method was not the same. The lateral post deflections seen in test no. MGSMRH-1 were, on average, larger than the lateral post deflections seen in test no. MGSMRH-2. The static soil strength data for each system is shown in Figure 75. The 34-in. (864-mm) tall MGS had slightly stiffer soil at the time of the test, but the overall rail deflection was greater than the deflection of the 36-in. (914-mm) tall MGS. However, more posts were deformed during the test of the 36-in. (914-mm) tall MGS.

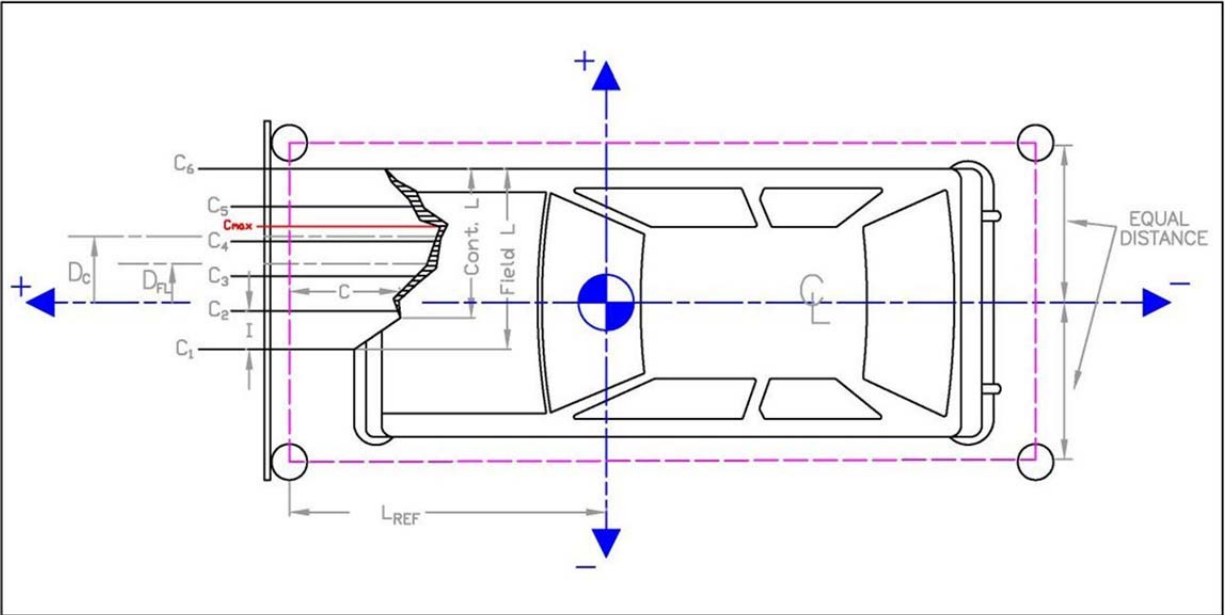
Figure D-5. Exterior Vehicle Crush (NASS) - Front, Test No. MGSMRH-1

in.	(mm)
Distance from C.G. to reference line - L_{REF} :	77	(1956)
Width of contact and induced crush - Field L:	32.125	(816)
Crush measurement spacing interval (L/5) - I:	6.425	(163)
Distance from center of vehicle to center of Field L - D_{FL} :	16.0625	(408)
Width of Contact Damage:	28.125	(714)
Distance from center of vehicle to center of contact damage - D_C :	18.0625	(459)

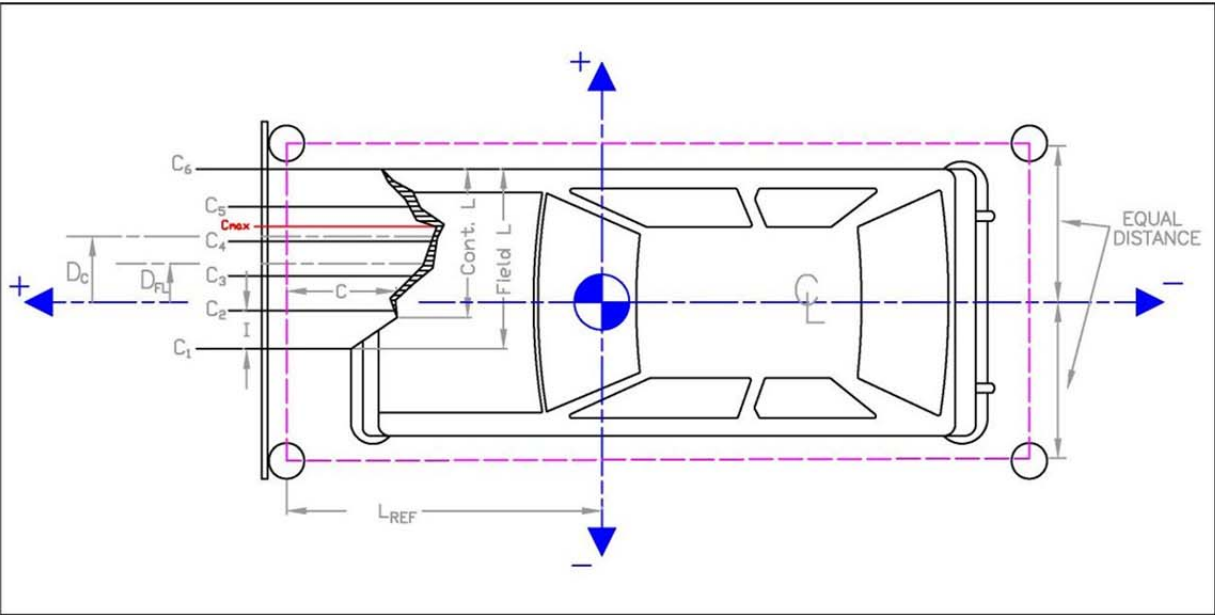
Figure D-11. Exterior Vehicle Crush (NASS) - Front, Test No. MGSMRH-2

in.	(mm)
Distance from C.G. to reference line - L _{REF} :	71.75	(1822)
Width of contact and induced crush - Field L:	32.375	(822)
Crush measurement spacing interval (L/5) - I:	6.475	(164)
Distance from center of vehicle to center of Field L - D _{FL} :	16.1875	(411)
Width of Contact Damage:	25.375	(645)
Distance from center of vehicle to center of contact damage - D _C :	19.6875	(500)
