Determination of the Maximum MGS Mounting Height -- Phase I Crash Testing

*Midwest States Regional Pooled Fund Research Program
Fiscal Year 2009-2010 (Year 20)
Research Project Number TPF-5(193)
NDOR Sponsoring Agency Code RFPF-10-MGS*

DETERMINATION OF THE MAXIMUM MGS MOUNTING HEIGHT – PHASE I CRASH TESTING

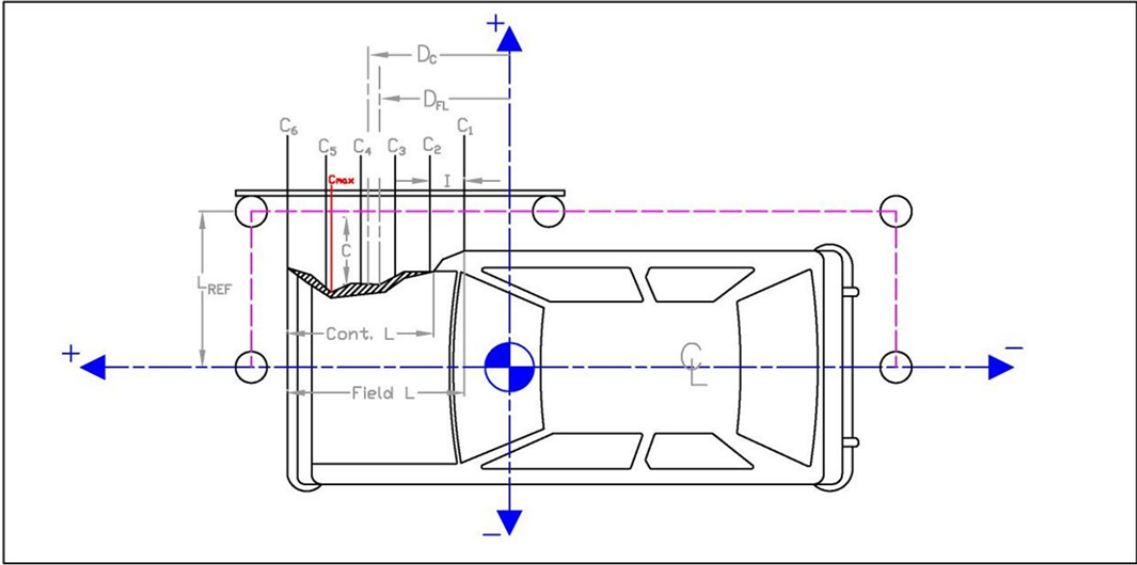
Figure D-12. Exterior Vehicle Crush (NASS) - Side, Test No. MGSMRH-2

in.	(mm)
Distance from centerline to reference line - L _{REF} :	39	(991)
Width of contact and induced crush - Field L:	90.75	(2305)
Crush measurement spacing interval (L/5) - I:	18.15	(461)
Distance from vehicle c.g. to center of Field L - D _{FL} :	24.375	(619)
Width of Contact Damage:	90.75	(2305)
Distance from vehicle c.g. to center of contact damage - D _C :	50.25	(1276)
