Development and Evaluation of Weak-Post W-Beam Guardrail in Mow Strips

Report # MATC-UNL: 206

Final Report
WBS:25-1121-0003-206

16. Abstract <p>The objective of this study was to adapt and evaluate a weak-post, W-beam guardrail system for use within mow strips and other pavements. The weak-post guardrail system was originally designed as the MGS bridge rail and has also been adapted for use on culverts. It was envisioned that the weak-post design would absorb the impact forces and prevent damage to the mow strips, thereby minimizing maintenance and repair costs.</p> <p>Evaluation of the weak posts in mow strips began with three rounds of dynamic bogie testing. Round 1 of bogie testing showed that 4-in. (102-mm) thick concrete would sustain only minor spalling from impacts to the posts. However, the posts would push through 4-in. and 6-in. (102-mm and 152-mm) thick asphalt mow strips. During Round 2, 24-in. (610-mm) long, 4-in. x 4-in. (102-mm x 102-mm) sockets with 10-in. x 9-in (254-mm x 229-mm) shear plates were utilized to better distribute the impact load to the asphalt pavement and prevent damage. However, Round 3 of bogie testing consisted of dual-post impacts, and the asp

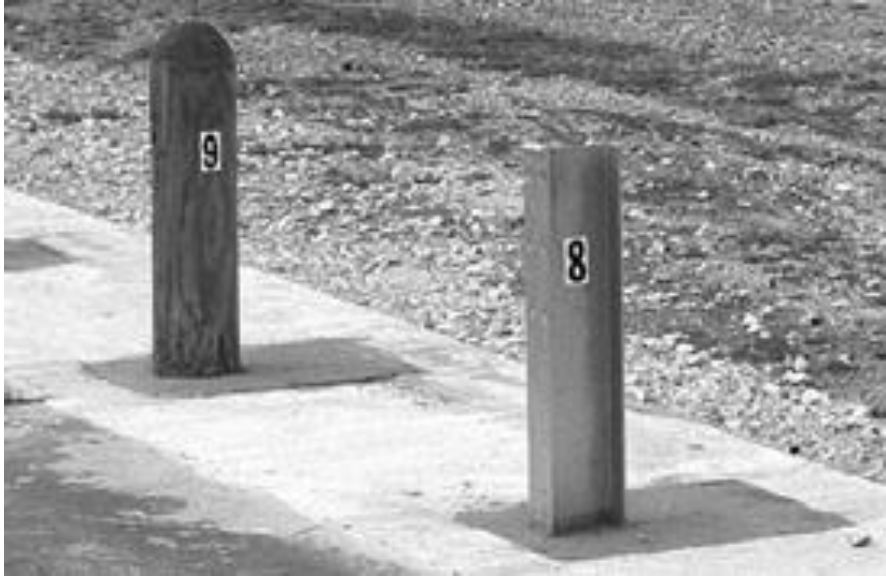
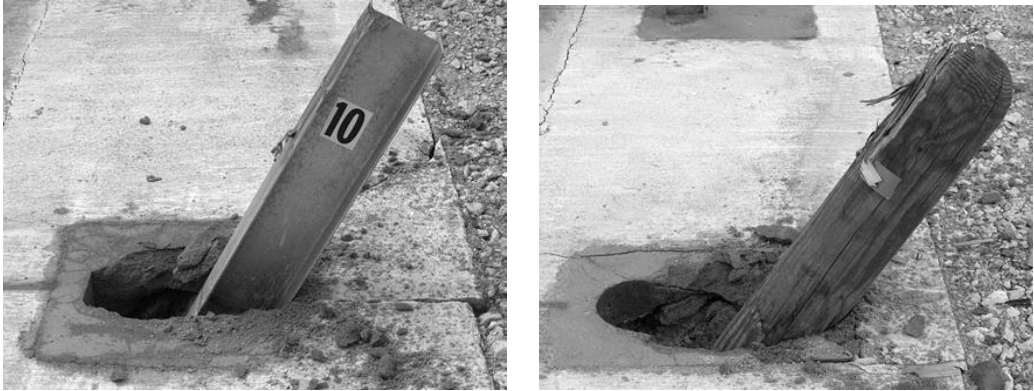
Figure 1. Pre- and Post-Test Photos of Posts in Grout-Filled Leave-Outs [3]

Currently, guardrail posts installed within mow strips have required a blocked-out area or “leave-out” that surrounds each post. Leave-outs allow posts to rotate through the soil, which results in acceptable safety performances for standard W-beam guardrails [3-6]. Many leave-out designs incorporate weak cement, grout mixes, or rubber/foam pads that restrict plant growth but crumble away under impact loads. After an impact event, the debris is removed, soil is retamped, a new post is driven into place, and a new batch of the weak cement/grout is poured into the leave-out. Therefore, significant effort is required to reset a post after an impact. Examples of typical grout-filled leave-outs before and after impact are shown in Figure 1.

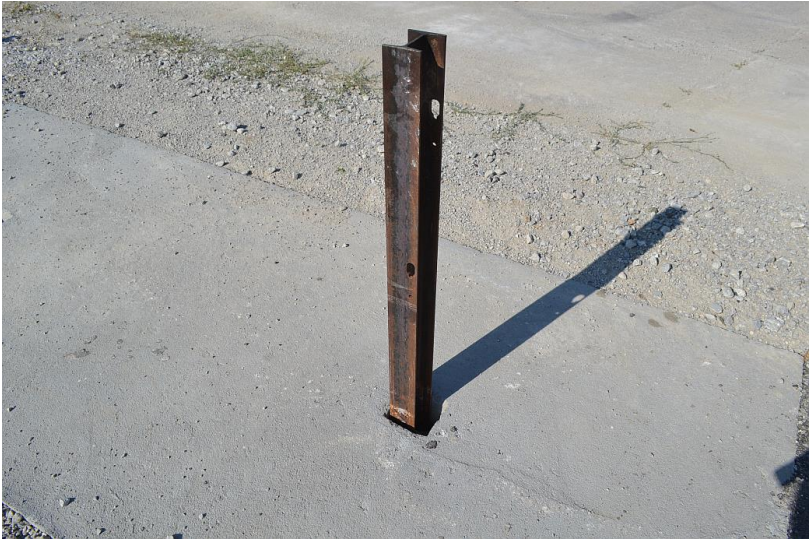
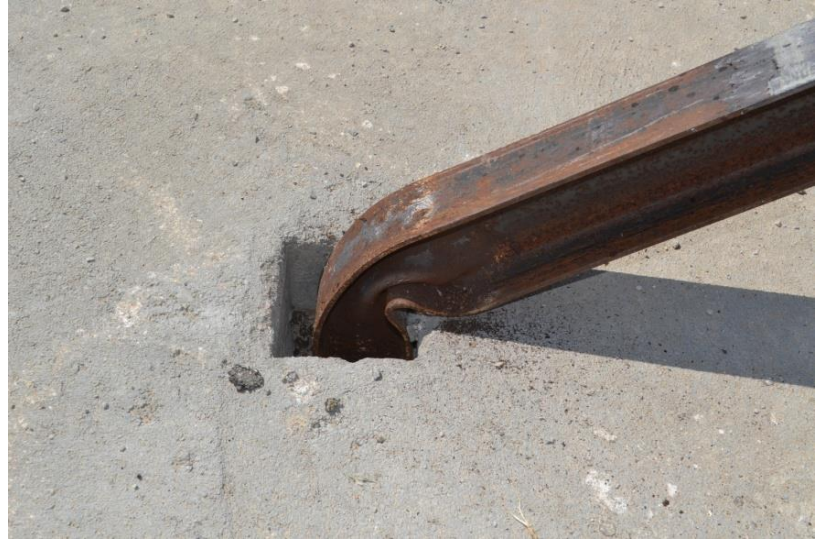
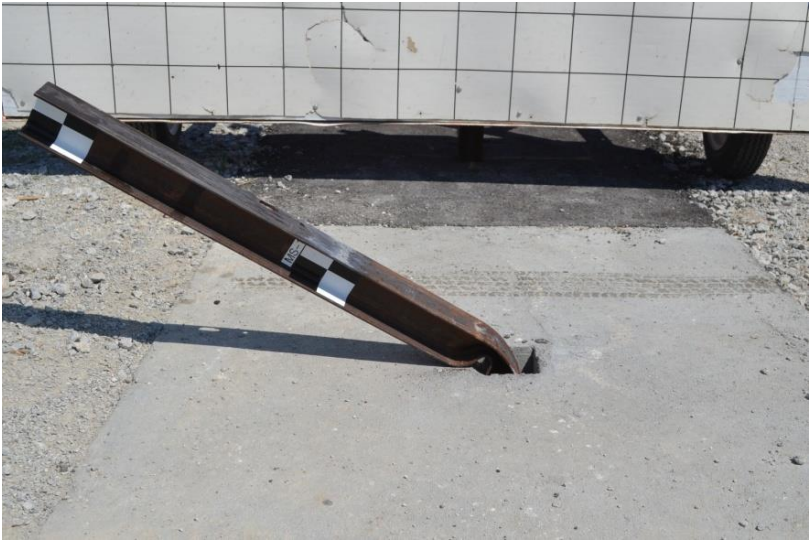
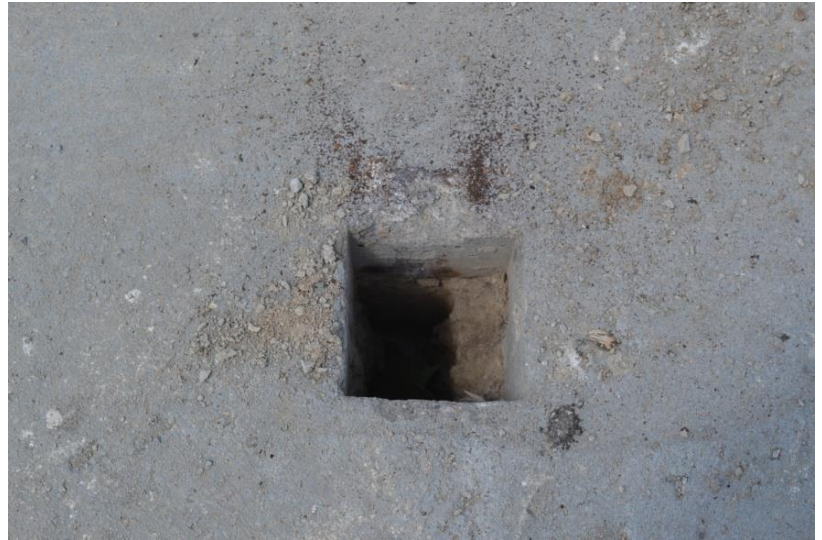
Figure 9. Pre- and Post-Impact Photographs, Test No. MS-1

Damage to the test article consisted of plastic bending of the post at the groundline and minimal surface spalling at the back edge of the concrete hole. The spalling was less than ¼ in. (6 mm) deep, and cracking was not evident. The post was removed without causing further damage. Thus, a new post could be installed without repairs to the concrete. Time-sequential photographs and pre- and post-impact photographs are shown in Figures 8 and 9, respectively.

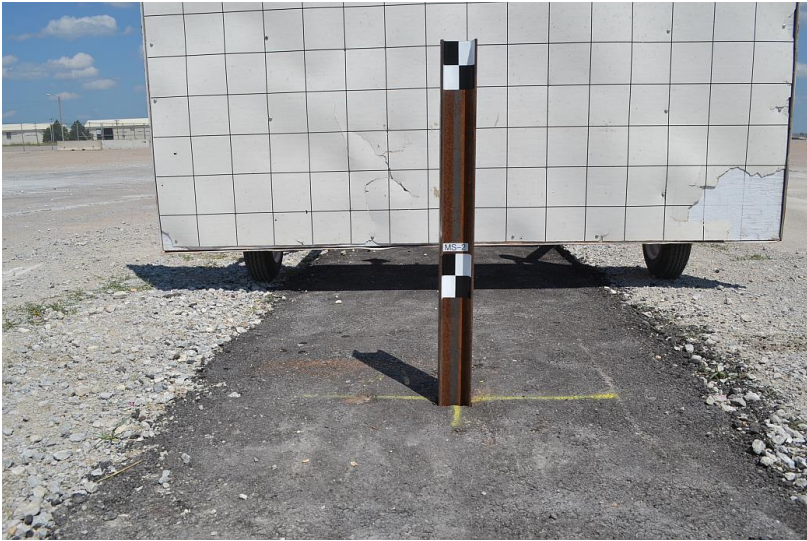
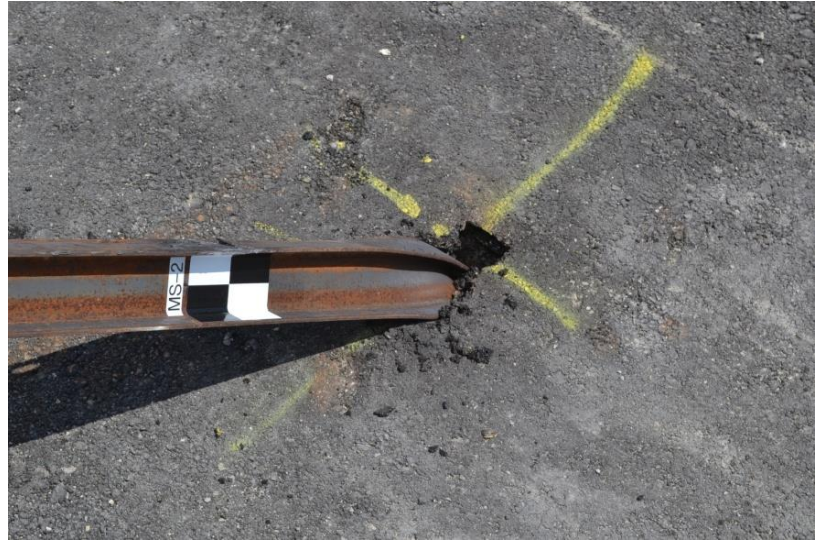
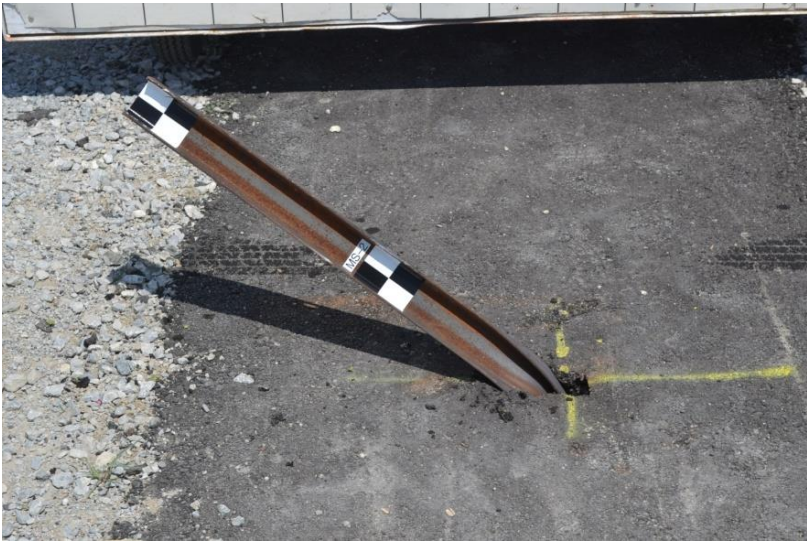
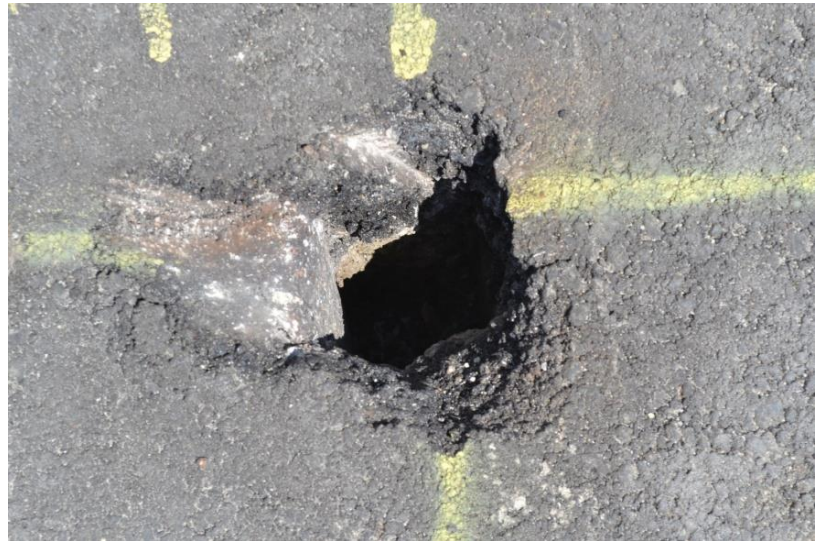
Figure 12. Pre- and Post-Impact Photographs, Test No. MS-2

Damage to the test article consisted of plastic bending of the post at the groundline and displacement and spalling of the asphalt. The post displaced backward approximately 2.5 in. (64 mm) into the asphalt mow strip, which caused displacement and spalling of the asphalt. Removal of the post caused further spalling and cracking to the asphalt. Time-sequential photographs and pre- and post-impact photographs are shown in Figures 11 and 12, respectively.

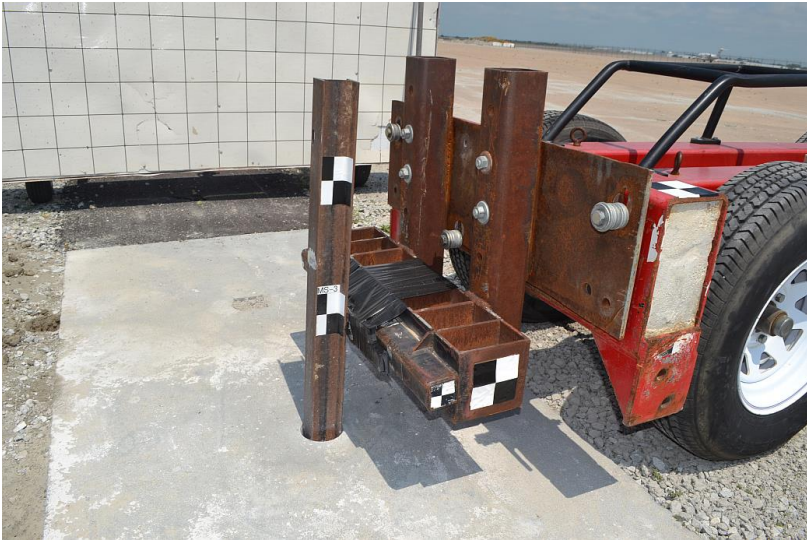
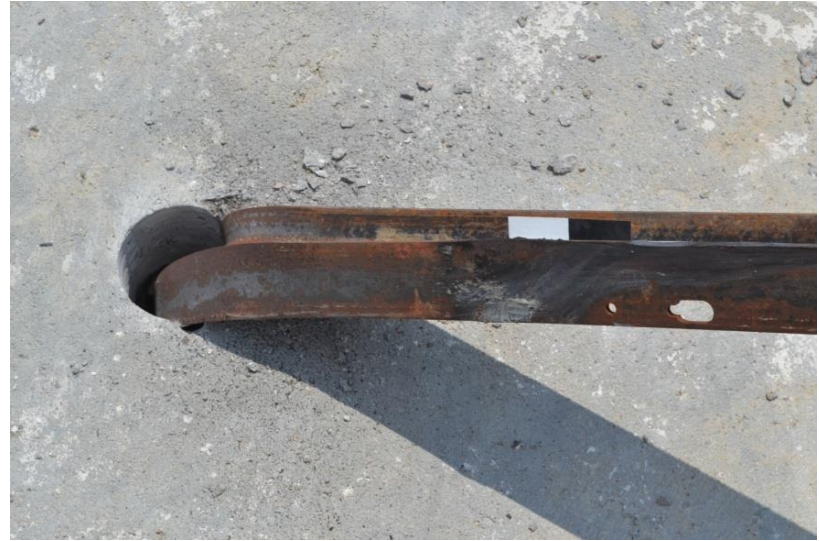
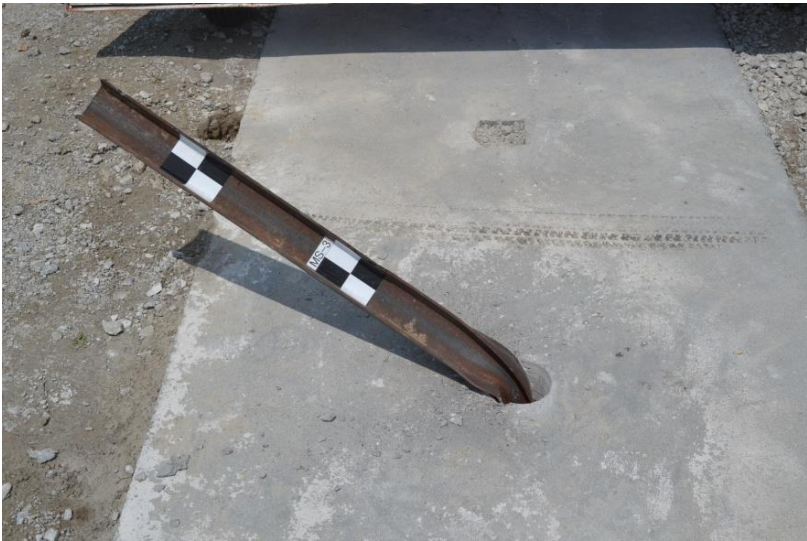
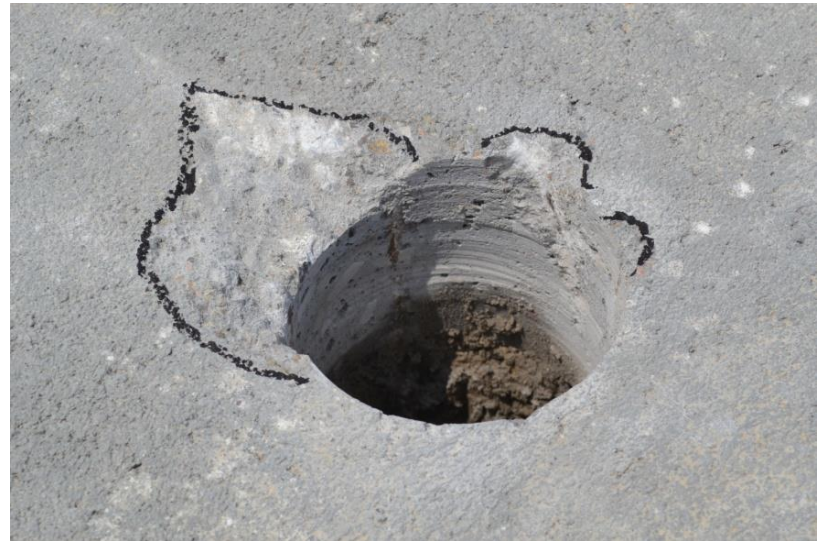
Figure 15. Pre- and Post-Impact Photographs, Test No. MS-3

Damage to the test article consisted of plastic bending of the post at the groundline and some surface spalling at the back edge of the concrete hole. However, the spalling was less than ¼ in. (6 mm) deep, and cracking was not evident. The post was removed without causing further damage, so a new post could be installed without repairs to the concrete. Time-sequential photographs and pre- and post-impact photographs are shown in Figures 14 and 15, respectively.
