Pavement Quality Indicators Study

Five Year Report

**Construction Management Department
University of Nebraska
Lincoln, NE 68588-0500**

**Researcher: Cody Kluver
Advisor: Wayne Jensen**

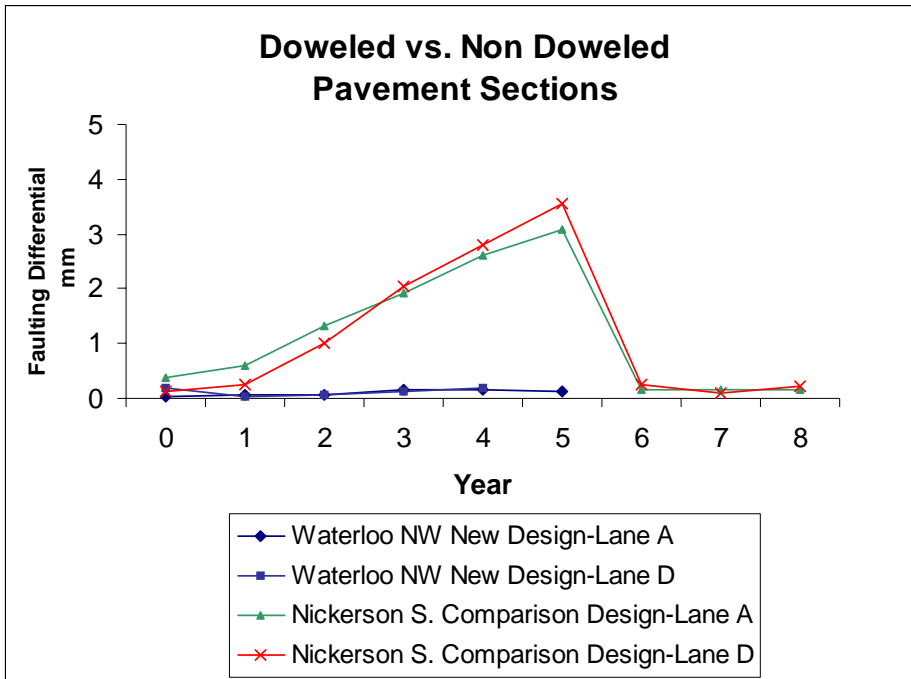
Figure 1.1: Faulting Differential, Waterloo NW and Nickerson South

This graph shows how the dowel bars used in the Waterloo NW section have limited the amount of faulting over the past five years.

The graph also shows the benefits of dowel bar retrofits. Nickerson South experienced a dowel bar retrofit in year 6 as is visible by the significant decrease in the level of faulting. Its important to notice the initial trend over the first five years (prior to the retrofit) as that trend shows a steady increase in faulting to nearly 3 mm (half the allowable maximum) by year five.

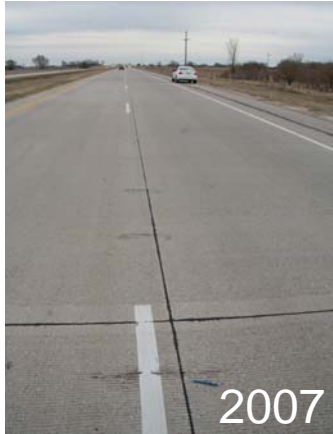
Location: MM 168.5

- Placement of tie bars too close to pavement surface across longitudinal joint caused surface cracking shown in photo at left.

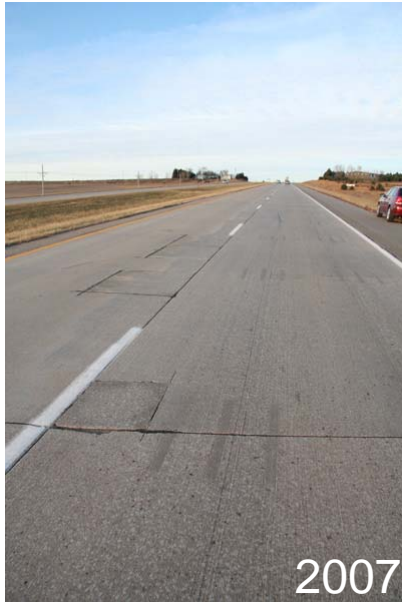
Location: MM 268

- Saw cut patches showing disintegration of concrete.
- Grout patches from dowel bar retrofit are also visible.

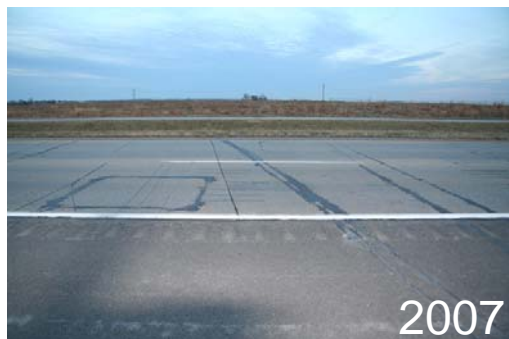
Location: MM 253

- Cracks forming where roadway was undermined during utility work.

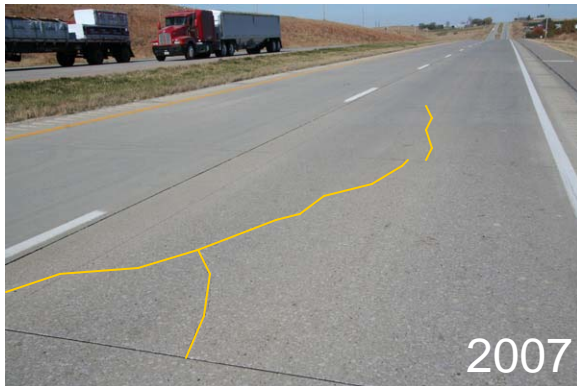
Location: MM 43.8

- High slab cracking.
- Concave road surface for three sections.
- Standing water in shoulder joints.

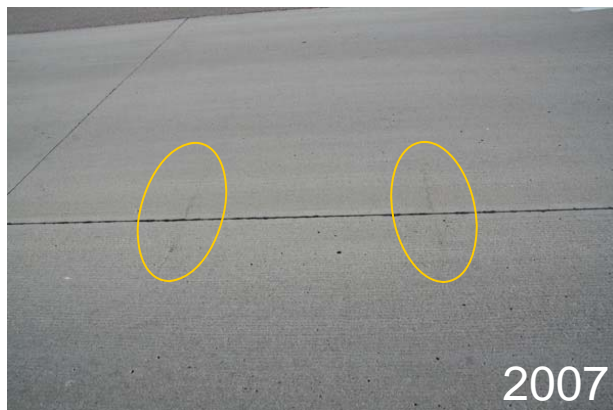
- Perpendicular edge cracking along centerline.
- 2"– 8" transverse cracks approximately every four feet along centerline.
- High placement of tie bars across longitudinal joint caused surface cracking shown at left.

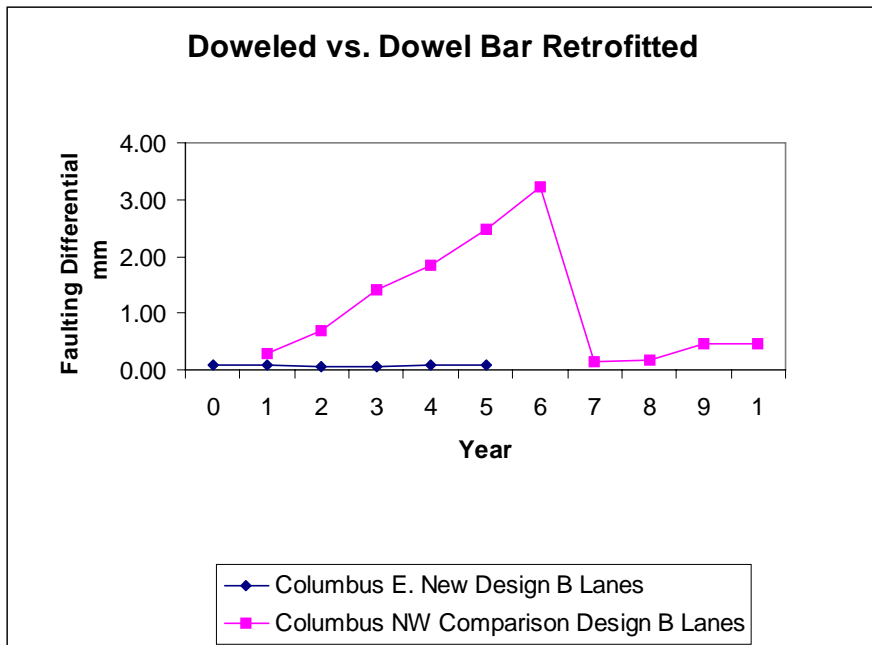
Figure 3.1: Faulting Differential, Columbus E. and Columbus NW.

Columbus NW, originally a non-doweled section, experienced a steady increase in the level of faulting to almost 3 mm after six years.

The level of faulting significantly decreased after a dowel bar retrofit was performed on the Columbus NW section in the seventh year. While Columbus NW has seen a slow increase in the level of faulting, faulting is now much less severe than prior to the dowel bar retrofit.

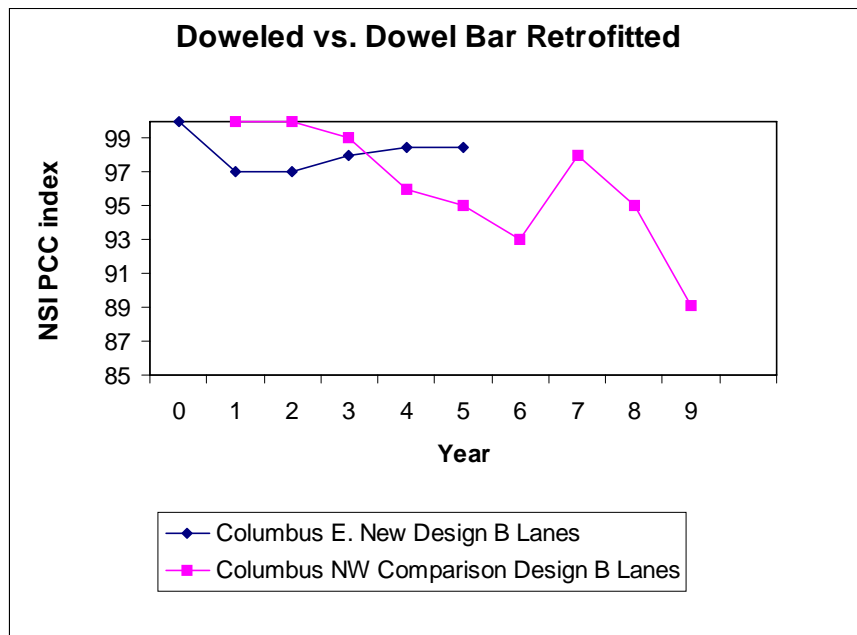
Figure 3.2: NSI PCC, Columbus E. and Columbus NW.

This graph shows how Columbus NW section reacted to a dowel bar retrofit in year seven. Since the retrofit, there has been a significant decrease in the Nebraska Serviceability Index (NSI). This decrease is caused by placing the retrofitted dowel bars too close to the shoulders, thereby causing cracking of pavement along the shoulders. This problem is visible in the pictures of the Columbus NW section.

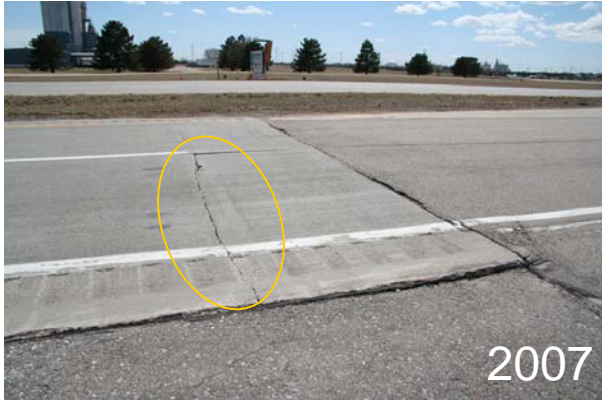
Location: MM 384.35

- Transverse cracking near the end of the study section.
- Faulting greater than 3 mm.

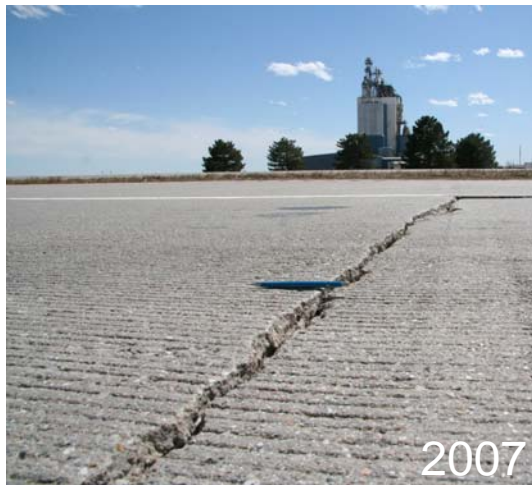
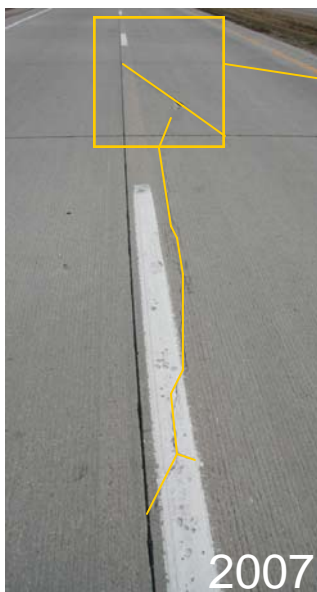
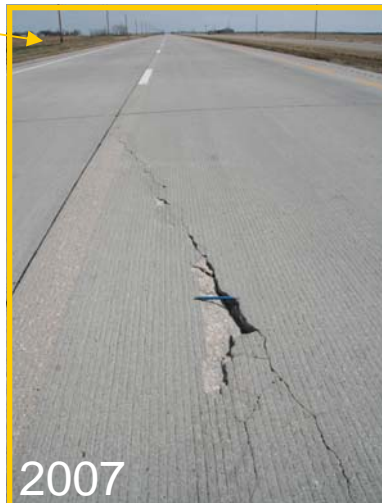
Location: MM 190.8

- Longitudinal cracking.
- Extends three panels i(~50 feet) in length.
- Longitudinal cracking is not typical of this section.

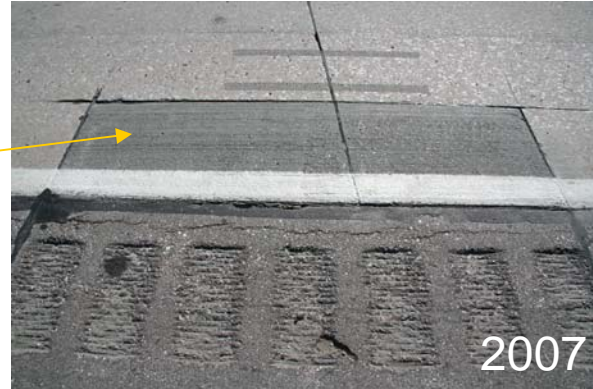
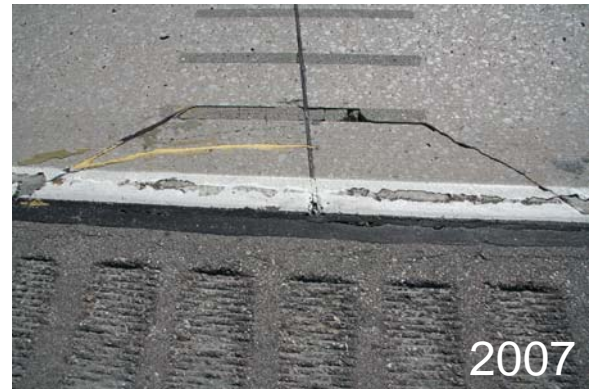
Location: MM 115.9

- Cracking along shoulder where dowel bars were retrofitted is common throughout the study section.
- Euroteck foam was used to prevent additional settling and to raise cracked panels.
- Retrofitted dowel bars placed too close to edge of pavement caused the cracking.
- Retrofitted dowel bars are now placed 6” closer to the centerline to prevent cracking of this type.

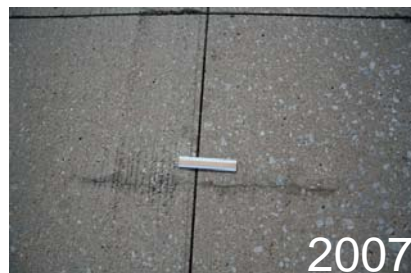
- Surface cracking extending through 11 to 12 panels along longitudinal joint.
- 2'8" cracks above tie bars across longitudinal joints.

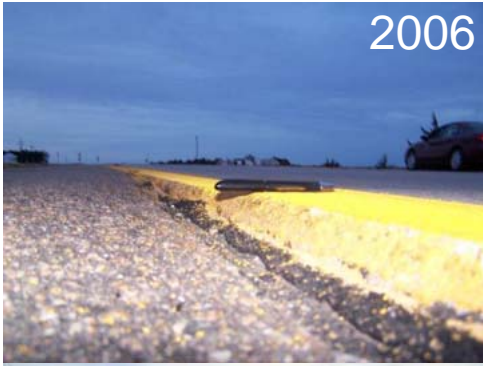
Location: MM 17

- Shoulder drop off.

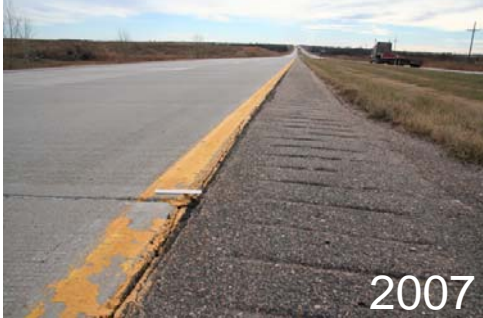
- Magnitude of drop off has not increased from previous years.

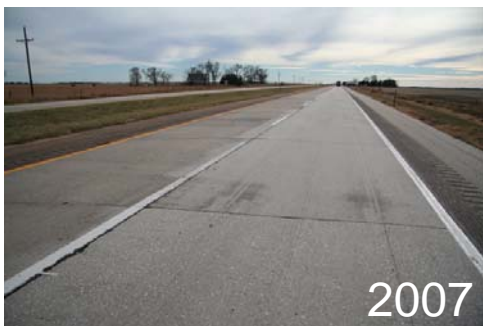
Location: MM 14.9

- Pavement disintegration.
- Prominent crown between lanes.

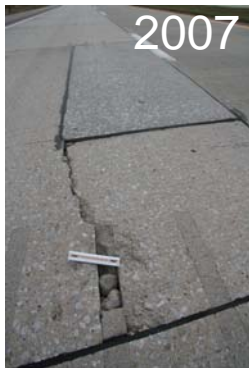
Location: MM 15

- Severe longitudinal cracking where highway was undermined for utilities work.

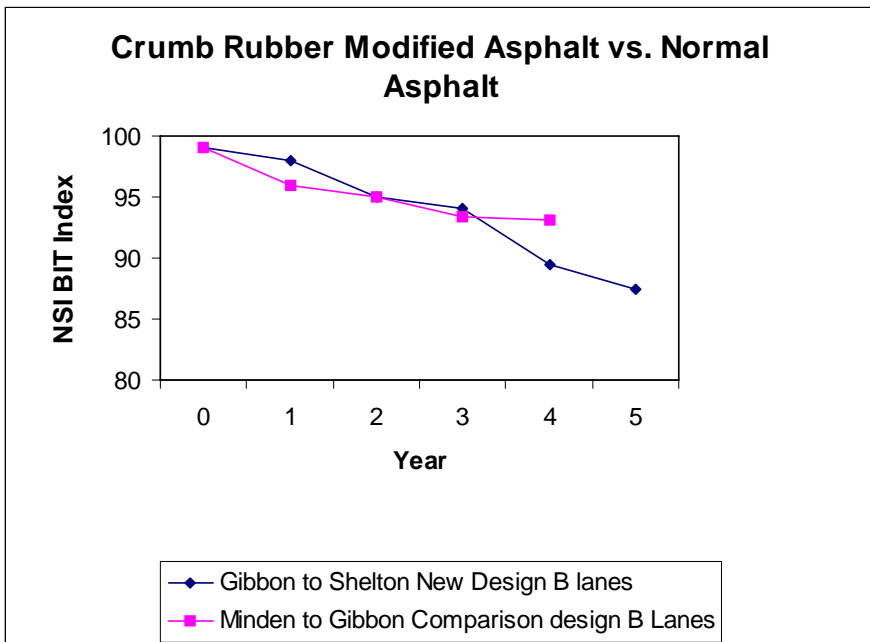
Figure 5.1: NSI Bit, Gibbon to Shelton and Minden to Gibbon.

The crumb rubber modified asphalt from Minden to Gibbon has outperformed the conventional asphalt comparison section with regard to surface condition of the pavement as measured by the NSI bituminous index (see graph at left).

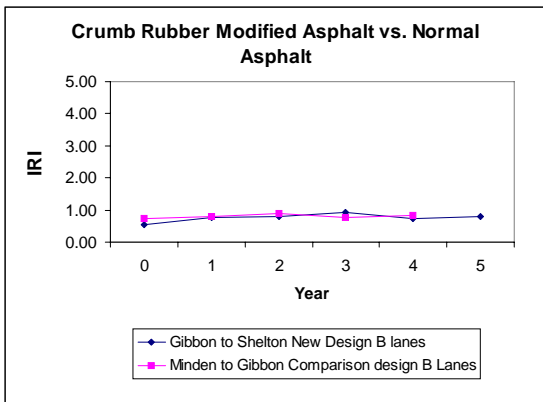
Figure 5.2: IRI, Gibbon to Shelton and Minden to Gibbon.

These two sections behaved very similarly with respect to the International Roughness Index (IRI), Present Serviceability Index (PSI) and rut depth. The crumb rubber modified asphalt appears to perform marginally better only because it appears to maintain slightly better surface integrity over identical service life.

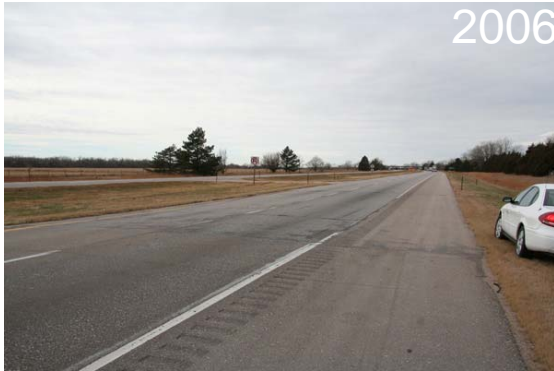
Location: MM 290.96

- Surface distress near end of study section.
- Longitudinal and transverse cracking.

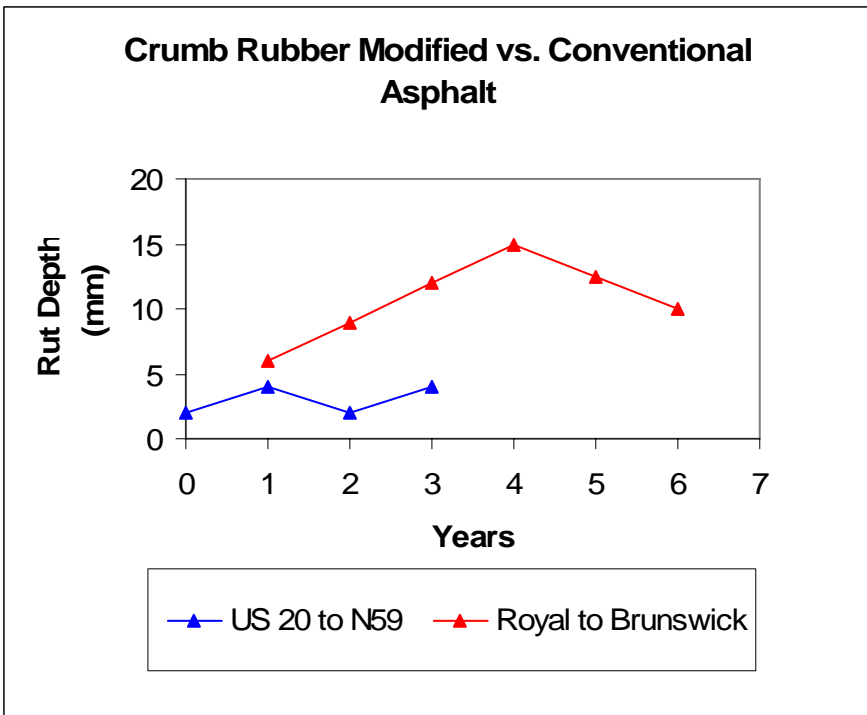
Figure 6.1: Rutting Depth, US20 to N59 and Royal to Brunswick.

The crumb rubber modified asphalt (US20 to N59) shows far less rutting than the conventional asphalt pavement section.

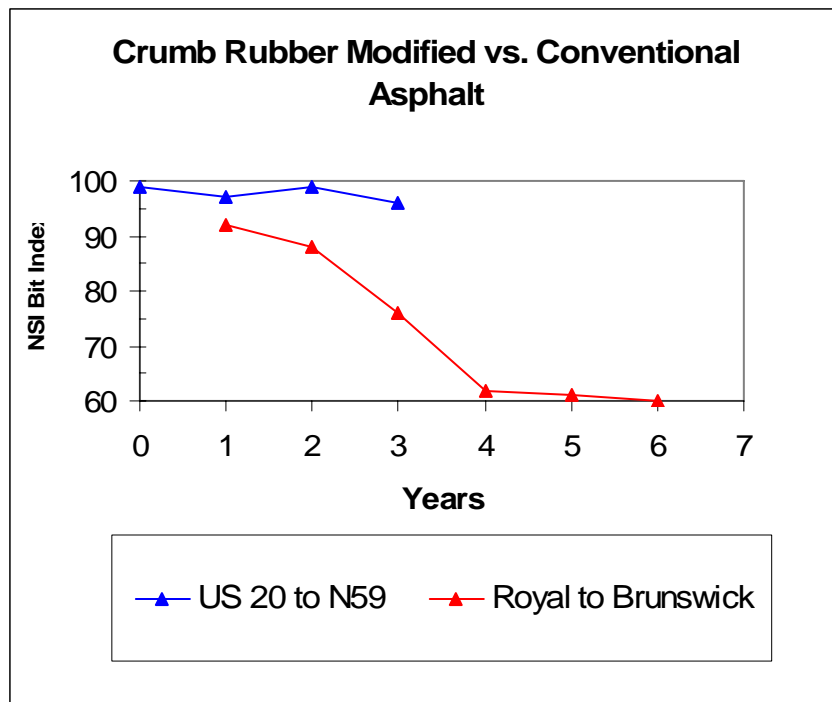
Figure 6.2: NSI Bituminous Index, US20 to N59 and Royal to Brunswick.

The crumb rubber modified asphalt (US20 to N59) has consistently outperformed conventional asphalt with regard to surface condition of the pavement as reflected by the NSI bituminous index.

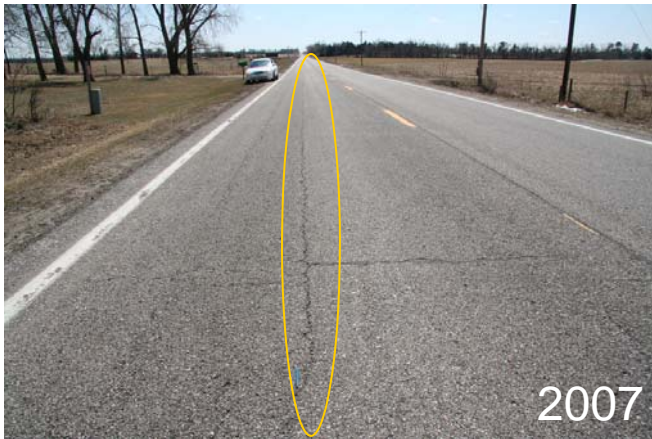
Location: MM 171.3

- Longitudinal crack ~ 100' in length.

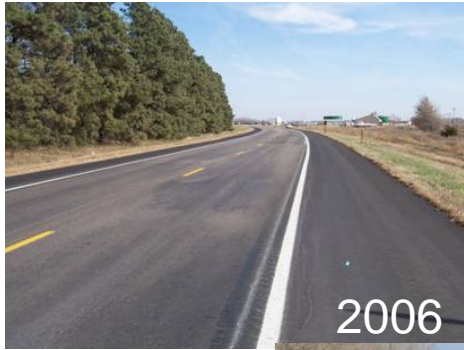
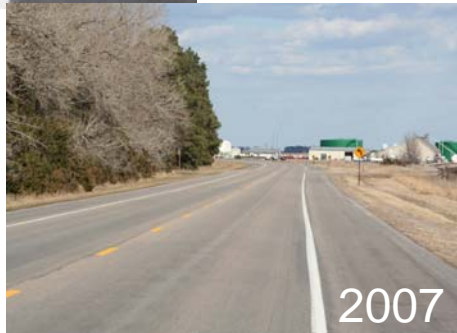
Location: MM 341.9

- Pavement rehabilitation in 2006.
- Some surface wear was already visible in 2007.

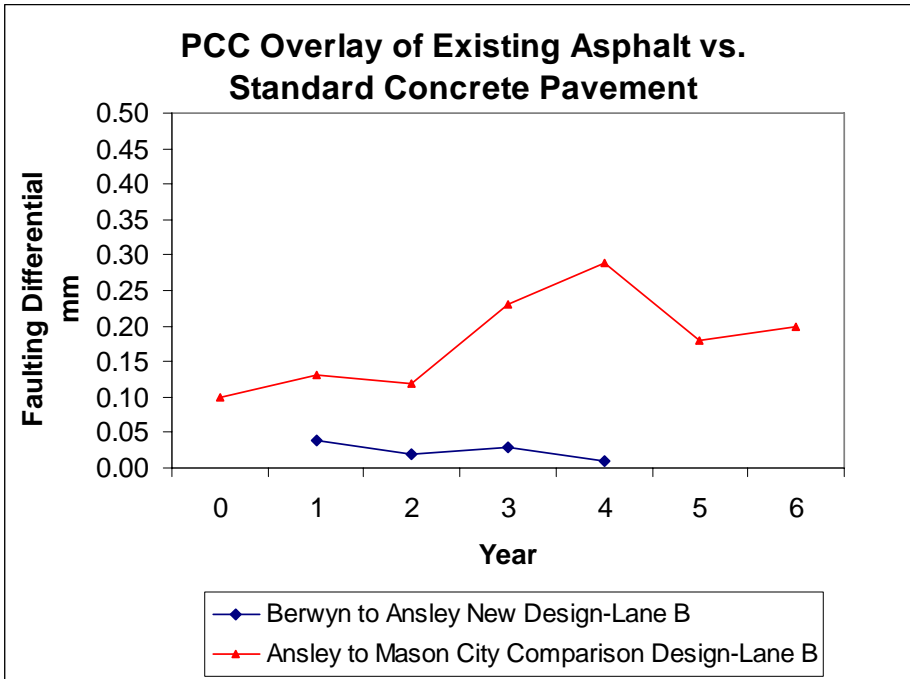
Figure 7.1: Faulting Differential, Berwyn to Ansley and Ansley to Mason City.

Dowelled pavement (Berwyn to Ansley) has outperformed the conventional PCC section for all parameters.

While the non-dowelled pavement has seen an increasing trend of faulting over the past six years, the dowelled pavement has shown little to no faulting over the four years of the study.

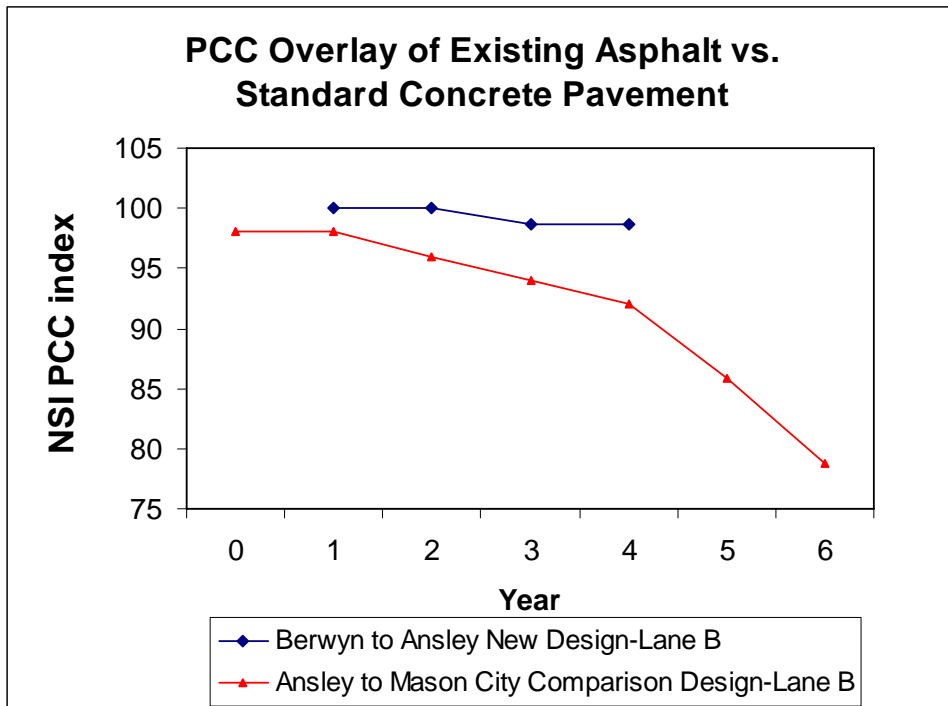
Figure 7.2: NSI PCC, Berwyn to Ansley and Ansley to Mason City.

The PCC overlay has outperformed the comparison section in relation to surface condition of the pavement.

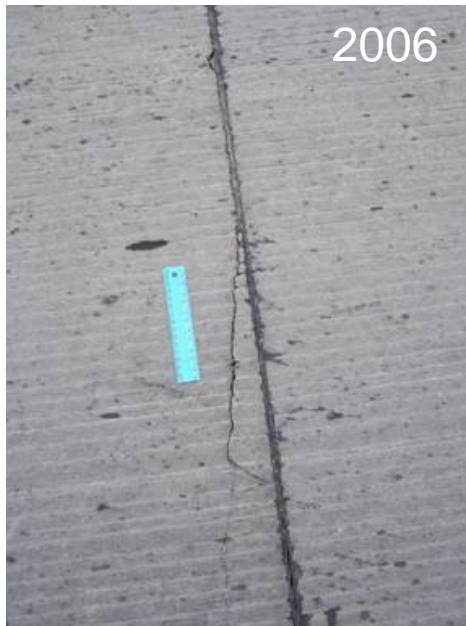
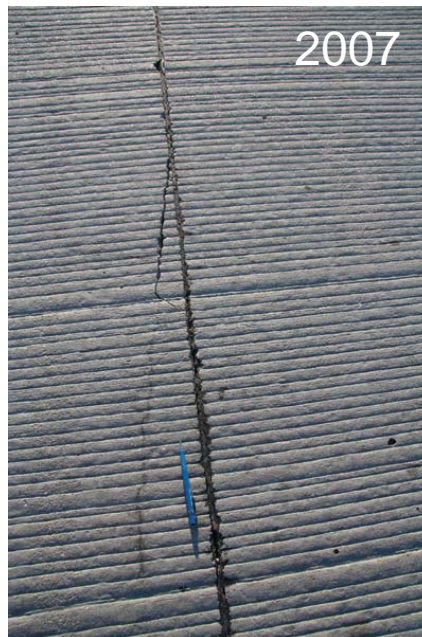
Location: MM 293.9

- 1.5' diagonal slab cracking.
- Between 2006 and 2007 hairline cracks advanced about six inches.

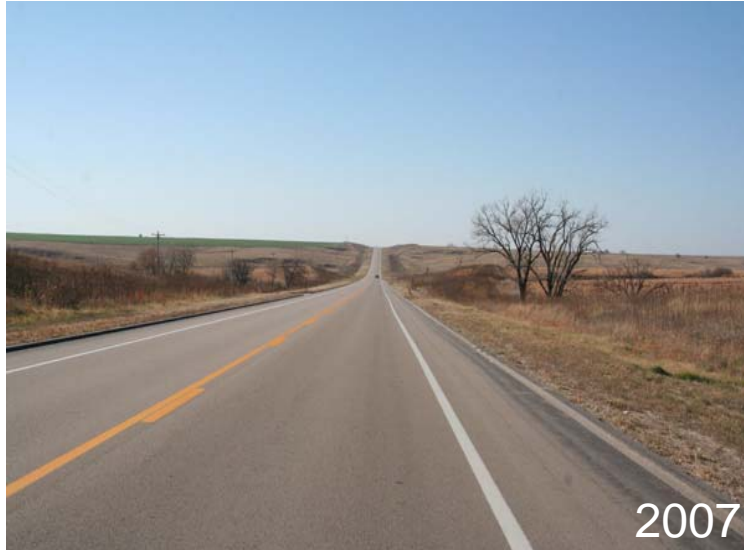
- The study section was in excellent condition during the fall of 2007.

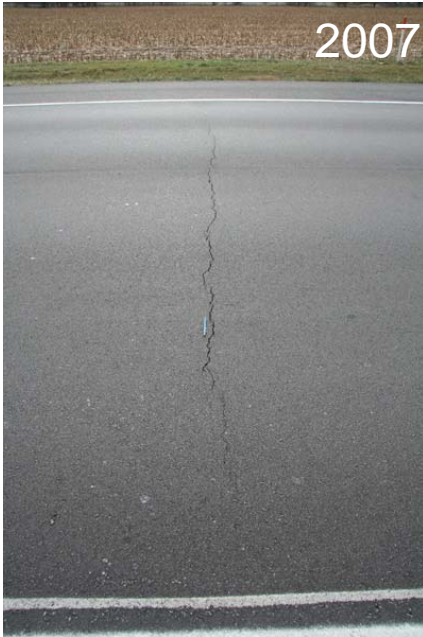
Location: MM 442 +20

- Thin transverse cracking.
- Roadway appears in excellent condition, but it is possible to see thin transverse cracks when walking the section.
- Cracking is surprising because this section is less than one year old.
