Failure Analysis of a Failed Anchor Chain Link

(Accepted for publication in Engineering Failure Analysis, 4 March 2018)

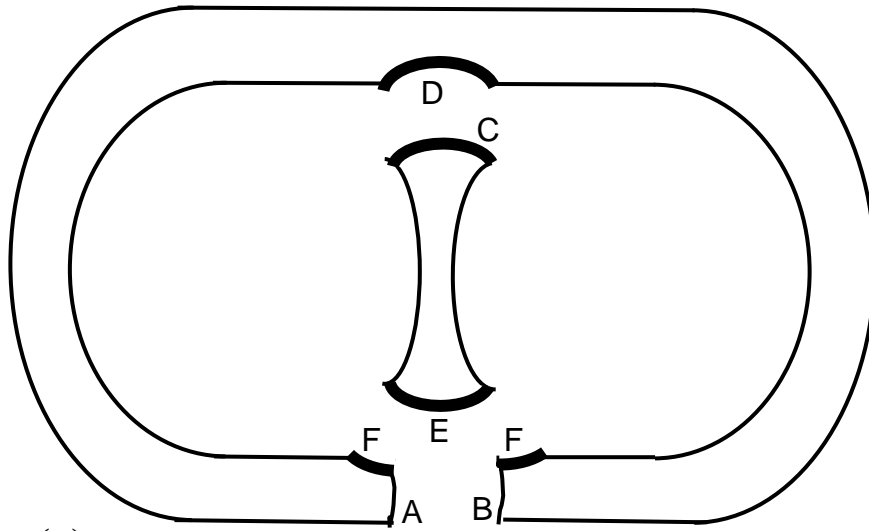
- Figure 1: Schematic of a chain link (a) without a stud and (b) with a stud
- Figure 2: (a) Schematic diagram of the failed anchor chain link showing the location of the fracture surfaces A, B, C, D, E and F, (b) the as-received failed anchor chain link and (c) the detached stud link. The locations of where the diameter is measured are indicated as Points 1, 2, 3 and 4.

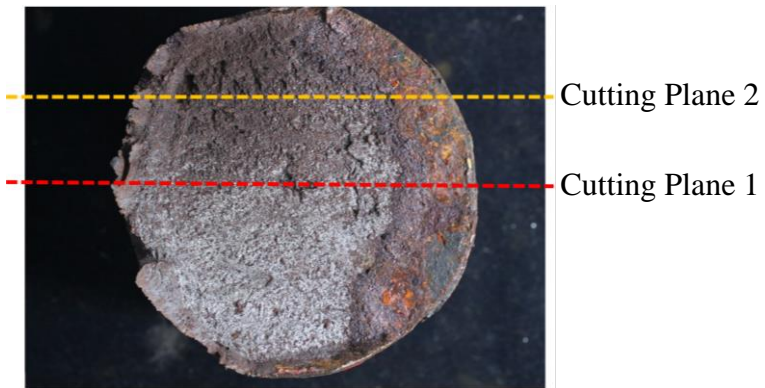
Figure 5: (a) Longitudinal cutting planes on fracture surface A; (b) longitudinal cross-section of fracture surface A along cutting plane 2; (c) magnified view of the shear lip, (d) magnified of the fracture initiation site showing the inclusion, and (e) longitudinal cross-section of the fracture surface along cutting plane 2.

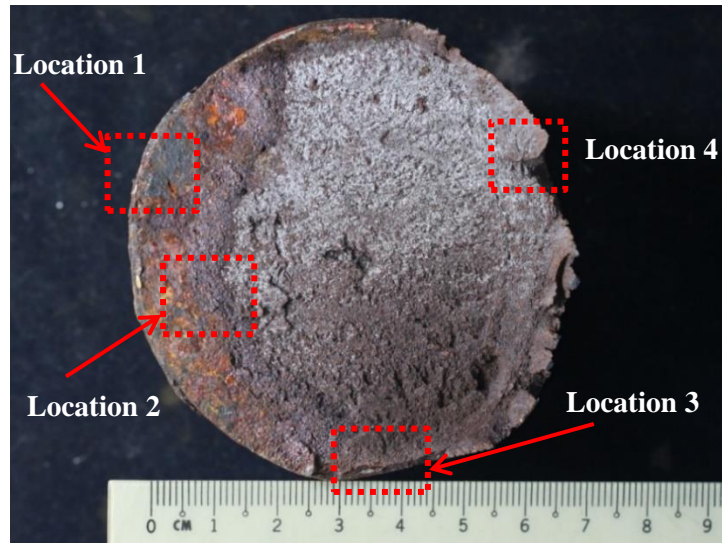
(a)

For the paint-like coating present at the black region of fracture surface A, a major presence (>10 mass%) of iron, oxygen and a minor presence (< 10 mass%) of carbon and manganese were detected (Fig 7a). We note that the element composition of the paint present on the outer circumference of the chain link (not shown) was similar to that found on the fracture surface; this further confirms that the pre-existing crack was not detected when the painting was carried out.

Figure 7: EDX analysis of different locations on fracture surface A

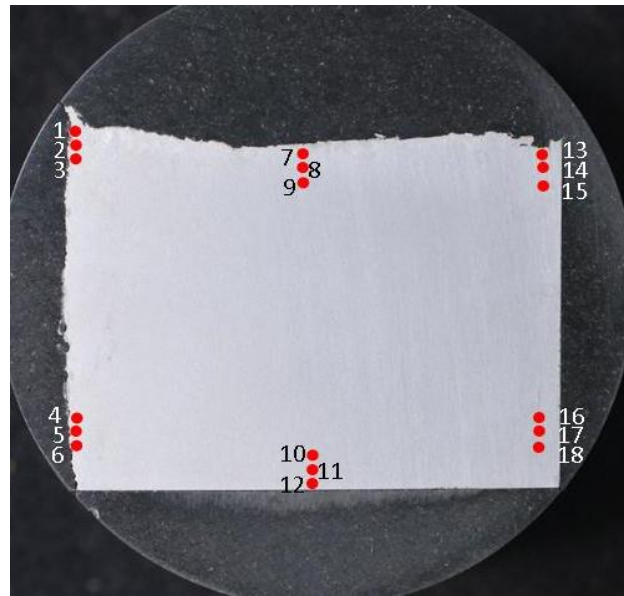
Vickers Hardness Number (HV) (Test Load Applied:10kgf)						
No	Fracture Surface A	Test Location	No	Fracture Surface B	Test Location	
1	303	HAZ	1	271	HAZ	
2	278		2	198	Weldment	
3	274		3	327	HAZ	
4	231	4	306			
5	234	Base Metal	5	287	Base Metal	
6	231		6	230		
7	217		7	229		
8	221		8	226		
9	219		9	224		
10	217		10	212		
11	224		11	214		
12	223		12	214		
13	220		13	204		
14	230		14	201		
15	224					
16	217					
17	194					
18	209

Figure 8: Hardness test locations on the longitudinal cross-section of (a) fracture surface A and (b) fracture surface B.
