47TH TURBOMACHINERY & 34TH PUMP SYMPOSIA
HOUSTON, TEXAS | SEPTEMBER 17-20, 2018
GEORGE R. BROWN CONVENTION CENTER

Gas Seal Failures Caused by Axial Vibrations

James Byrne – BRG Machinery Consulting
Patrick Potter – Cincinnati Gearing Systems
Jose Vazquez – BRG Machinery Consulting

This case study describes the root cause investigation of 12 dry gas seal failures in three integrally geared centrifugal compressors over a period of 12 years. These compressors are in fuel gas booster service, supplying a 500 MW gas turbine combined cycle power plant.

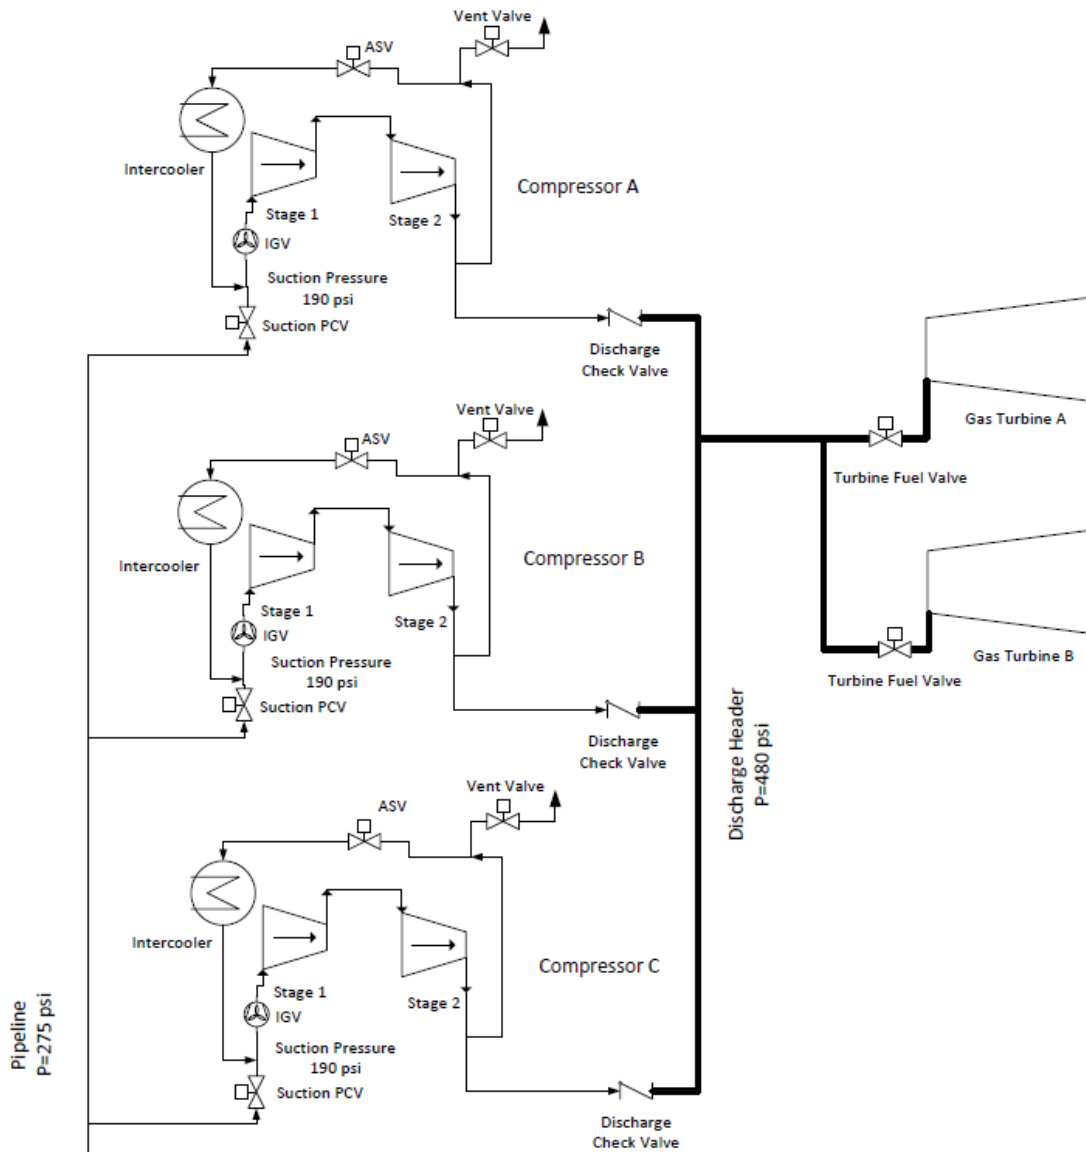
System Schematic

- System is typical of natural gas fired combined cycle power plants
- Two of three compressors operate at all times
- Turbines can also run on liquid fuel

- Some failure events followed system upsets:
 - Turbine trip causes immediate, step change reduction in flow required – gas valves slam shut
 - Compressor suction pressure control valve must close – but is too slow
 - Anti- surge valve must open – but is too slow
 - Vent valve opens to maintain suction pressure
 - System is unstable, 4 valves opening and closing
- Side note: plant trips, swap to liquid fuel common at this plant
 - Redesign of compressor control scheme
 - Dynamic simulation
 - Feed forward control system

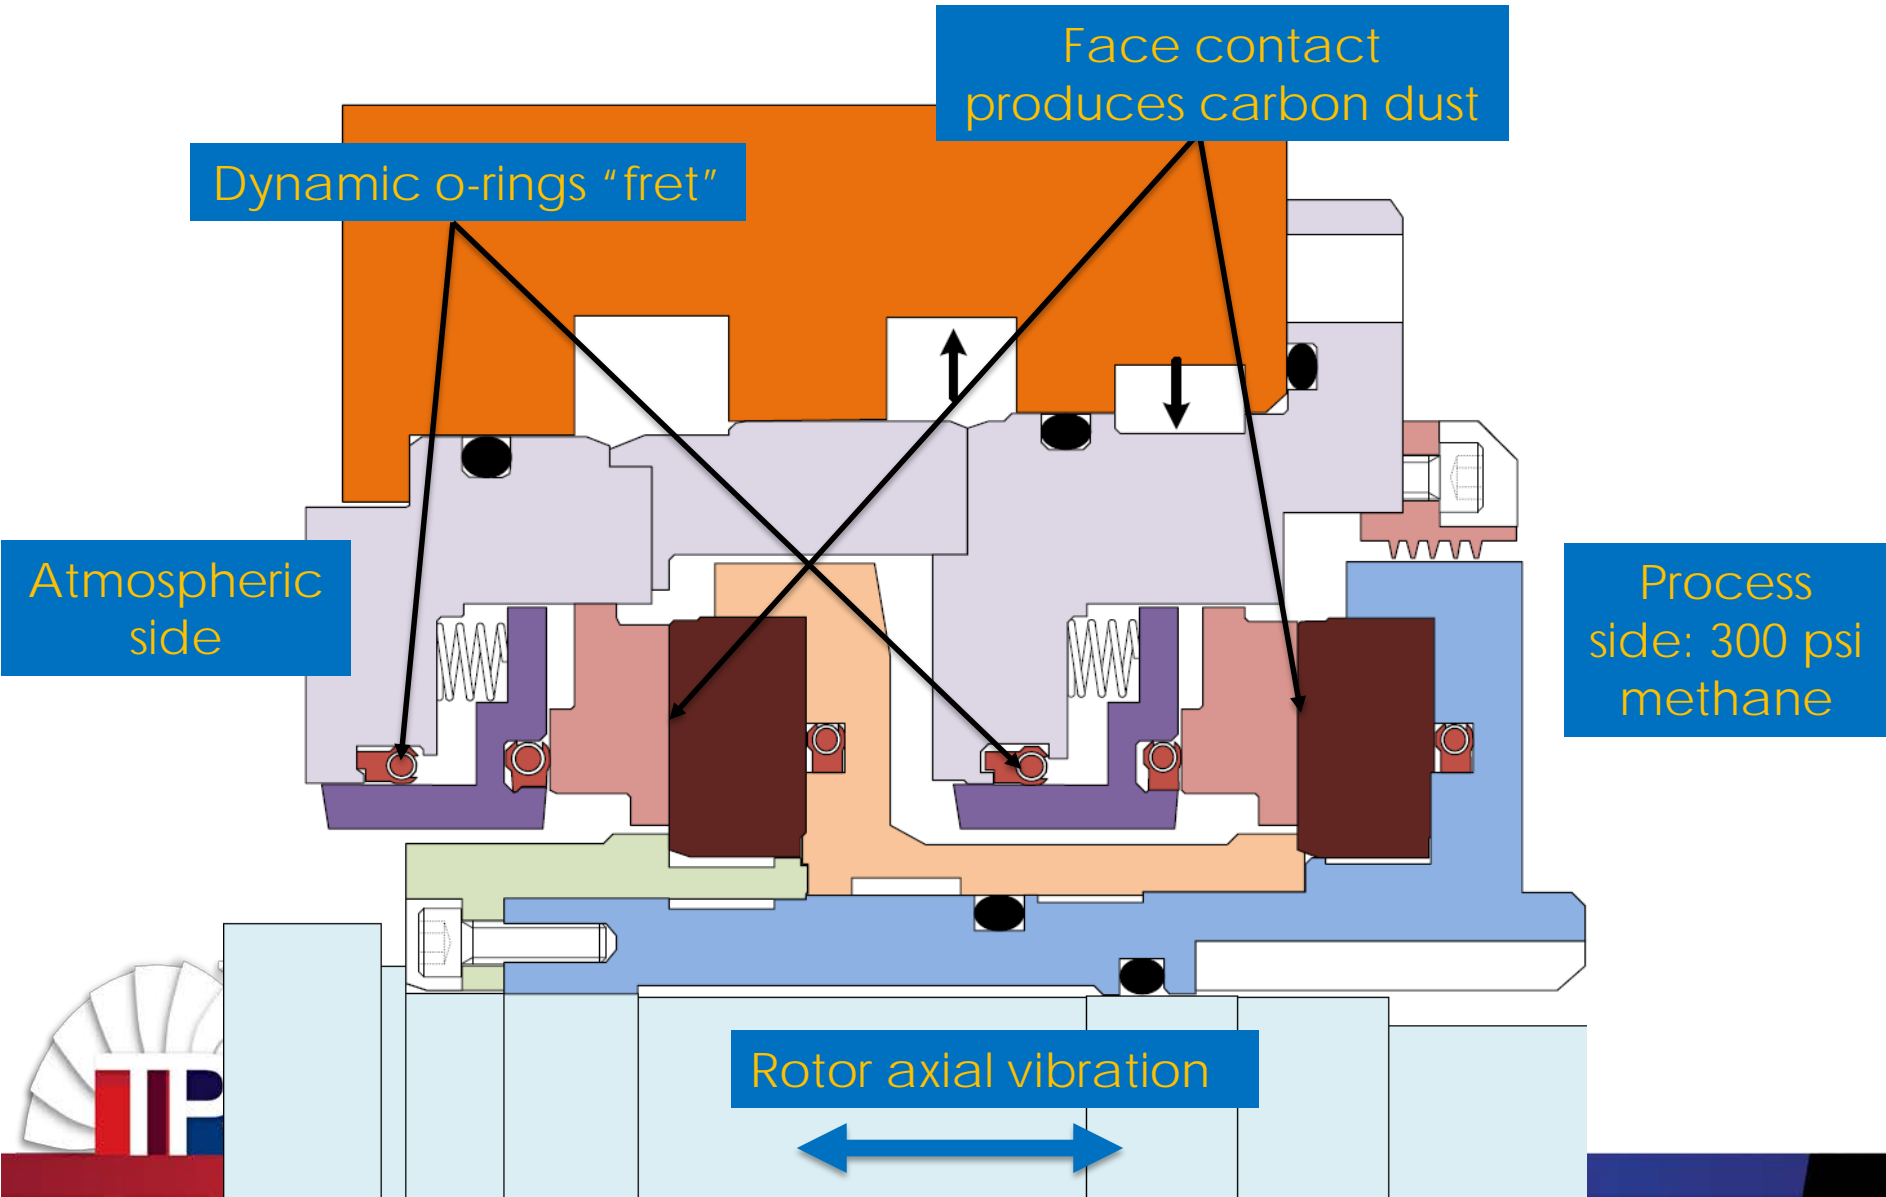
Axial vibration failures – DGS aspects

- Some gas seal failures occurred when seal faces “stuck” open
- Disassembly inspection identified:
 - “fretted” o-rings
 - Carbon dust resulting from face contact
- Axial vibrations suspected
