47<sup>TH</sup> TURBOMACHINERY & 34<sup>TH</sup> PUMP SYMPOSIA  
HOUSTON, TEXAS | SEPTEMBER 17-20, 2018  
GEORGE R. BROWN CONVENTION CENTER

# Analysis and Countermeasures for Sideband of Gear Mesh Frequency(GMF) Induced by Shaft Fretting Corrosion in a Gearbox

Seungil Bae / Bumsu Kim  
Jongoh Jang / Sangjoo Lee

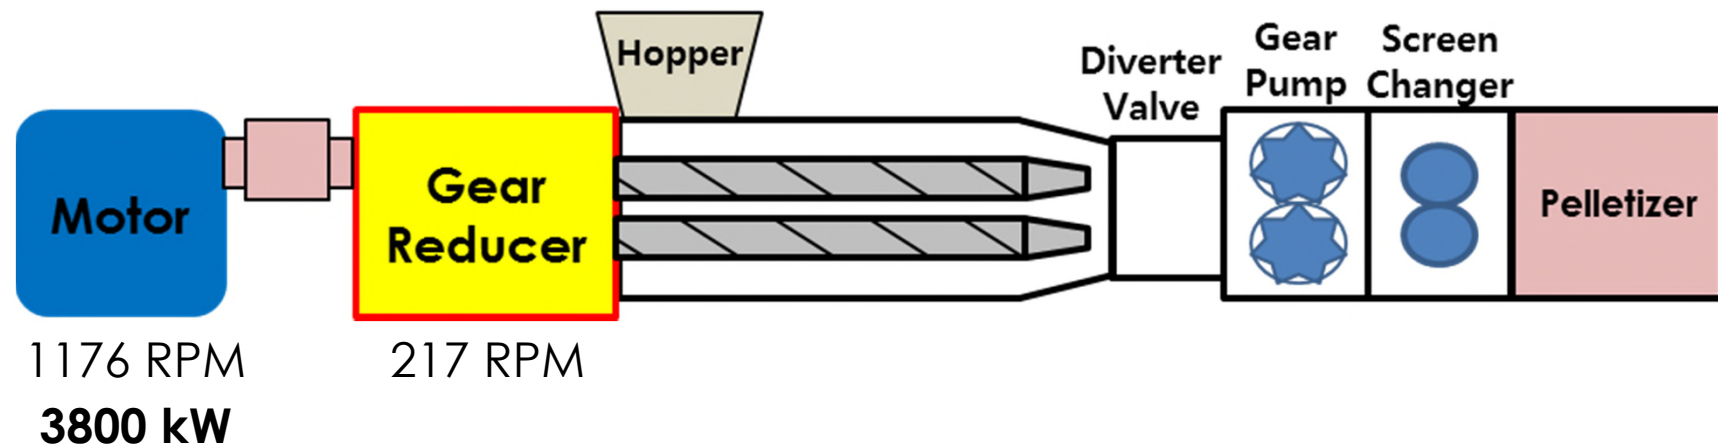
Fig. 1 Schematic drawing of extruder train

Located in a polypropylene plant, an extruder pushes molten polymer through a die plate to make the final product (pellets)

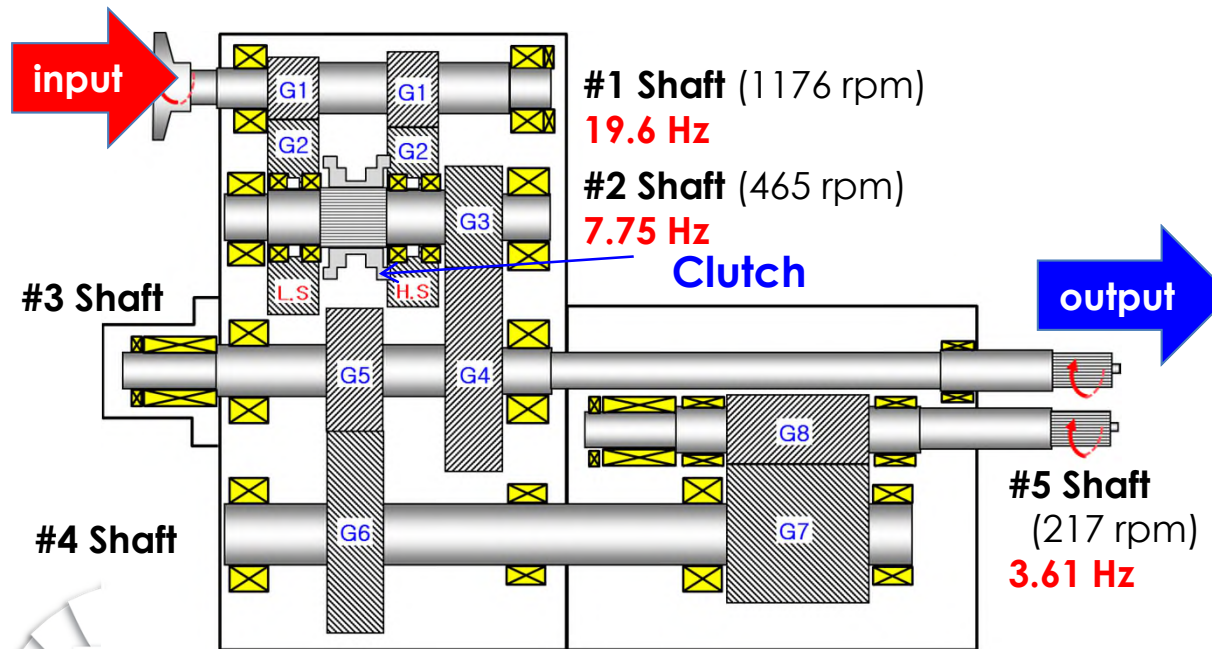
Table. 1 RPM & GMF

Overall gear reduction(ratio) is **5.4**, as determined by 5 shafts & 8 gears(without low speed)

※ Gears assembled on the shafts by shrink fit

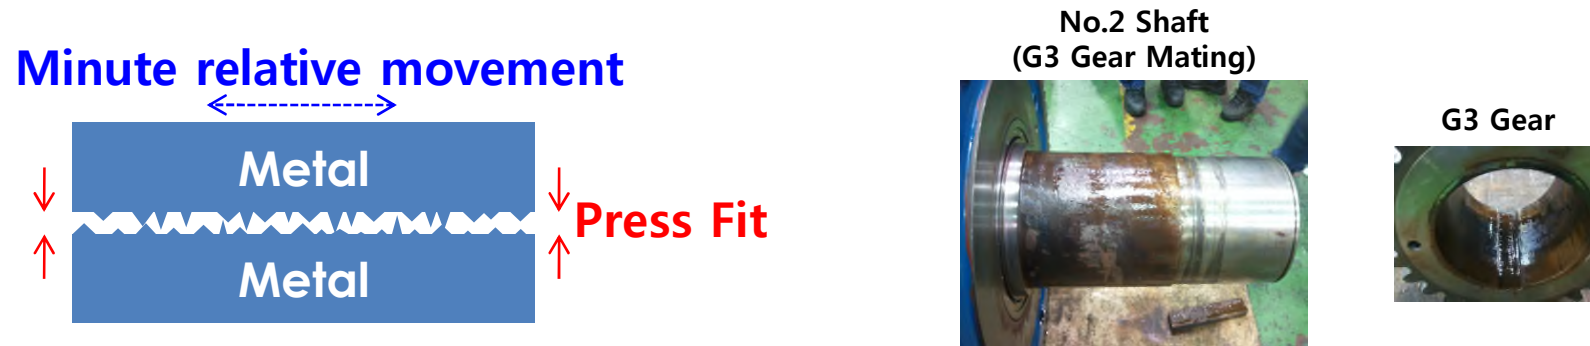
Fretting corrosion obviously occurs due to minute relative movement (of parts) operating under high pressure.

**Since the gear and shaft are assembled by shrink fit (=high pressure), one must find out why relative movement happens.**

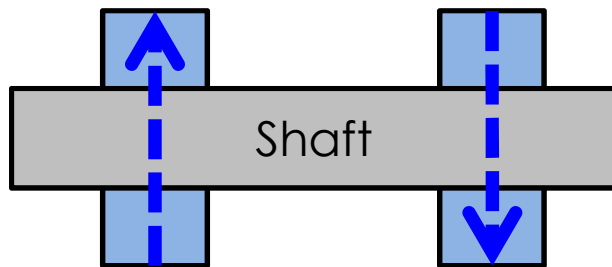
Gear Reaction Force  
by Input Gear

Shear from gear reaction force can cause shaft bending, thus resulting in relative displacement.

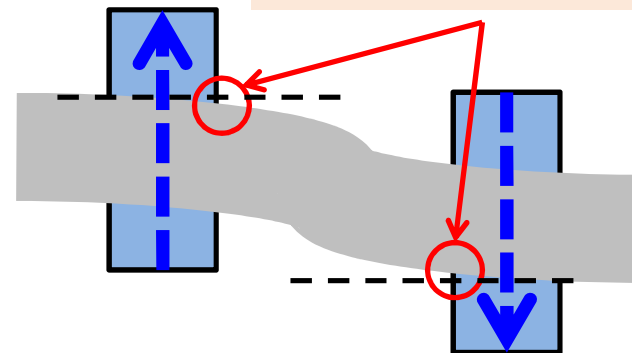
Relative Displacement  
at Torque Input & Output

Fretting corrosion starts from torque input & output by torsion and bending, then propagates to opposite side

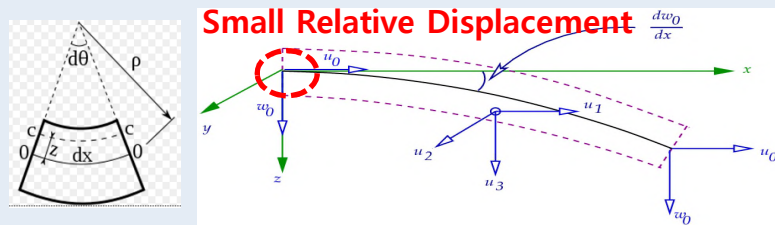
① Apply Euler Beam Theory to long shaft

- ① Long distance between two gears  
: **Small Relative Displacement**
- ② Short distance between two gears  
: **Large Relative Displacement**

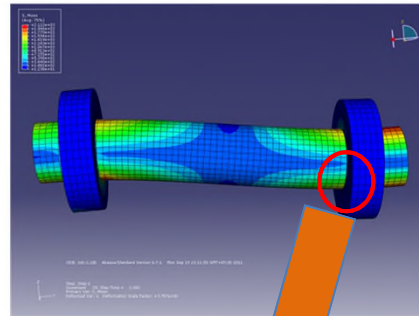
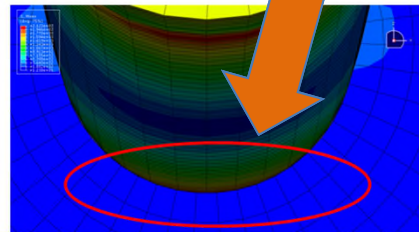
Long Shaft(Euler Beam Model)

FEM results also reveal a short shaft undergoes a large relative displacement.

Long Shaft has smaller relative displacement

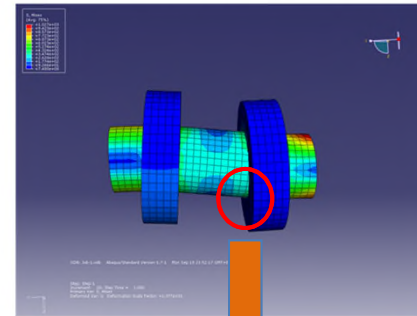
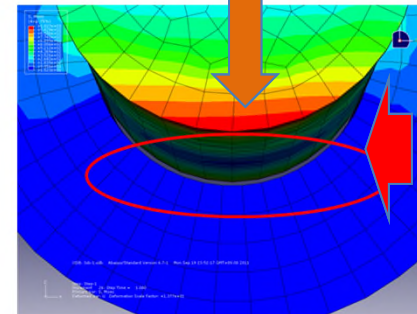
Short Shaft(Timoshenko Beam Model)

Large relative displacement

Thus, the distance between two gears is a critical parameter for causing fretting corrosion b/w a gear and shaft

To prevent reoccurrence of fretting corrosion on #2 shaft, The distance between G2 and G3 must be increased.
