FIELD OBSERVATIONS ON THE PERFORMANCE OF HERITAGE STRUCTURES IN THE NEPAL 2015 EARTHQUAKE

Arun Menon⁽¹⁾, Shivangi Shukla⁽²⁾, Shibu Samson⁽²⁾, N. Aravaind⁽²⁾, Xavier Romão⁽³⁾ and Esmeralda Paupério⁽⁴⁾

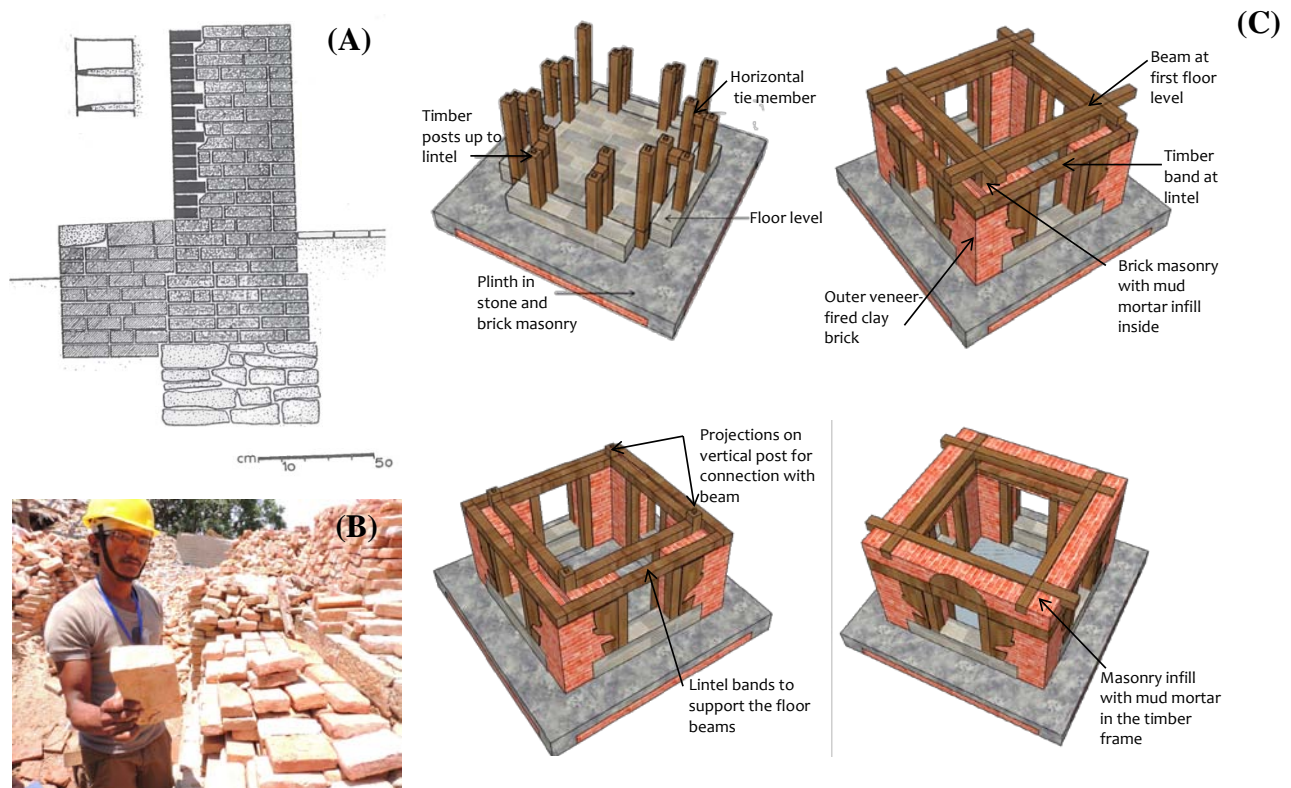
Fig. 6 – (A) Typical wall section [3]; (B) Wedge-shaped fired clay unit
(C) Assembly of timber posts, lintels and beams, and masonry walls in the Kileshwar Mahadev Temple

Another possible contributory factor for the out-of-plane collapse of the masonry leaves is wedge-shaped configuration of the units of the outer leaf (recall photograph in Fig. 6B). In the absence of through-stones or interconnecting elements with the inner leaf of sun-dried bricks, the outer-leaf by itself has almost no out-of-plane resistance and individual units will rotate about the thicker end due to the gaps created by deteriorated mud mortar joints above and below along the width of the unit, thereby making the wall very susceptible to out-of-plane shaking.
