FULL-SCALE VEHICLE CRASH TEST ON THE IOWA STEEL TEMPORARY BARRIER RAIL

TRANSPORTATION RESEARCH REPORT TRP-03-20-89

December, 1989

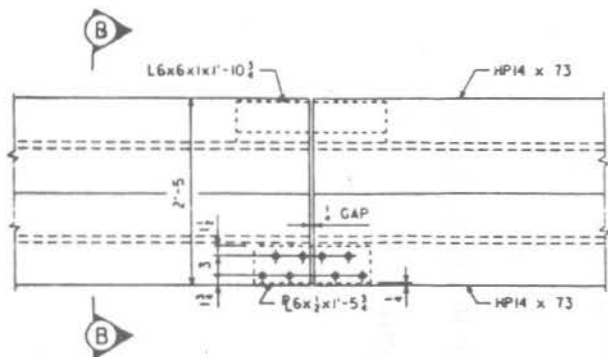
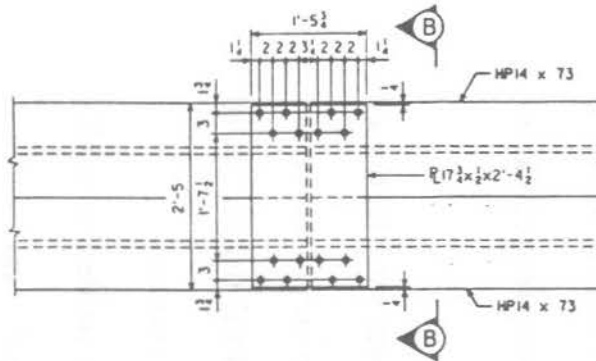
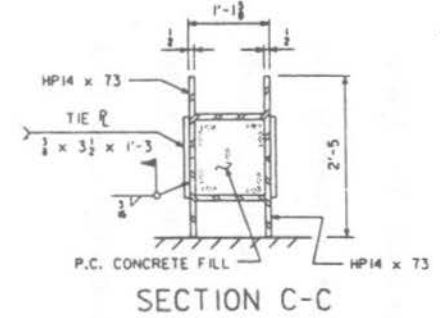
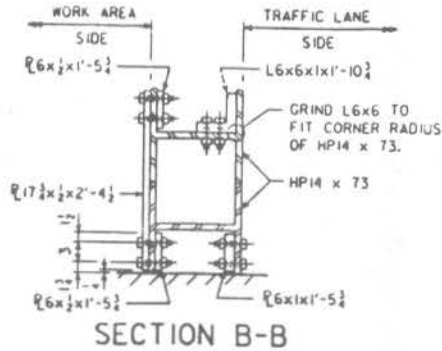
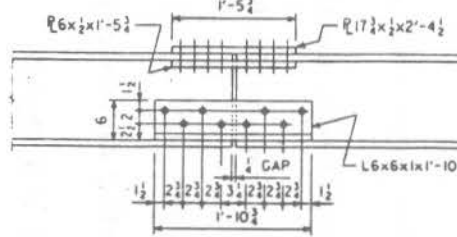
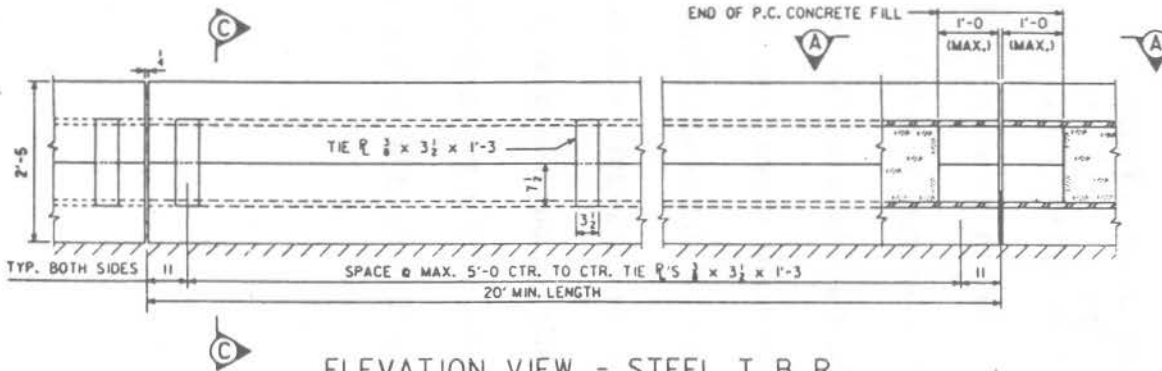
FIGURE 4. DETAIL DRAWING OF TEMPORARY BARRIER RAIL.

In order to increase the weight and stiffness of the barrier, the inside box section between the HP shapes was filled with concrete. The height of the barrier was 29 inches. The 20 foot length sections were bolted together with splice plates at the test site. The fill concrete stopped one foot short of each end of a section.

After the vehicle had impacted and displaced the barrier rail, removal of the connection bolts was found to be both time consuming and difficult. The time required to assemble and disassemble the barrier rail installation could be reduced if the bolted connections were redetailed.

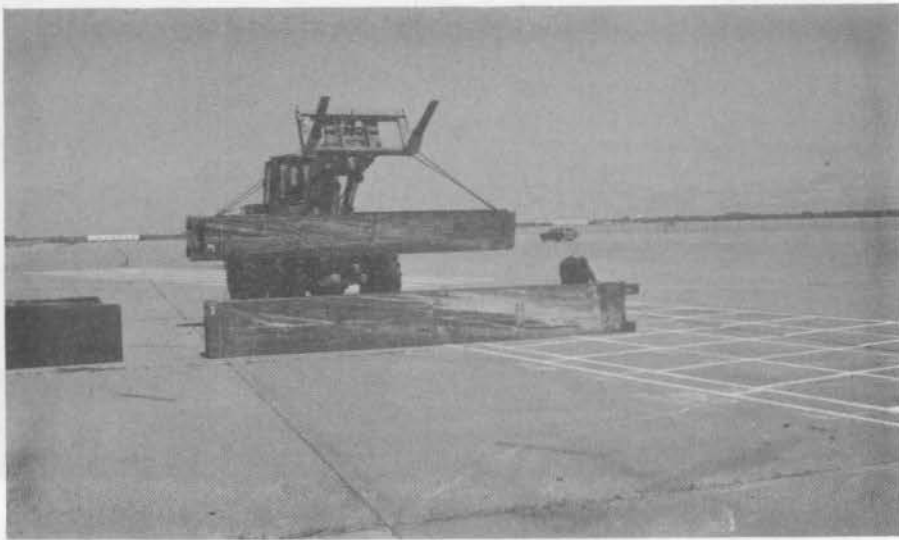
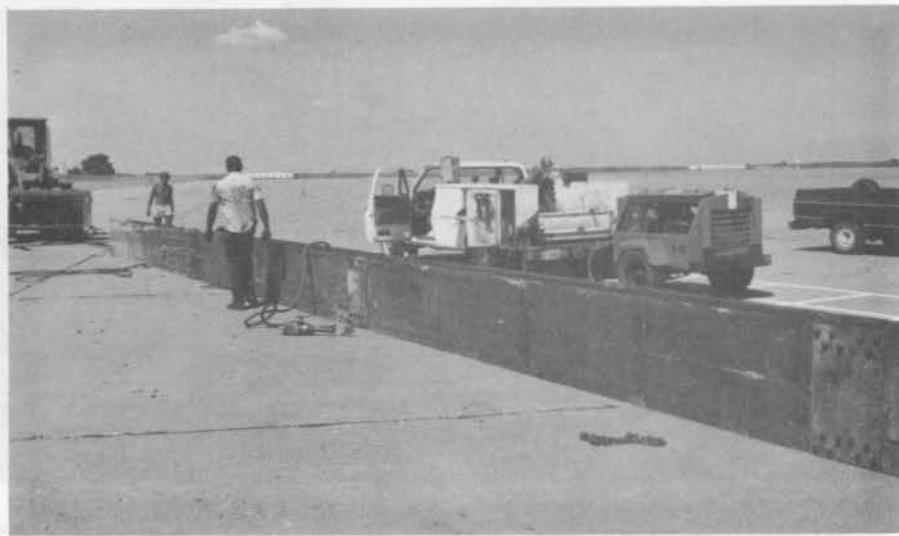
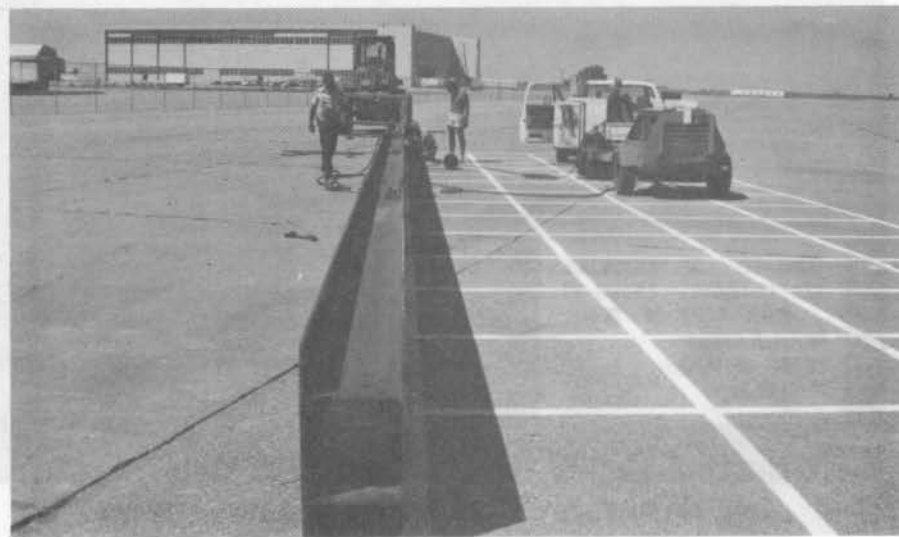
FIGURE 5. PHOTOGRAPHS OF BARRIER RAIL INSTALLATION.

The Iowa Steel Temporary Barrier Rail performed very well. The amount of work required to assemble and disassemble the barrier rail was found to be very time consuming, as stated in Appendix B. This does not promote the design concept of being portable or temporary. When the connection holes were match drilled and oversize drilled (varying between 1/16" and 3/16"), the barrier rail was still time consuming to install on the level concrete apron surface.

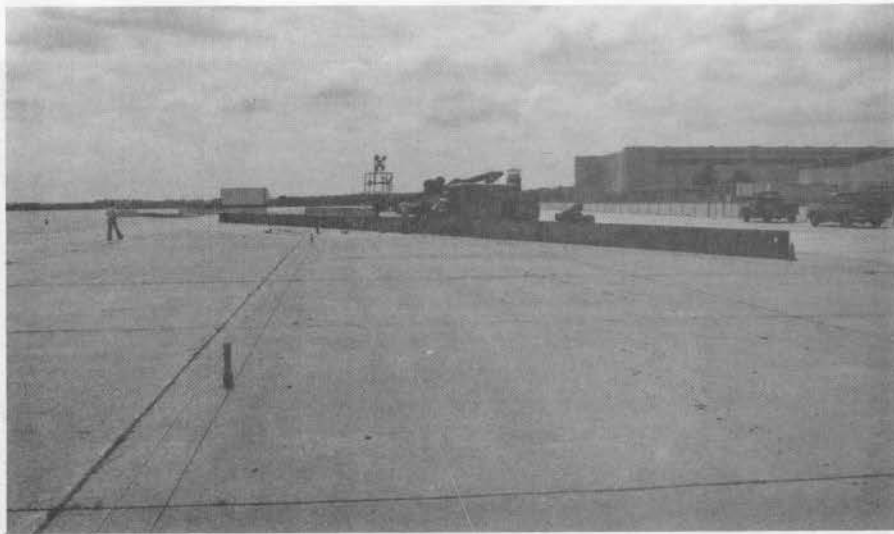
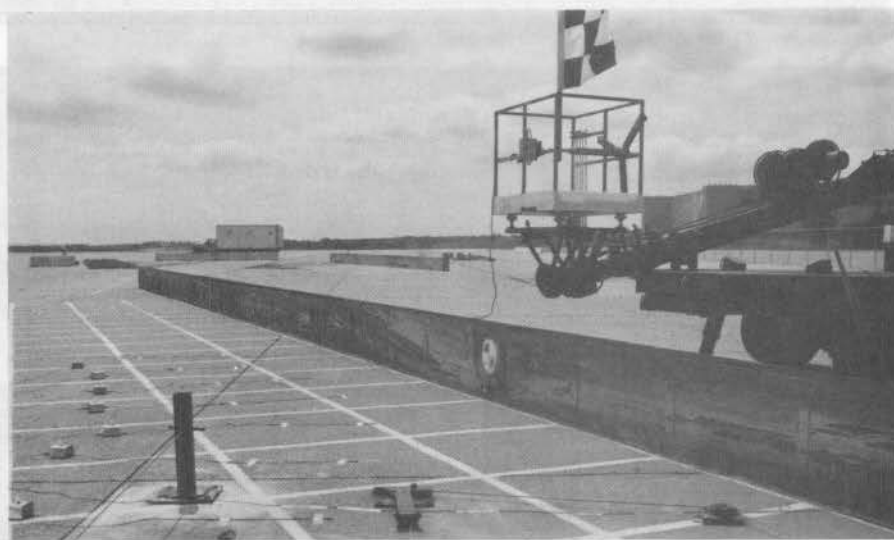
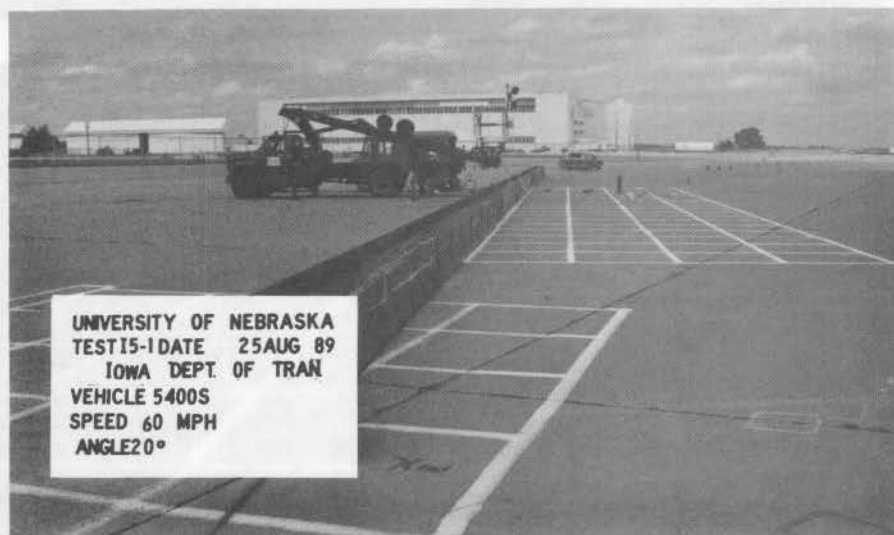
FIGURE 6. PHOTOGRAPHS OF BARRIER RAIL BEFORE IMPACT AND THE VEHICLE GUIDANCE SYSTEM.

Photographs of the barrier prior to conducting the test are shown in Figure 6. The barrier was "free-standing" with no attachments to the level concrete apron.
