AN INVESTIGATION INTO THE NON-UNIFORM DECAY OF HARDWICK STONE

Robert Brough⁴ & Elizabeth Laycock

Hardwick stone as used on the vernacular Hardwick Estate buildings decays in a non-uniform way. Typically stones at Hardwick decay cavernously leaving the mortar matrix behind. Levels of decay can vary dramatically from stone to stone with one stone showing advanced decay whilst adjoining stones are relatively intact. Ten sample buildings giving a total of 1587m² of elevations and with a good geographical spread across the estate were surveyed. Ratings were assigned according to condition. It was shown with 95% confidence that the weathering on the western elevations is significantly worse than that seen on the eastern elevations of the sample buildings. Northern elevations had high levels of stonework in good condition, while western elevations had the lowest. The prevailing wind direction on the Estate is west to north-west. The difference in levels of decay below 1 metre and above 1 metre has been shown to be significant at the 95% confidence level with a slight correlation between levels of stone decay and building height (above sea level). The survey also highlighted stone decay

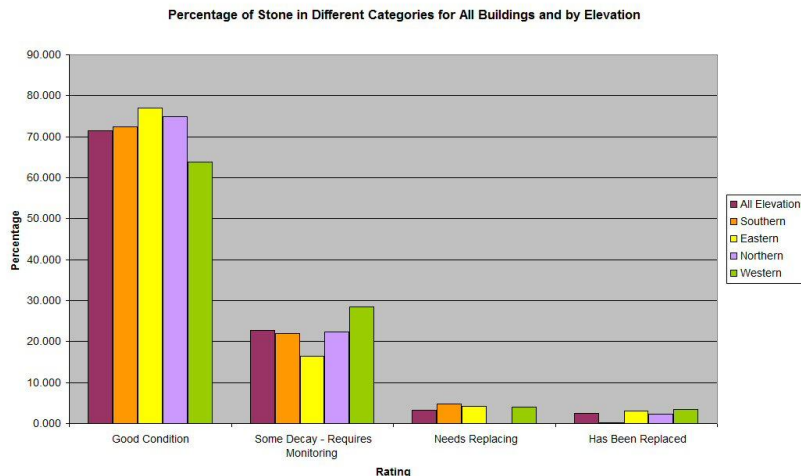
Figure 3: Graph of stone condition for all buildings

As can be seen from above the eastern elevations of the buildings surveyed have the highest proportion of stone in good condition (77%). The western elevations have the lowest proportion of stone in good condition (64%). The average for all elevations is 71%. The western elevations also have the highest proportion of stone that is showing some signs of decay (28%), the eastern elevations have the lowest (17%). The southern and northern elevations are close to the average figure for all elevations in this category both at 22%. The average is 23%. The northern elevations have no stone that requires replacement although 2% of northern elevations have already had stone replacement. The average for all elevations in

Given the difference between the proportion of western elevations that have stone in good condition and the proportion of eastern elevations that have stone in good condition the Chi-square test has been applied to the data to assess whether this apparent difference is statistically significant or not. The Chi-square test was used and it can be said with 95% confidence that the two sets of results are significantly different between the amount of weathering occurring on the western elevations of the sample buildings and the amount of weathering occurring on the eastern elevations. Ted Edwards, Head Warden Hardwick Hall Estate, (pers. comm. March 2008) states that the prevailing wind direction at Hardwick is west to north-west. This could help to explain the difference in weathering observed between the western and eastern elevations, however it would not necessarily explain the lower weathering seen on the northern elevations, as Figure 11 shows, the northern elevation has the second highest proportion of stone in good condition at 75%. This is an interesting finding as it may be expected that the northern elevation would receive high levels of wind and rain and low levels of insolation. Robinson and Williams (1999, p.11) investigating the weathering of Hastings Beds sandstone gravestones suggested that the more severe weathering of gravestones on their western sides could be attributed to their facing the prevailing wind, and thus being more frequently rain-soaked as well as them being sun-lit in the later parts of the day when air temperatures are highest, which may cause them to become drier than the eastern sides. This might indicate that decay is by cyclic wetting and drying rather than frost or chemical degradation.

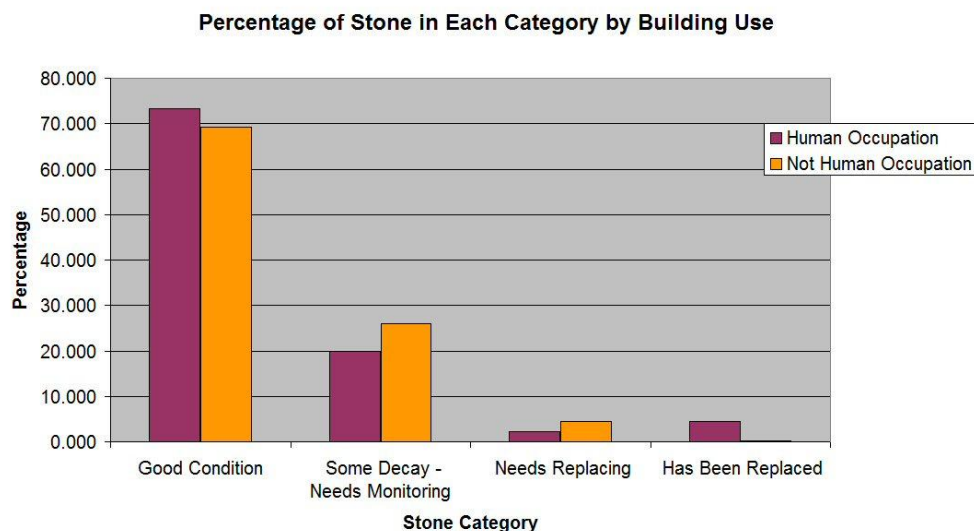
Figure 124: Graph of stone condition by building use

As can be seen from Figure 124 those buildings designed for human occupation have a slightly higher proportion of stone in good condition than those designed for other uses 73%

There are various reasons as to why stone might fare better on buildings designed for human occupation. They are generally built using better materials, techniques, designs and craftsmanship in the first place. For example a number of buildings designed for human occupation have overhanging roofs which provide protection to the walls. They have more efficient mechanisms for carrying rainwater off the roof and away from the building i.e. functioning gutters and downpipes. In addition there is more likelihood of earlier and effective care and maintenance, for example a building that is occupied by humans is less likely to be damp as the occupiers are likely to take steps to rectify any dampness and the internal space will be heated. Buildings not designed for human occupation probably suffer more abuse over their lifetimes. For example: buildings that have been used as animal shelters often have contaminated masonry due to contact with animal waste which occurs over a period of many years. Water is a major agent of decay since water can transport salts into the pore spaces of stones, either from the ground or other sources; cause decay due to the freeze-thaw process and can also cause decay due to its acidity. The text above sets out a number of reasons why buildings designed for human occupation may suffer less from water penetration and therefore from salt crystallisation, freeze-thaw and acid attack. However the Chi-square test has been carried out on the data for the relative proportions of stone in good condition for human and not-human occupation. The results of the test show there is no significant difference between the two sets of data and thus the hypothesised better quality of stone in human habitations cannot be proved by the observations made.

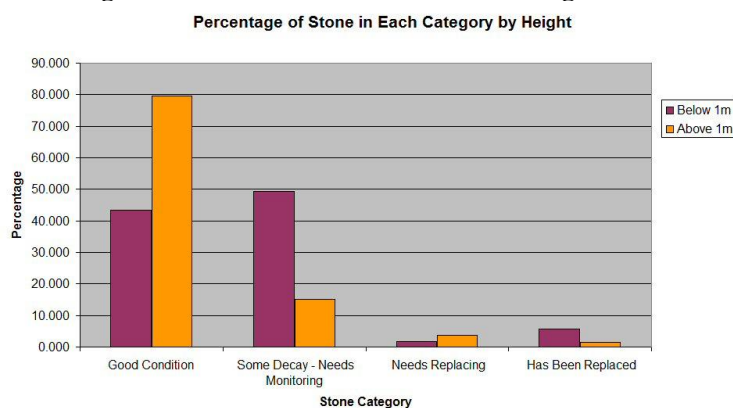
Figure 13: Graph of stone condition by height above ground level

Whilst carrying out the survey of the buildings detailed in this report it became apparent that much of the decay seemed to occur at low level; up to 1 metre in height from the ground level. The graph below illustrates the percentages of stone in the different categories for stonework below 1 metre and stonework above 1 metre in height.

Figure 1 illustrates large differences in the condition of the two sets of stone in the first two categories. Only 43% of stone below 1 metre in height is in good condition, whereas 79% of stone above 1 metre in height is in good condition. 49% of stone below 1 metre is showing signs of decay compared to only 15% of stone above 1 metre. Results for stonework that needs replacing, although low in percentage terms, are markedly different from each other.

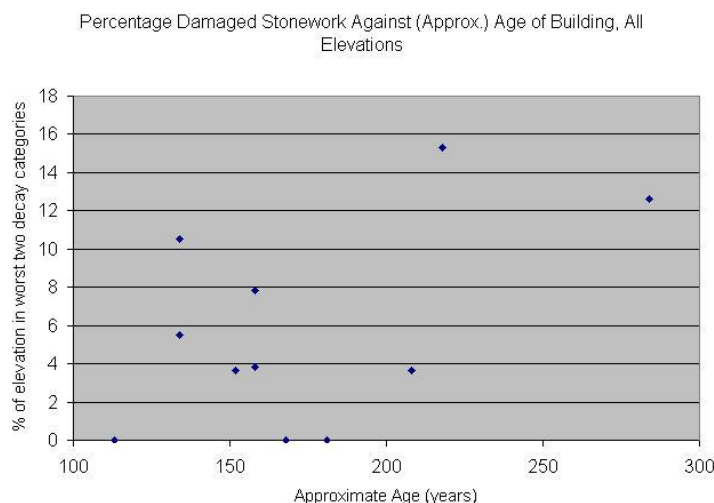
Figure 14: Graph of stonework damage against building age - all elevations

There appears to be a general correlation between building age and the percentage of stonework in the worst two damage categories, the older a building is, the higher the proportion of damaged stone, indicating that decay continues throughout the life of the building in a progressive, although not necessarily linear, manner. Factors such as the quality of the stone used, the local topography, the building's design, the maintenance regime will also affect the rate of decay.
