Remote Inspection of a 46 Year Old Buried High Level Waste Storage Tank

Author: J. B. Elder

Savannah River Technology Center
NDE and Materials Reliability
Materials Technology Section

April 22, 2003

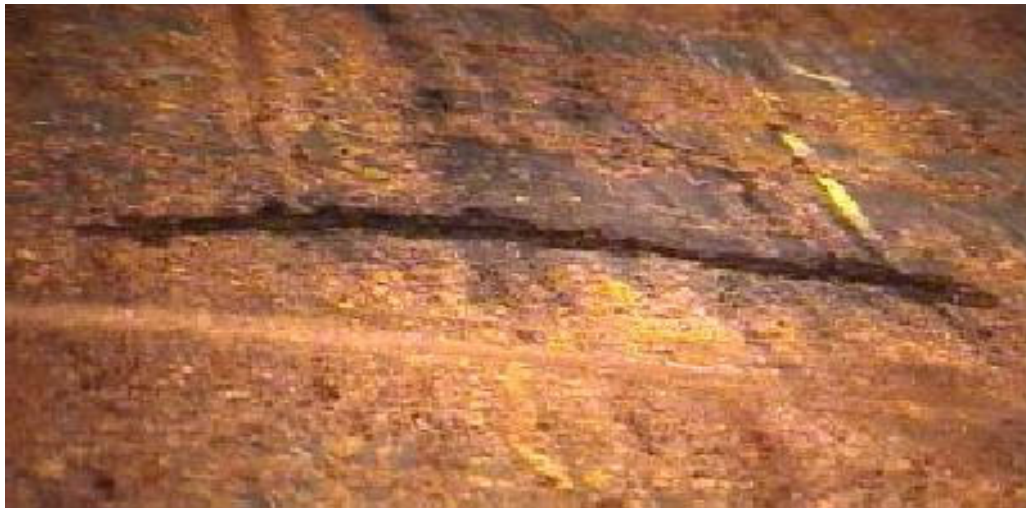
Figure 5: Example of Through-Wall Bleed-Out

Through-wall bleed-out is the term used to describe a field implemented variation of the liquid penetrant surface inspection technique. It was noted that the water being used as the UT couplant, would penetrate (through capillary action) into cracks that were open to the external surface. The tank wall was ~120 degrees F because of the radioactive decay of radioisotopes contained in the tank, thus the wetted surface would dry rapidly as the UT inspection crawler moved away. However, where there was a crack open to the exterior surface, the water drawn into the crack would bleed out continuously wetting the near crack surface and providing a high contrast image of the open crack. Video cameras were used to view these indications (Figure 5) and make crude measurements of length as the crawler was driven along the indication(s).
