**Ferguson, David and Catterson, Victoria M. (2015) Designing for reliability in wind turbine condition monitoring systems. In: EWEA 2015 Annual Event, 2015-11-17 - 2015-11-20, Paris expo Porte de Versailles. ,**

# Designing for Reliability in Wind Turbine Condition Monitoring Systems

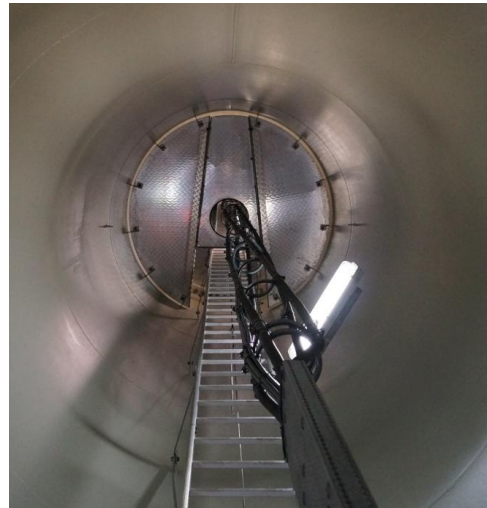
**Figure 5: Wind turbine tower with power cables in centre**

Fibre optic cable by its nature does not have a lot of flex in it and therefore when subjected to excessive strain will break relatively easily. To prevent the fibre optic cable from coming under excessive strain it must be installed in a way that allows it to have enough slack in it to prevent over straining yet be secured in the right places to avoid any one part bearing the weight of the cable below it. Where possible any new fibre optic cable being installed should follow as closely as possible the path of the existing fibre optic cable which is used for the wind turbine control communications. The most likely location in the wind turbine for the fibre optic cable to come under excessive strain is at the yaw deck. It is therefore crucial within this area to leave sufficient slack to be taken up as the wind turbine yaws. A turbine will typically be able to yaw two complete rotations in either direction before it corrects itself.

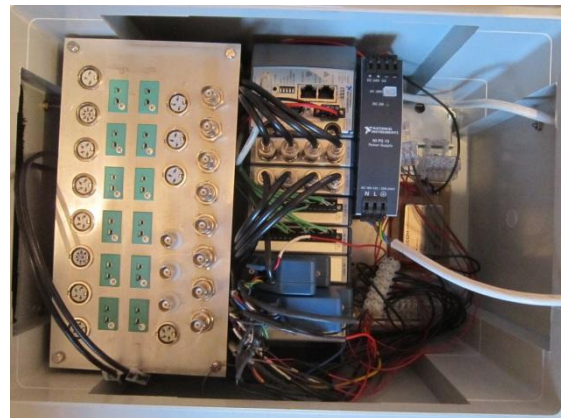
Figure 4: New CMS enclosure

The use of a cRIO also allowed the main CMS enclosure to be significantly smaller in size. Figure 4 shows the new CMS enclosure. The cRIO can be seen located in the centre of the enclosure with its power supply sitting to its immediate right. The 24Vdc power supply for the cRIO is also used to supply power to all of the sensors. A DC-DC converter seen on the right-hand side of the enclosure is used to convert the 24Vdc in to  $\pm 12$ Vdc and 5Vdc required for different sensors.

As can be seen from Figure 4 the connector panel was brought inside of the main enclosure which will reduce the chances of moisture entering at the connectors which could result in corrosion. The sensor cables enter the enclosure via a brushed entry system which although reduces the enclosure's ability to prevent water from powerful jets it will still prevent large volumes of dust entering. To prevent any moisture ingress through drips from above a rubber seal with a flap which extends over the cable entrance was fitted to the enclosure.

In Figure 4 the connector panel can be seen on the left hand side of the main CMS enclosure. On the previous system the connector panel was mounted on the outside of the enclosure. This however meant that the sensor connectors were susceptible to being knocked off or damaged whilst maintenance work was being carried out in the nacelle. For this reason it was decided that it would increase system robustness to have the connector panel inside the enclosure. The sensor connectors enter the enclosure via a brushed opening which allows the connectors to pass through but reduces the exposed area in which dust may enter.
