# Lessons Learned from Dike Failures in Recent Decades

**ABSTRACT:** *The paper describes five different dike failures that occurred in recent decades. The case histories were located on different rivers and involved different loading conditions. The observed failure mechanisms involved erosion and stability problems. The types of erosion observed were both internal erosion due to extreme groundwater flow and external erosion caused by the river flow and wave action. The case involving instability was caused by uplift, i.e., increased hydraulic head led to a sharp reduction in maximum shear strength between subsoil layers. Two cases demonstrate the importance of dike management and maintenance. Despite the variations in the loading conditions and failure mechanisms, all the cases show that the strength of a dike depends not only on the material used to build the dike but also on the strength of the subsoil.*

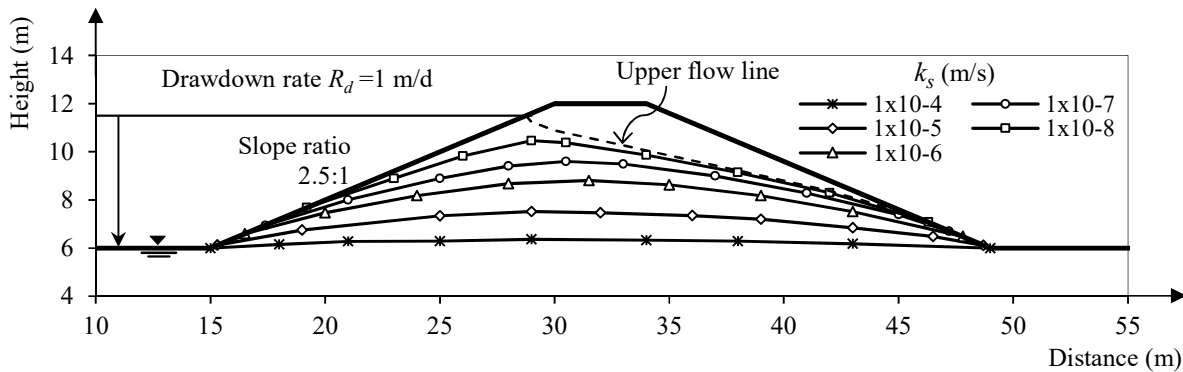
Figure 7. Phreatic surfaces (desaturation lines) at the end of the water drawdown stage in a dike with variable hydraulic conductivities  $k_s$ , (López-Acosta et al. 2015)

These analyses evaluated several homogeneous and isotropic dikes with a 2.5(H):1(V) slope and total dewatering head of 5.5 m for different hydraulic conductivities. Figure 7 shows the upper flow line for the initial steady-state condition and desaturation lines at the end of water drawdown in dikes with different hydraulic conductivities  $k_s$  for the transient-state condition and assuming a constant drawdown rate of  $R_d = 1$  m/d. As can be seen from this figure, where  $k_s = 1 \times 10^{-8}$  m/s, the desaturation line remains practically in the same position as the upper flow line, which is associated with the *fully rapid drawdown mode*. In this case, it can be assumed that the soil behaves undrained. For  $k_s = 1 \times 10^{-4}$  m/s, the desaturation line inside the dike drops down almost in line with the reservoir water level, which is associated with the *fully slow drawdown mode*. In this case, it can be assumed that the soil behaves drained. It can also be assumed that the desaturation lines between these two extreme modes represent the *transient drawdown mode* in which a curvilinear water line is generated in the soil structure, the position of which depends on the drawdown rate and the constitutive material properties. The remaining pore pressure in the dike is therefore transient, it varies as a function of time, but also with the soil's ability to retain water. Several authors have recognised the three water drawdown modes described here (examples being Lane & Griffiths, 2000 and Berilgen, 2007).

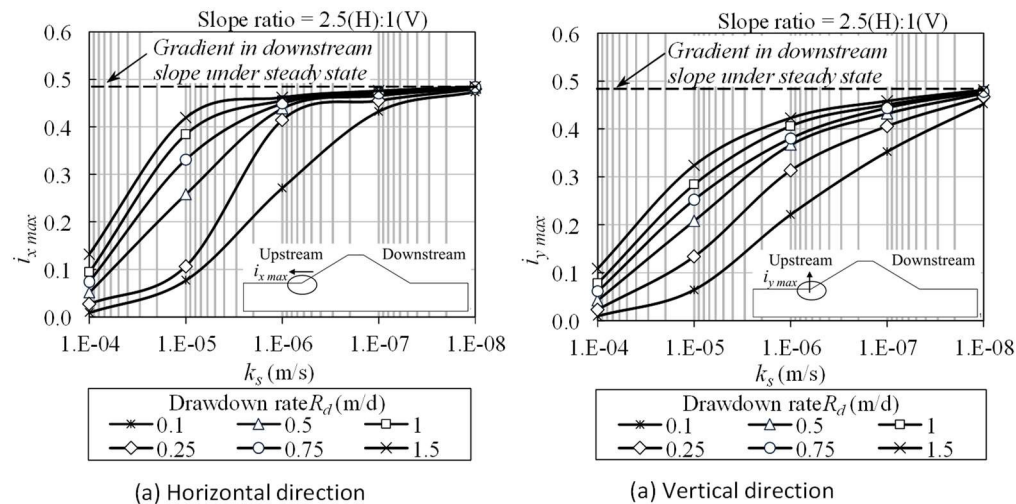
Figure 8. Effect of drawdown rate  $R_d$  on exit hydraulic gradients in dikes for variable hydraulic conductivities  $k_s$ , (López-Acosta et al. 2015)

Figure 8 shows the effect of the drawdown rate on exit hydraulic gradients in the horizontal and vertical directions, corresponding to the x and y axes respectively, in both the upstream and downstream slopes of the dikes with variable hydraulic conductivities  $k_s$ . In addition, Figure 9 summarizes the results obtained assuming variable permeabilities  $k_s$  and a constant drawdown rate ( $R_d = 1$  m/d). The following conclusions can be drawn on the basis of the results of these parametric analyses:

- The exit hydraulic gradients were observed to increase when the drawdown rate increased.
- In general, given the admissible values suggested by several authors for local erosion and piping (for example, Den Adel et al., 1988; Wan & Fell, 2004; Ahlinhan & Achmus, 2010), the magnitude of the gradients computed here is significant. One suitable way of preventing internal erosion or piping is the installation of filters or drains placed strategically in the earth structure.

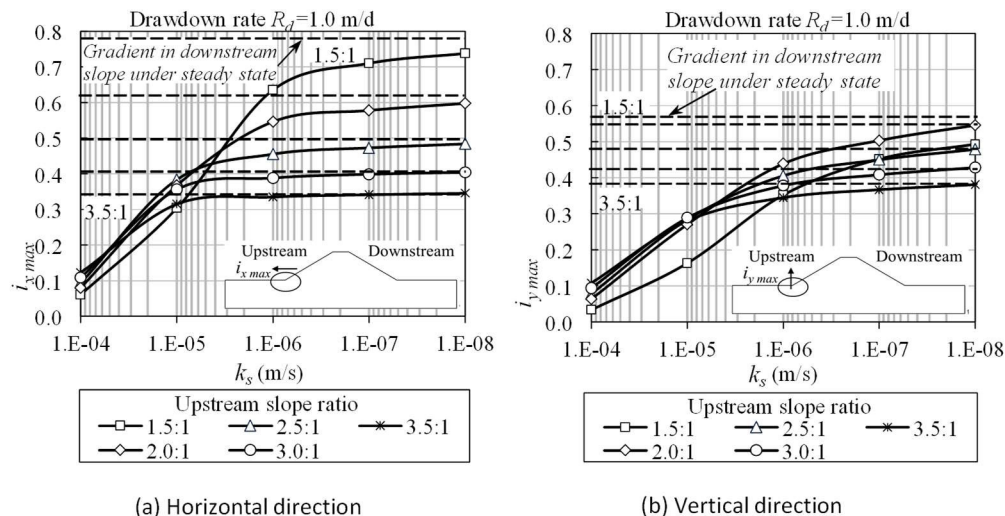
Figure 9. Effect of the slope ratio (H:V) on exit hydraulic gradients in dikes for different hydraulic conductivities  $k_s$ , (López-Acosta et al. 2015)

- Under a steady-state flow, the exit hydraulic gradients in the downstream slope remain constant for all  $k_s$  permeabilities studied.
- Changes in the slope ratio of dikes have a more significant effect on the magnitude of the exit hydraulic gradients than changes in the drawdown rate. It was observed that steeper slopes generate greater values for exit gradients.

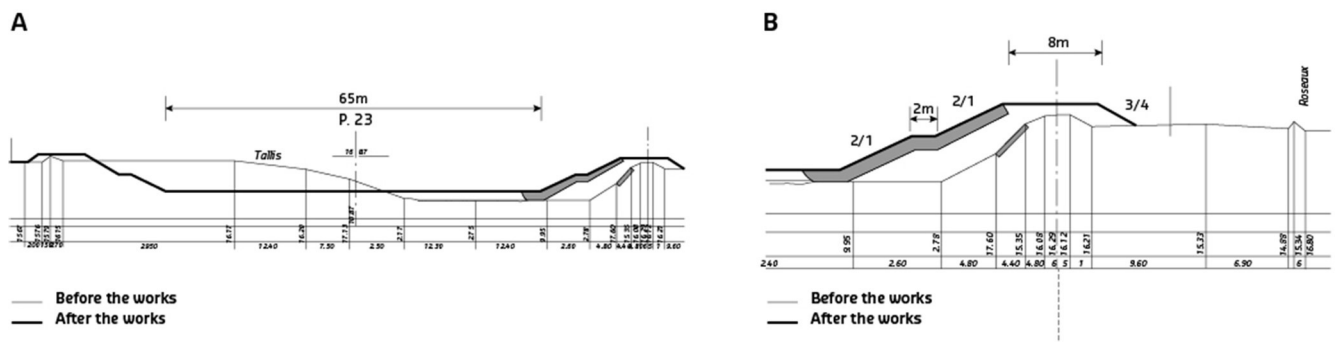
Figure 12. a) Re-profiling of the river and construction of the dikes, b) armoring of the river side of the dikes in concave sections

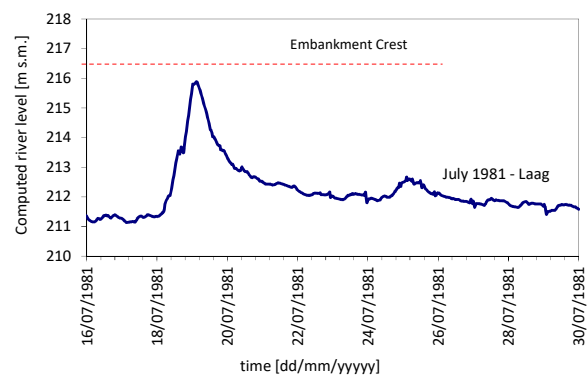
The river level at Laag and St Florian was derived from hydrometer measurements upstream (Branzoll hydrometer), assuming a uniform flow between the section where the hydrometer was installed and the sections where the embankment instabilities were located. The river level computed during the flood event is shown in Figure 17 and 19. At its peak, the river level in Laag and St Florian was still approximately 50 cm below the crest of the dike (Figure 17). Failure was therefore associated with water flow through the dike and/or its foundations and the collapse involved the instability of the landside bank.

Figure 17. River level computed at Laag (km 106.185) from 16 July to 30 July 1981. The elevation of the embankment crest is reported as a reference.

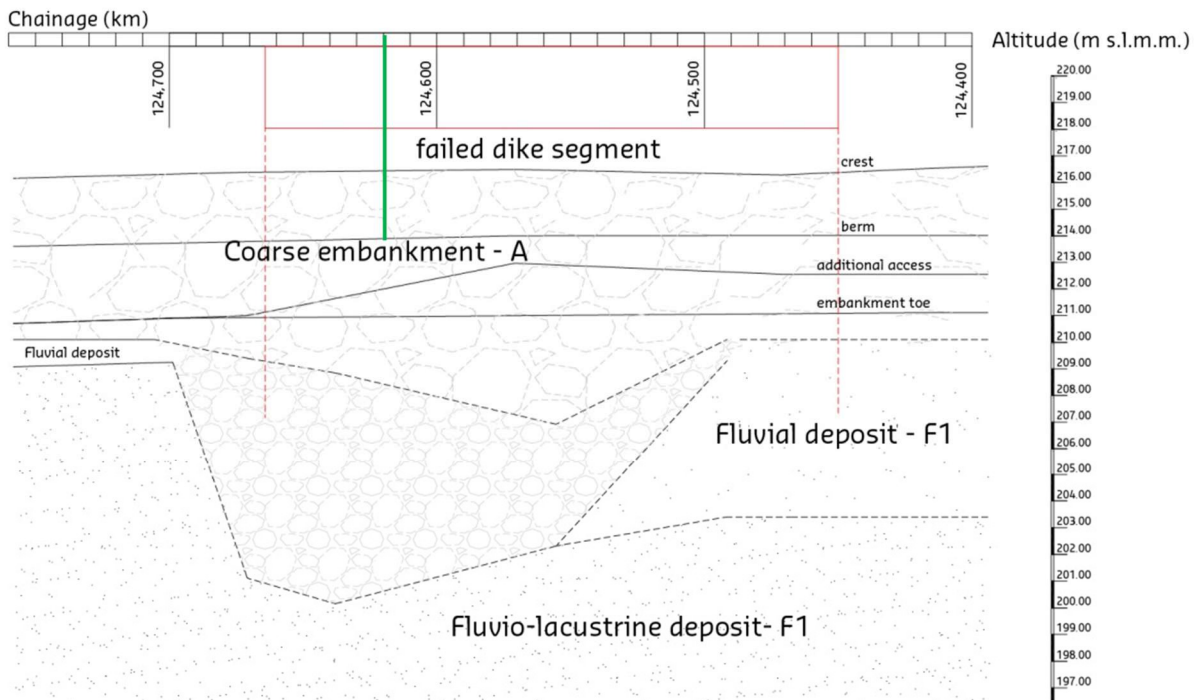
Figure 20. Longitudinal soil profile of the dike segment in Laag that includes the section breached in 1981. The location of the representative cross-section is indicated by the green line.

Figure 20 shows the longitudinal soil profile that includes the segment of the dike in Laag breached in 1981 and then reconstructed after 1981. The dip in the interface between the coarse-grained embankment and the ancient river bed is attributable to the excavation of the ancient river bed material after the dike was breached. During the flood, the embankment was patrolled frequently (a few times a day) and no evidence of sand boiling was detected. It is not possible to exclude that

sand boiling was occurring between one visual inspection and another. However, it would appear that failure was mainly caused by underseepage rather than erosion triggered by uplift pressures at the landside toe of the embankment.

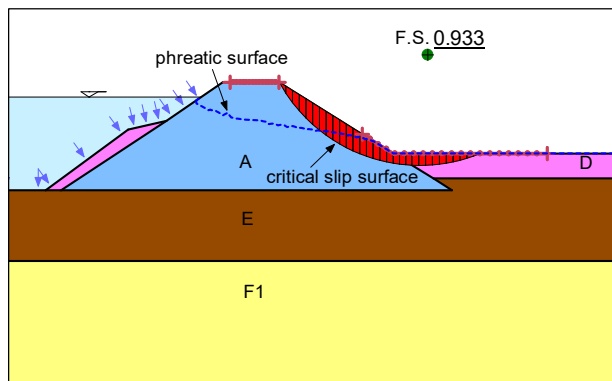
Figure 24. Stability analysis and relevant soil parameters at flood peak and transient flow condition of the section at km 124.62 in Laag;  $c' = 0 \text{ kN/m}^2$

where  $\sigma_n$  is the normal stress,  $\mathcal{G}_w$  is the volumetric water content,  $\mathcal{G}_s$  is the saturated volumetric water content and  $\mathcal{G}_r$  is the residual volumetric water content. The results of the stability analyses at flood peak for the two cross-sections based on transient flow conditions are shown in Figures 24 and 25. The stability analysis consistently returns factors of safety  $< 1$  for these sections, which proved to be unstable in 1981.

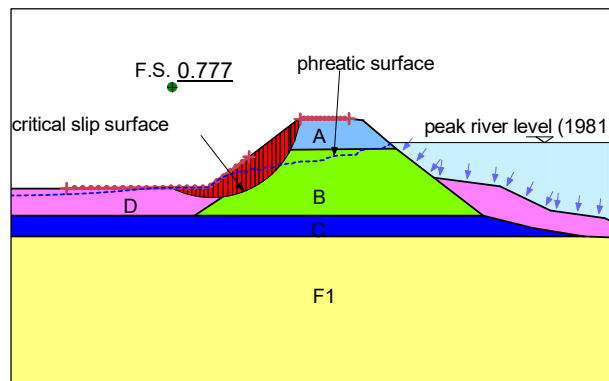
Figure 25. Stability analysis and relevant soil parameters at flood peak and transient flow conditions of the section at km 122.248 in St. Florian;  $c' = 0 \text{ kN/m}^2$ .

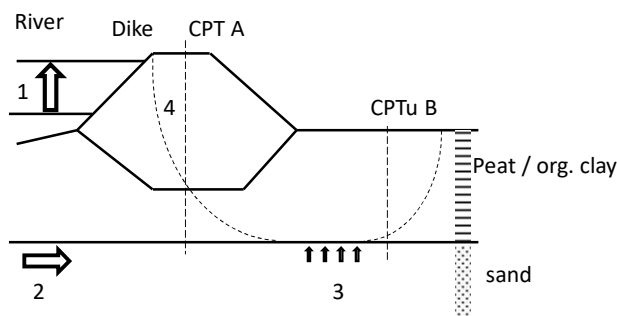
A typical failure mechanism for dikes in this area is loss of stability due to uplift of the soft soil layers at the toe. Figure 28 explains the failure mechanism. There is a hydraulic connection between the river and the Pleistocene sand layer. A rise in the river level (1) results in an increase in the hydraulic head in the Pleistocene sand layers (2) until the pore pressure equals the weight of the Holocene layers on top (3). The shear strength at the transition between the Holocene clay and peat layers on the one hand and the Pleistocene sand deposit on the other is drastically reduced, creating the conditions for a long, deep, slip plane (4). The uplift phenomenon is described in further detail by Cooling & Marsland (1953), Marsland (1961), Bauduin et al. (1989) and Van (2001). Observations of stability loss due to uplift are scarce and it was decided to study the uplift phenomenon at the Bergambacht test site.

Figure 28. Impression of the uplift failure mechanism, 1: river level rise, 2: hydraulic connection to sand layer, 3: pore pressure rise until uplift top layer, 4: failure plane.

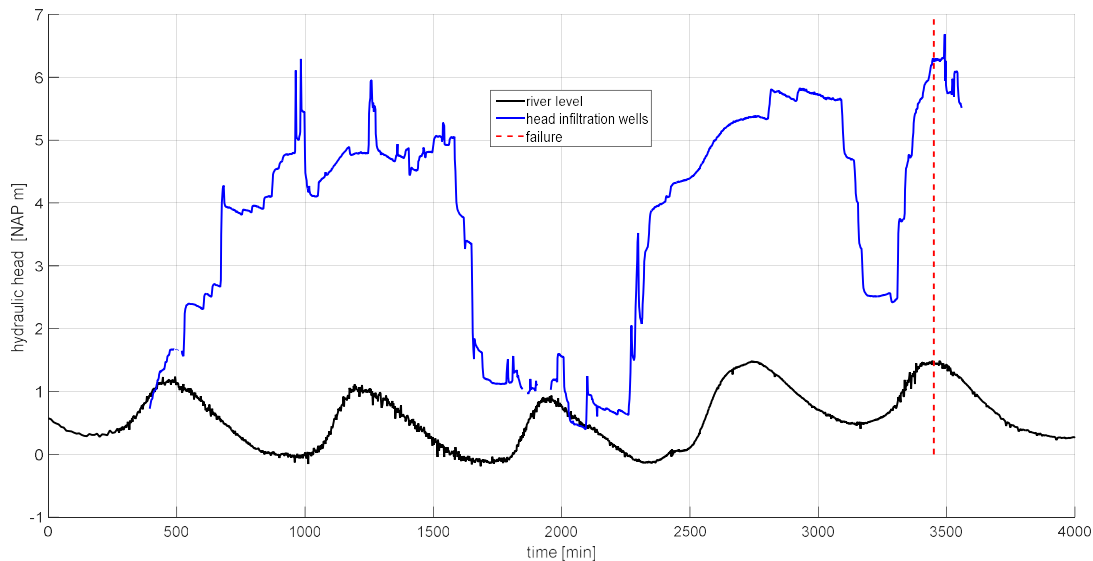
The test began at 06.00 on 26 November 2000,  $t = 0$  in the graphs below. Figure 32 shows the river level and the average head in the nine infiltration wells. Infiltration started at  $t = 370$  min, 6 hours after the start of the test. Initially, the hydraulic head in the wells followed the fluctuations in the river level. It should be noted that the test site is close to the sea and that the tidal wave has a pronounced influence on the water level in front of the dike. Although drinking water was used for infiltration, the infiltration wells clogged up after 26 hours,  $t = 1580$  min, reducing well capacity. Due to maintenance, required to regain the full pumping capacity, the hydraulic head was seen to fall between  $t = 1580$  and 2260 min, a period of 11.3 hours (Figure 32). Maintenance was also needed between  $t = 3090$  and 3308 min, a period of 3.6 hours. Failure was observed at  $t = 3450$  min, approximately 2.5 days after the start of the test, in the form of large longitudinal cracks in the dike body accompanied by major subsoil deformation (see Figures 33 and 34). The difference in height at the location of the cracks increased to more than 1.0 m (Figure 27b).

Figure 32. River level and hydraulic head in infiltration wells during the test

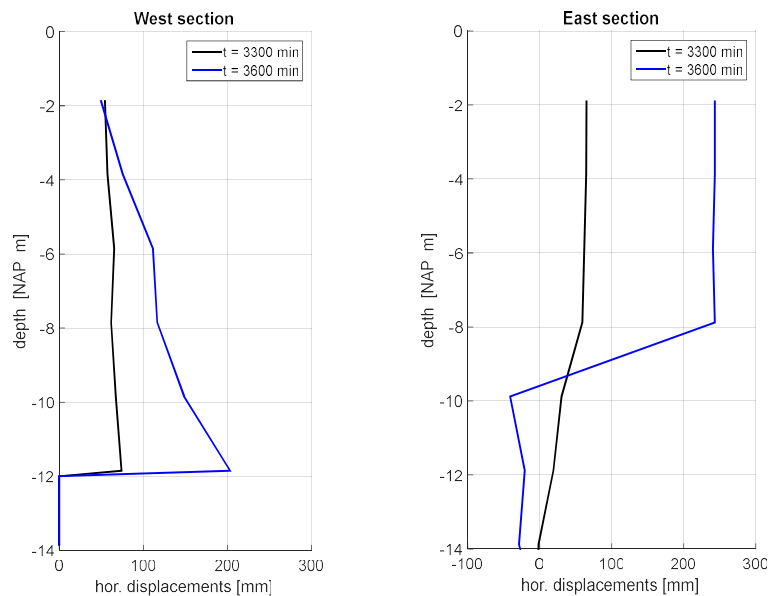
Figure 33 shows the horizontal displacements measured at the toe in the eastern and western sections at  $t = 3300$  min (55 h) and  $t = 3600$  min (60 hours). Note that there was no inclinometer in the central section. The maximum displacement was found at the transition between the Pleistocene and Holocene layers, which was not at the same depth in both sections. Figure 34 shows the development of the maximum displacement for both sections. In the western section, horizontal displacements started to develop as soon as infiltration began. At approximately  $t = 1500$  min, infiltration was suspended temporarily and no further deformation was observed until  $t = 2500$  min, when infiltration resumed. Soon after, horizontal displacement developed in the eastern section as well. Infiltration was suspended for a second time, and horizontal displacement stopped again. Soon after infiltration resumed, displacement accelerated until the dike failed at  $t = 3450$  min (57.5 hours) after the start of the test.

Figure 33. Horizontal displacement at the toe (both polder-side west respectively east of the central section as shown in Figure 27a)

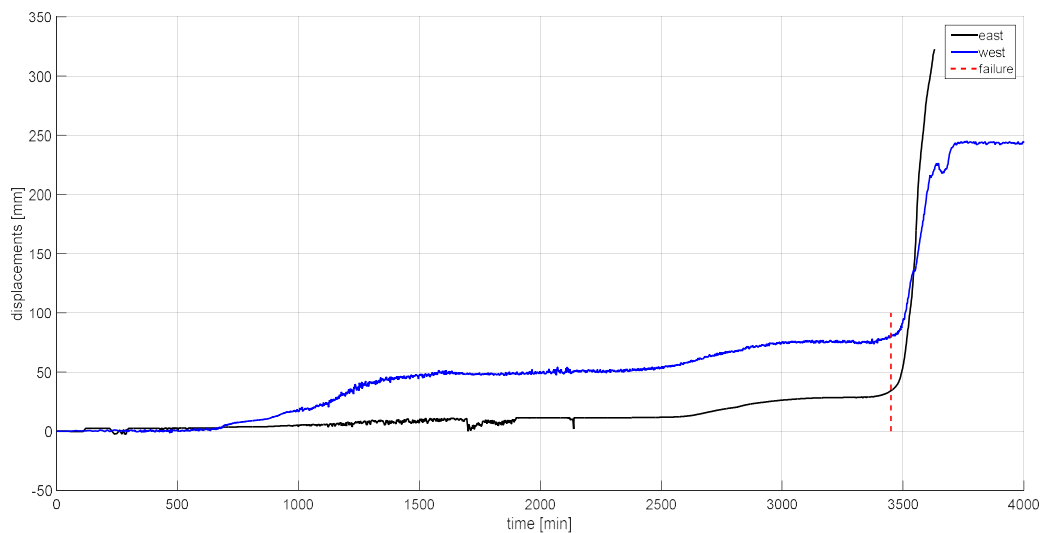
Figure 34. Development of maximum horizontal displacement during the test

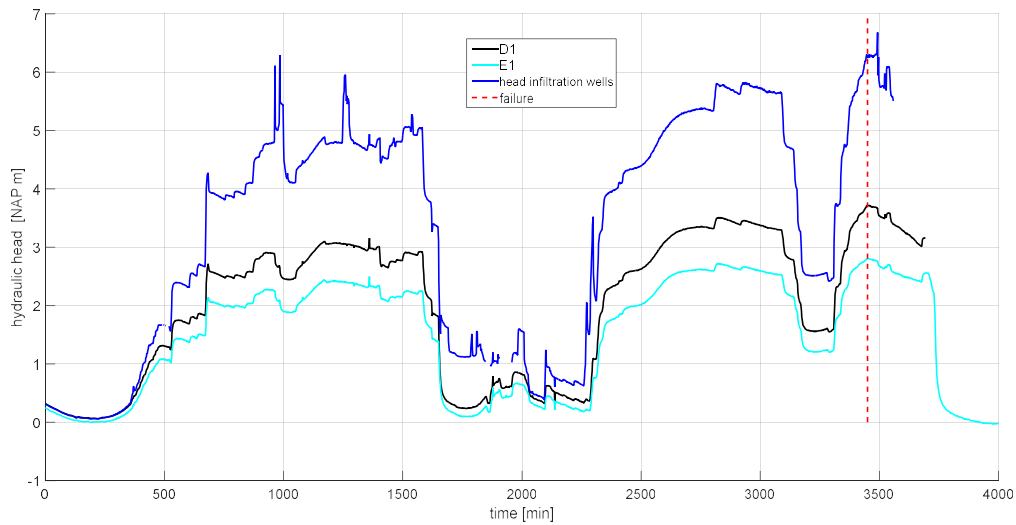
Figure 35. Hydraulic head in Pleistocene sand layer, locations D1 and E1 (see Figure 29)

Figure 35 shows the hydraulic head observed in the Pleistocene sand layer at distances of 21 and 42 m from the infiltration wells. The effect of infiltration declined with increasing distance from the well; the hydraulic head at D1 was lower than in the infiltration wells and a further reduction in maximum head was observed in E1.

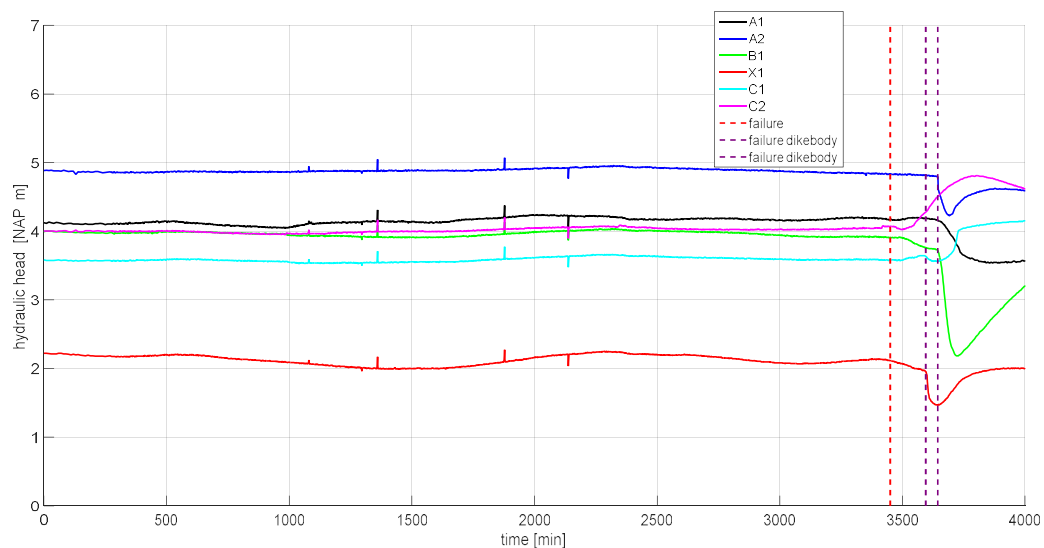
Figure 36 shows how hydraulic head developed inside the dike body. Prior to failure there was no significant fluctuation in hydraulic head. The range in hydraulic heads measured by the different transducers can probably be explained by suction forces at the top of the dike. With the exception of C2, there was a sharp drop indicating failure. Close inspection shows that, inside the dike body, the response to failure was later than given by the observed horizontal displacement at the toe,  $t = 3450$  min at which only the pore pressure at location C2 shows a response. There was a minor initial response at B1 and C1 shortly after  $t = 3450$  min. The sharp drop in hydraulic head was observed later. The drop at X1 and C1 was observed at  $t = 3595$  min, or 145 min (2.4 hours) later. At  $t = 3644$  min (50 minutes later) the hydraulic head at B1 and A2 dropped significantly. The time differences for local failure found at different locations shows the propagation of the failure plane, starting deep in the subsoil and moving towards the crest. It should be noted that the development of the failure plane resulted in breakage of the infiltration wells. When infiltration ceased, the uplift conditions were no longer in place and sliding along the slip plane as indicated by Figure 28 stopped.

Figure 36. Hydraulic head in the dike body for locations A1 to C2 (see Figure 29)

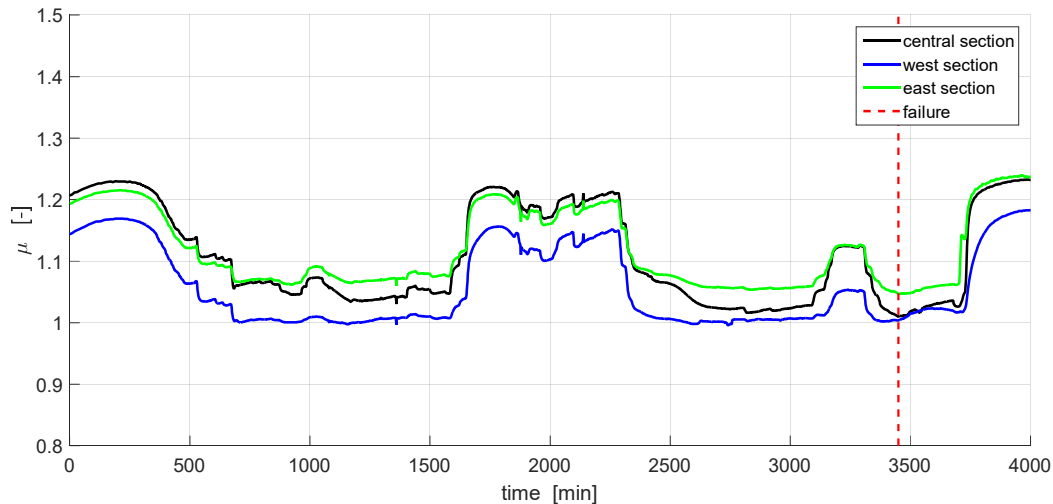
Figure 37. Ratio of total overburden pressure to pore pressure,  $\mu$ , during the test

To check on the uplift conditions during the test, the ratio,  $\mu$ , of the weight of the Holocene layer to pore pressure in the Pleistocene sand layer was determined for each of the transducers in the Pleistocene sand layer. Figure 37 shows the ratio,  $\mu$ , during the test for the transducers placed at 46 m from the crest of the dike in the central, eastern and western sections. Initially,  $\mu = 1.2$ . When infiltration began, this value reduced, as expected. Due to differences in the subsoil layer,  $\mu$  varied for the different sections, with the lowest value in the western section, where the value remained approximately 1. In the central and eastern sections,  $\mu$  seemed to reduce slightly during the test. This corresponds to the slight increase in infiltration pressure during the test, as shown in Figure 35. The value did not drop significantly below 1.0. This could be explained by the pumping capacity, which does not allow for any further increase in pore pressure in the sand layer at the toe of the dike. It can also be hypothesized that when the pore pressure in the sand layer starts to exceed the weight of the clay and peat layers above it, a gap is created which is filled with pore water from the sand layer until a new equilibrium is attained. When pumping capacity is further increased, the gap may be widened, maintaining the equilibrium in vertical forces. In this hypothesis,  $\mu = 1.0$  could be a physical boundary that will have prevented any further decline in the  $\mu$  value in the western section during the test. It should be noted that, at larger distances from the dike, the Pleistocene hydraulic head decreased, causing an increase in  $\mu$ . Close to the dike,  $\mu$  is affected by the weight of the dike body.

Figure 33 shows that horizontal displacement in the western section was initially higher than in the eastern section. This corresponds well to the lower  $\mu$ -value found for the west section, indicating that uplift was reached at an early stage of the test in the western section. The dike was seen to fail when the  $\mu$ -value reached the lowest level during the test in the central section,  $\mu = 1.01$ , and eastern section,  $\mu = 1.05$ .

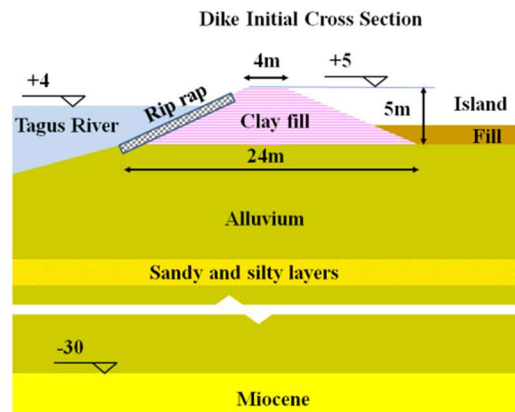
Given the location of the island in the Tagus River delta, one of the widest estuaries in Europe, the geological scenario is very complex: alluvium deposits, mainly very soft clays, with  $S_u$  not greater than 20 kPa, sometimes interbedded with silty and sandy layers, with an overall depth of approximately 30 m (Figure 39). The alluvium rests on the bedrock of Miocene sandstone.

The main failure mechanism is related to the erosion of the clay fill due to water inflow and the mechanical action of the waves on the outer face of the dike. Failure originated with the erosion of the riprap revetment (Figure 39). The presence of a permeable sandy layer below the dike foundations also contributed to the failure mechanism. The actual dike failure began during the severe winter of 2015 - 2016 and involved a section with an overall length of approximately 30 m. When the failure occurred, the water level in the Tagus River was approximately Mean Sea Level, MSL, +4.20 m. In October 2016, the overall length of the dike failure line had increased to approximately 80 m.

Figure 39. Initial dike cross-section and geotechnical profile.

The main lesson learned is that the need for preventive maintenance should be emphasised. In this case, the lack of maintenance work on the riprap protection was the main reason for the failure, which was further facilitated by the absence of a suitable geotextile. The installation of a comprehensive monitoring and survey system is also very important. The installation of the monitoring and survey system should be accompanied with a better understanding of the geological and hydrogeological conditions and assessment of subsoil characteristics as strength, stiffness and permeability.
