47TH TURBOMACHINERY & 34TH PUMP SYMPOSIA
HOUSTON, TEXAS | SEPTEMBER 17-20, 2018
GEORGE R. BROWN CONVENTION CENTER

Resolution of high vibration on a Generator

Baker Hughes, a GE Company

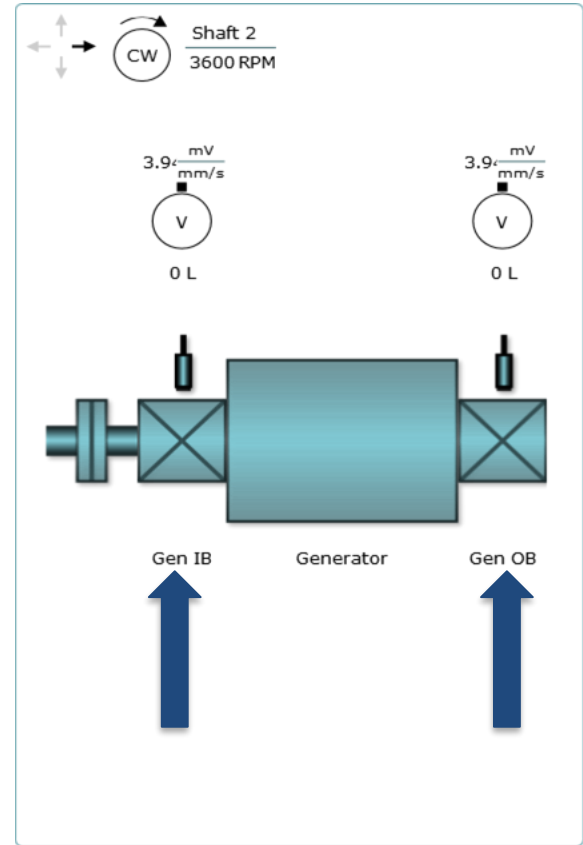
- The generator was running with acceptable vibration level (in vertical direction only) which was below alarm set point till 20 Aug, 2013, after that the unit was tripped on 21 Aug, 2013 due to lube oil temperature as indicated in DCS.
- Several start up trials were done but failed to reach FSNL and tripped due to high vibration in vertical direction which was exceeding the danger set point.

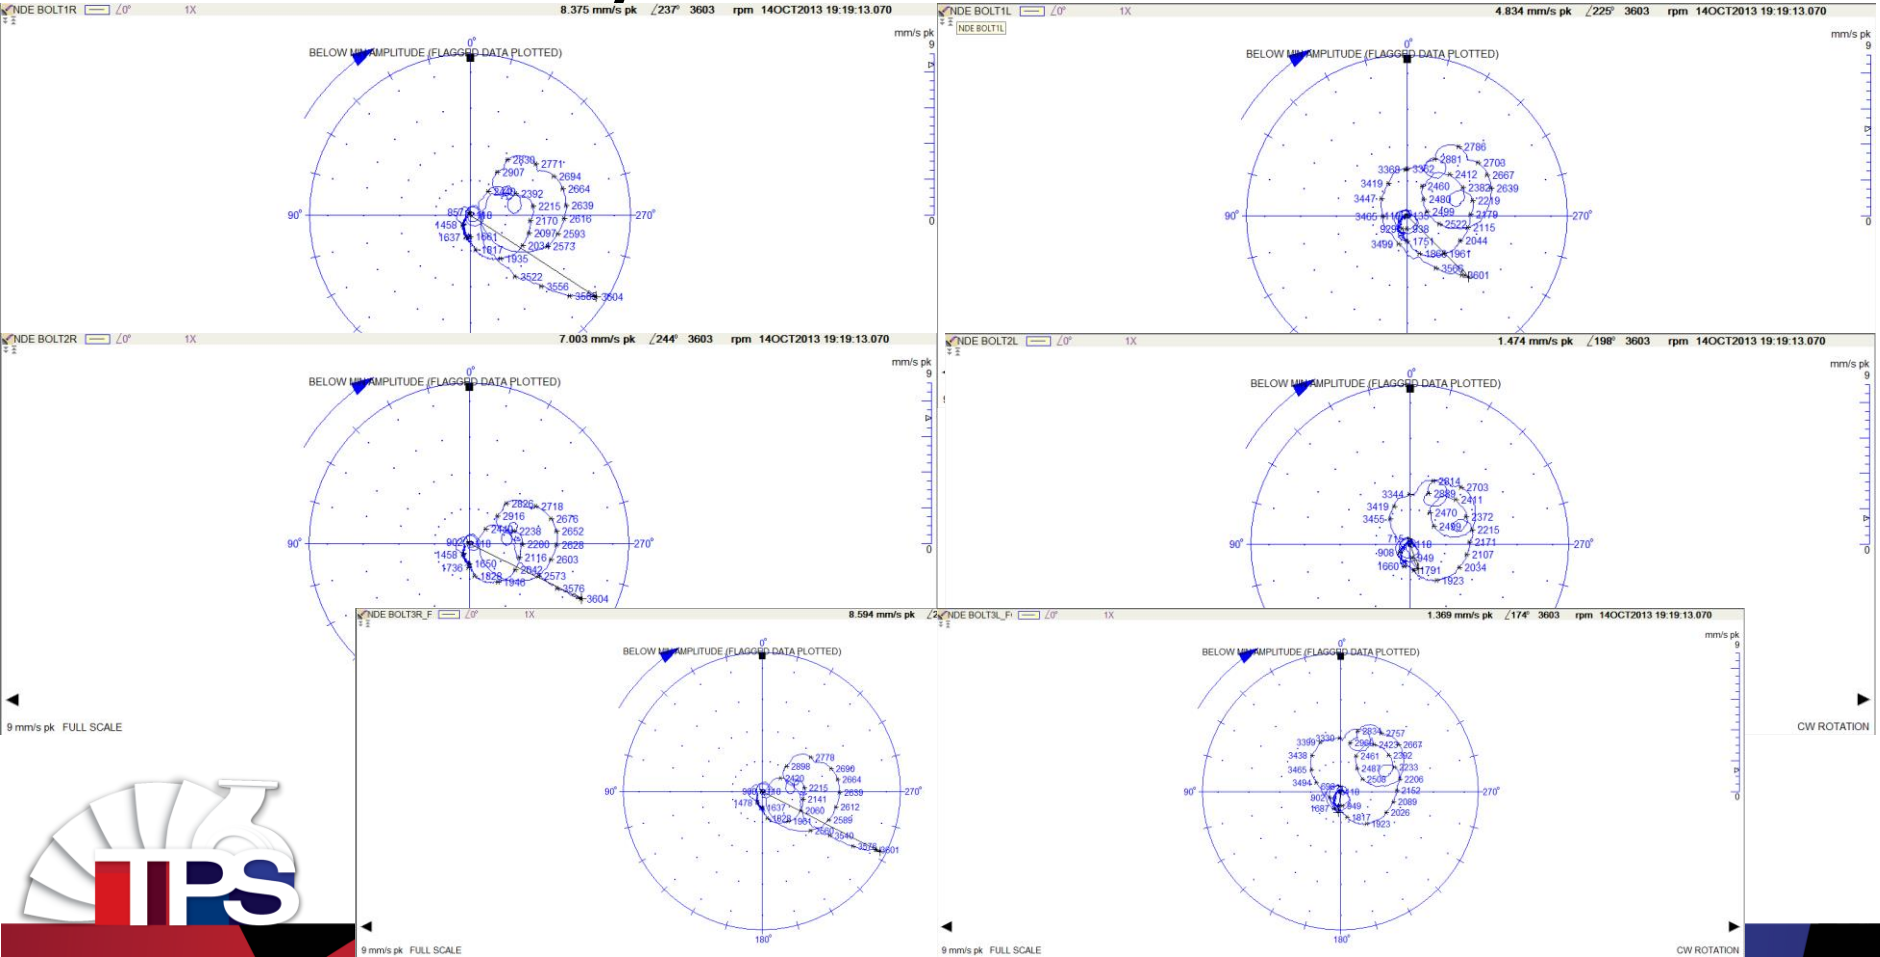
Data Analysis-Structural measurement

Out of Phase/ Relative Phase between Gen IB right & left
"Rocking Motion"

- The extremely high vibration levels on the generator and structure was mainly due to foundation looseness.
- Rocking motion was observed at Gen IB between right and left side due to looseness.
- Anisotropic system was observed due to different stiffness between horizontal & vertical.
- Bump test showed natural frequencies near to the running speed (65 Hz) in the horizontal direction.

- Overall inspection for all generators supports structure including the foundation, baseplates, soleplates, bearing pedestals, grout condition, etc.
- Verify that all support leg bolts, base to pedestal bolts, anchor bolts and pedestal hold down bolts are torqued properly.
