47TH TURBOMACHINERY & 34TH PUMP SYMPOSIA
HOUSTON, TEXAS | SEPTEMBER 17-20, 2018
GEORGE R. BROWN CONVENTION CENTER

CASE STUDY: Impeller High cycle fatigue failure on a natural gas pipeline compressor following choked flow operation

P. ALAS, F. LIBEYRE and F. MOYROUD

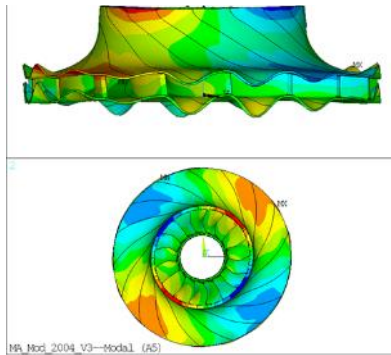
Impeller natural mode shape (2ND + 15ND/17ND at TE)

Crossing at 100% speed between 4.8kHz impeller hub TE mode shape and 32/Rev aero. excitation (vaned diffuser 2nd harmonic)

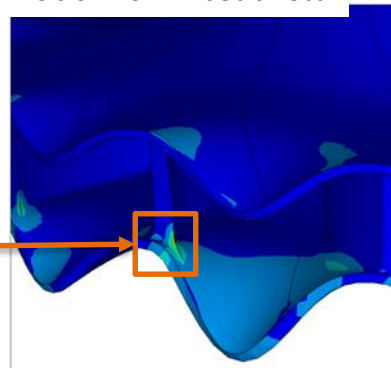
Modal Von Mises stress

Markers : impeller mode shapes
Iso-speed excitation lines : 80% and 105% speed
Vaned diffuser time harmonics

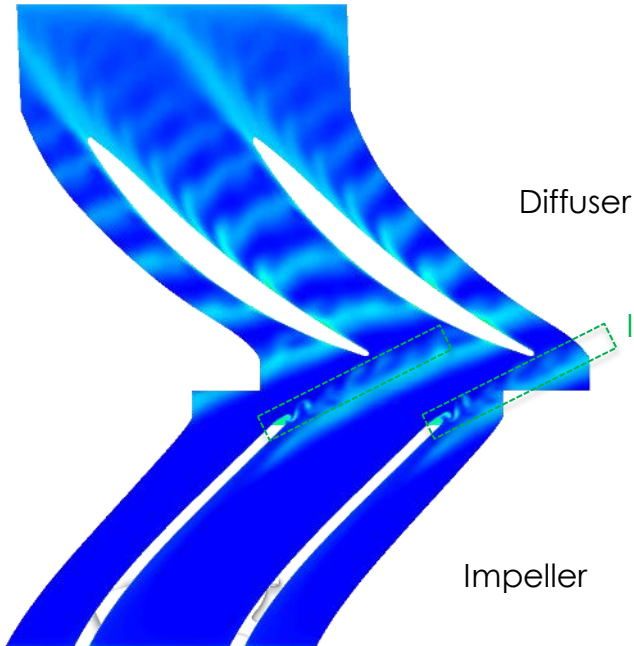
Entropy waves

Impeller/vaned diffuser aerodynamic interactions (RCA 1.1, 2.1-2.2)

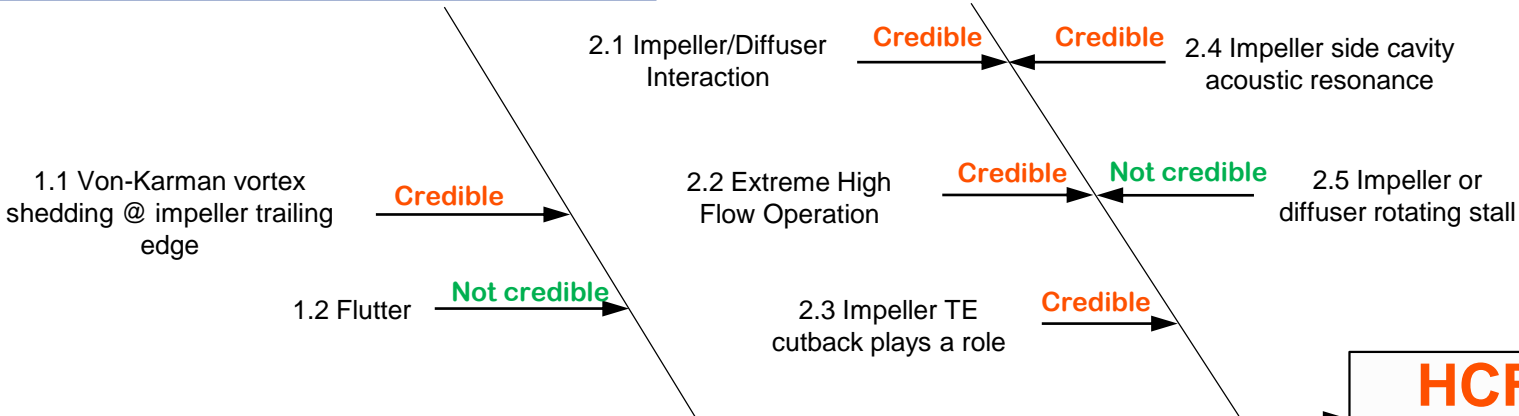
HCF Failure

1. Non-synchronous aerodynamic excitation and High Cycle Fatigue

2. Synchronous Vibration and High Cycle Fatigue (HCF)

3.1 Material non-conformity **Not credible**

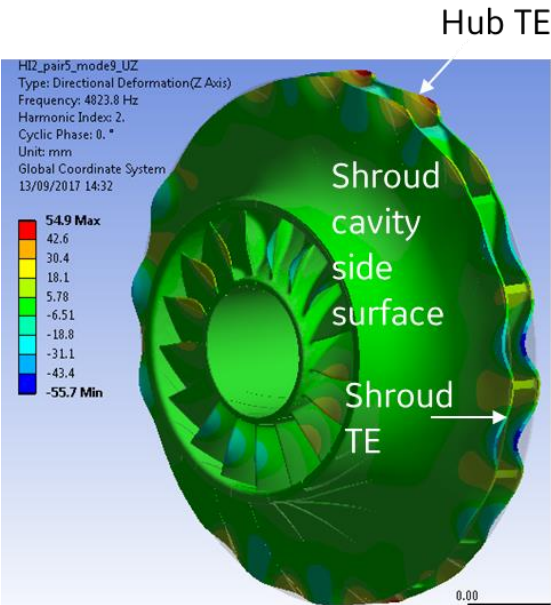
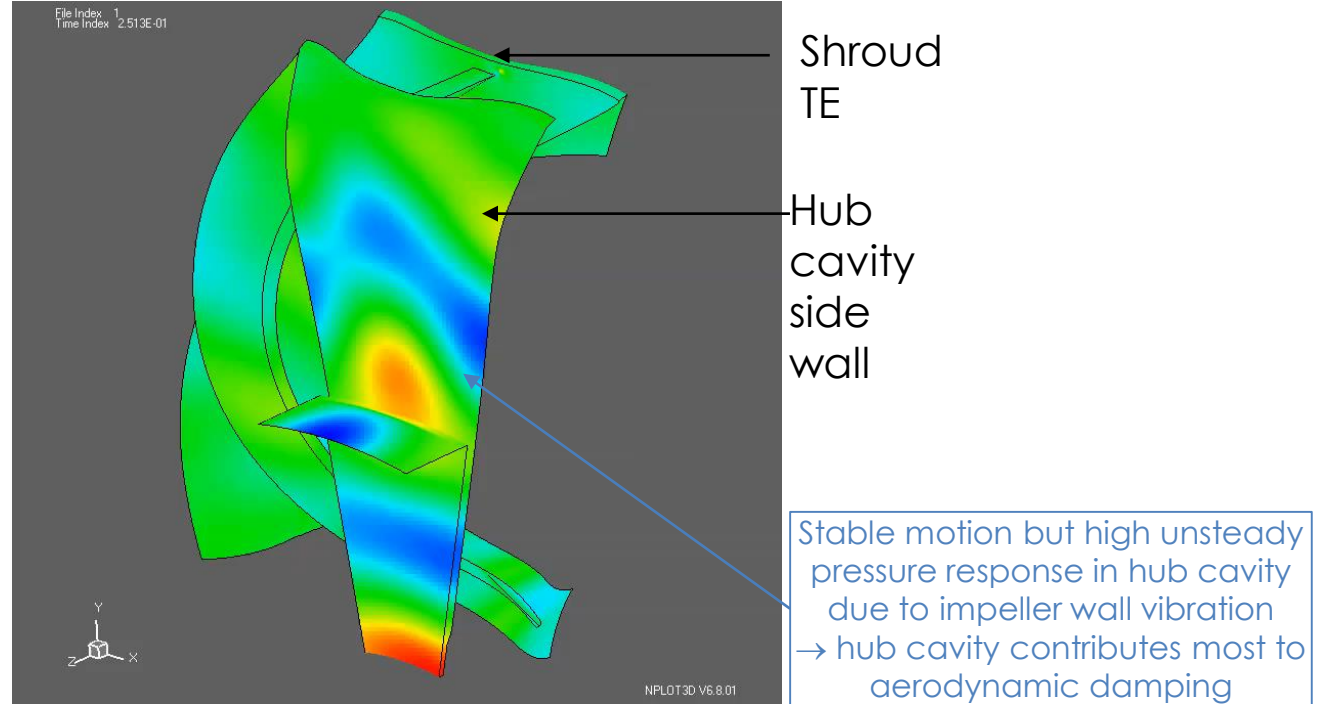
Impeller natural mode

Unsteady flow response to impeller wall vibration under impeller mechanical resonance

| | Method | Evidence |
|--|--|--|
| 1.2 Flutter | Unsteady CFD simulation to predict response of unsteady flow due to impeller wall vibration in resonance condition (no aerodynamic excitation) | No aeroelastic instability predicted for suspected impeller natural mode (sign of aerodynamic work and damping showing inherently stable vibratory motion) |
