47TH TURBOMACHINERY & 34TH PUMP SYMPOSIA
HOUSTON, TEXAS | SEPTEMBER 17-20, 2018
GEORGE R. BROWN CONVENTION CENTER

Improvement of Rotating Equipment Reliability Using Optical Metrology

Vacuum Bottoms Pumps

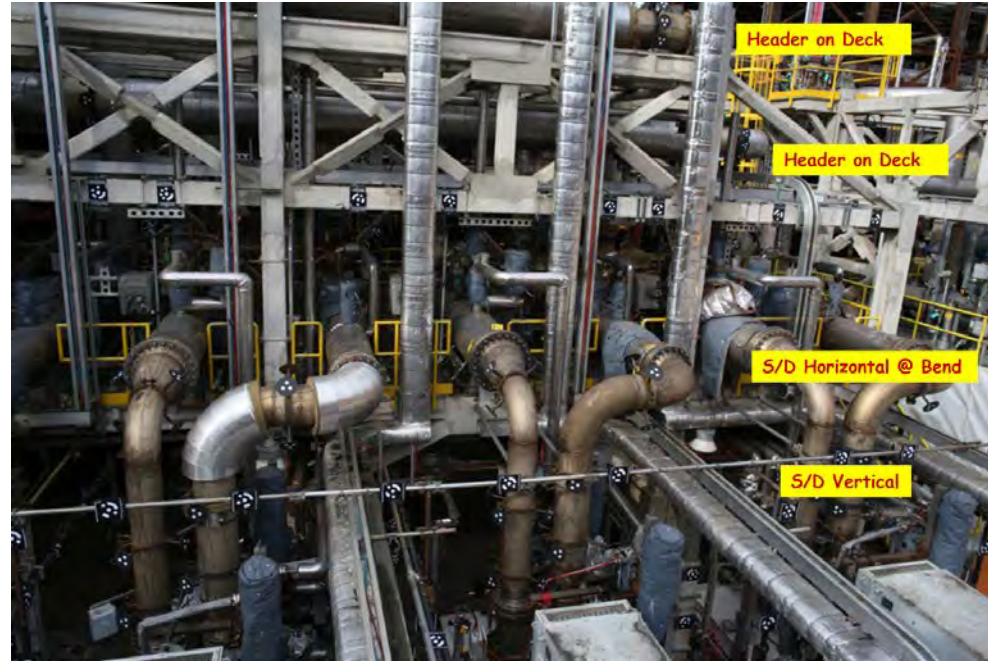
Above, shows an overview of the (3) pumps tested with the coded markers used by the optical metrology system. The label S/D refers to both suction and discharge piping

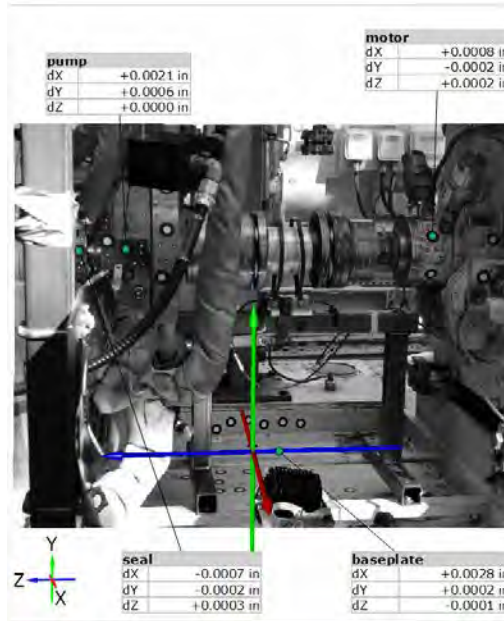
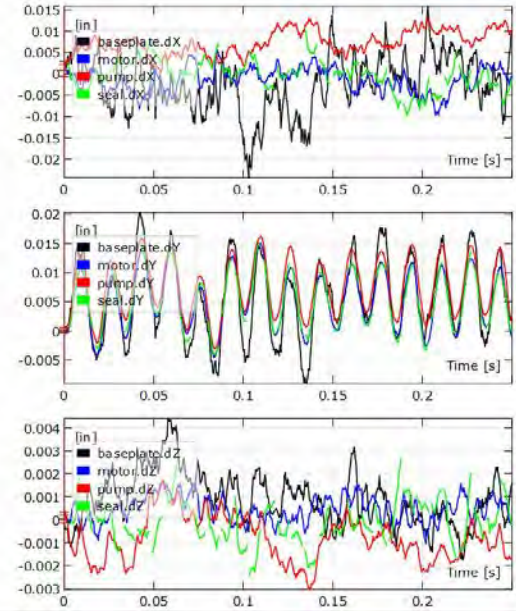
Displacement Tracking of key components during steady state run of Pump C

- Data collected during a Steady State Run using high speed optical metrology (3585 RPM, 473F)
- Movie at right provides full analysis
- X-axis (Horizontal axis), baseplate in and out of phase with the pump (top)
- Y-axis (vertical) all in phase (middle)
- Z-axis (shaft axis) baseplate & motor in and out of phase with the pump (bottom)
