"Reparación de Muros de Construcciones Históricas de Tierra Mediante El Sellado de Fisuras y Refuerzos Estructurales Adicionales"

### TESIS PARA OPTAR EL GRADO ACADÉMICO DE MAGÍSTER EN INGENIERÍA CIVIL

# Seismic Simulation Tests to Validate a Dual Technique for Repairing Adobe Historical Buildings Damaged by Earthquakes

# USING MUD INJECTION AND AN EXTERNAL ROPE MESH TO REINFORCE HISTORICAL EARTHEN BUILDINGS LOCATED IN SEISMIC AREAS

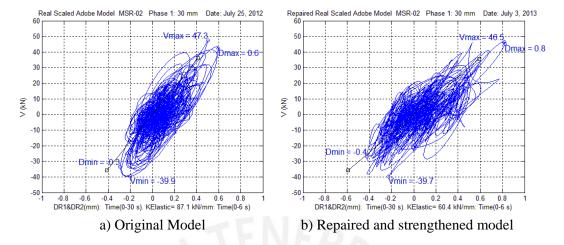
**Figure 9.** Base shear vs. top displacement curves for first testing phase ( $D_0 = 30 \text{ mm}$ )

The base shear versus global displacement curves for the model in its original, undamaged condition and after repair and strengthening are shown in Figures 9 and 10. Figure 9 shows that for low level of shaking (D0 = 30 mm) the combined mud injection repair and external nylon mesh reinforcement were quite effective in recovering the mechanical characteristics of the undamaged model: the maximum base shear was resisted without problem by the model in both cases (close to

47~kN) and almost 70% of the lateral stiffness (87 kN/mm for the original model and 60 kN/mm in the repaired and strengthened model).

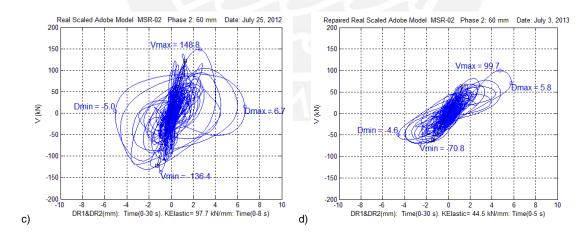
**Figure 10.** Base shear vs. top displacement curves for second testing phase ( $D_0 = 60 \text{ mm}$ )

For higher level of shaking (D0 = 60 mm) there was significant nonlinear response and the original model was severely cracked and was close to collapse. The lateral force versus displacement graphs presented in Figure 10 show that the repair and reinforcement scheme was effective in preserving a stable dynamic response, albeit with some structural damage, manifested as a reduction of lateral strength of about 33% (from 149 kN to 100 kN) and a stiffness degradation of about 45% (from 98 kN/mm to 45 kN/mm).

The seismic response for the stronger shaking imposed on the retrofitted model was excellent, from the point of view that the provided mesh reinforcement improved the structural connection between roof and walls, controlled excessive displacements and avoided partial collapses, thus preserving the integrity of the structure.

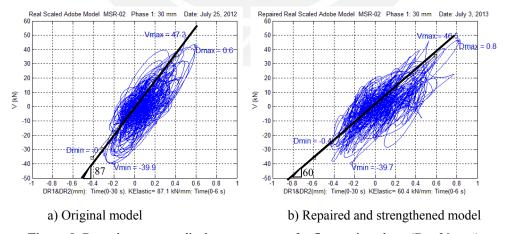
**Figure 9.** Base shear vs. top displacement curves for first testing phase (D = 30 mm)

The base shear versus global displacement curves corresponding to the first low level shaking phases (D = 30 mm) for the model in its original and retrofitted conditions are shown in Figure 9. The retrofit procedure of mud injection plus external nylon mesh reinforcement was quite effective in recovering the mechanical characteristics of the undamaged model. In both cases, the maximum base shear sustained by the model was close to 47 kN, and the retrofitted model had almost 70% of the lateral stiffness of the original model (60 kN/mm versus 87 kN/mm).

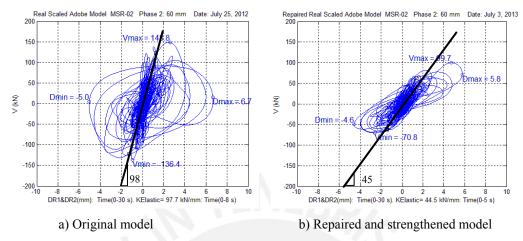
Figure 10. Base shear vs. top displacement curves for second testing phase (D = 60 mm)

For a higher level of shaking, corresponding to a command displacement D=60 mm, there was significant nonlinear response in the original and retrofitted conditions. The original model was severely cracked and was close to collapse, but the reinforcement was successful in keeping the structural integrity. The lateral force versus displacement graphs presented in

Figure 10 show that the retrofit scheme was effective in preserving a stable dynamic response, even when the structure suffered some structural damage, manifested by a reduction in lateral strength of about 33% (from 149 kN to 100 kN) and a stiffness degradation of about 54% (from 98 kN/mm to 45 kN/mm).
