Seismic response analysis and damage verification of notojima bridge during noto peninsula earthquake

SEISMIC RESPONSE ANALYSIS AND DAMAGE VERIFICATION OF NOTOJIMA BRIDGE DURING NOTO PENINSULA EARTHQUAKE

S. FUKADA¹, K. MAEGAWA², H. SAKO³ and Y. YAMAZAKI⁴

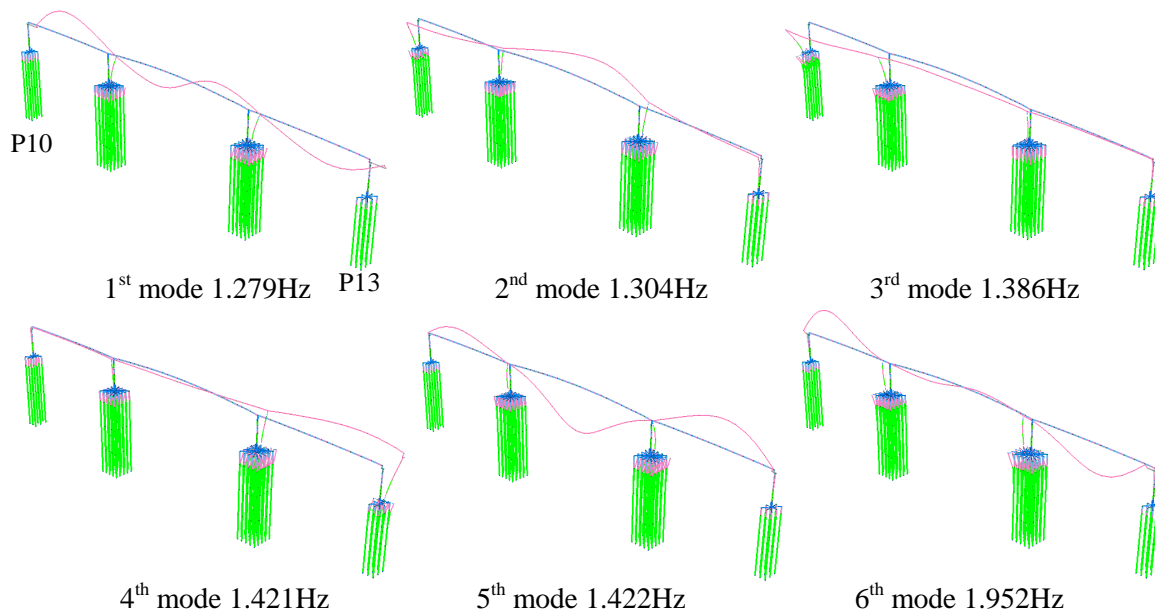
Figure 8. Frequencies and vibration modes

Eigen value analysis was carried out to confirm the natural frequencies and vibration modes. The results of the natural frequencies, participation factor and vibration modes are shown in Figure 8. It shows that the asymmetric mode is occurred by influence on the length of the steel pipe piles in P10 and P13. Therefore the mode amplitude of the P10 in 1st vibration mode is larger than that of the P13. Vibration test by the ambient vibration was carried out in the P10 and P13. The frequency of the P10 and P13 in transverse direction was 1.3Hz. The validity of the bridge model is confirmed with comparison between the results of experiment and analysis.

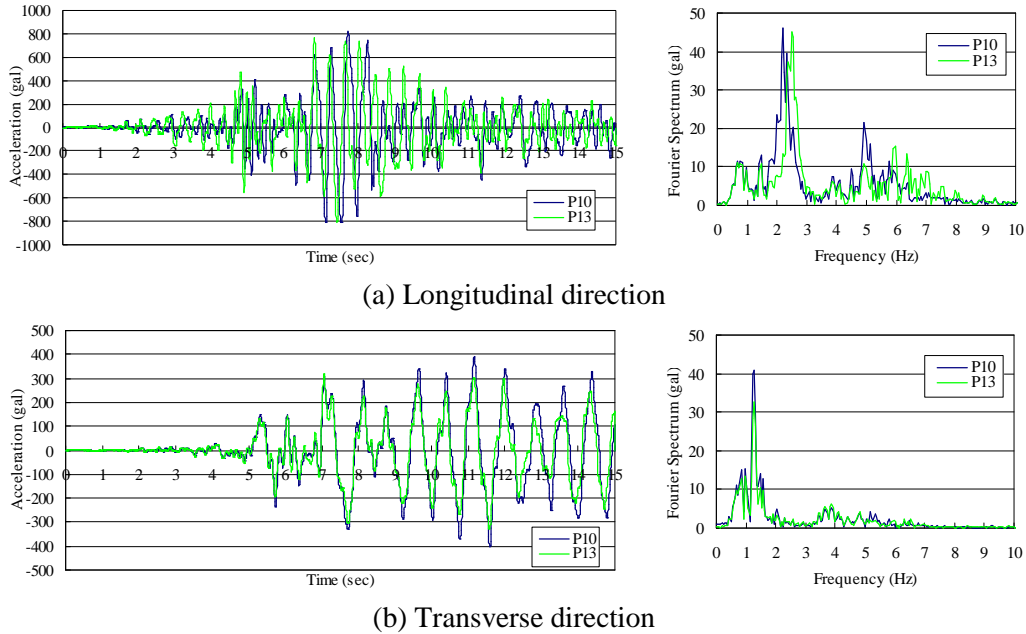
Figure 9. Horizontal acceleration and spectrum at the top of P10 and P13 by non-linear analysis

Horizontal acceleration and spectrum at the top of P10 and P13 obtained by non-linear analysis ($h=0.03$) are shown in Figure 9. The vibration modes, which have big participation coefficients in longitudinal and transverse direction, are shown in the analytical spectrum. The acceleration amplitude of transverse direction at the top of P10 is larger than that of P13.
