**ESTIMATION OF MALFUNCTION
OF A HEALTHCARE FACILITY IN
CASE OF EARTHQUAKE**

Nebil Achour

March, 2007

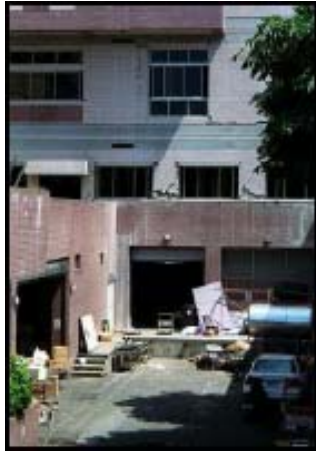
The hospital is composed of two main reinforced concrete structure sections. The oldest was built in 1979 and the newest was built in 1995. The main shock did not cause any structural damage, slight non-structural and lifeline damage occurred and equipment moved, see Photo 3.1. However following one of the aftershocks the facility suffered significant damage to its non-structural elements and lifelines which resulted in its evacuation, one week after the main shock; some of patients were moved to prefabricated buildings and some others to different facilities. The severity of damage was the cause of reducing the capacity of the hospital by 50 beds (which represents 8% of its real capacity). The first floor remained open and it was used for emergency treatment, patient registration and so forth, see Photo 3.2. The following are the most important results of that damage:

Photo 3.1- Exterior damage,
Christian Hospital (Source: Lee et al, 2000)

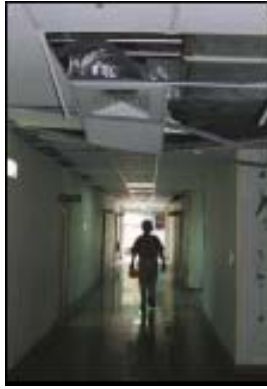
The Veteran Hospital is a multi-buildings facility as Photo 3.3 illustrates. The oldest buildings were built in 1974 and the others three years before the event. Some buildings suffered very severe damage, causing their complete closure, see Photo 3.4 and Photo 3.5. Some of the patients were moved to the other buildings while others to different facilities. The capacity of the hospital was dramatically reduced to 50% (220beds). The Medical Centre suffered considerable structural damage, lost its water supply and lost its electrical power. Emergency power did not work, since it was situated on the second floor of a separate building and as result of the amplified acceleration the majority of the components broke and caused their damage. Later on, the Medical Centre building had to be demolished and rebuilt, and the Administration Centre had to be repaired.

Photo 3.4-Interior damage, Veteran Hospital

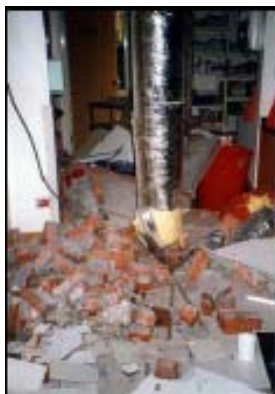
This facility represents a special case as it is a private hospital, the largest in Nantou County and was only built two years before the earthquake. It was composed of 9 stories with a reinforced concrete structure. Given that the facility was very close to the Chelungpu fault (about 120m); it suffered sizable damage to its non-structural elements, see photos 3.6 and 3.7. The second and the third stories suffered the most damage, see Photo 3.8, and since the most important facilities operation rooms, recovery rooms were located there, the 400-beds facility had to be totally evacuated to other hospitals. Finally the hospital was closed. Resembling the previous two hospitals, many patients suffered trauma during their transfer. “Seven patients died due to the stoppage of life-support systems” (Lee et al, 2000).

Photo 3.6-Interior damage, Shiu-Tuan Hospital

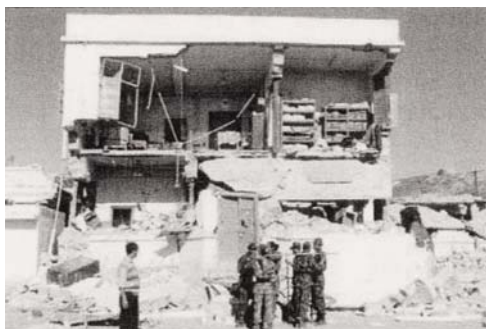
The majority of the hospitals in the area that were supposed to receive injuries failed to do so and in many cases this caused the death of many people. Aside from patients, doctors, nurses and other support staff were killed in this earthquake. In Bhuj General Hospital more than 172 were killed after it collapsed, see Photo 3.9. Since the latter facility collapsed, the Military Hospital provided medical treatment to 12,254 patients through its Out-Patient Department. However, the Military Hospital became over crowded in a very short time. The Jubilee Hospital completely collapsed too as shown in Photo 3.10. The fairgrounds and Jubilee Grounds, were opened to receive patients, many doctors volunteered to give the injureds initial treatment. Within the two first days hundreds of patients were transferred to other hospitals.

Photo 3.9- Collapsed Bhuj Central Hospital

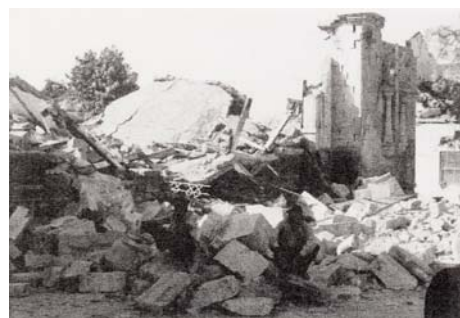
Photo 3.10- Collapsed Jubilee Hospital

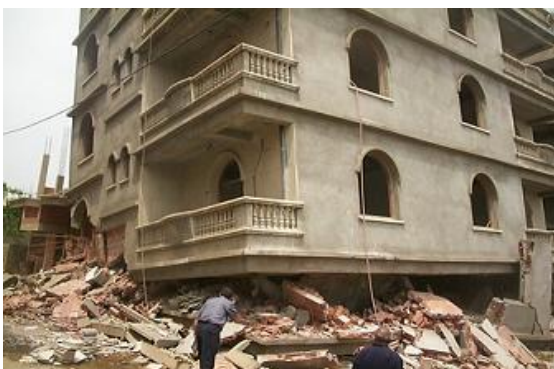
Photo 3.11- Damage to new buildings

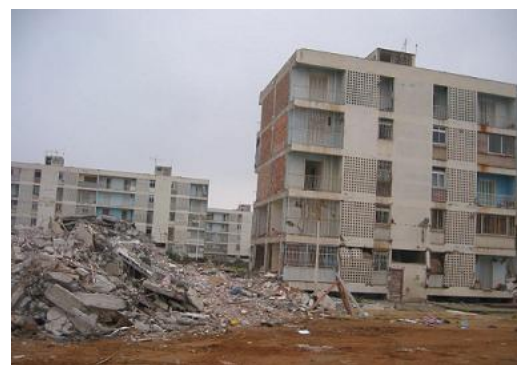
Photo 3.12- Collapse of residential building

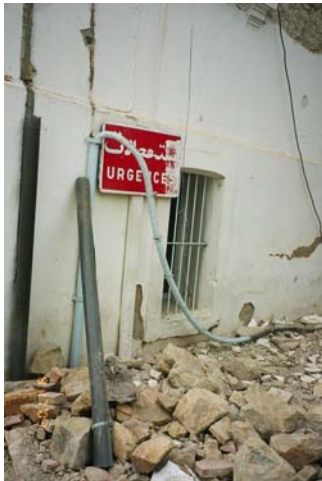
Photo 3.15- Damage to the
emergency wing

elements were totally collapsed throughout the majority of the facility. Non-structural elements had fallen, became broken and made the area inaccessible from all wings. The damage obliged the government to supply prefabricated buildings that were used instead of the actual facility, as is shown in Photo 3.18. The prefabricated buildings were used as the actual facility in which patients were being treated. Those prefabs were equipped with electricity and air conditioners to make life easier for the medical staff as well as the patients. The structural damage had a clear impact on the patients since they had difficulty being treated. The staff could not access or move the inpatients and many patients had to be transferred to other hospitals because their treatment became impossible in that hospital.

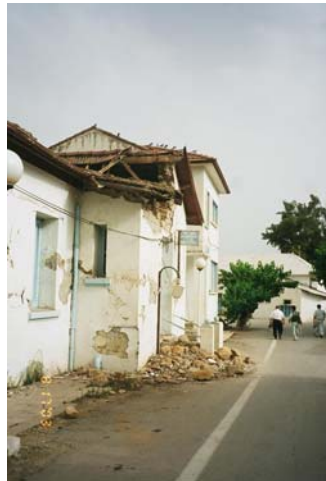
Photo 3.16- Collapsed roof
of another wing

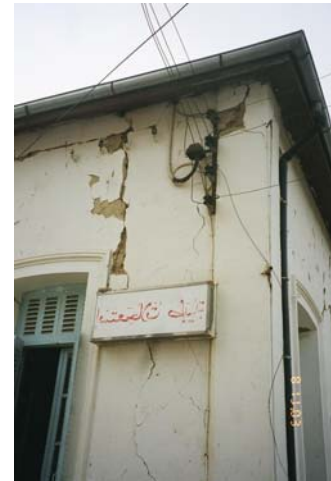
Photo 3.17- Cracks in the
walls of the emergency wing

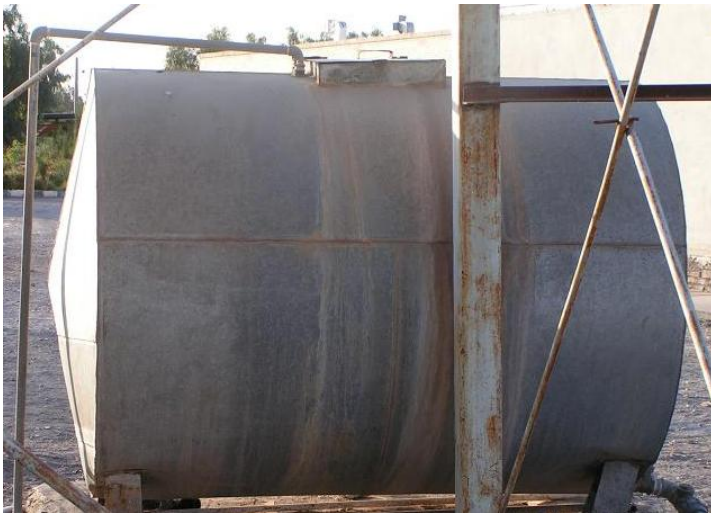
Photo 3.36- Water Tank 1, Aflatoonian Hospital

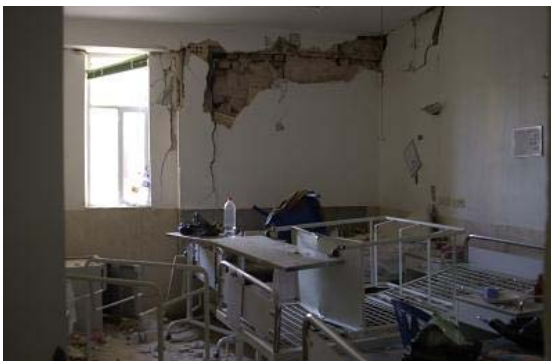
Photo 3.38- Topple of equipment
Aflatoonian Hospital

As a result of the shaking many pieces of equipment got damaged which may be the result of displacement, topple, rocking or displacement-rocking. The personnel of the Aflatoonian Hospital stated that almost all the equipment was damaged with various degrees of severity; the cost of repairing the damage was between 10-100% of the price of the equipment itself. For instance, Table 3.13 shows some of the equipment and the severity of its damage. Some of them were fixed and some others were disposed, such as the radiology unit shown in Photo 3.41. As a result of the displacement the pipelines to the water supply attached to the Central Sterilization Room (CSR), shown in Photo 3.42, were damaged rendering the equipment useless.

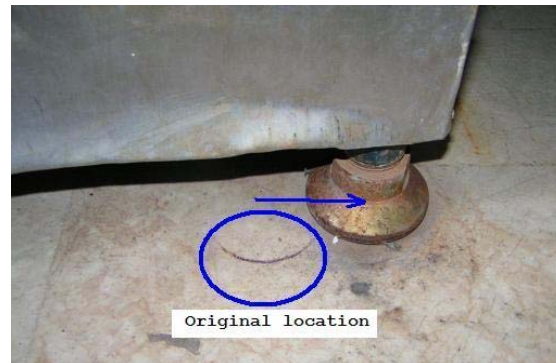
Photo 3.39- Displacement of a sterilizer
Aflatoonian Hospital

Unit	Severity of damage	Remarks
X-Ray	10%	
Sterilizer (CSR)	10%	Damage to the water pipes because of the displacement, Photo 3.42 and Photo 3.39
Radiology	100%	Photo 3.41

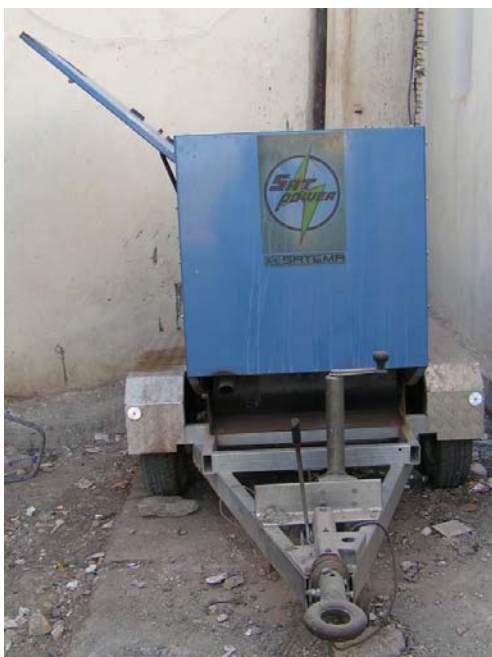
Photo 3.40- Electric power generator, Aflatoonian Hospital

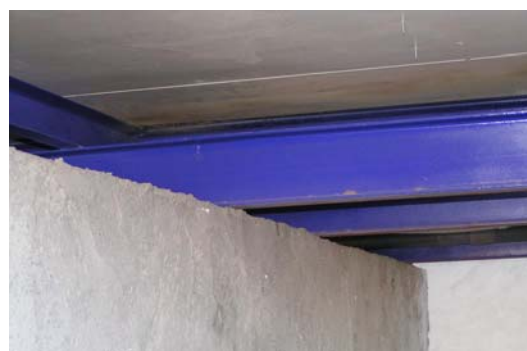
Some services are still operating in prefabricated buildings, such as the operation room and women’s ward. The prefabs are located on small masonry walls without being attached to any support which may make them unstable in case of strong shaking, see Photo 3.43 and Photo 3.44. The masonry is not capable of resisting horizontal loads, which is the case of earthquakes; this may result in their damage during an earthquake. The damage to walls leads to the total malfunction of the service provided in the prefabricated building.

Photo 3.44- Operation room, base view

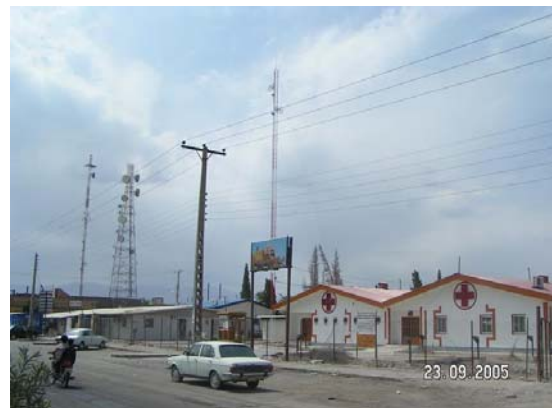
The facility is a public hospital located in the centre of Bam City. Its capacity is 100 beds, and it hosts 290 staff members; 24 doctors, 146 nurses and 120 administrative personnel. The facility had many problems that hampered its normal functioning; mainly the severe structural damage that it experienced, see Photo 3.47. The international aid teams installed prefabricated hospitals beside the actual building, as Photo 3.28 and Photo 3.29 show. They lent Iranian personnel some of their equipment, which was used for treatment. Later the rubble was cleared and the rest of the original building was demolished. Some prefabricated buildings were installed by international companies and societies and are being used as small clinics, Photo 3.48, Photo 3.49 and Photo 3.50.

Photo 3.48- Prefabricated buildings installed instead of the Imam Khomeini Hospital September 2005

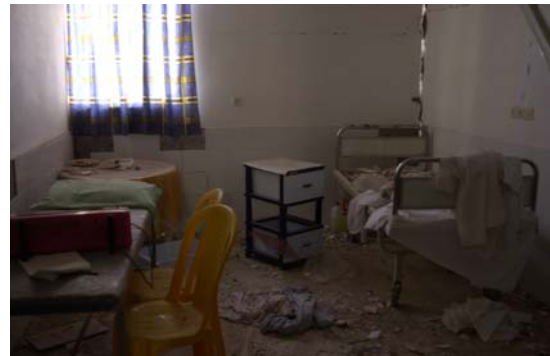
Photo II.2- Displacement of equipment
