Strain Induced in Cracked Utility Poles and Damage to Dwellings from the Dec 26, 2003, Bam Earthquake

Kazuo Konagai^{1)*}, Masayuki Yoshimi²⁾, Kimiro Meguro¹⁾, Miho Yoshimura¹⁾, Paola Mayorca¹⁾, Masasuke Takashima¹⁾, Alireza Farahani¹⁾, Hossein Tahghighi¹⁾ and Mohammad Keshavarz³⁾

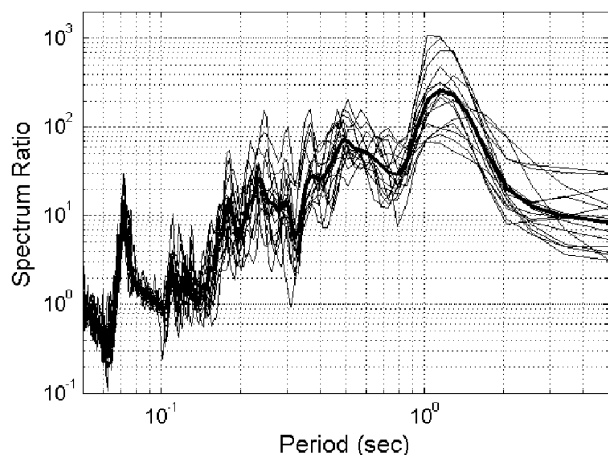
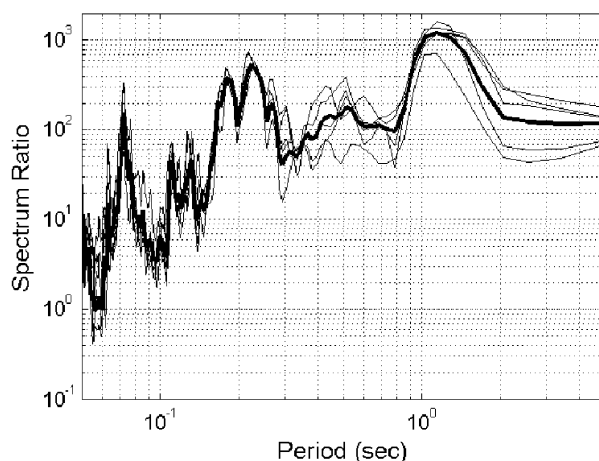
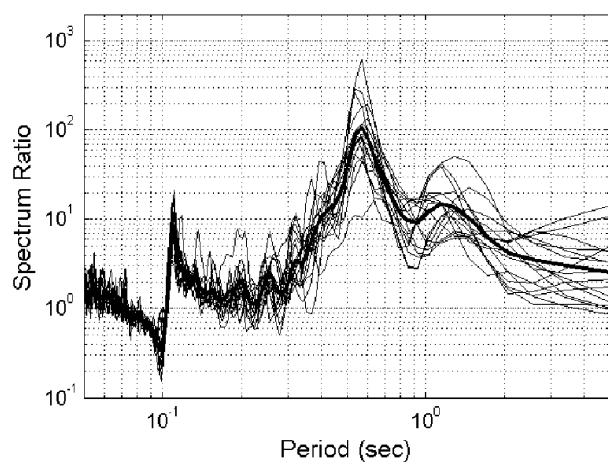
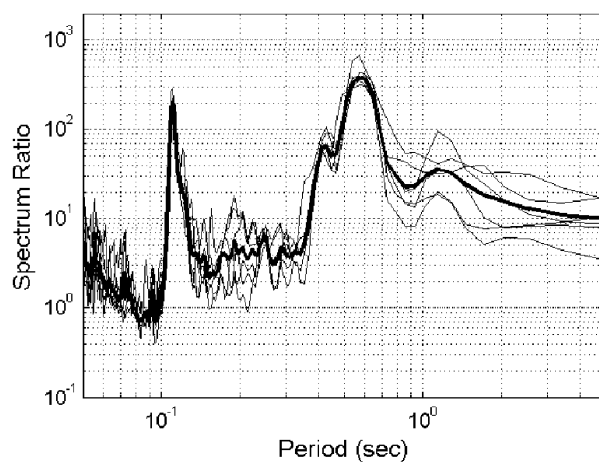
Fig. 5. Transfer functions for pole P-1.

Figure 5 shows the transfer function for P-1. It is clear in Y-direction that there is little change of the predominant periods between the ambient and hit cases. In both cases, clear peaks are found at 0.105 and 0.57 sec, with the main difference being the peak relative amplitudes. When the structure is hit, the lower period amplitude becomes higher.

Poles exhibit quite different vibration features in the X-direction (Compare Figs. 5 (a) and 5 (b) with 5 (c) and 5 (d)). As for ambient vibration cases, 2 peaks at 0.07 and 1.10 sec are distinguished among the others at 0.18, 0.21, and 0.6. When the structure is struck, 2 clear peaks appear at 0.18 and 0.21 s, in addition to 0.07 and 1.10 s, but the 0.6 s peak is not clearly seen, suggesting that this peak is crosstalk from the Y-component of the pole vibration.

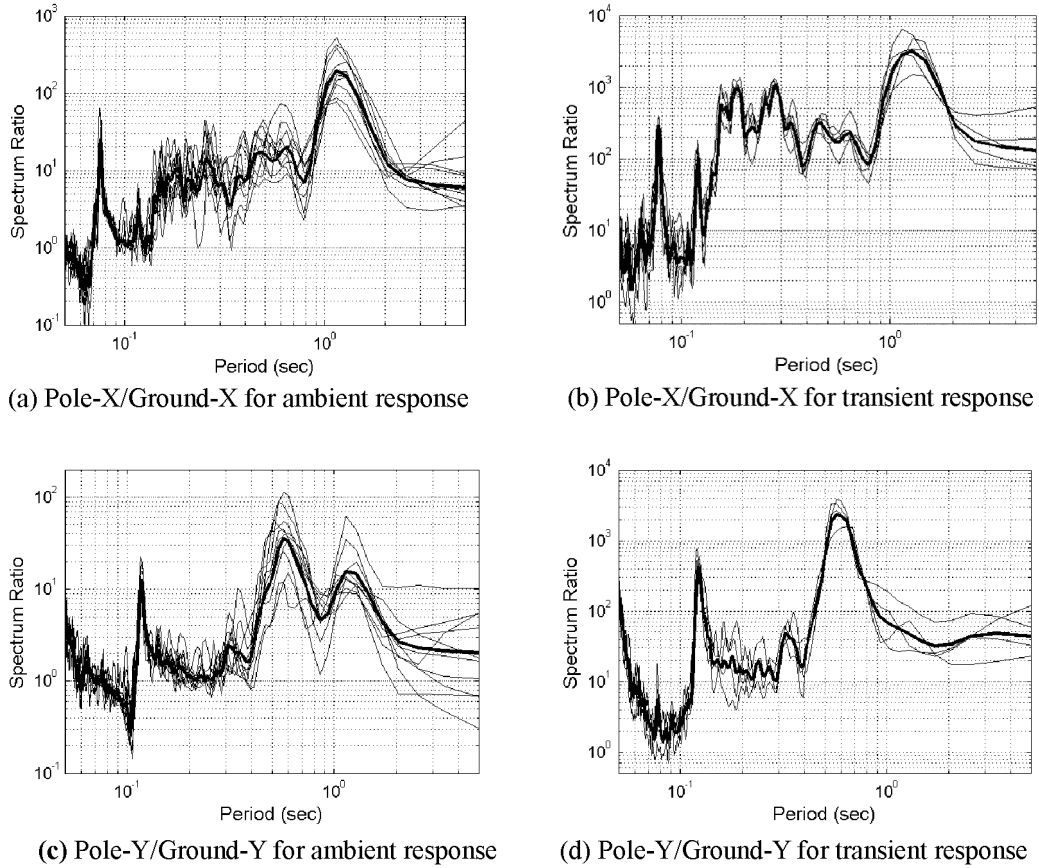
Fig. 6. Transfer functions for pole P-2.

Figure 6 shows the transfer functions for the P-2 pole. The functions have similar shapes to those for

the P-1 pole in all cases, suggesting that mortar filled in the holes had little effect on the dynamic behavior of the pole. Fig. 7 (a), (b) and (c) show X, Y, and Z components of the pole vibration spectra. It is noted

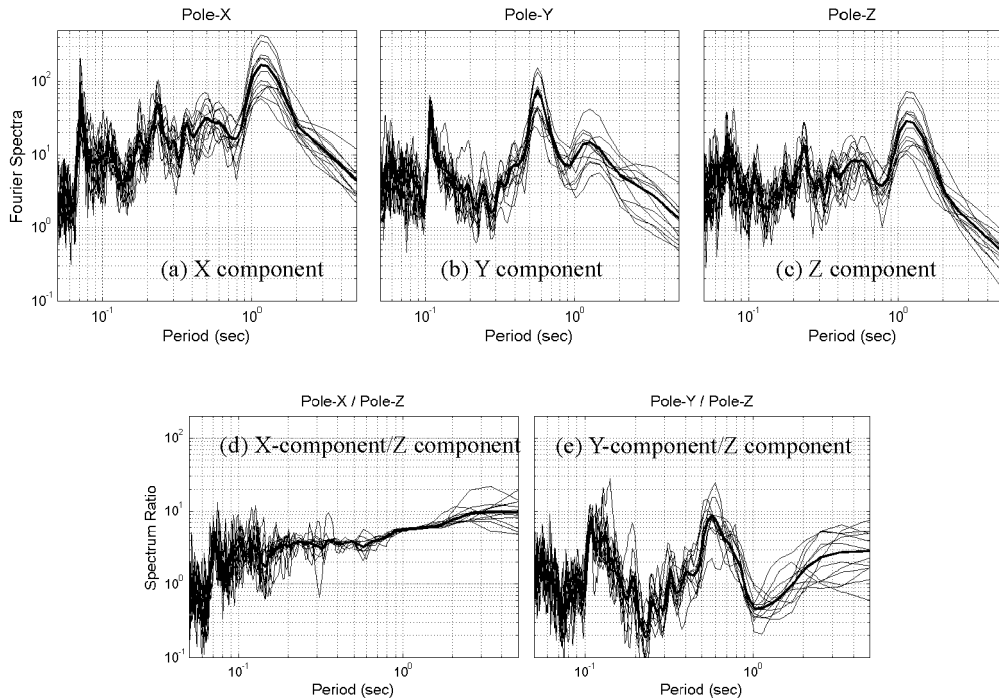
Fig. 7. Comparison of P-1 spectra in three directions.

that the spectra for X and Z components are similar to each other, while the Y component exhibits some different shapes. Fig. 7 (d) shows X/Z and Y/Z spectra ratios to highlight this feature. Assuming that the vertical vibrations of the pole were mainly induced by cable oscillations, it may be concluded that a cable has an important effect on the pole's motion along the cable.
