Investigation and Analysis of Damage to Buildings during the 2003 Bam Earthquake

Hossein Mostafaei* and Toshimi Kabeyasawa

Earthquake Research Institute, The University of Tokyo

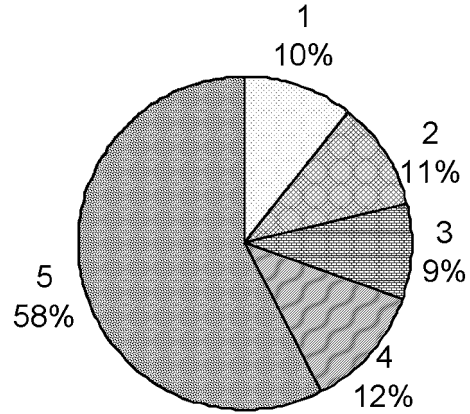
grade 1: negligible to slight damage, grade 2: moderate damage, grade 3: substantial to heavy damage, grade 4: very heavy damage, and grade 5: destruction. Figure 19 illustrates the survey results of total structural damage grades for the different types of building. The figure indicates that almost 70% of the buildings in Bam city suffered very heavy damage or complete destruction, with grade 4 or grade 5, and only 10% of the buildings in the city were observed with slight damage or grade 1.

Fig. 19. Damage grades for all types of building in Bam.

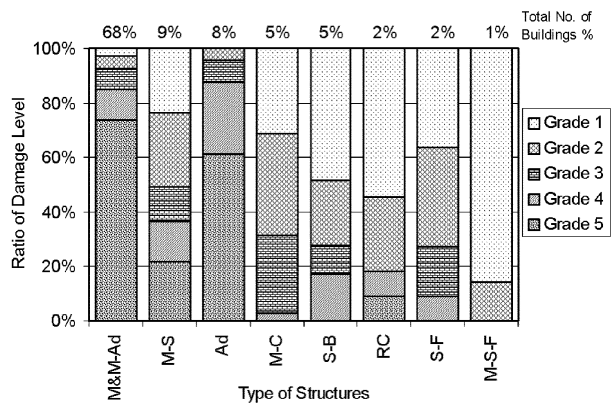
A further estimation was made to obtain damage grades for different types of structure. Figure 20 shows the outcomes of the study. As indicated by the figure, masonry buildings, types M and M-Ad, and also adobe constructions, type Ad have the highest rates of damage among the different types of structure. The main reason for such a high level of destruction is the very low lateral load-bearing capacity of their structural systems against seismic loads. On the other hand, reinforced masonry buildings such as type M-C and M-S had considerably lower damage rates compared to those of masonry or adobe buildings. These results emphasize the importance of reinforcing masonry buildings, which is also outlined in the seismic code of Iran.

Fig. 20. Building damage grades for different types of structure.

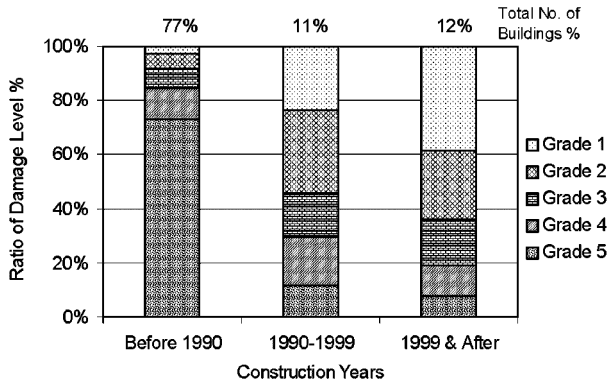
Figure 24 shows damage rates for buildings sorted by construction date. As the statistical results indicate, 77% of the buildings in the city were constructed before 1990, the mandatory year of the seismic code, and suffered very high rates of damage. However, among buildings built from 1990 and after the second edition of the seismic code was published in 1999, the damage rates were significantly reduced, which shows efficient results of applying the seismic code.

Fig. 24. Damage rates based on year of construction.

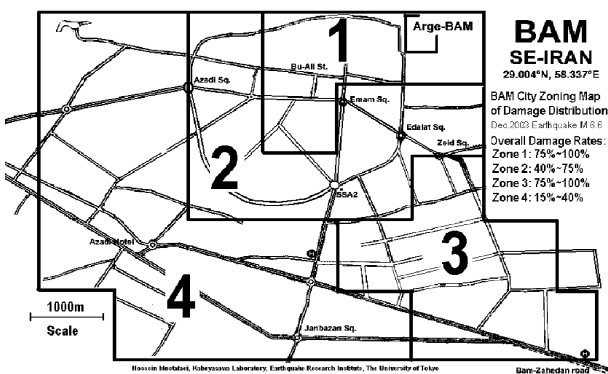
The 4 zones of Bam city, zones 1 to 4 in Fig. 18, are shown magnified in Fig. 25. This map shows the zoning map of building damage distribution, as well as overall damage ratios in each zone based on data collected only in Bam city. By comparing Figs. 18, 25, and 26-a, it can be inferred that the damage rates decreased significantly in zones 4, 8, and 9, although they are not far from the epicenter. According to the results, zone 3 followed by zone 1 show the highest damage rates in the area. However, zone 2, which is located between zones 1 and 3, shows lower damage ratios. Figure 26-b illustrates damage ratios in Zones 1 to 4 for only one type of structure, masonry buildings. Based on the figure, zone 2 again has lower rates of damage than zone 1 and zone 3. Therefore, the different damage rates might be due to other factors such as fault mechanism. Further study is recommended on this outcome.

Fig. 25. Zoning map of building damage distribution in Bam city.

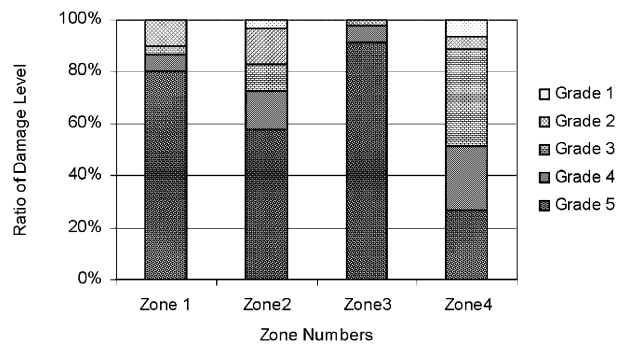
Fig. 26-b. Damage rates in zones 1 to 4 based on damage ratios of masonry buildings.

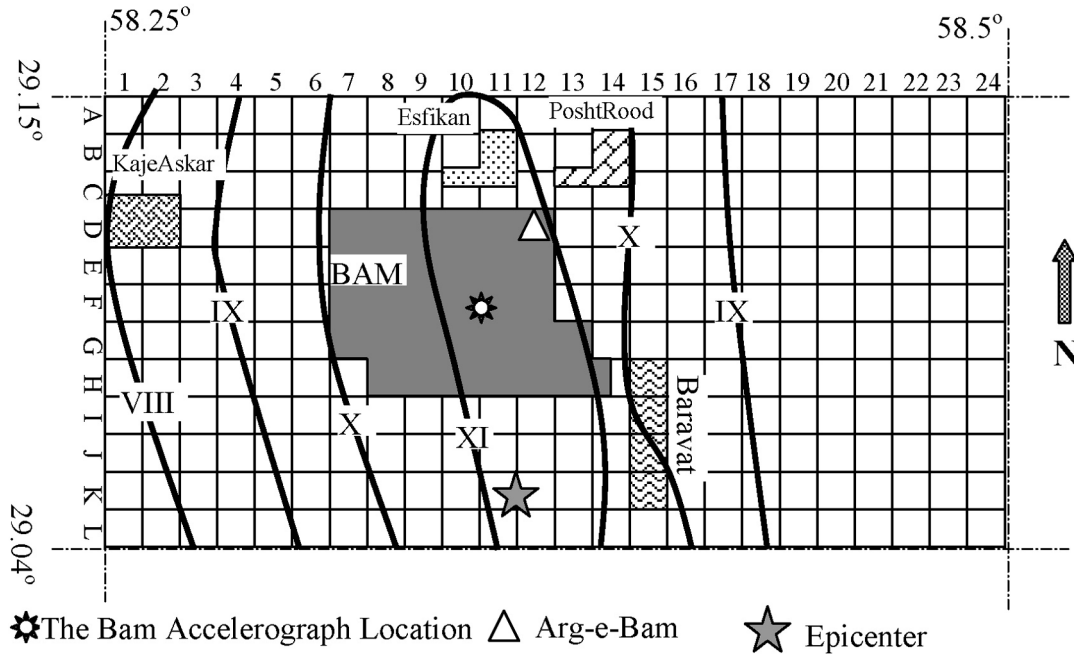
To estimate the intensities, Bam city and nearby villages were divided into bins with the network shown in Fig. 28. For the surveyed buildings located in each bin, damage rates corresponding to the each damage grade were computed and correlated with MSK intensity, according to Table 2. The correlated MSK intensity was selected as the estimated intensity for the corresponding bin. Finally, the contours were drawn using an interpolation method. The outcomes were modified considering the location of

Bam in the preliminary report of BHRC (2004), it can be inferred that most of the buildings in Bam are located in the area with an intensity of XI on the

Fig. 28. MSK intensity contours for Bam earthquake applying vulnerability class B.

MSK scale, which is about X on the Modified Mercalli Scale. The conversion can be applied using Fig. 29. According to the figure, the maximum acceleration for intensity X may be estimated at between 800 cm/s^2 and $1,000 \text{ cm/s}^2$, which are almost in the same ranges as those recorded.
