Garnier, Christian and Pastor, Marie-Laetitia and Eyma, Florent and Lorrain, Bernard *The detection of aeronautical defects in-situ on composite structures using Non Destructive Testing*. (2011) Composite Structures, vol. 93. pp. 1328-1336. ISSN 0263-8223

The detection of aeronautical defects in situ on composite structures using Non Destructive Testing

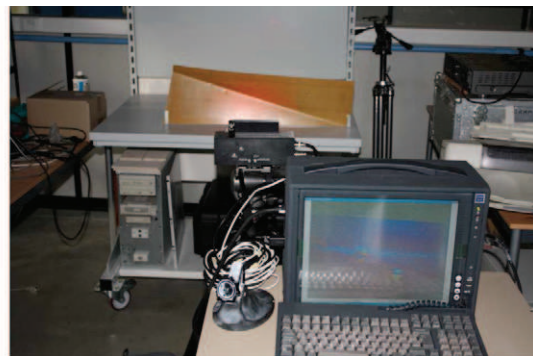
Each specimen has surface damage. The defect on Specimen A is delamination caused by an in-service impact. During a GVI, the size of the defect can be obtained quite simply using a steel ruler. The GVI defect is 98 mm and 18 mm.

Fig. 4.1. Specimen A: carbone/epoxy rod.
