ORIGINAL RESEARCH PAPER

Performance of industrial buildings during the Emilia earthquakes in Northern Italy and recommendations for their strengthening

Dionysios A. Bournas · Paolo Negro · Fabio F. Taucer

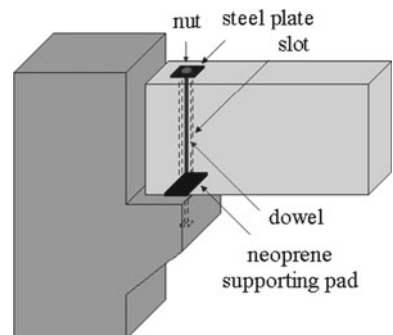
Fig. 12 Detail of a pinned beam-column joint connection

The main feature of precast industrial buildings constructed with seismic provisions lies in the type of beam-column connections. When horizontal forces are taken into consideration in design, the most common connection system for the construction of single-storey industrial buildings in Europe comprises hinged beam-column connections by means of dowel bars (shear connectors). This type of connection is able to transfer shear and axial forces resulting from the seismic actions. Practically, the horizontal beam-column connection is established by means of vertical steel dowels (typically one or two) which are protruding from the column into special beam sleeves, as shown in Fig. 12. This pinned beam-column connections are constructed by seating the beams on the column capitals and by holding the beam ends in place by the use of these vertical steel dowels.

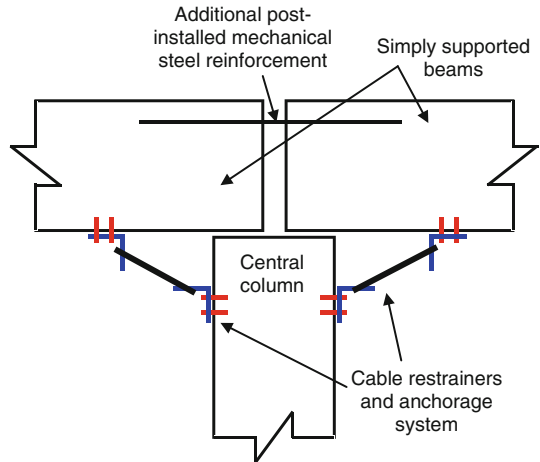
Fig. 21 General concept of a retrofit solution for industrial buildings with beams simply supported on the column top comprising seismic cable restrainers and possibly additional steel reinforcement

A proposal for the strengthening of existing industrial building consists in adopting a scheme which is used for the seismic retrofit of simply supported bridges: to reduce the likelihood of collapse due to unseating, cable restrainers are used between the girders and the piers/abutments of the bridge. Cable restrainers were first used in the United States after the collapse of several multi-frame bridges that collapsed due to unseating during the 1971 San Fernando earthquake in California (Jennings 1971). The performance of bridges in the 1989 Loma Prieta and 1994 Northridge earthquakes showed that cable restrainers were effective in limiting damage (Saïdi et al. 1993; Priestley et al. 1994; Moehle 1995). DesRoches et al. (2003) evaluated the force-displacement behavior of a cable restrainer assembly, used for the seismic retrofit of simply supported bridges. The cable restrainers were connected to the bridge pier using steel bent plates, angles, and undercut anchors embedded in the concrete as specified by typical bridge retrofit plans. The test results demonstrated that this strengthening configuration was effective in cases where seat widths were very small and relative displacements needed to be limited. The results of this study might form a good basis for future research on the use of cable restrainers for the retrofit of industrial buildings with beams simply supported at the top of columns (Fig. 21). The restrainers in such a system would be anchored at the column and beam ends, where the bending moment is minimum, with the advantage that their installation would not significantly disturb the functioning of the building.

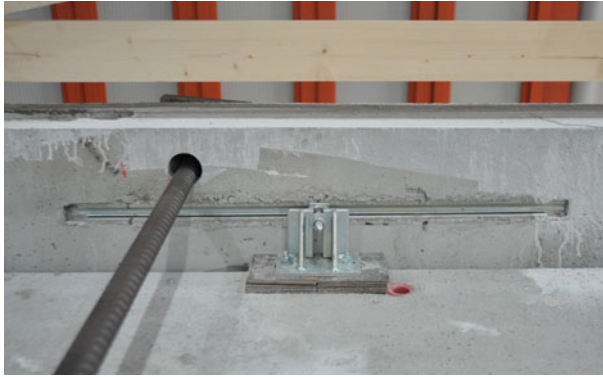
Fig. 22 Panel connection device that provides resistance in the vertical and out-of-plane directions and accommodates large relative deformations in the lateral direction

In order to ensure the standard design approach in which the claddings do not contribute to seismic response, stringent design criteria for the design of the connections should be enforced: connections devices should be able to provide the required strength in the vertical and out-of-plane directions while accommodating large relative deformations in all other directions (Fig. 22). A viable option would be to prescribe adequate fail-safe restraints, so that the panels would not fall even in case the relative displacement capacity of the connection is exceeded.
