Case History

S.R. 237 in Perry County, IN

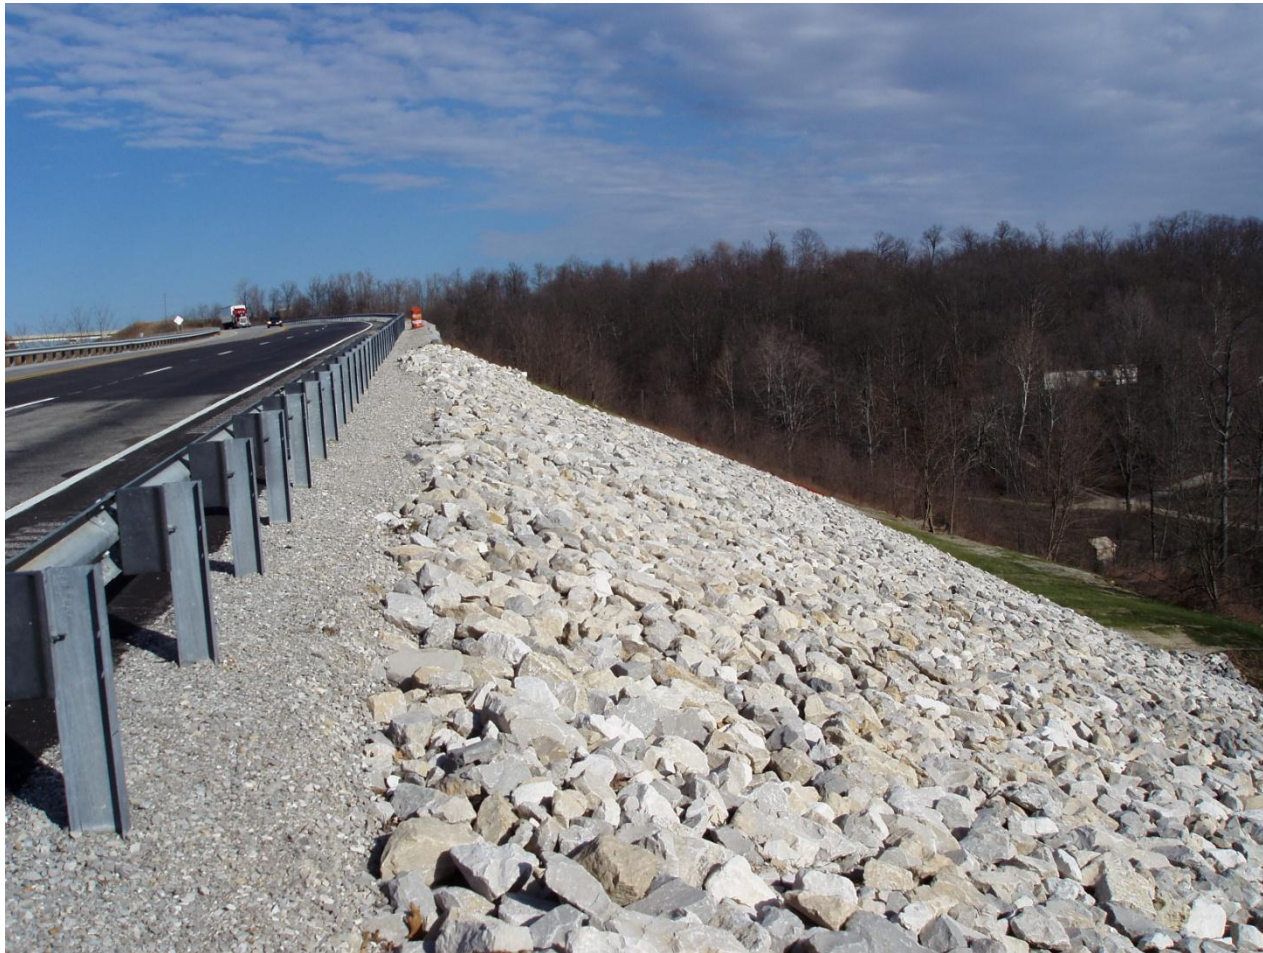
After First Correction

Second Slope Failure

- In April 2012 during heavy rain, the slope in front of the wall moved. It gradually dropped vertically approximately 12 feet due to new failure.
