Hazards Caused by Uncontrolled Vegetation and Inadequate Maintenance Practice in Earth Dams

Escolano-Sánchez, F., & Fernández-Serrano, R. (November-December, 2015). Hazards Caused by Uncontrolled Vegetation and Inadequate Maintenance Practice in Earth Dams. *Water Technology and Sciences* (in Spanish), 6(6), 137-144.

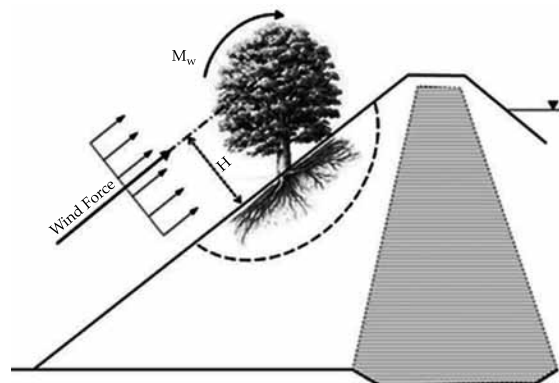
Spillways are the most important safety elements on dams, so they must be always clean of brushes and tree trunks which can prevent the correct water flow in normal or emergency dam-work situations (floods). Trees growing on the reservoir near the spillway lip are water obstacles (Fig. 5), and potential clogging bases. For the case depicted in Fig. 6 of a tree that has grown just in the middle of spillway, in the upper side of the downstream slope, should have also been removed to prevent potential problems of seepage, erosion, burrowing animals, etc.

Figure 5. Big tree growing just below the dam crest in the spillway channel of an earth dam, under the spillway dam crest bridge. The channel continues with a rip-rap cover along the downstream slope.
