INTEGRATED SURVEY TECHNIQUES: PRELIMINARY STUDIES FOR THE CONSERVATION OF VILLA GALVAGNINA

KEY WORDS: Villa Galvagnina, integrated survey techniques, decay mapping, cultural heritage preservation

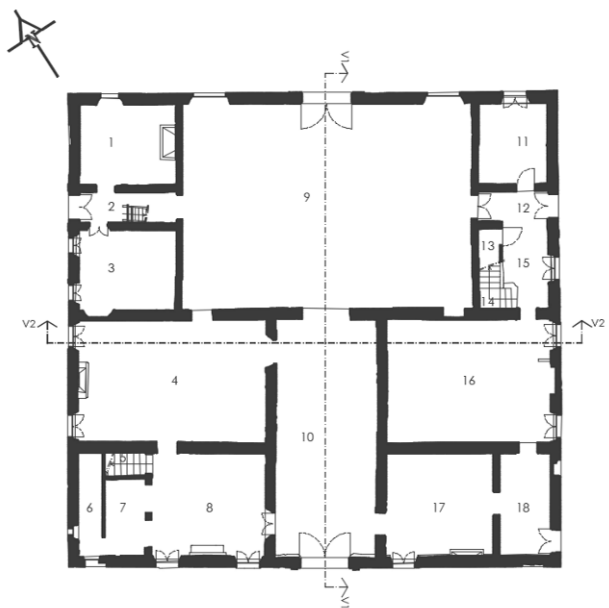
Figure 2: Ground floor plan H1 obtained from the points cloud (Municipality of Mantua).

by the safety works conducted by the Superintendence: each of the ground floor rooms, with the exception of room number 11 (Fig. 2), and the rooms number 24, 27 and 28 on the upper floor (Fig. 3). However, a preliminary crack pattern of some other rooms could be outlined, on the base of the laser scanning survey. This draft has to be validated by a direct inspection.

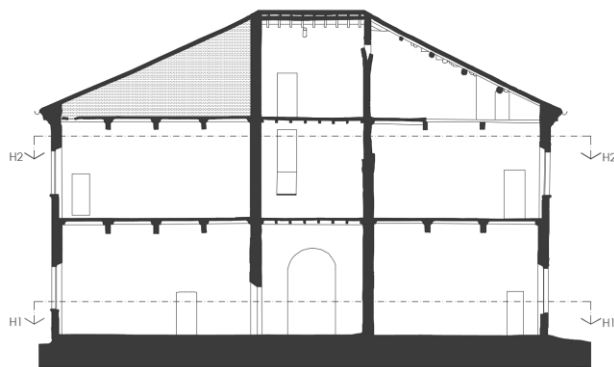
Figure 5: Vertical section V2 obtained from the points cloud (Municipality of Mantua).

The outer brick walls and the brick walls of the main rooms are characterized by a thickness between 45 centimetres and 50 centimetres and a height of about 10 meters. The entrance hall walls, as well as the dividing wall between the main hall and the entrance hall, reach a height of about 14 meters (Fig. 5), so they have a remarkable slenderness.
