DISMANTLING AND RECONSTITUTION OF PRASAT SUOR PRAT, ANGKOR THOM, CAMBODIA

This paper presents a geotechnical aspects of dismantling process of one of masonry towers named Prasat Suor Prat that had been constructed in the end of 12th century during the Angkor Period in Cambodia. A series of 12 towers had been constructed from south to north along the east side of Royal Plaza in Angkor Thom.

One of the towers, named as N1 Tower, was found badly displaced with inclination of about 5 degrees to the north-west and horizontal spreading at the foundation level. The Tower was dismantled before restoration work by JSA (Japanese Government Team for Safeguarding Angkor) to study possible mechanism that had caused inclination of the Tower and horizontal spreading of stair stones. Dismantling upper structures as well as foundation mound were performed by archaeological trench. The trench had revealed the mechanism of deformation of the structure as well as foundation. Before the dismantling, was the inclination caused by tilting of the foundation mound caused by general sliding failure of the foundation towards adjacent pond. However, it was revealed that the mound was not tilted but kept hor

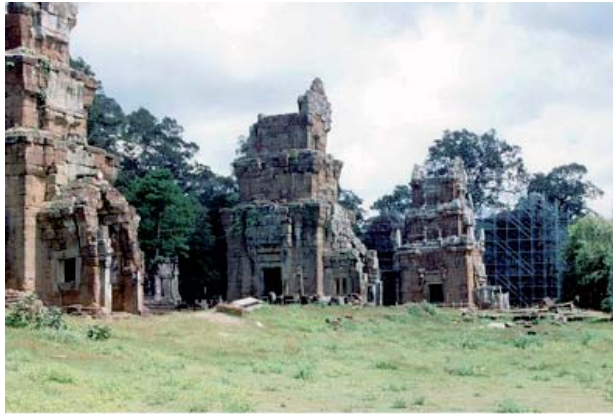
Photo 1. Prasat Suor

Prasat Suor Prat (Tower of Rope Dancer) is a group of 12 independent towers along the west side in the Royal Plaza as shown in Photo-1 and in Fig.4 of plan view. These towers are divided into two groups of North and South. The inclination of side walls for all the towers at Prasat Suor Prat were measured and listed in Table1 and shown in Fig.5. Inclinations of the towers are less than 2-4 degrees except N1 and S1 and with direction of NW to NE. N1 and S1 show the largest inclination among each

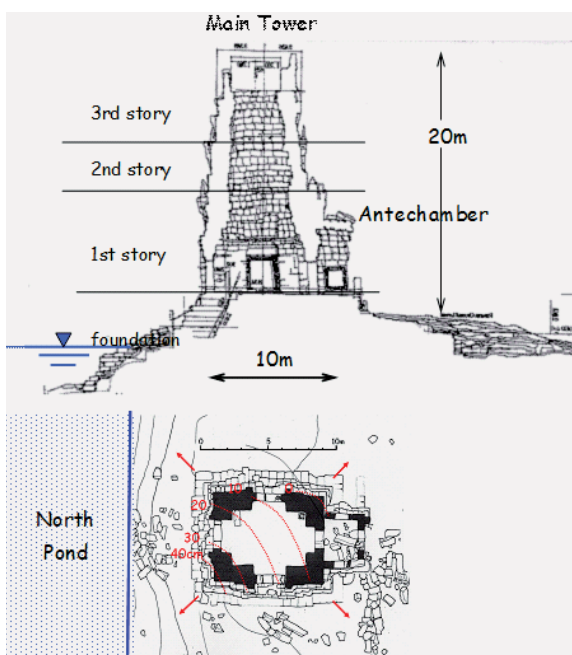
Fig.6 Vertical section and plan for N1 Tower

One of the 12 towers named as N1 that had been inclined about 5degrees northwards was selected by JSA for safeguarding work as shown in Photo 2. The tower consists from a main tower with a front room called antechamber. The main tower is three story masonry structure with laterite bricks with 10m in width at foundation and about 20m in height. The inside of the tower is hollow structure with four open windows at every wall. Fig.6 shows vertical section and plan view of the N1 tower nearby the north pond.

The differential settlement of the foundation was measured about 40cm at the north and west corner

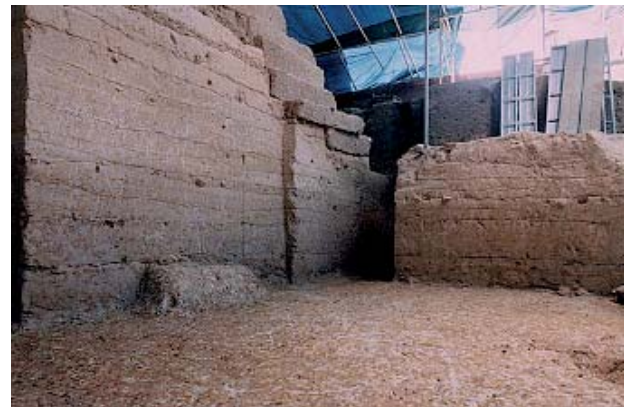
When the trench proceeded to the level of +0.00m, the manmade compacted sand layers were exposed. We had expected the same inclination of the compacted soil layers in the foundation mound. However, amazingly, we found the manmade layers of soil mound formed almost horizontal layers as shown in Fig.8. It was mysterious for us to understand until the excavation reached to the much lower level.

Photo 5. Trenched EW section (note the horizontal layers)

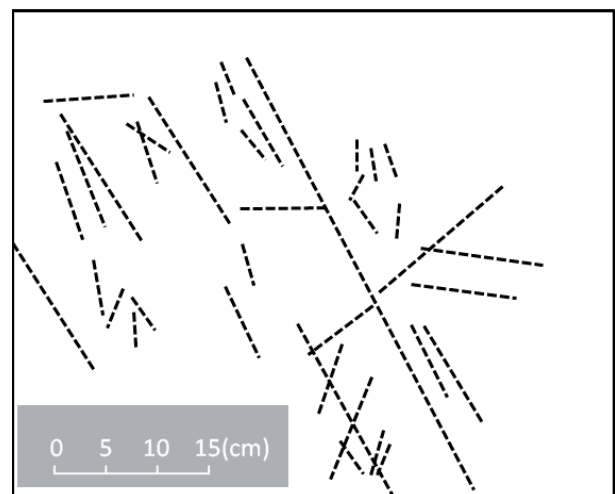
As shown in Photo 7 and in Fig.10, many streak lines were found on the face of trenched section of platform and foundation mound. Based upon the photos of the sections, the streaks were analyzed in the part of squared section of “Area of Analysis of Streak lines” shown in Fig.8.

Since the internal frictional angle of sand obtained by laboratory test was 30 degrees, θ become 30 degrees when the vertical overburden stress is the major principal stress. The appearance of these streak lines suggests that the foundation mound might have experienced plastic yielding under vertical load.

Fig. 10. Sketch of streak line on trench surface of Photo 7

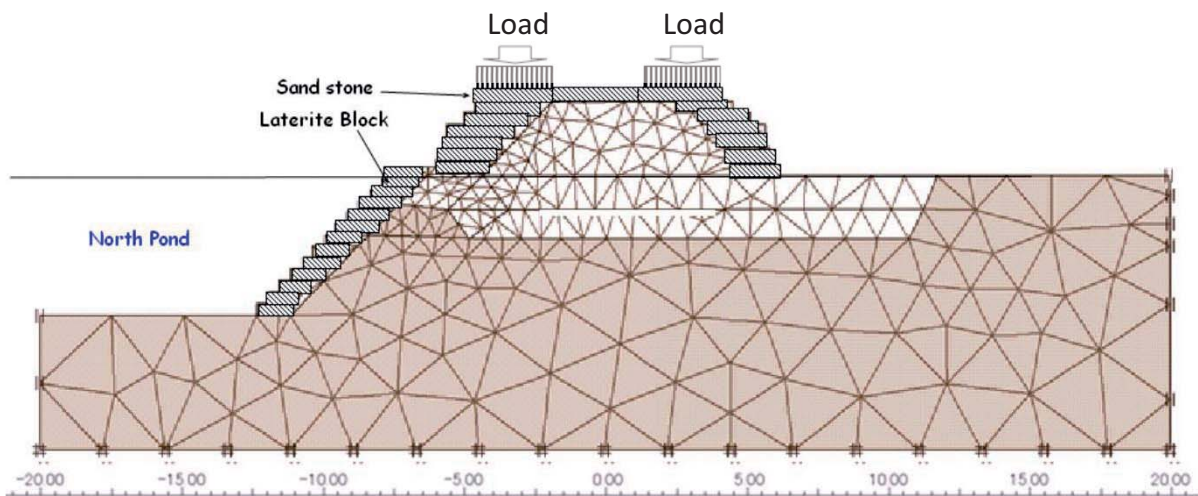
Fig.14. FEM mesh by PLAXIS 2D

The soil parameters are based upon some typical number estimated by the authors. However, the FEM results suggest the essential features of the characteristics of deformation of the Tower.

The seasonal change of level of underground water might have affected the strength of the soil mound and repeated nature of weakening soil mound has caused yielding of the mound and the
