The value of multiple earthquake missions: the EEFIT L'Aquila Earthquake experience

Keywords L'Aquila Earthquake · Field survey · Strong ground motion · Building damage · Return mission

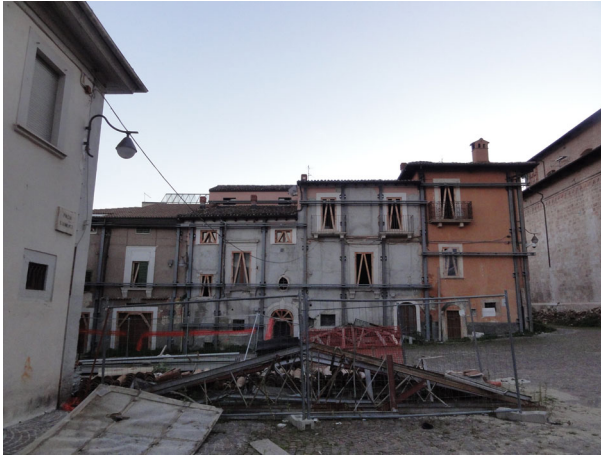
Fig. 5 Example of an aggregate: four distinct building units sharing party walls

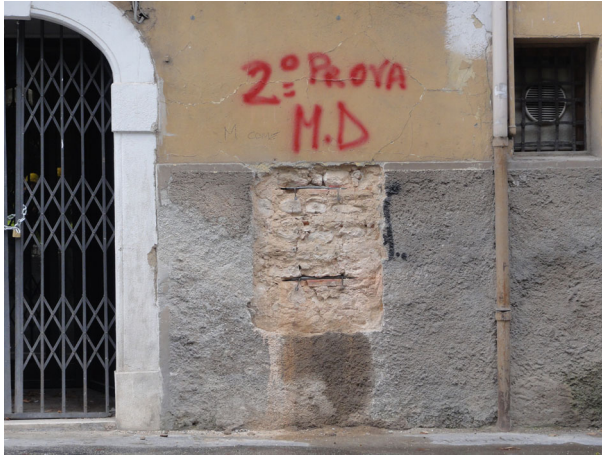
Fig. 6 Photo of typical double flat-jack test to determine compressive strength and mechanical characteristic of masonry
