An Investigation of Excessive Seepage from the Al-Fulaij Recharge Dam, Oman

Y.E.A. Mohamedzein*, S.M. Al-Hashmi and A.A. Al-Rawas

Department of Civil and Architectural Engineering, College of Engineering, Sultan Qaboos University, Muscat, Oman

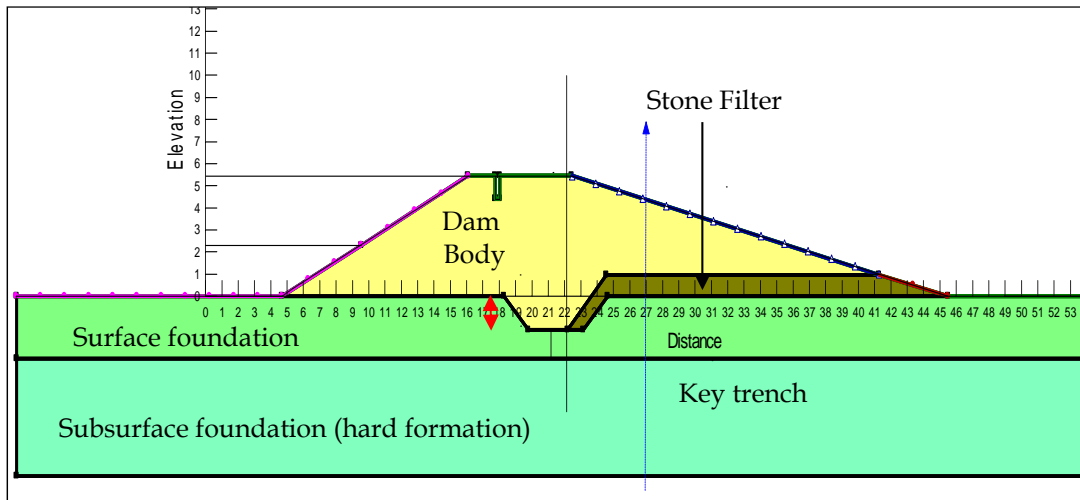
Figure 7. Design case of the dam as modeled in the program (SEEP/W 2007).

To show the effect of the presence of the permeable layer underneath the dam on the seepage quantity, the problem was modeled according to the design case and the actual case. The design case represents the dam without the causes of the seepage problem. This means that the presence of the gypsum material at the site was not considered since it was not evaluated properly during the design stage; hence, the values of the hydraulic conductivity (k) of the different material are as shown in Table 5, and the case is shown schematically in Fig. 7.
