Thermal Evaluation of High Voltage Hermetic Motors Experiencing Recurrent Insulation Failures

H-P. Liu, J.D. Herbst, H.E. Jordan
Center for Electromechanics
The University of Texas at Austin
Austin, TX 78712

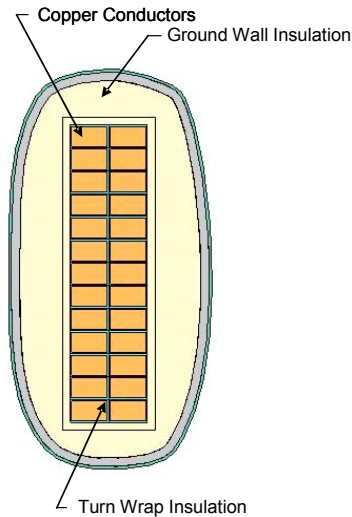
Figure 3. Stator coil thermal model

To evaluate void content in the stator coils, photographs of 44 different coil cross sections have been examined. For those cross sections with voids, an average of approximately two discrete voids was observed, with the majority of the voids found in the ground wall insulation. Voids adjacent to copper conductors were found in nine cross sections. A generic 2-D void free thermal model is shown in figure 3.
