The Preservation of the John A. Kerr Building

Report

Master of Science in Historic Preservation

May 2012

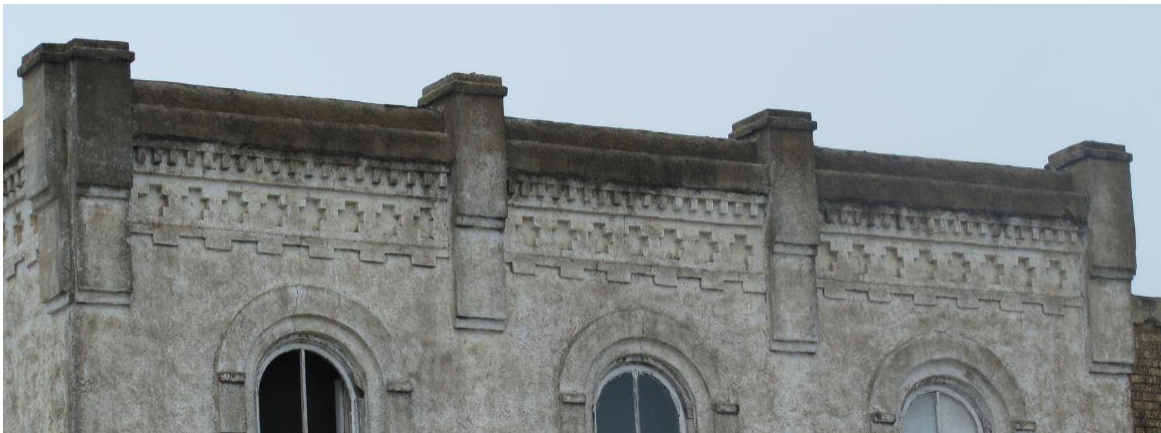
Figure 11: Image of the façade's parapet as it looks today. East elevation.

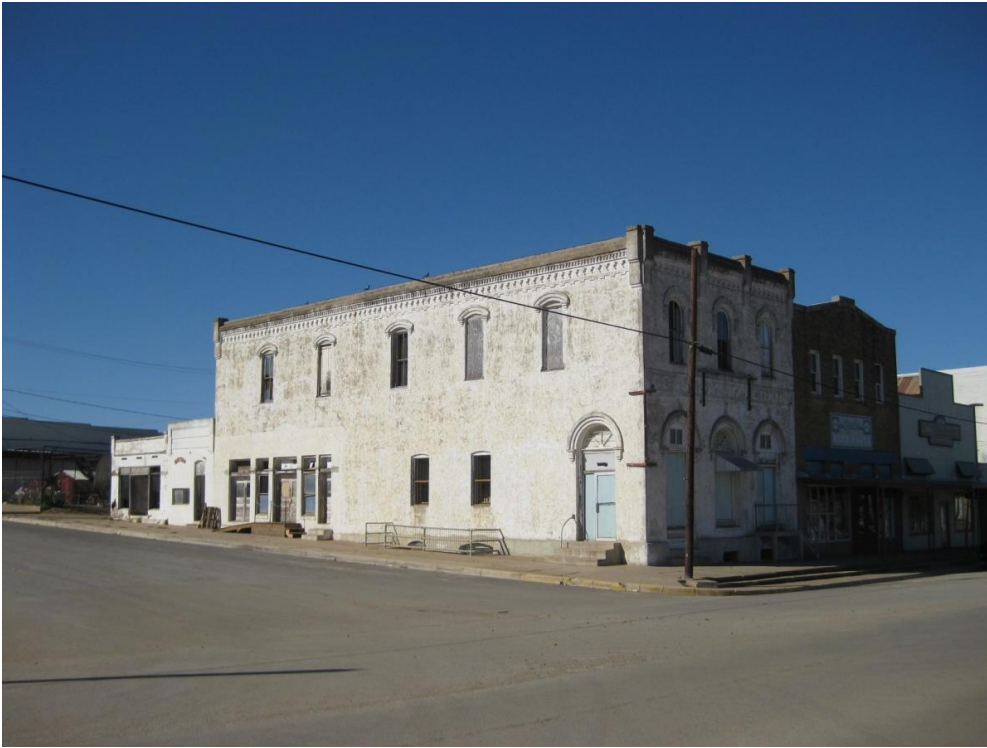
Figure 12: Overview of the Kerr Building. South and east elevations.

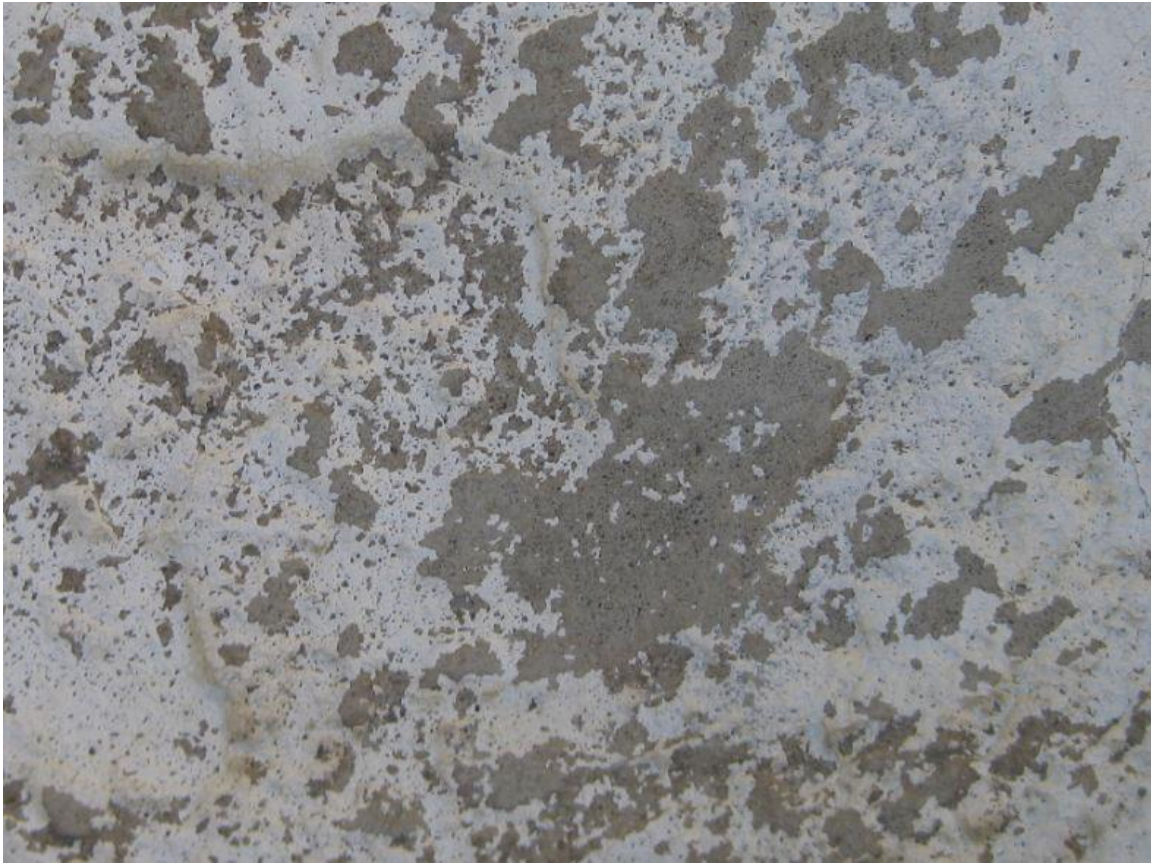
Although constructed with locally made Cotulla brick and a locally available sedimentary stone, ironstone, the building has been coated with two types cement stucco, one that covers the upper two stories and another that covers the upper portion of the basement, visible from street level. The basement stucco is smooth and light grey in color, coating the ironstone. The stucco on the upper two floors covers the brick walls and the stucco aggregate is visible with the naked eye (Figure 13). Although originally painted white, much of the paint has now flaked off to varying degrees. The stucco's intended finish is heavily textured, and appears to be a modified Monterey style, heavily applied and unsmoothed.

Figure 13: Cement stucco with aggregate visible.

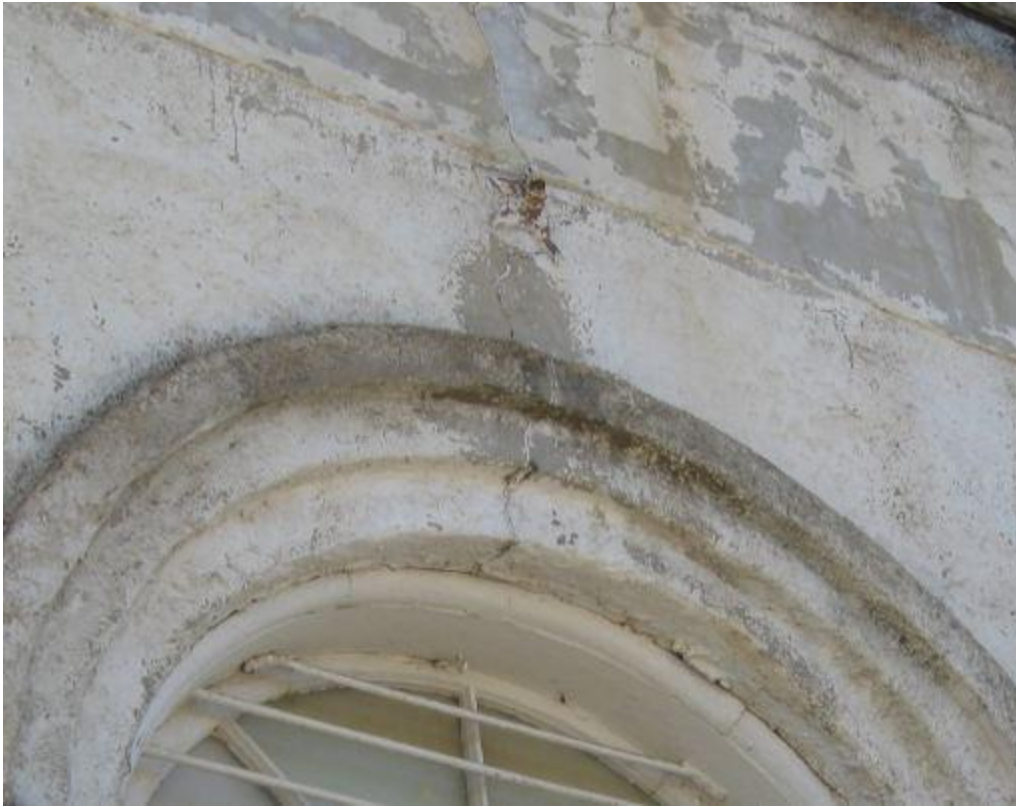
Figure 14: Star-shaped tie above the center opening. East elevation.

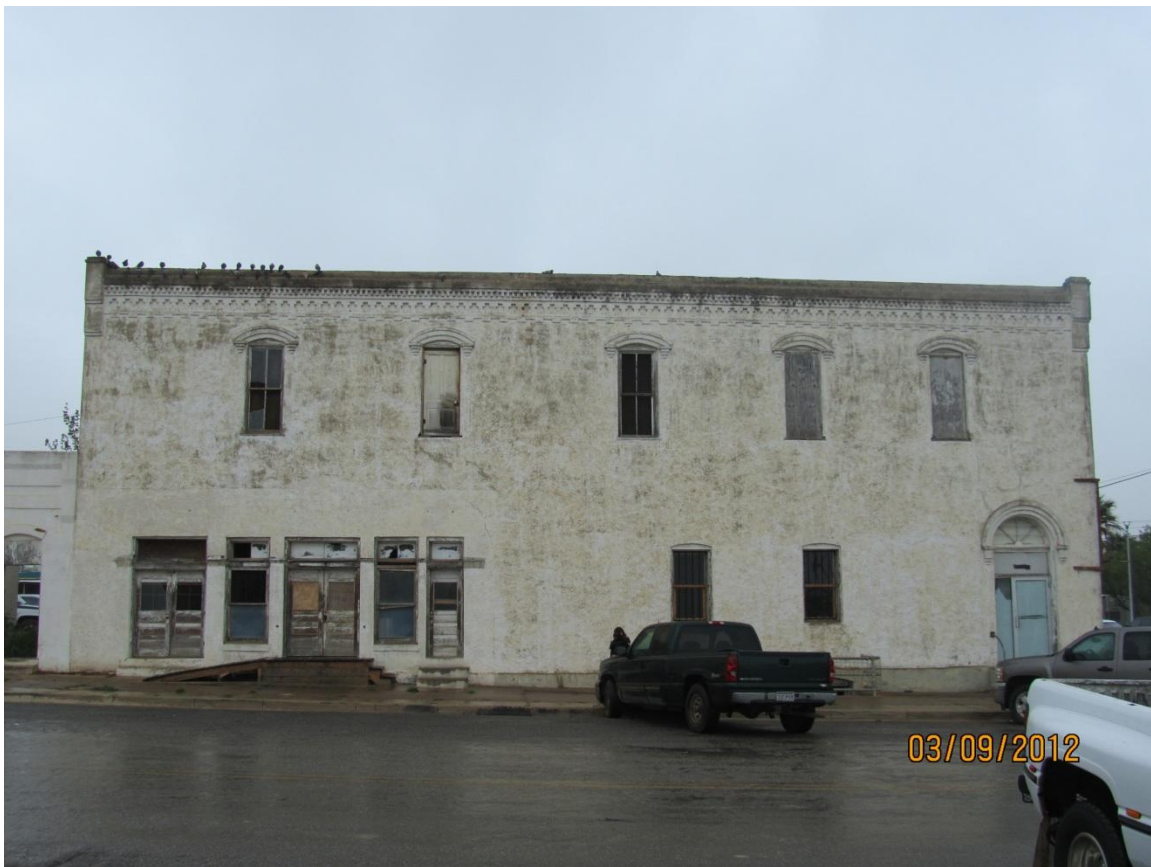
Figure 15: The south elevation of the Kerr Building.

On the south elevation, there is a section of stucco that appears to have ghosting along the west end of the first floor, along the cluster of doors and windows, visible in Figure 15. This area is also painted white and exhibits paint coating deterioration. However, this area has retained more paint than the rest of the building, and is brighter in appearance, which may indicate that an awning at one time covered this area, providing not only shade but protection from weathering. Above one of the set of doors, there is a rounded area of ghosting, which may indicate this area was the main entrance for this section of the building; currently, a nonoriginal wood ramp and steps are in front of the set of doors. Additionally, some of the dentils on the south elevation parapet are damaged or are missing.

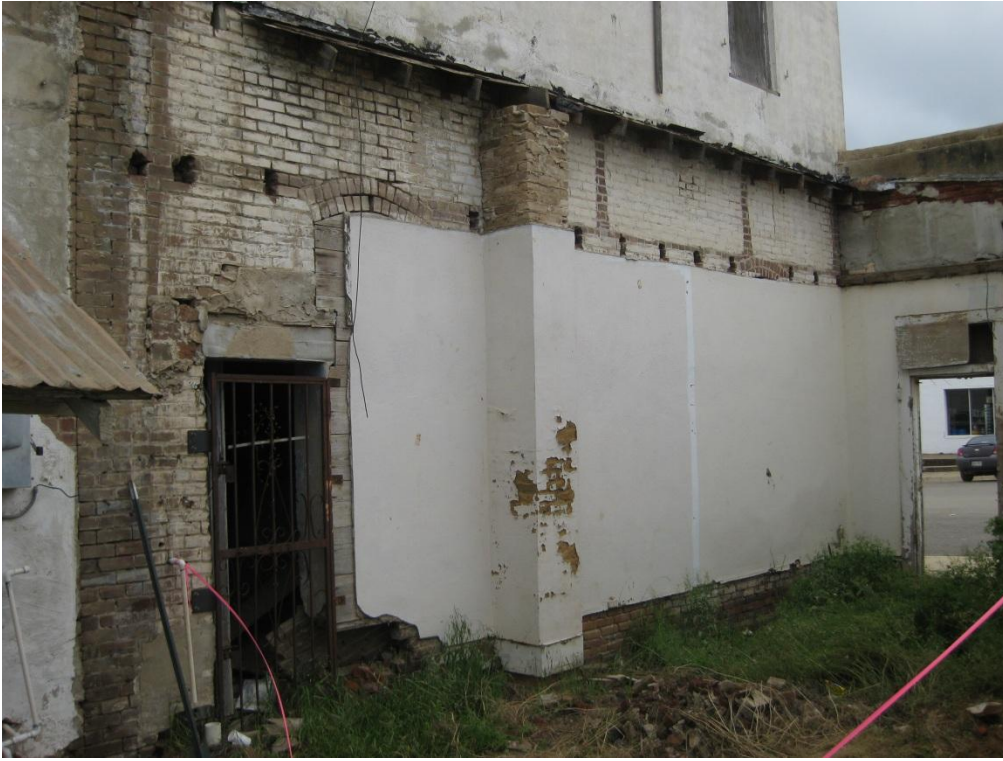
Figure 16: First floor of the Kerr Building's west elevation.

In line with the brick arches, just visible above the plaster wall, are a series of large holes that have been punched into the building, presumably to receive wood beams that would have supported the roof and ceiling of the adjoining building. Much of the brick along this upper area has a white appearance, indicating that the plaster may have discolored the brick or left behind a residue or deposit following removal. Above this is the remaining section of the roof of the adjoining building. This consists of a tar-like and cementitious type substance, covering a wood roof structure and wood beams, both of which are still attached to the Kerr Building, as can be seen in Figure 16.

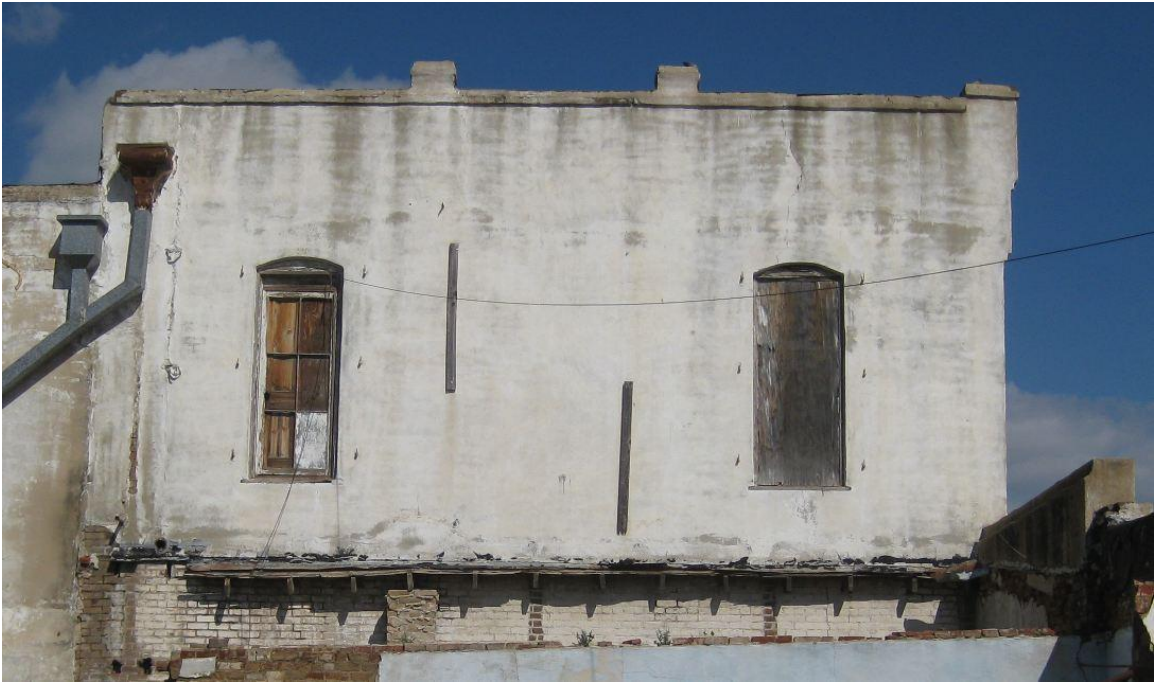
Figure 17: Second floor of the Kerr Building's west elevation.

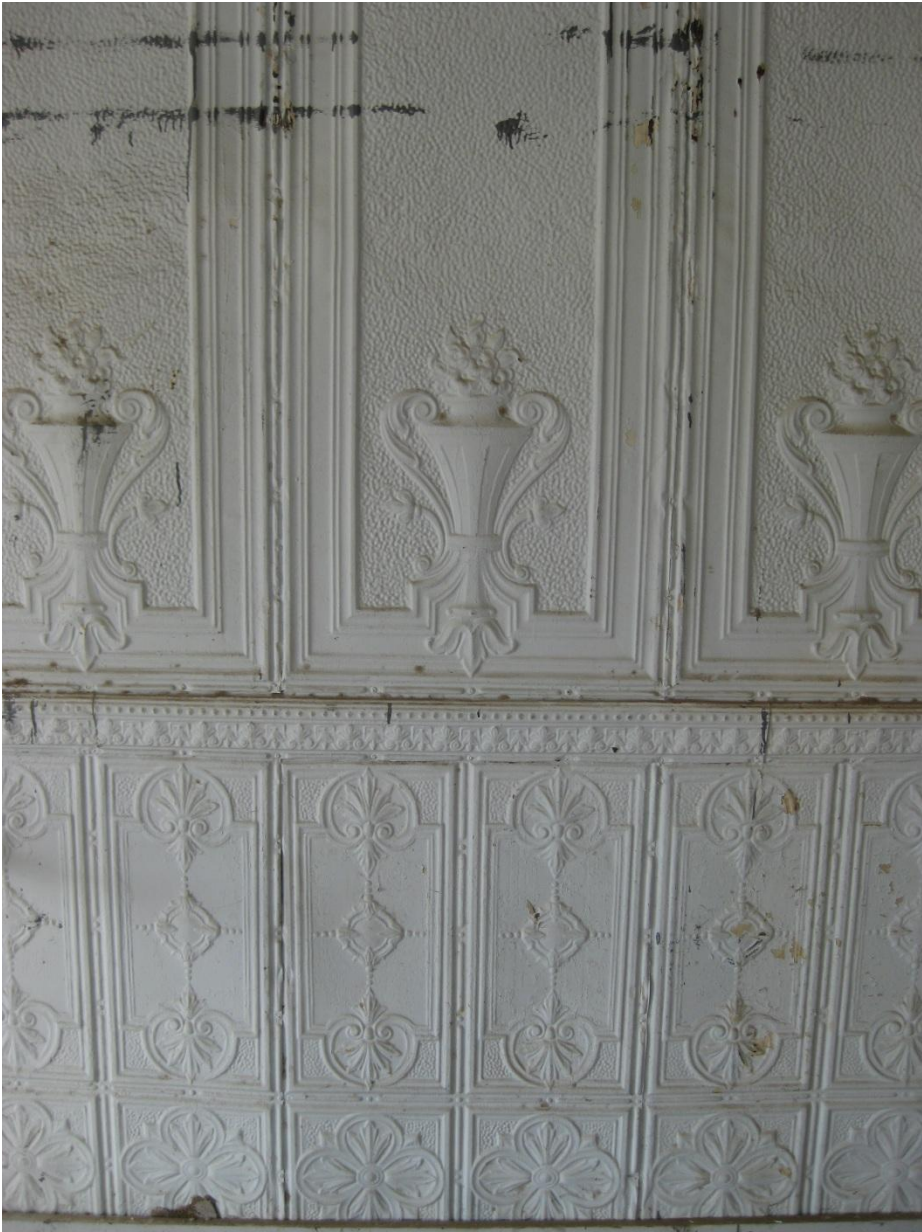
Figure 19: Lower portion of the pressed metal wall.

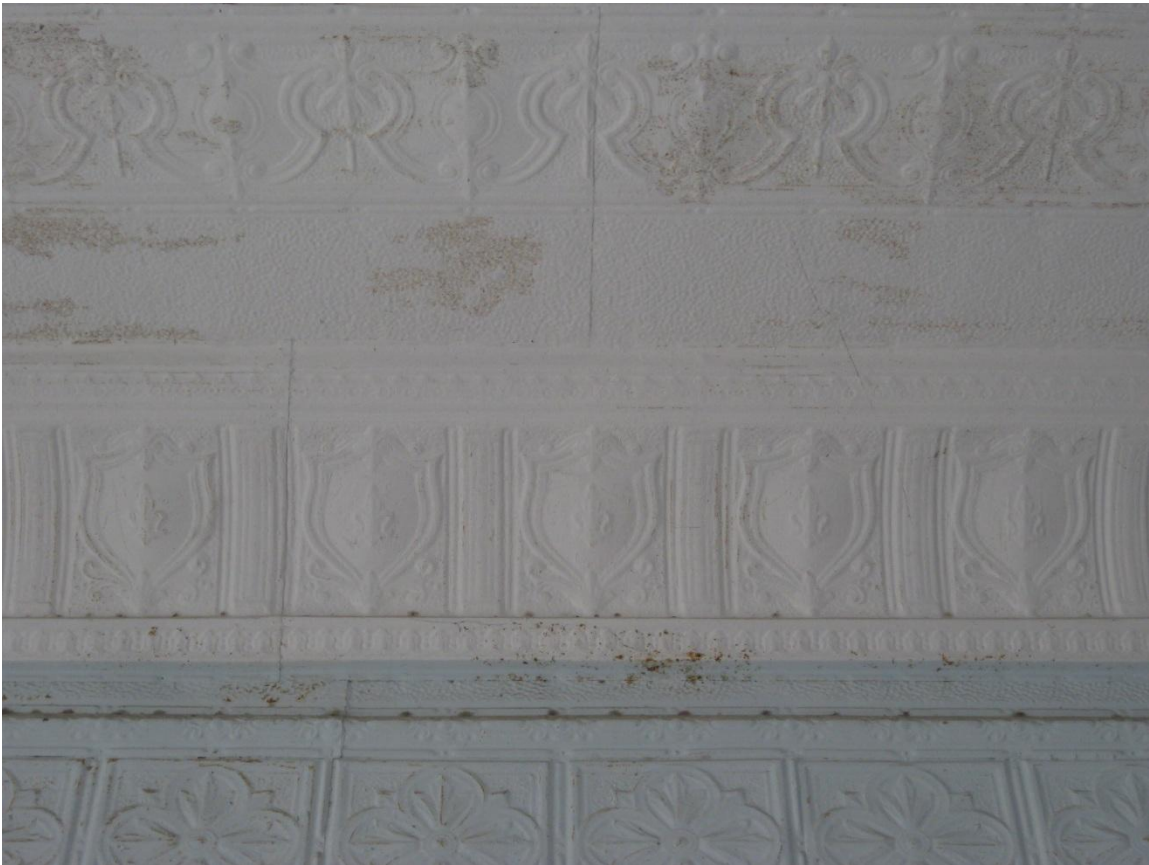
Figure 20: The transition from pressed metal wall to pressed metal ceiling.

Providing a transition between the wall and ceiling is pressed metal molding. Contained on either side by decorative, abstract motifs, the body of the molding consists of shields with a fleur-de-lis in the center, surrounding by organic scrollwork. Separating each shield is a simple rectangular motif (Figure 20). The corners of the molding contain a larger more elaborate shield, divided diagonally by two waving bands (Figure 21). There is also a transition from this molding to the ceiling and walls; above and below the molding can be found pressed metal that is adorned only with a stippled or “rusticated” effect.

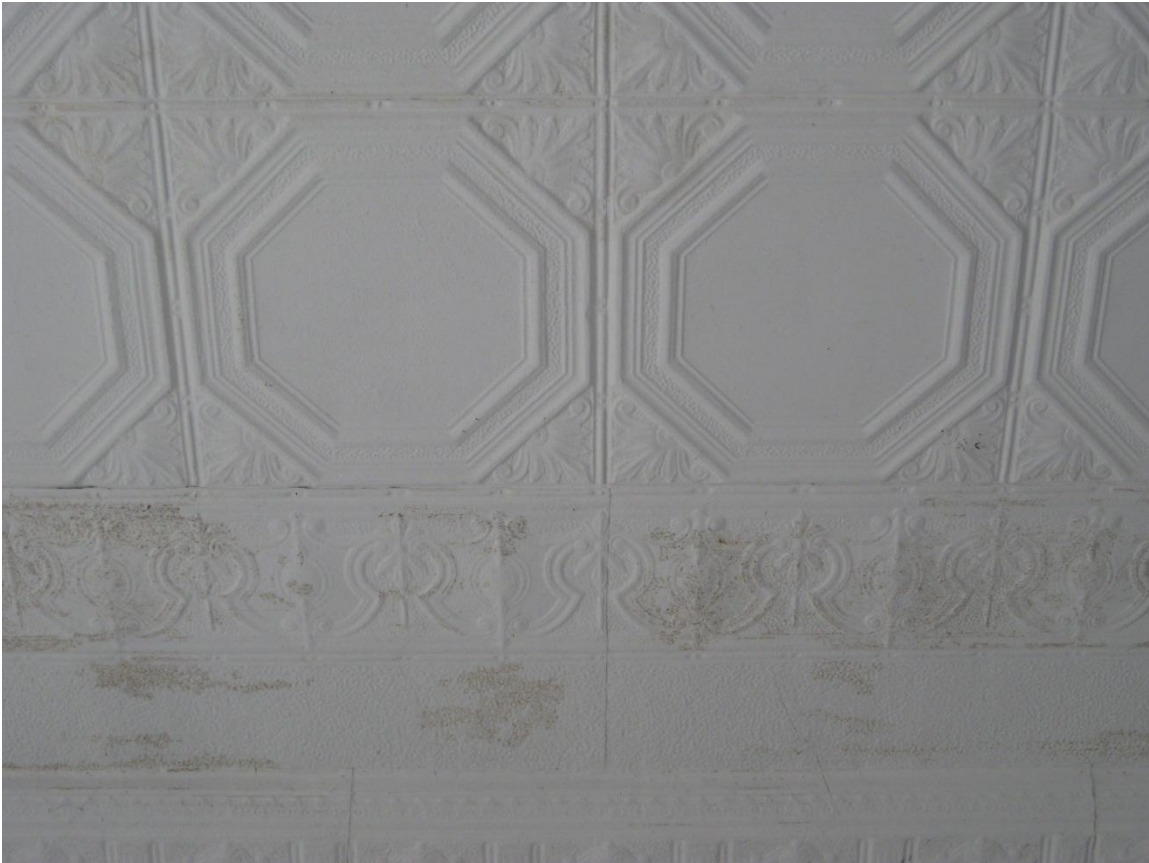
The outer edge of the pressed tin on the ceiling is unadorned as it transitions from the pressed tin molding. After this transition, there is a band of symmetrical curlicue and stylized floral motifs, which contain octagonal designs that comprise most of the area of the ceiling. The octagonal designs have smaller, concentric octagons inside them, and they line up with each other forming rows. The empty areas that the corners of these designs contain have more stylized organic motifs (Figure 22).

Figure 22: The outer edge of the ceiling's pressed metal. The transitional molding from wall to ceiling is at the bottom of the image.

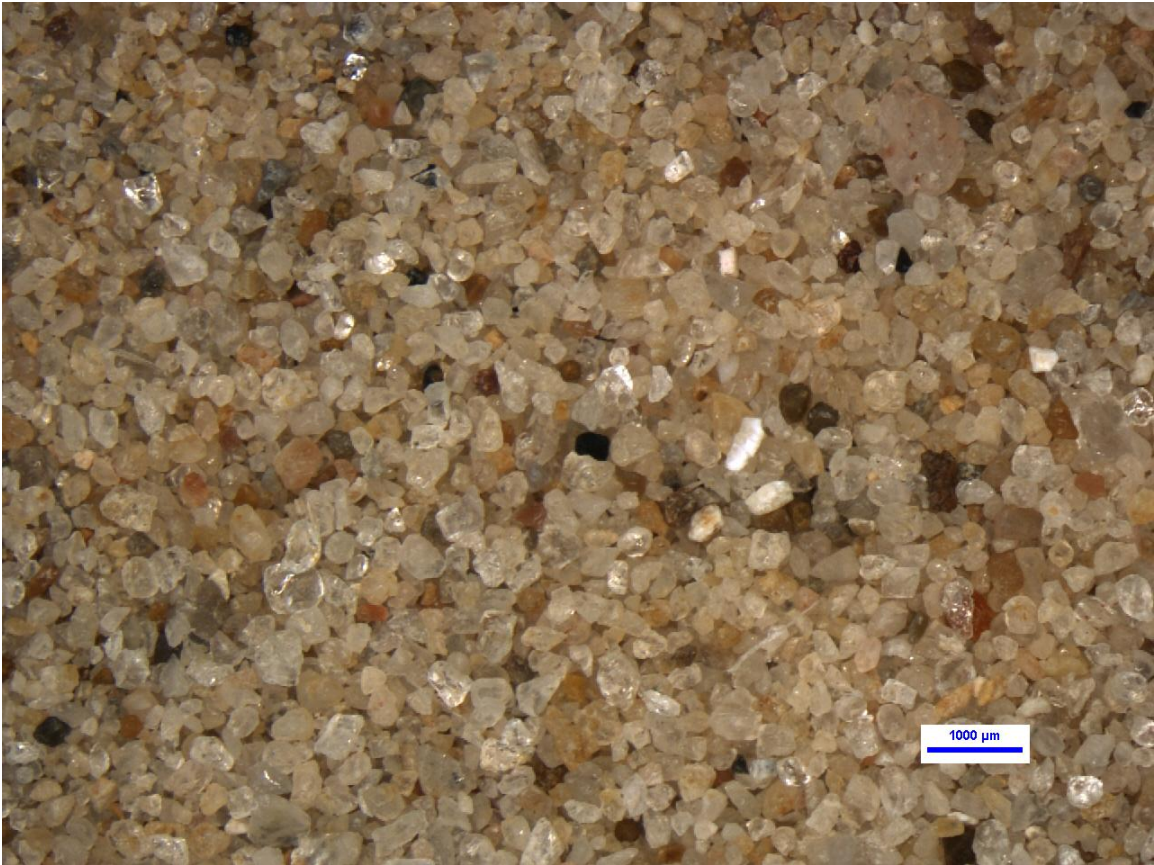
When viewed at various magnifications, ranging from 20x to 50x, the aggregate is subangular. This is indicative of “river sand,” from an “immature stage” of a river.¹⁶⁵ Visually, the majority of the aggregate is clear and colorless. This is interspersed with white, milky aggregate grains and a smattering of darker grains throughout. The most prominent colors, other than these clear grains, are amber and yellowish. The darker grains range from amber-brown to dark-brown (Figure 35). When using a sieve set made according to ASTM E 11, Standard Specification for Woven Wire Test Sieve Cloth and Test Sieves, the largest sand grains were retained on the No. 30 sieve (0.60 mm) and the smallest on the No. 200 sieve (0.075 mm), with some fine, silt-like grains remaining. Combining the acid soluble fraction and fines, the binder represents 24% of the total. In selecting sand for repointing, a small portion of the original sand should be given to the contractor in order to find a match.

Figure 35: Sand grains from the mortar sample viewed at 10x.

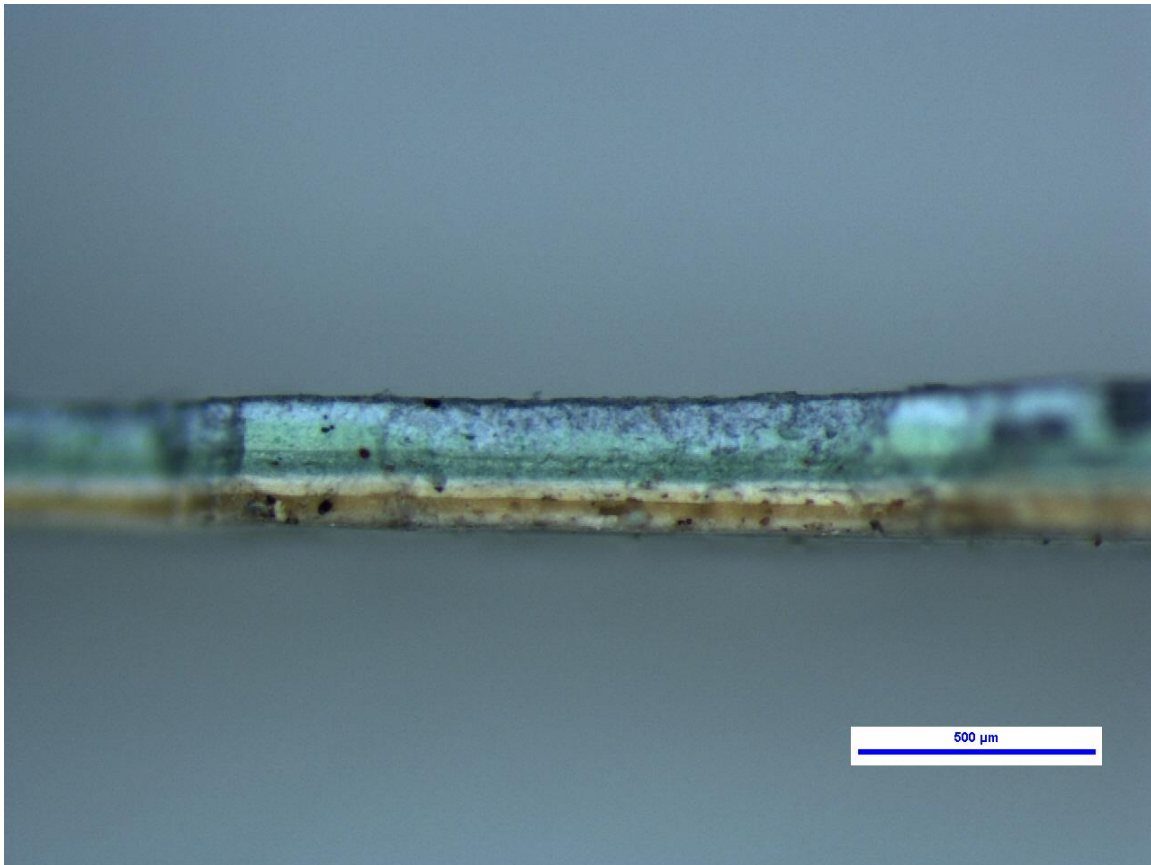
In total, eight of the same layers were present in the samples, not including the substrate and the additional tenth blue coating (Figure 36). The first coating was grey on the blue sample and brown on the white sample. This layer is very thin and glossy, indicative of a primer. Then, a thicker layer of yellowish-cream was applied over this. After this is a brown layer, a yellowish layer, a faint light green layer, a dark green layer, and a medium-green layer of more or less the same thickness.

Figure 36: Section of the blue paint sample viewed at 50x.

After these layers is a thicker light green layer (not as light as the first green layer), followed by a thinner white and blue layer, depending in the sample. These layers have air bubbles indicating a different manufacturing method was used; these may be modern paints.
