Design Considerations for Embankment Protection During Road Overtopping Events

Jeffrey D. G. Marr, Principal Investigator

St. Anthony Falls Laboratory

Final Report 2017-21

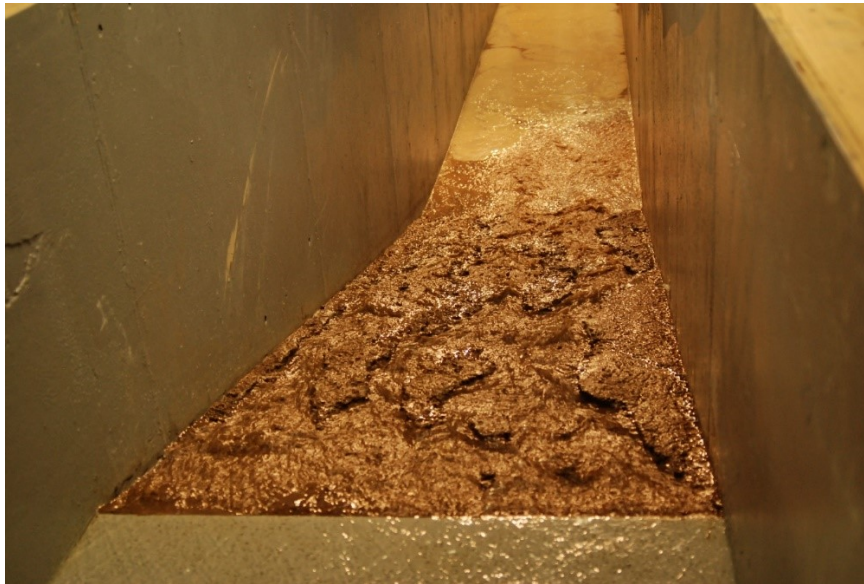
Figure 4.2. 4H:1V Slope mid-run with prevalent channels of flow looking downstream. Less than two minutes of run time.

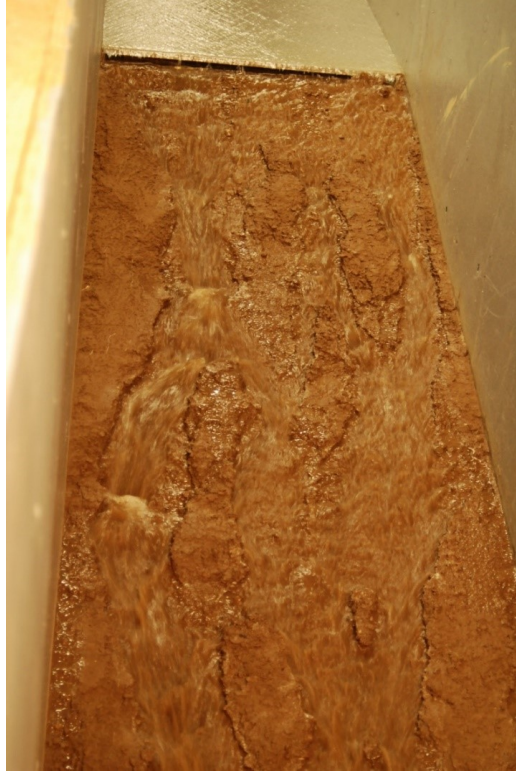
Erosion occurred immediately across entire slope. Preferential flow paths were quickly established then deepened by repeated flows. Concentrated erosion occurred immediately downstream of the fixed edge of the “shoulder”, eventually funneling all flow into the deepest preferential path, forming a pattern of cyclic steps, which are similar to pools and chutes, migrating upstream. If the shoulder were not fixed in place, it would most likely have undermined and collapsed.

Figure 4.3. Mid-run 4H:1V slope looking upstream. Flow channelized on slope with trough forming on the transition from shoulder to slope.

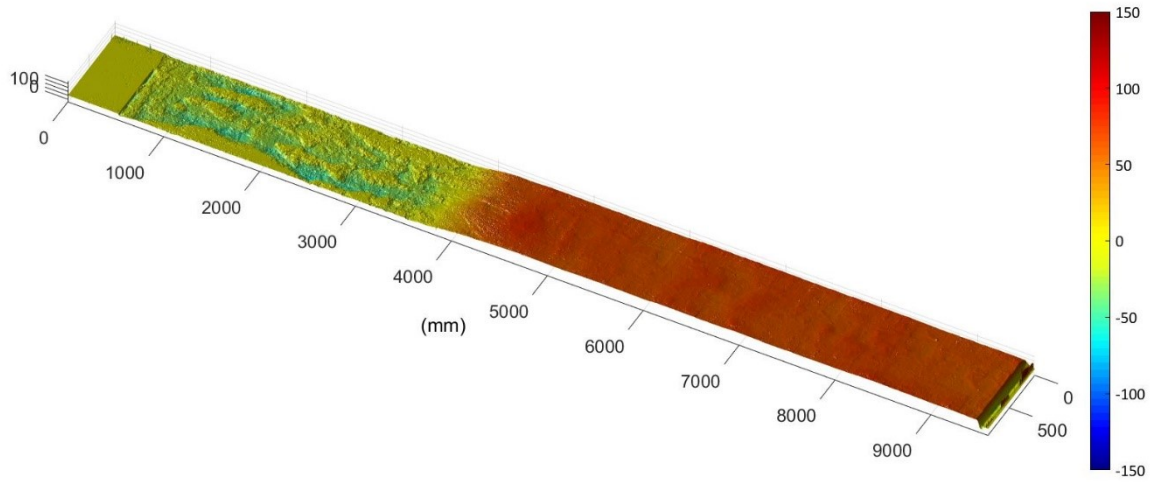
Figure 4.5 Topographic difference plot from zero to two minutes of run time, showing prominent channels being carved on slope. Elevation units are in millimeters.

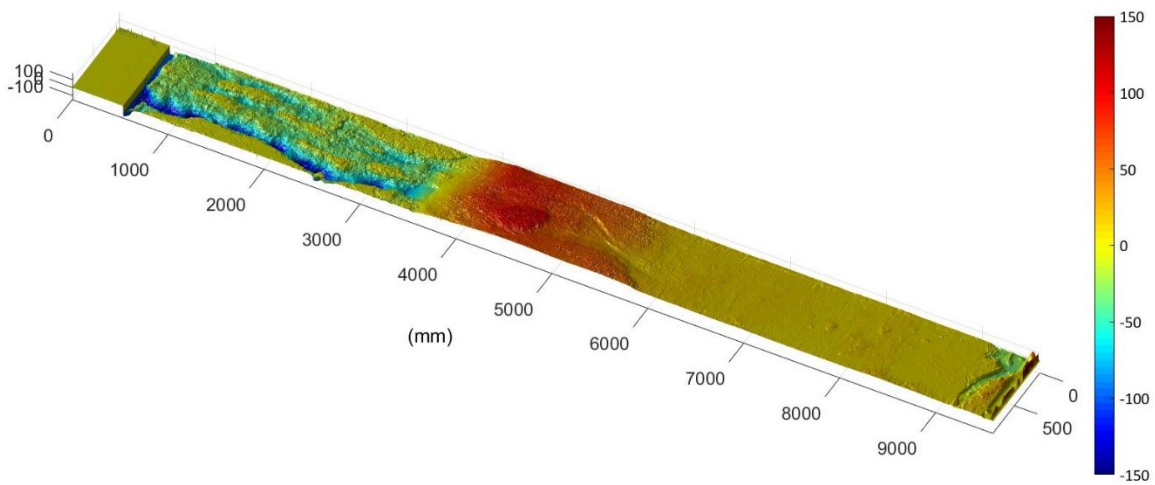
Figure 4.6 Topographic difference plot from zero to eight minutes of run time. Note scour and trough formation at upstream transition from shoulder to slope and primary channel of erosion.

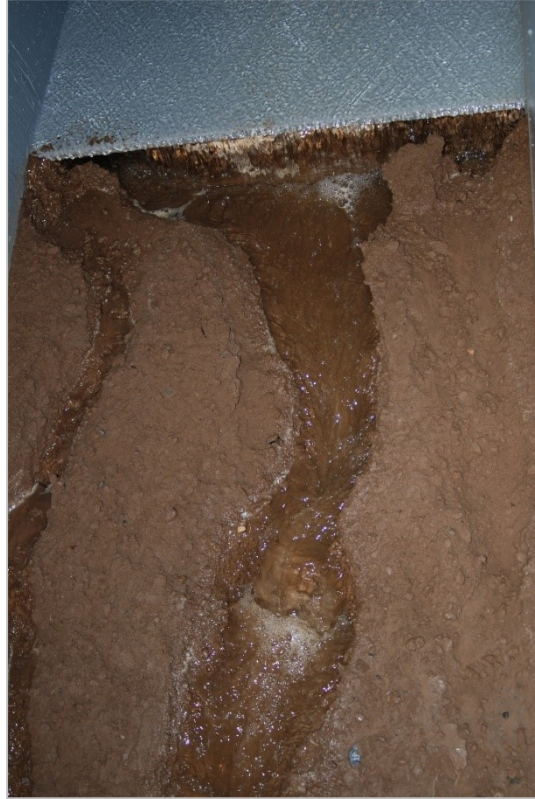
This slope's failure was similar to the 4H:1V slope except that the erosion occurred less rapidly and did not erode as deep into the slope. A trough formed immediately downstream of the shoulder and fed into carved channels that wove down the slope. On the lower half of the slope, several flow paths recombined and erosion was shallower and more prevalent as opposed to one deep prominent channel.

Figure 4.9. Channelized flow and separation from the edge of the shoulder forming trough at the transition.

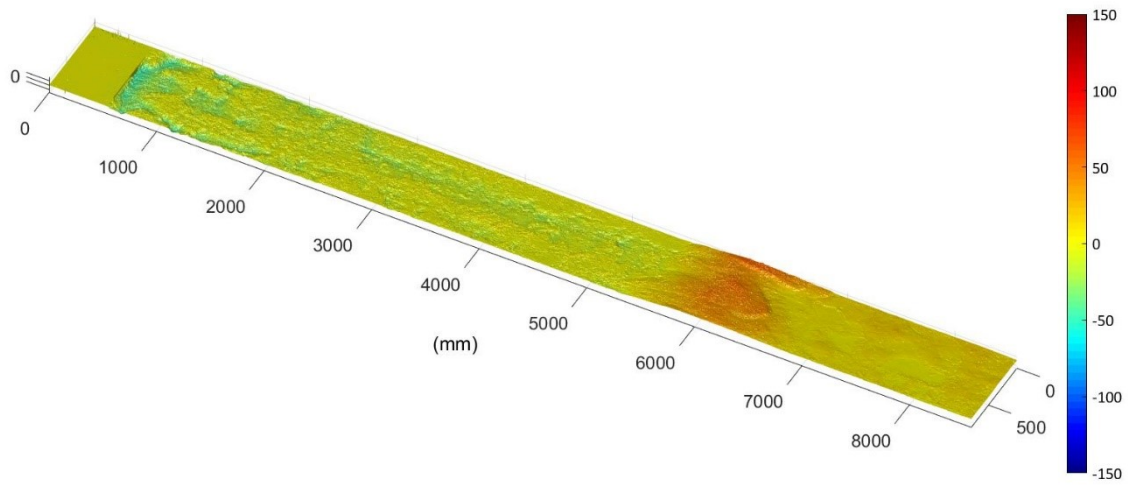
Figure 4.11. Topographic difference plot from zero to two minutes of run time. Note the large area of erosion immediately after the shoulder and channels downslope of it.

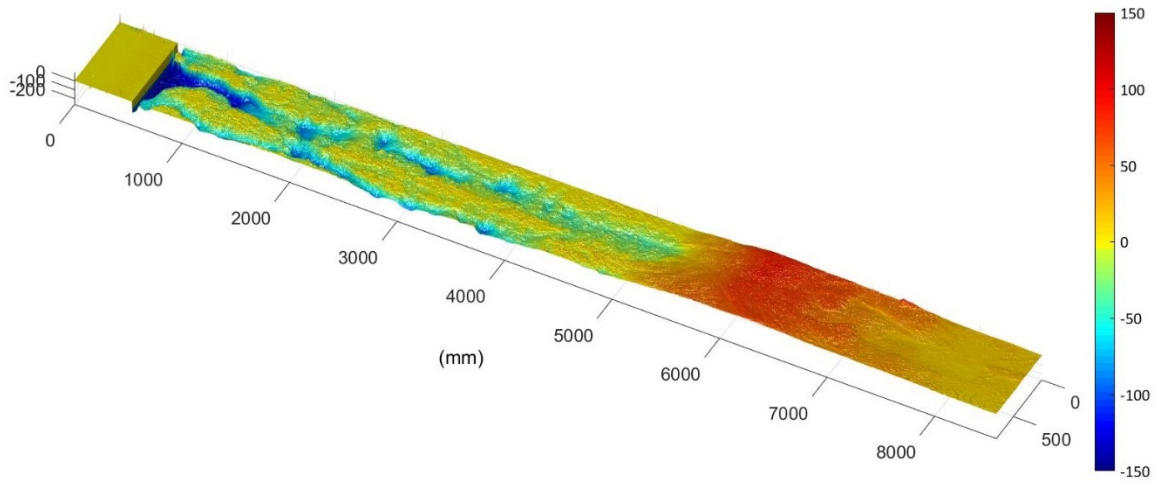
Figure 4.12. Topographic difference plot from zero to 10 minutes of run time. Only ten minutes of run time has undermined the shoulder.

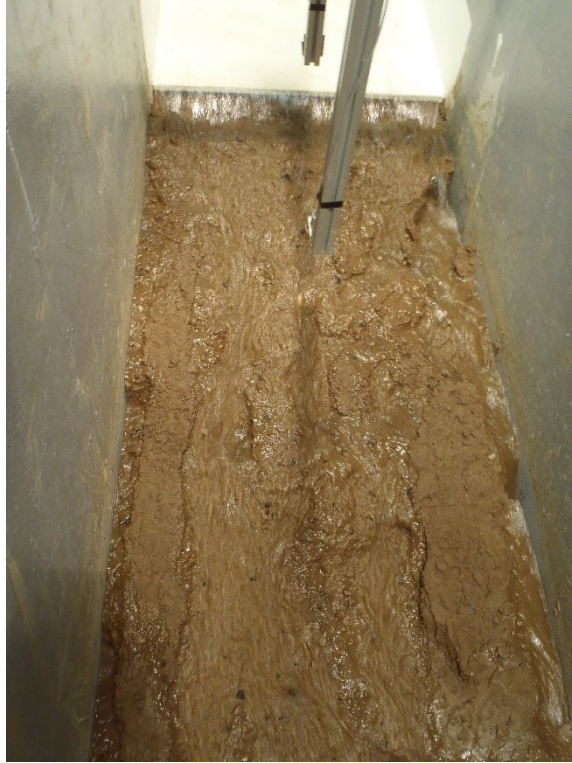
Figure 4.15. Looking upstream after approximately 25 minutes of run time. Channels and depressions forming, no trough or main channel forming.

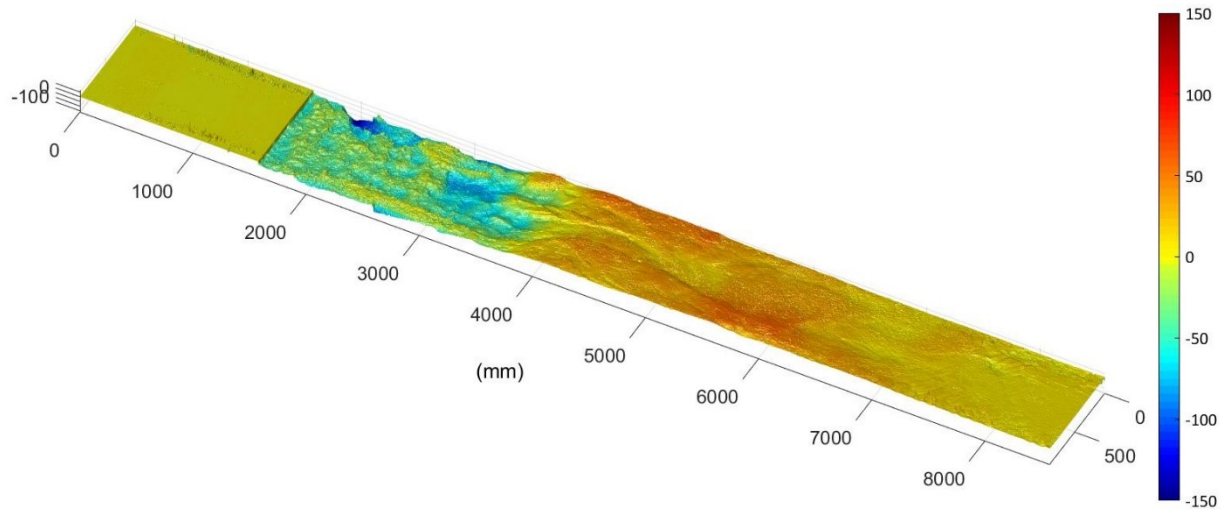
Figure 4.18. Topographic difference plot from two to 22 minutes of run time. Slope now has channels but not as definitive as other runs of bare soil, no primary channel on slope was eroded.

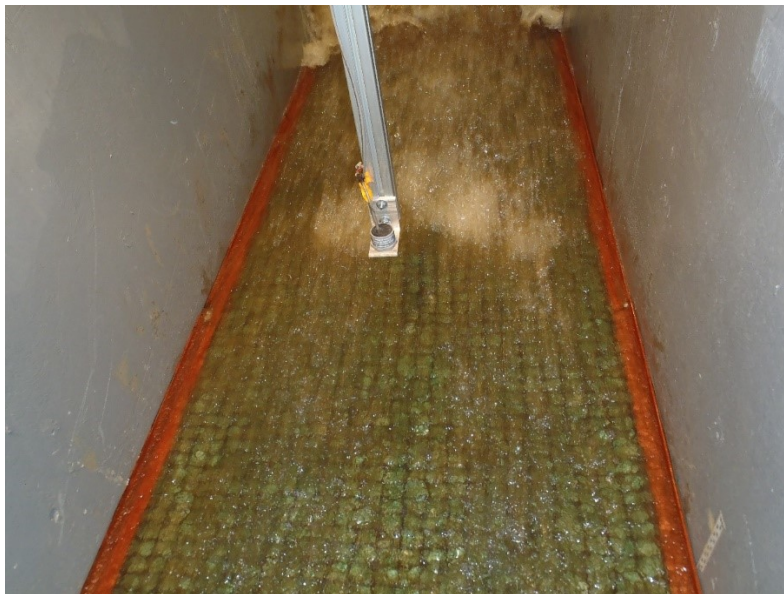
The first flow increments were uneventful with little noticeable erosion occurring. Water flowed both on top of the geogrid and through the erosion control blanket. At the end of the third flow step, some visible erosion occurred directly downstream of the shoulder. On the fourth flow step, an erosional scour hole formed just over half way down the slope, with a corresponding depositional mound clearly forming immediately downstream. Both features gradually grew in size and moved slightly upstream, until a large failure occurred within less than five minutes of the start time. Soil from an erosional trench, extending from the road shoulder to 2/3 of the way down the slope, was excavated and was partially retained by the geogrid and erosion control blanket creating a mound just upstream of the toe. On the upper part of the slope the geogrid spanned across the eroded region, while on the lower part of the slope the geogrid protruded upward over the soil mound.

Figure 4.21. Start of erosion about $\frac{1}{2}$ way down the slope indicated by the depression leading to a mound that aerated the flow in the center of the flume. Looking downslope from shoulder at mound and hydraulic jump.

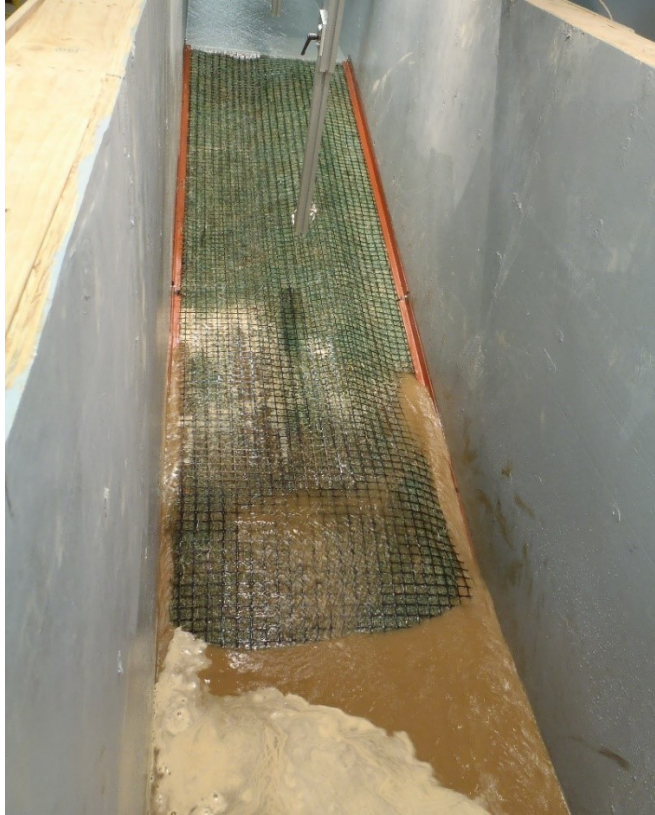
We observed a large amount of erosion on the right side of the embankment slope. The left edge opposite the erosional area remained intact. A large depositional mound just upstream of the toe of the slope could be a result of the soil that eroded and traveled under the ECB. Burying the ECB at the toe of the slope could have helped to reduce erosion. The erosion that took place along the river-right edge of the flume was unobservable from the surface during the flow event due to the bridging of the stabilization material.

Figure 4.22. Post flow erosion after 2.7cfs testing. Note the mound near bottom of slope and depression along the left side of the flume looking upstream. Sediment rich water on slope and in tail water indicating erosion occurring on the slope under the ECB.

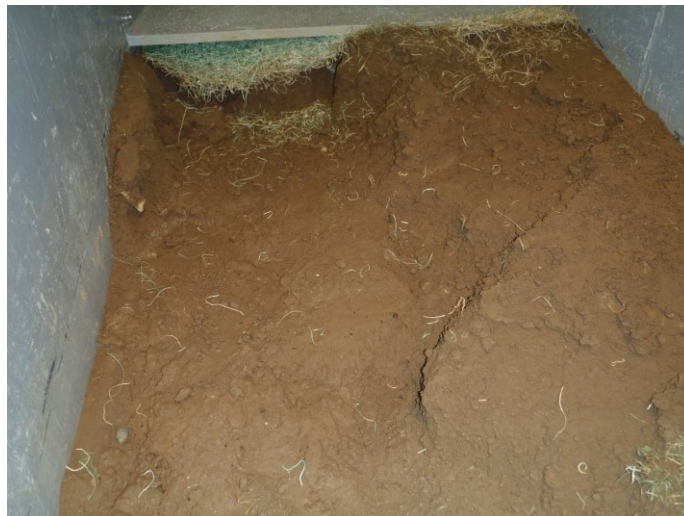
Figure 4.23. Slope with the shoulder at the top of the photo after ECB was removed post-testing. Note the undermining of shoulder and extensive erosion not seen with ECB still in place on previous photos.

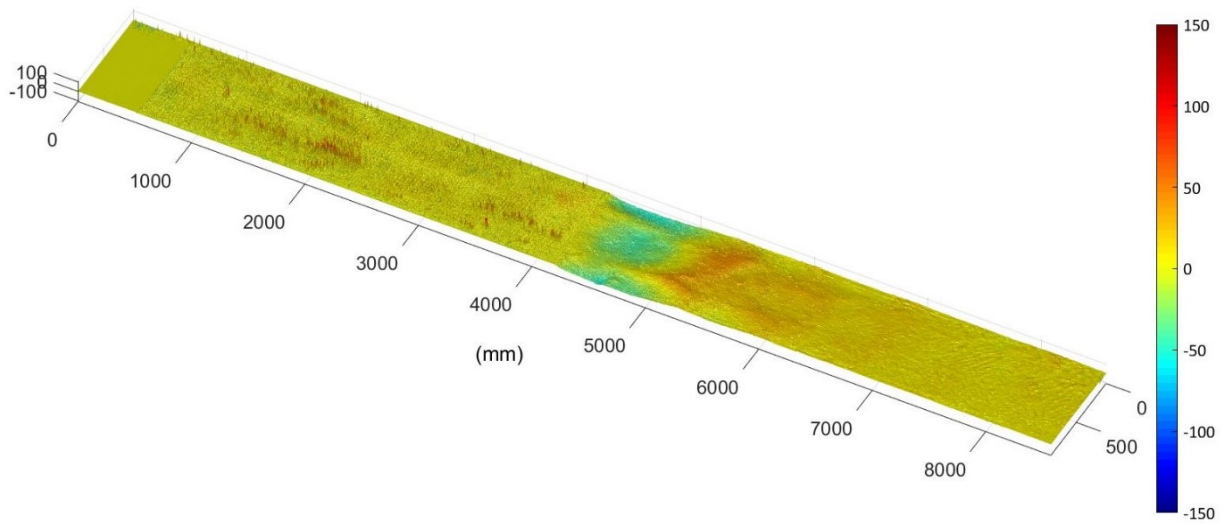
Figure 4.25. Topographic difference plot from zero to 1.5 hours of run time. Minimal erosion on the slope shown here with a depression after the toe of the slope.

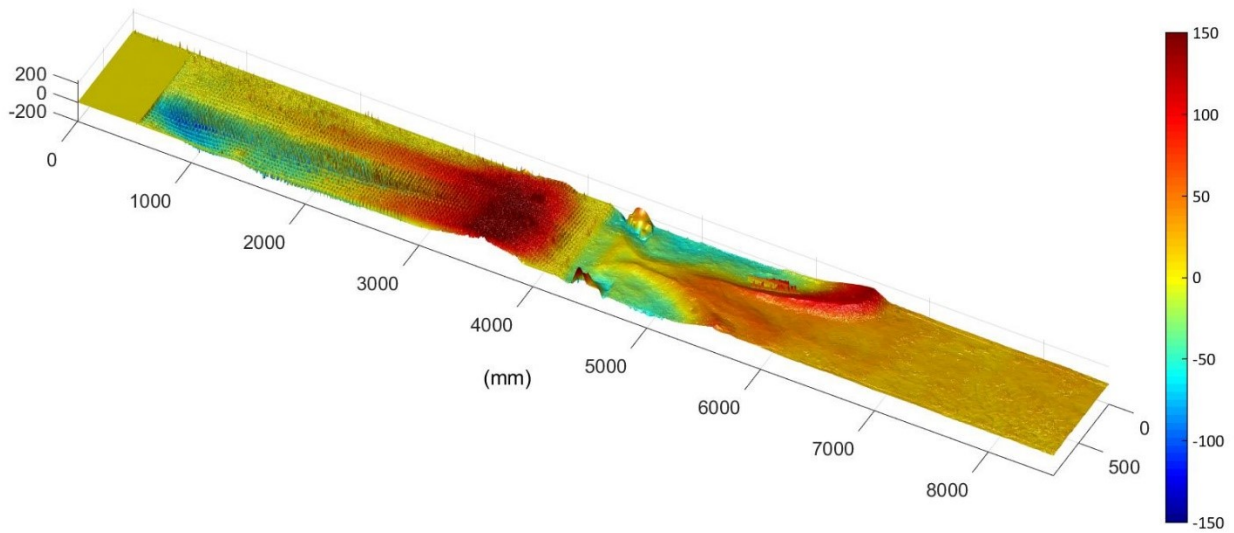
Figure 4.26. Topographic difference plot from zero to 1.93 hours minutes of run time. Note large area of erosion on the edge of the slope with soil deposition at the toe of the slope under the ECB.

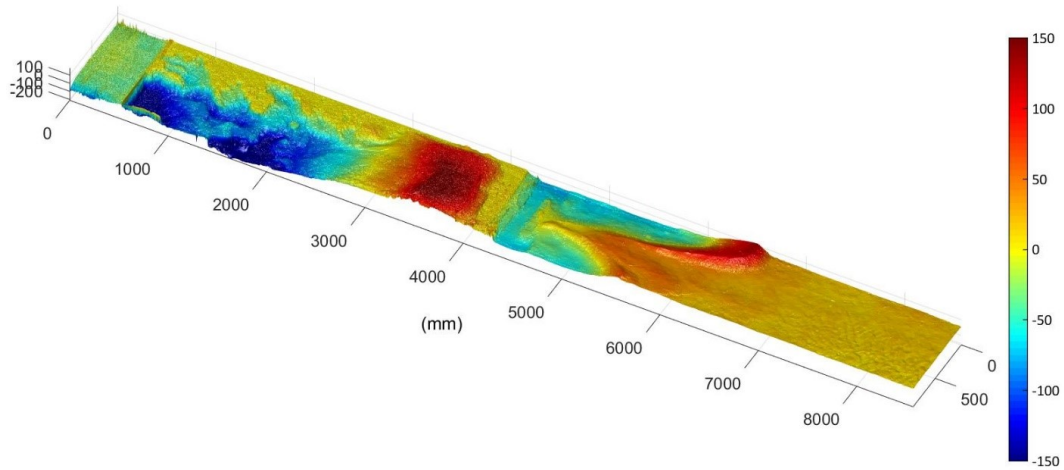
Figure 4.27. Topographic difference plot of bare soil before testing to 1.93 hours of run time with ECB removed. Removing the ECB reveals the extent of erosion that was occurring beneath the ECB.

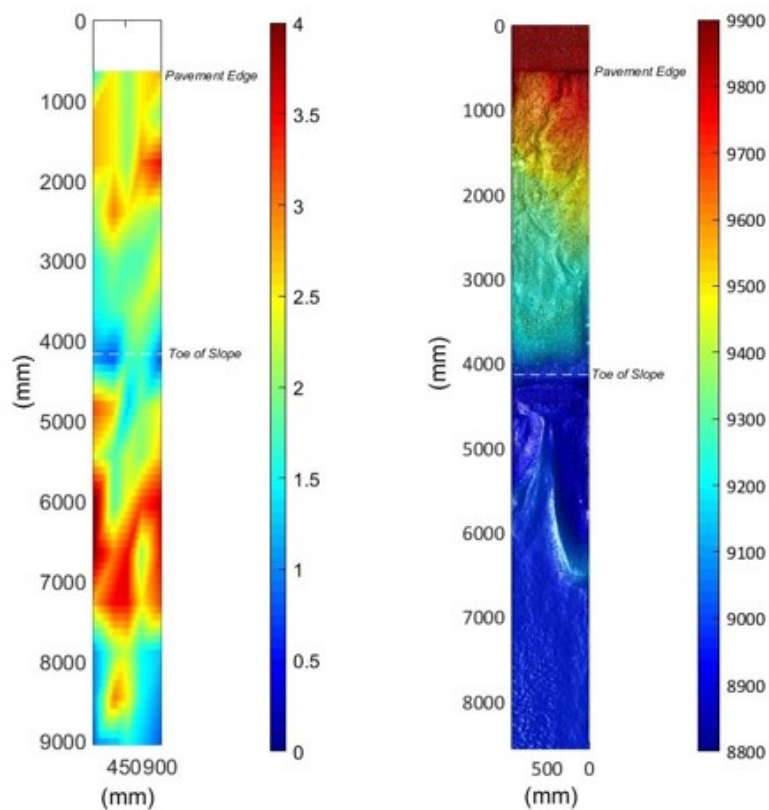
Figure 4.28. (Left) Aerial view of interpolated compaction data on slope. The vertical axis is distance in millimeters from mid-shoulder. Compaction is presented in units of tons per square foot. White area is the shoulder. The color bar on the right of the figure gives color range for compaction values. (Right). Aerial view of scanned slope after eight minutes of run time and ECB was removed showing large depression and channels near pavement edge.

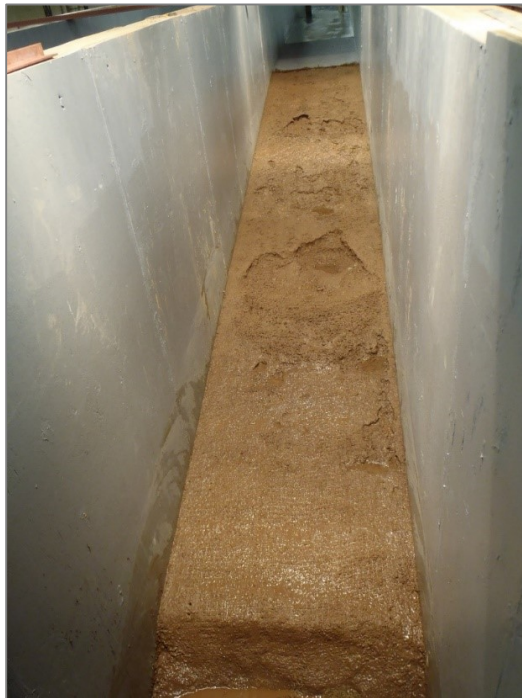
Similar to the 4H:1V slope “quick” test, there was little erosion during the first initial hours of run time. Through subsequent runs, aerially extensive but shallow erosion increased. Between 10 and 12 hours a small dip and mound was formed on the lower portion of the slope. This zone of erosion grew gradually until the test ended at 16 hours. The test was ended based on calculation of greater than 0.5 inches of soil loss. When the geogrid and erosion control blanket were peeled back, several other shallower areas of erosion were revealed.

Figure 4.32. Looking upstream at bare soil post run with treatment removed showing different locations of erosion on the slope.

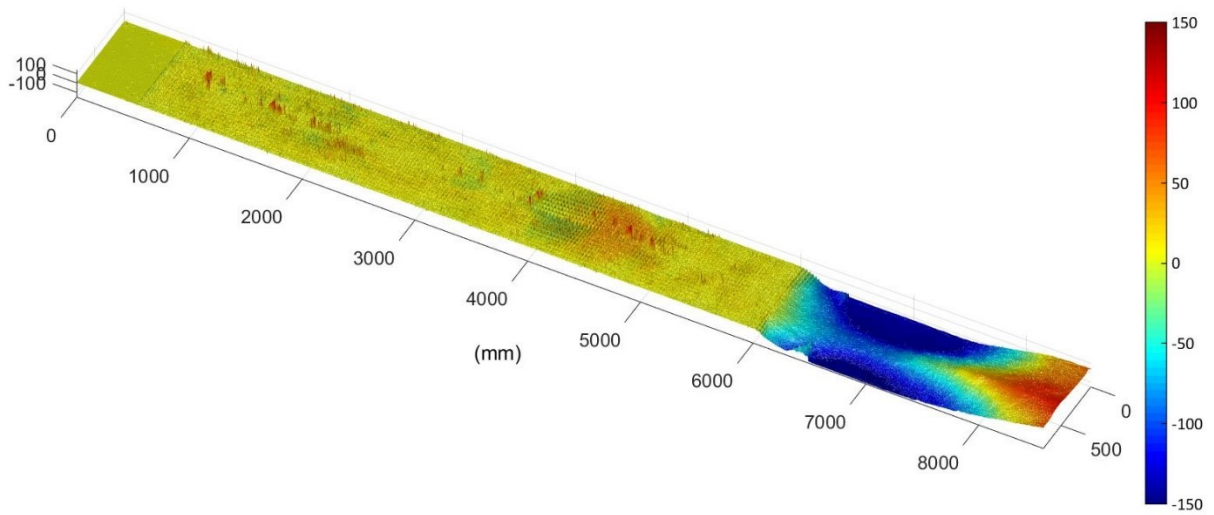
Figure 4.34. Topographic difference plot from zero to 16 hours of run time. Showing a depression and elevated mound $\frac{3}{4}$ of the way down the slope from the shoulder. Smaller depressions are also on the upper $\frac{1}{4}$ of the slope and at mid-slope

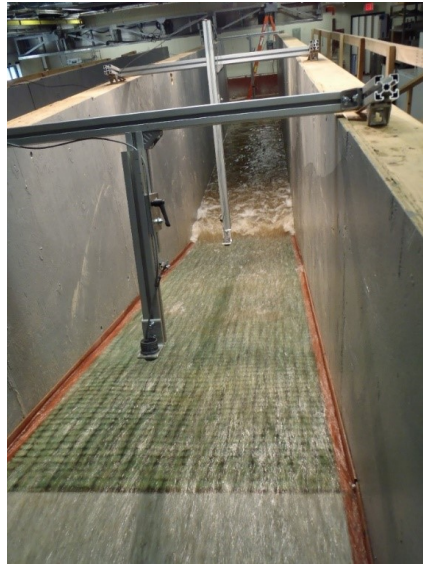
Almost immediately after the first flow began, erosion initiated just downstream of the shoulder resulting in flow penetrating beneath the geogrid and erosion control blanket. Water was turned off after 30 minutes. Erosion near the shoulder transition was similar to that of bare soil tests characterized by a scour hole immediately downstream of the shoulder.

Figure 4.37. Looking downstream at slope with indications of immediate erosion by murky tail-water during the first test.

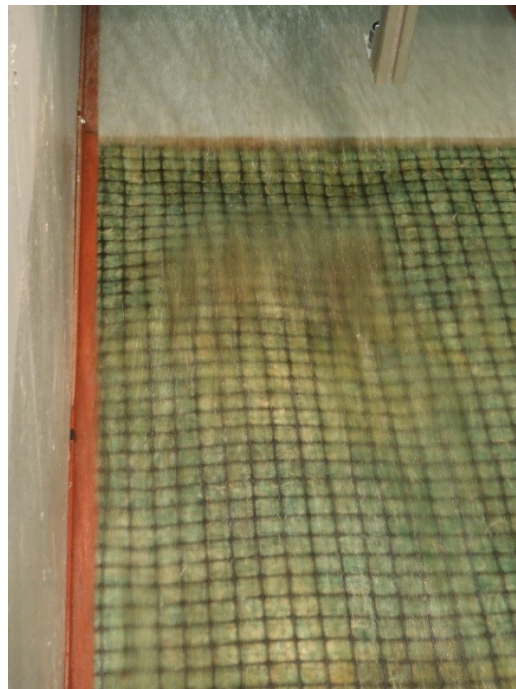
Figure 4.38. Close up of shoulder and slope transition looking upstream. Note the large depression immediately after the shoulder and mound of soil just downstream.

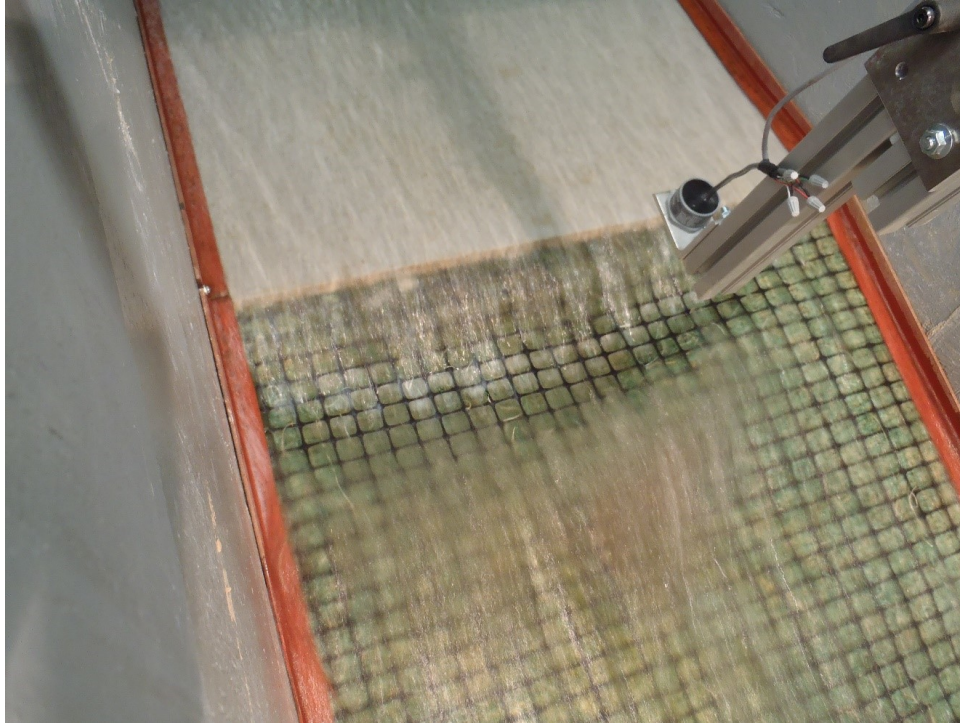
Figure 4.39. After only a few more minutes of run time the erosion has expanded to nearly the entire width of the transition from shoulder to slope.

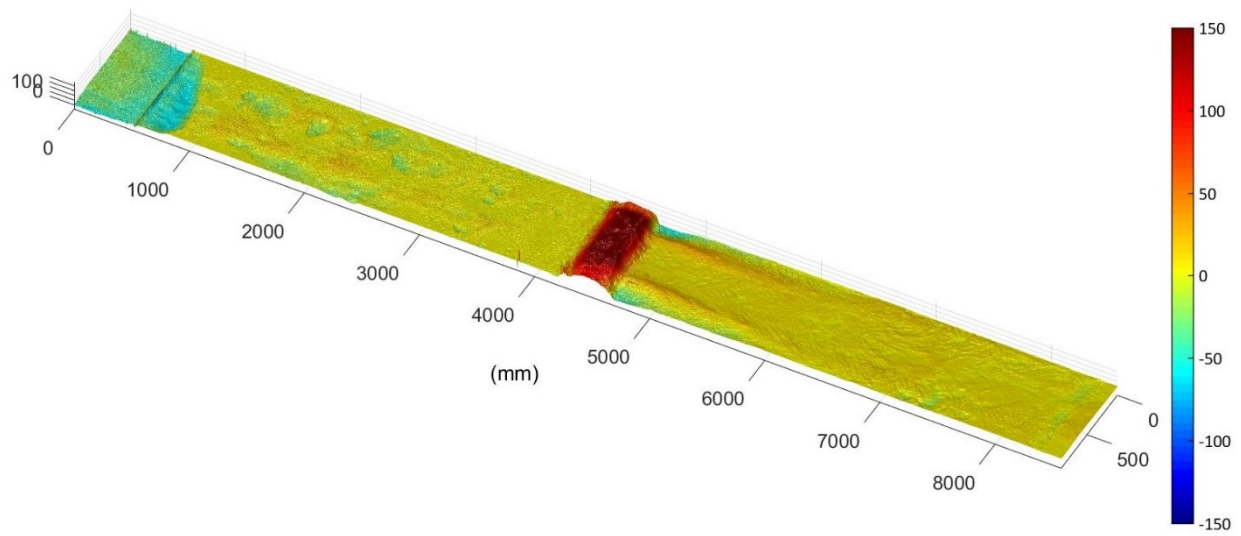
Figure 4.42. Topographic difference plot of initial bare soil vs. final bare soil after 30 minutes of testing. The large deposition at toe of slope is the ECB flipped over onto flat area, and not actually soil deposition.

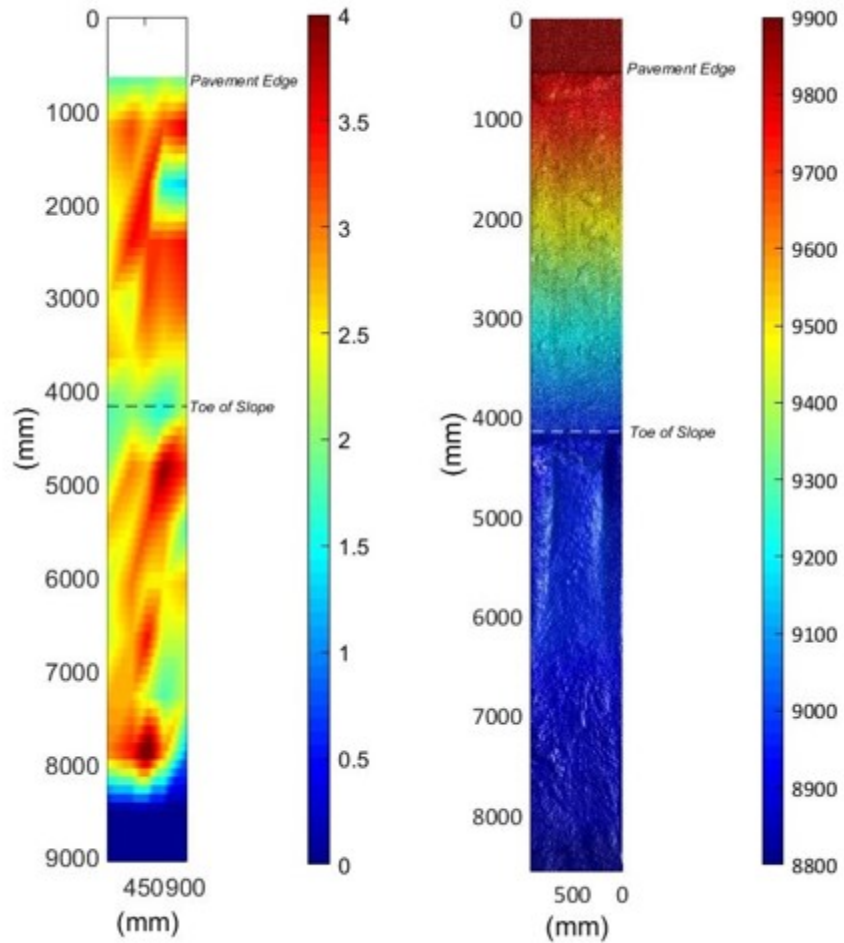
Figure 4.43. (Left). Aerial view of interpolated compaction data on slope. Compaction is presented in units of tons per square foot. (Right). Final bare soil scan showing areas of minor erosion.

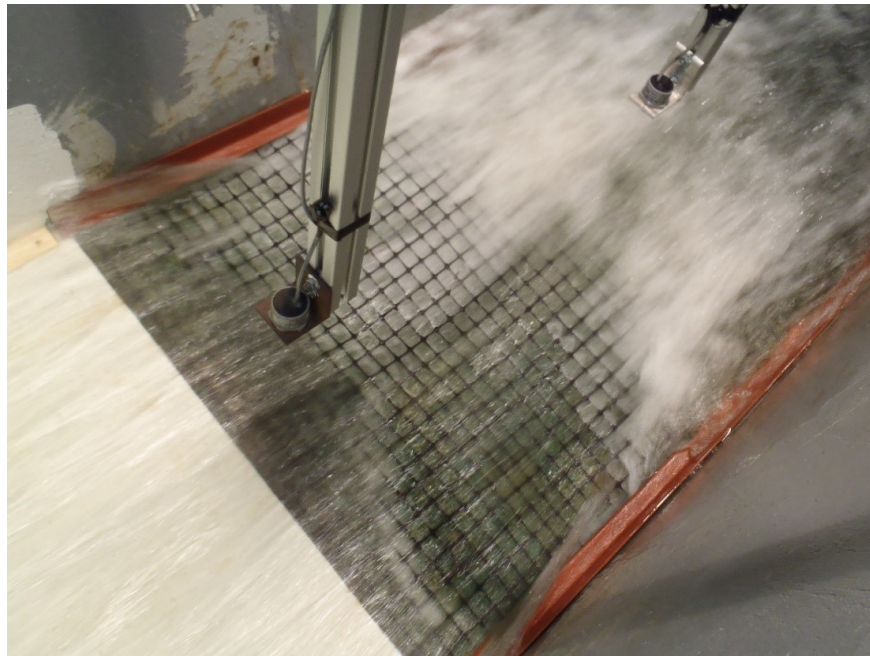
Similar to the 4H:1V “quick” test, the bulk of the erosion occurred near the top of the slope. The erosion and resulting mound extended across the width of the flume. Although the upstream eroded face was quite steep and the erosion was deep, the simulated paved edge was not undermined.

Figure 4.47. Looking downstream from shoulder near the end of the 4-6 hour run. Note the widespread area of erosion and flow separation from the shoulder hitting an angle where the deepest area of erosion is located.

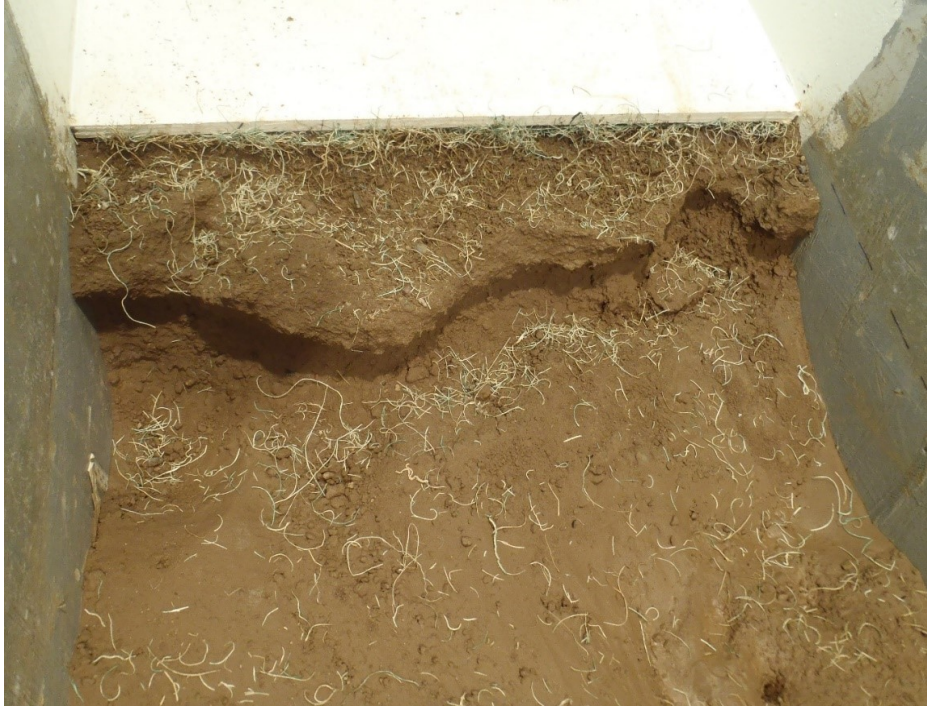
Figure 4.48. Looking upstream at shoulder and slope after stabilization material was removed. Note the remaining soil that was not undermined but close to it after 6 hours of run time.

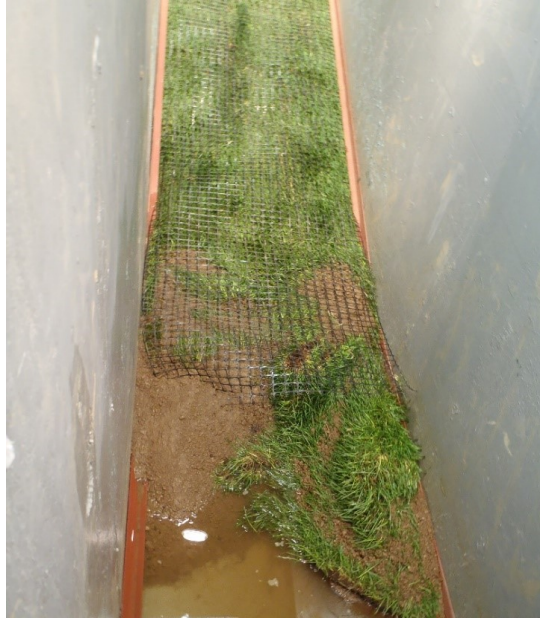
Although the sod did not root, it remained alive through the test and exhibited some growth. In this test, a progressive failure began at the flat run-out area and moved upstream. Sod pieces on the flat run-out area were washed away and soil was eroded to the floor. The soil beneath the sod at the toe of the slope was undermined, though the sod flexed to partly cover the eroding soil surface. Above the obvious eroded area, the soil was completely intact.

Figure 4.56. Looking upstream at toe of slope. Erosion beginning at toe of slope, undermining sod and washing some pieces away. Erosion working up the slope from run-out area.

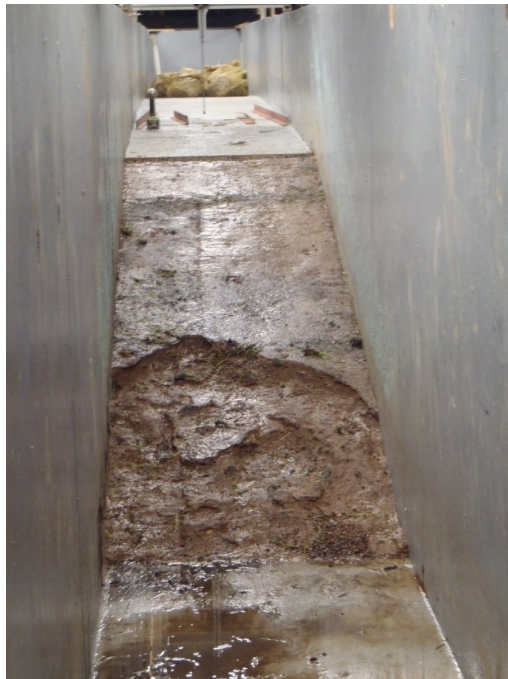
Figure 4.57. Looking upstream from run-out area. Stabilization material removed showing the extent of the erosion starting at the toe of the slope and working up towards the shoulder.

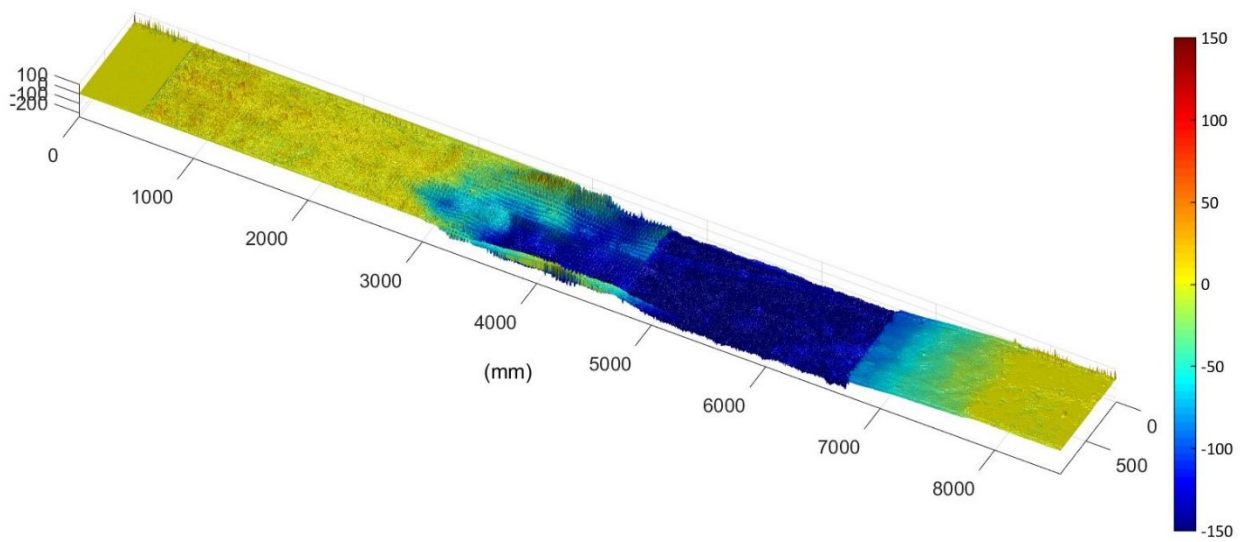
Figure 4.60. Topographic difference plot from zero to 4.5 hours of run time. Note the unchanged upper slope and erosion at the bottom of the slope.

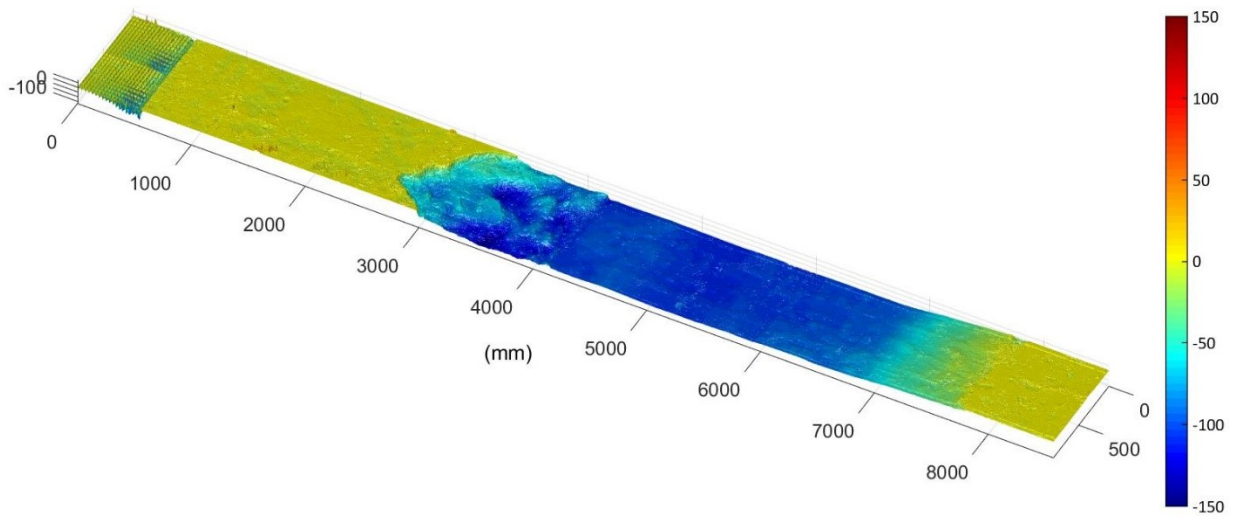
Figure 4.61. Topographic difference plot of initial bare soil vs. final bare soil after 4.5 hours of run time. Upper slope to approximately 2500mm downslope still intact.

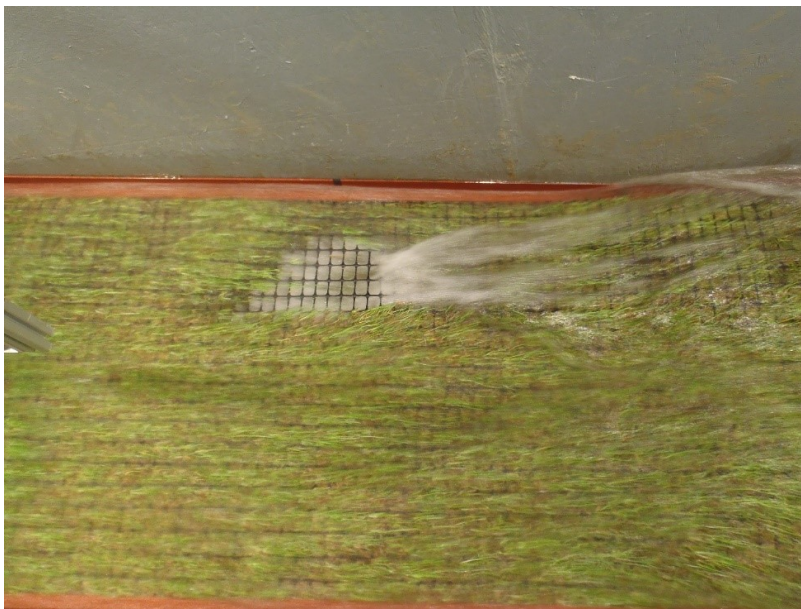
In contrast to the 4H:1V “quick” test, the slope first began to erode at a butt joint between sod pieces about halfway down the slope after more than two hours. This erosion was relatively localized until the flow step increase, when it expanded greatly. Similar to the 4H:1V “quick” test, soil eroded from beneath the sod before the sod washed away. At the end of the test a small section of sod near the top of the slope was still intact, as well as the soil beneath.

Figure 4.64. Aerial view of the slope just past halfway down the slope a large depression formed quickly at the seam of two pieces of sod just minutes before the end of the 2-4 hours testing time.

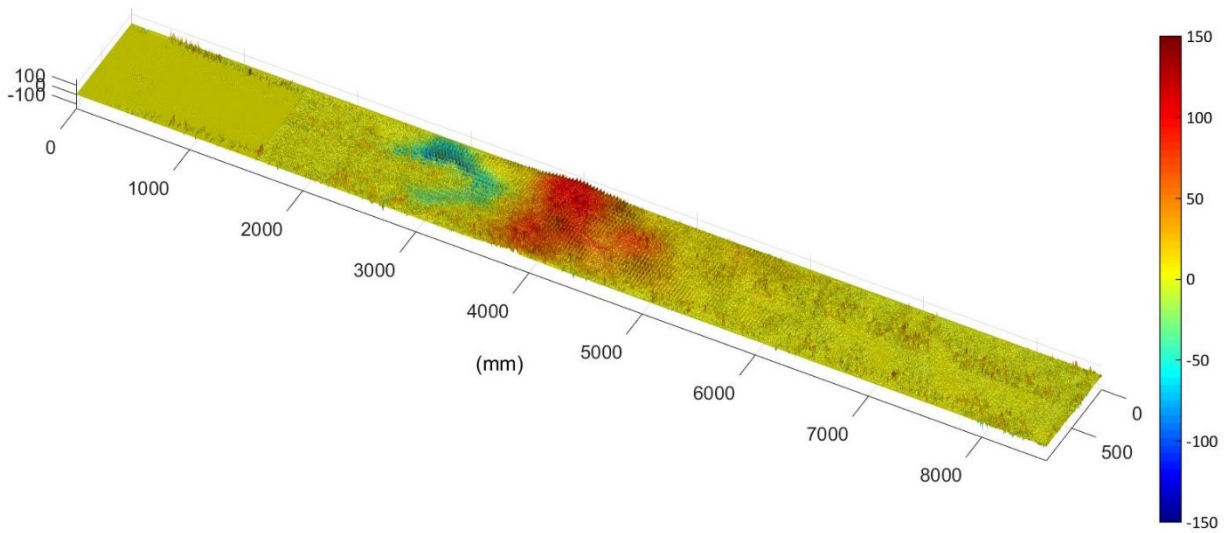
Figure 4.69. Topographic difference plot from zero to four hours of testing time. Note the large deposition at the toe of the slope and depression upslope of it.

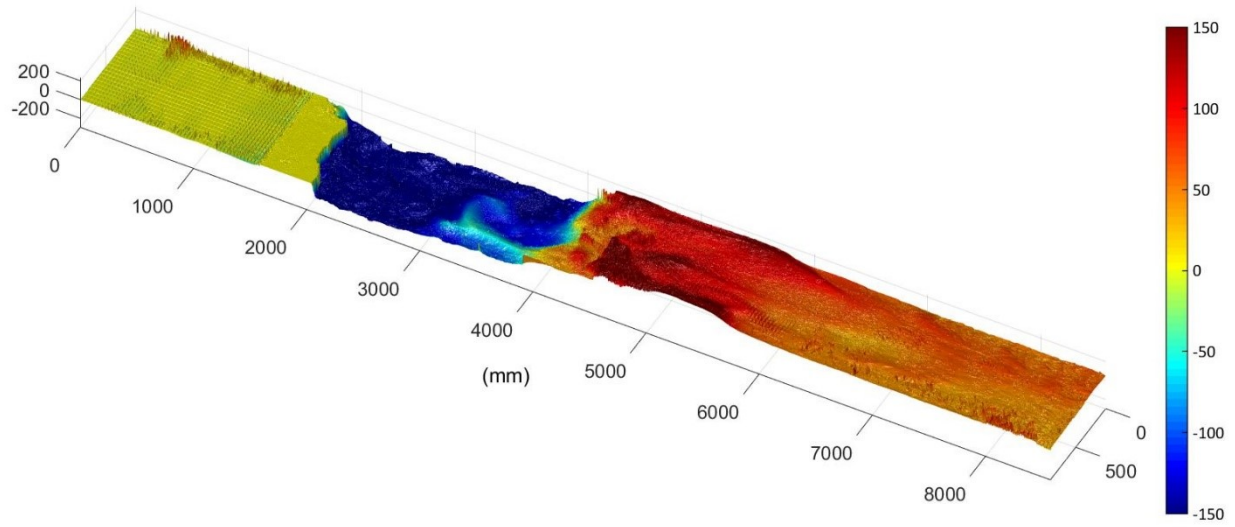
Figure 4.70. Topographic difference plot of initial bare soil vs. final bare soil after 9.5 hours of run time. The upstream slope is still intact. Note that the positive elevation on pavement section is the geogrid that has been flipped back over the surface.

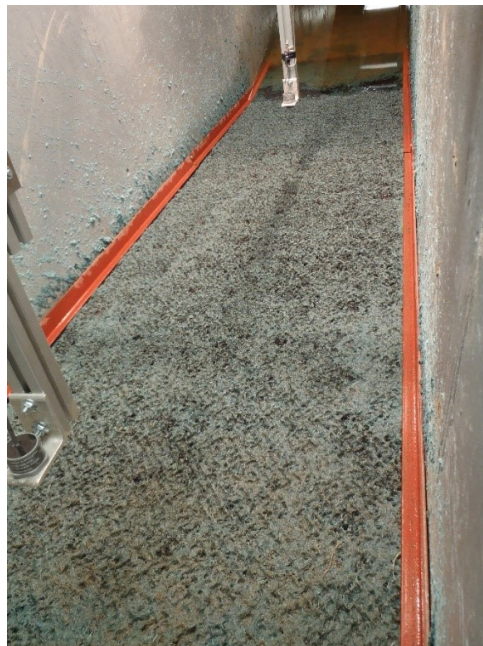
Figure 4.73. View from upstream after 1 hour of run time, note that some of the FRM has been washed away from the surface of the TRM.

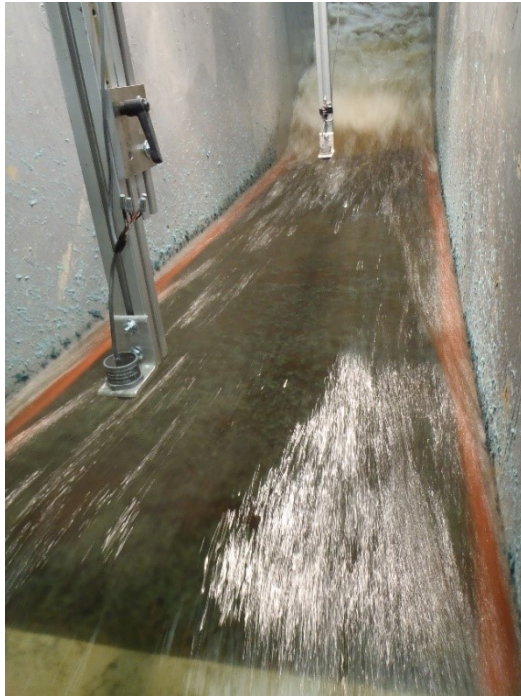
Figure 4.74. View from upstream during 2.5-3.0 hour run. Note that most of the FRM has been washed away at this point.

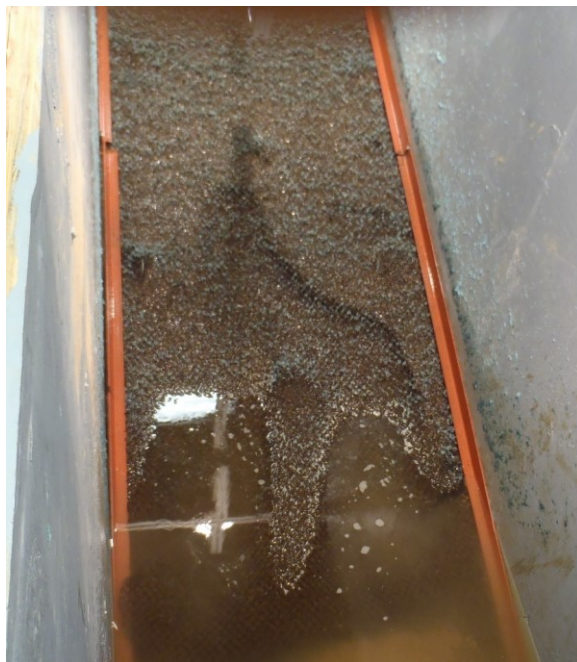
Although the FRM was fully integrated into the TRM it was progressively washed away exposing the TRM mat beneath. Erosion started in the lower third of the slope and slowly migrated upslope. Some soil was deposited beneath the TRM immediately upstream of toe of the slope. Other than several other isolated pockets of erosion the remainder of the slope was essentially free of erosion.

Figure 4.75. View from downstream after 3.5 hours of run time. Erosion working up the slope from the toe under the TRM.

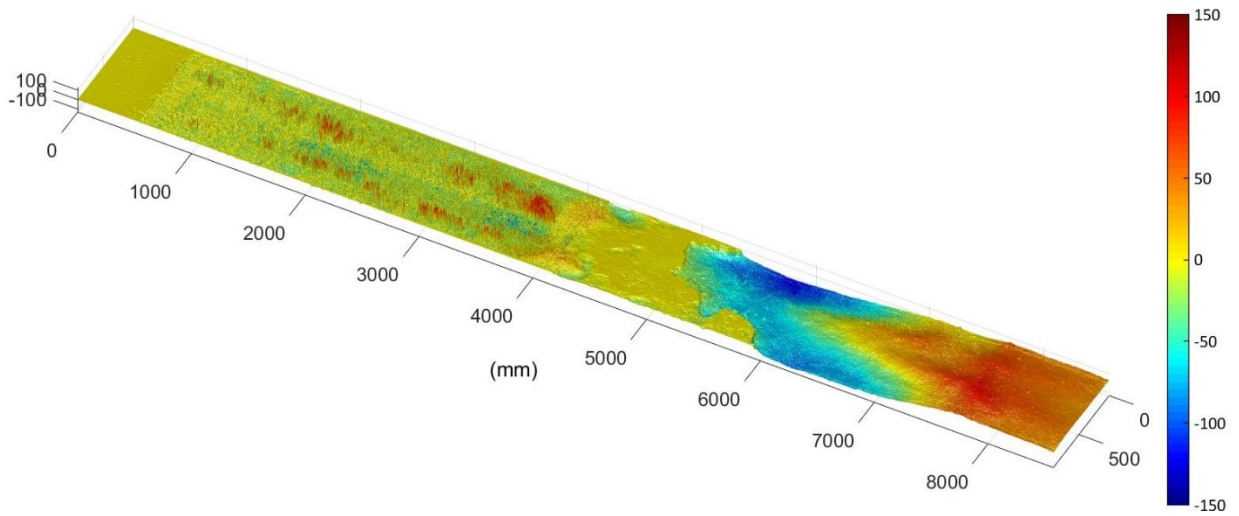
Figure 4.78. Topographic difference plot from zero to 2.5 hours of run time. Erosion and deposition occurring at the toe of the slope.

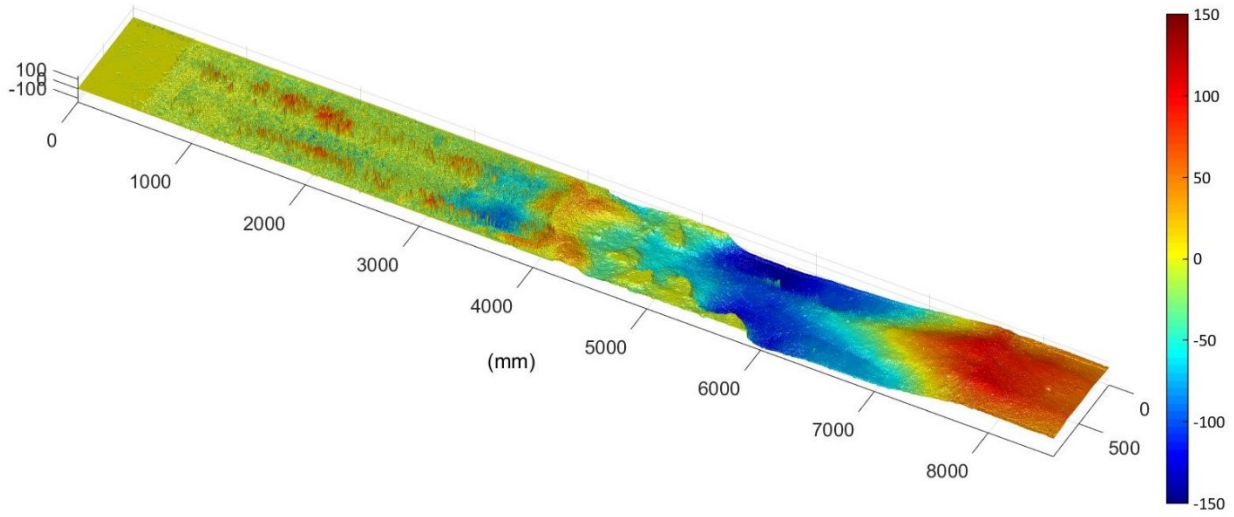
Figure 4.79. Topographic difference plot from zero to 3.5 hours of run time. Extensive erosion at the toe of the slope.
