Design Considerations for Embankment Protection During Road Overtopping Events

Jeffrey D. G. Marr, Principal Investigator

St. Anthony Falls Laboratory

Final Report 2017-21

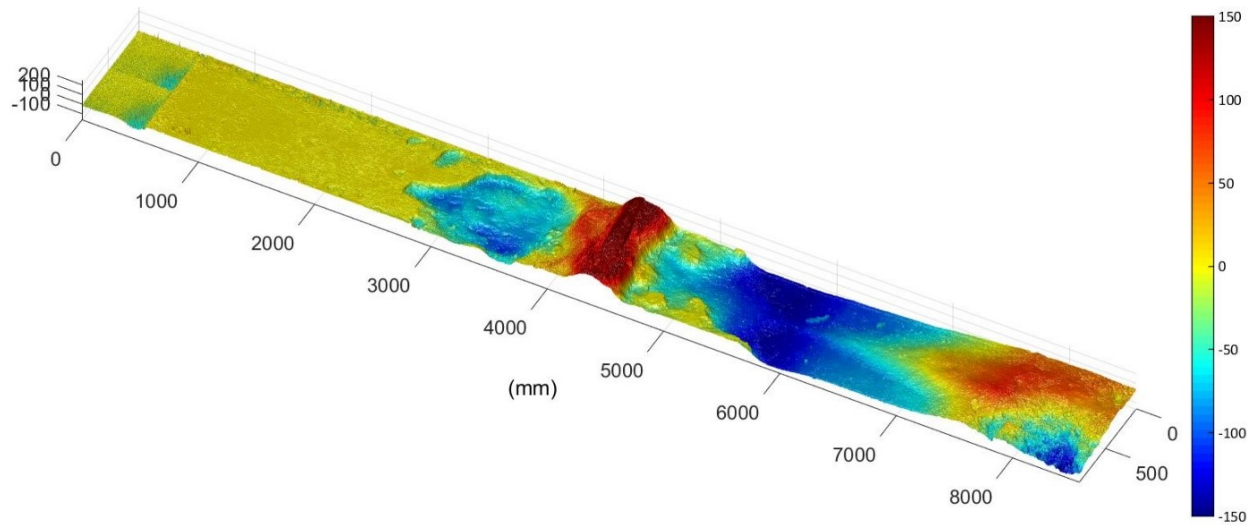
Figure 4.80. Topographic difference plot from initial bare soil vs. final bare soil after 3.5 hours of run time. Substantial erosion near the toe of the slope. The large depositional area at 4300 mm is the TRM after being flipped onto the flat run-out area.

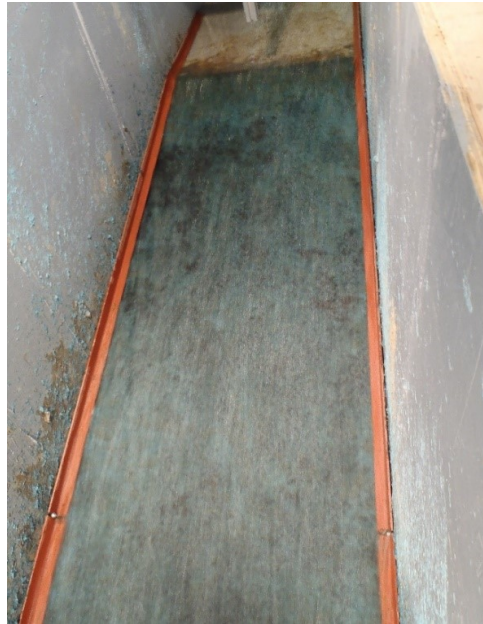
Figure 4.82. View from downstream during 0-2 hour run. Minimal erosion noticed. FRM is being washed away while TRM is remaining stapled to the slope.

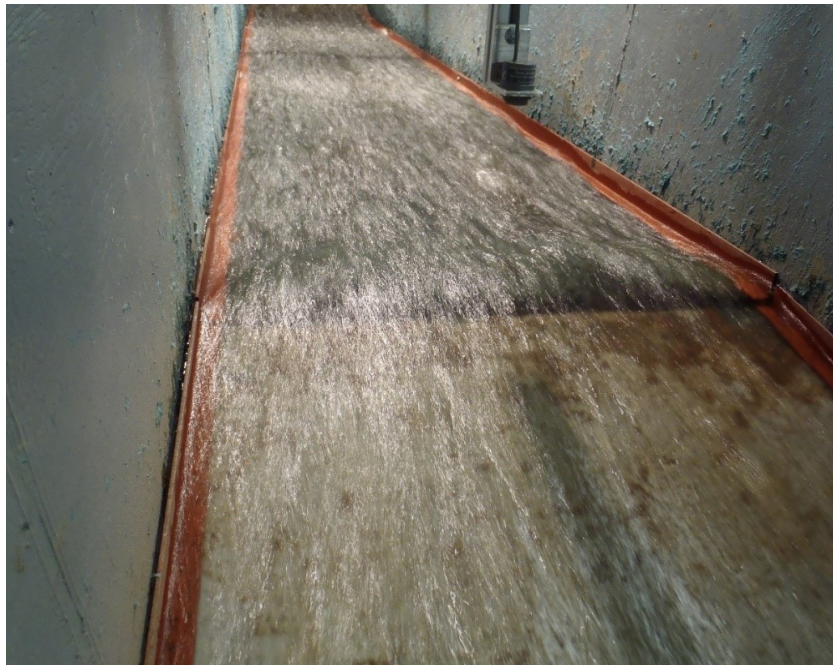
Within the first two hours a pocket of erosion formed adjacent to the edge of the shoulder. This area slowly grew larger and deeper in the following four runs, until a burst of erosion occurred 15 minutes into the fifth run. The erosion cut deeply along the right flume wall and would have continued to undermine the shoulder. Eroded particles became trapped in a series of small mounds between the deformed TRM and the soil surface where the TRM was anchored with wire staples.

Figure 4.83. View from upstream during 2-4 hour run. Noticeable depression after shoulder along right edge of slope. More of the FRM is being removed from testing.

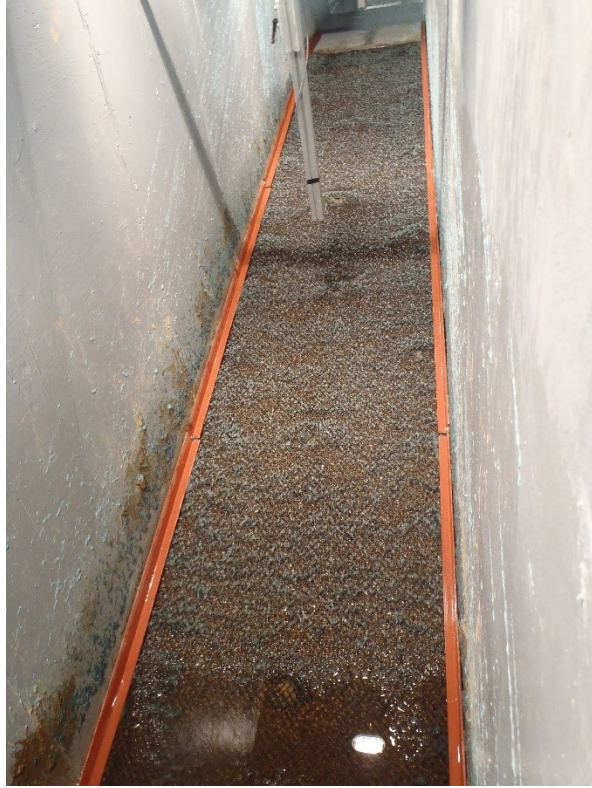
Figure 4.84. View looking upstream after six hours of run time. Almost all of the FRM has been washed away and the depression near the shoulder has gotten deeper.

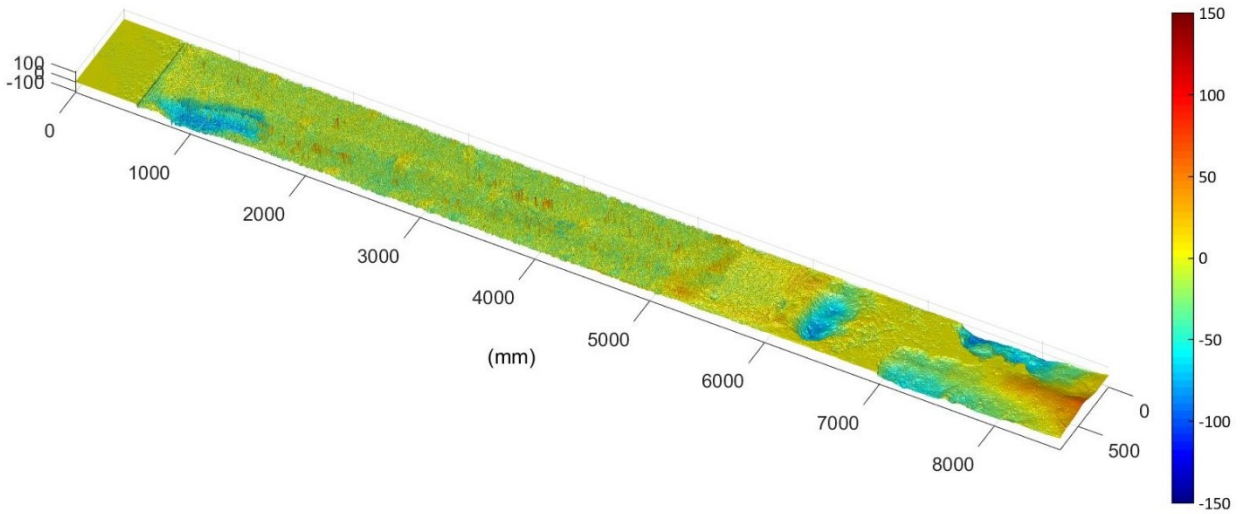
Figure 4.88. Topographic difference plot from zero to eight hours of run time. The start of erosion near the shoulder is detected.

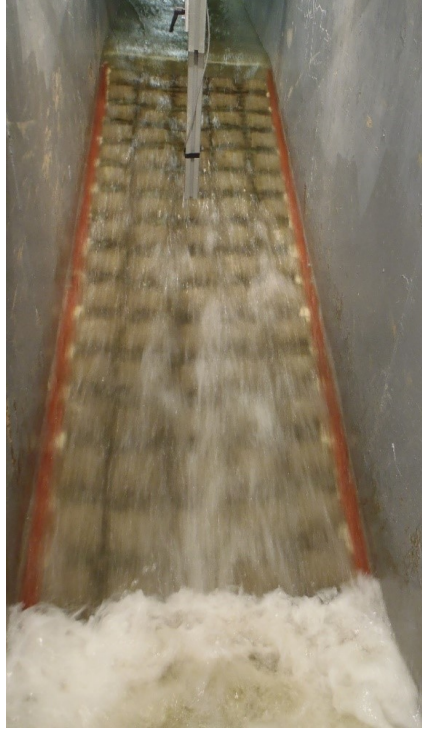
The first two runs, 0.4-inches and 3 inches of overtopping, resulted in only minor erosion. During the third run, a small scour hole and depositional mound became noticeable about 66% of the way down the slope. This void grew in size and at about 1.5 hours a second scour hole and depositional mound was observed downstream of the first. The experiment was then ended.

Figure 4.93. Looking upstream at slope near end of 1.5 hour run. Aeration near mid-slope and erosion/deposition areas stepping down the slope.

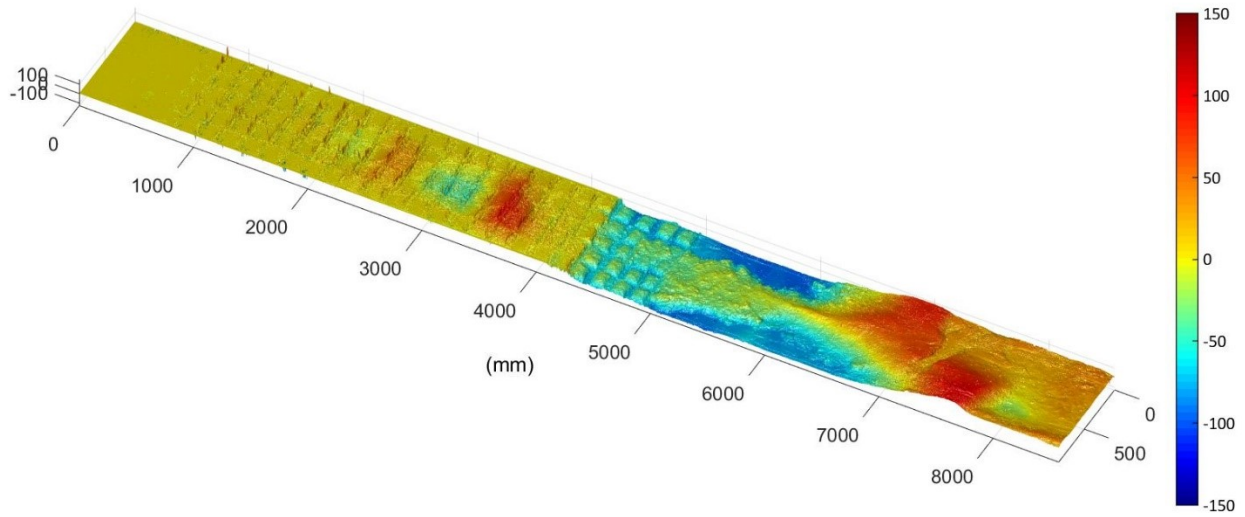
Figure 4.95. Topographic difference plot from zero to 1.5 hours of run time. Note the erosion in a stepped fashion with two depressions and two deposition areas in the middle of the flume.

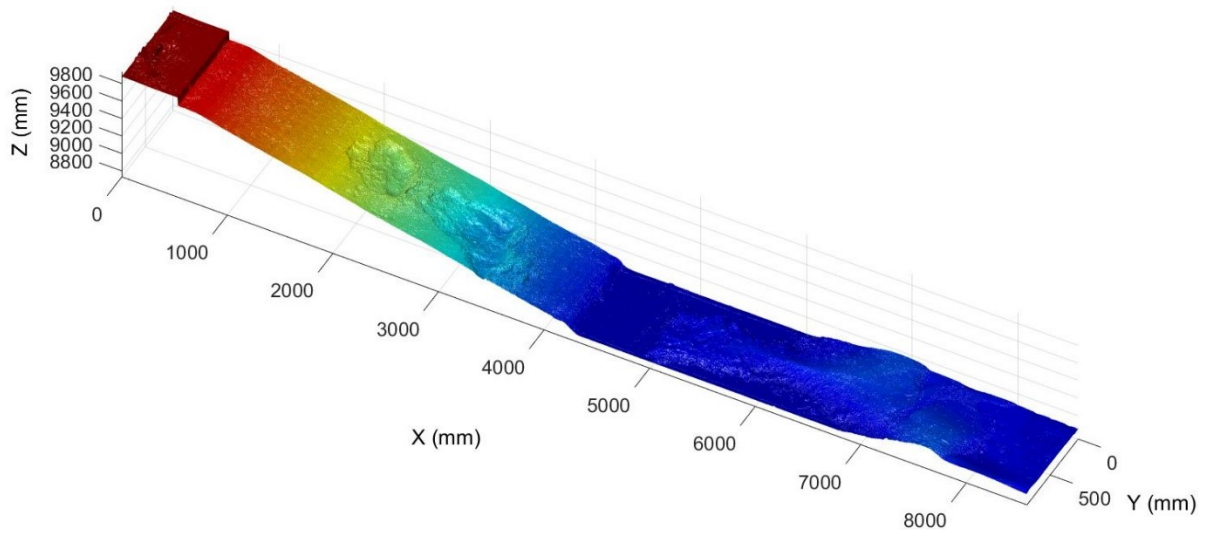
Figure 4.96. Scan of the final bare soil after the Flexamat[®] was removed. Two large depressions are shown here, similar to what is seen in the difference plot of zero vs 1.5 hours of run time, but more prevalent when seen without the Flexamat[®] covering it.

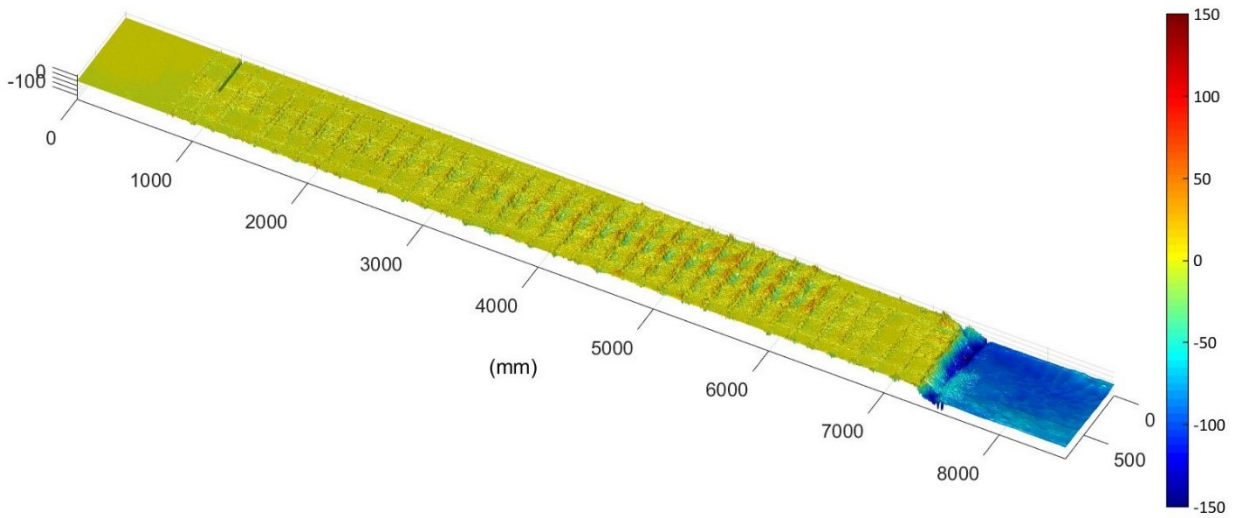
Figure 4.103. Topographic difference plot from zero to 30 hours of run time. Apparent differences shown are due to concrete blocks shifting downslope of their original resting place.

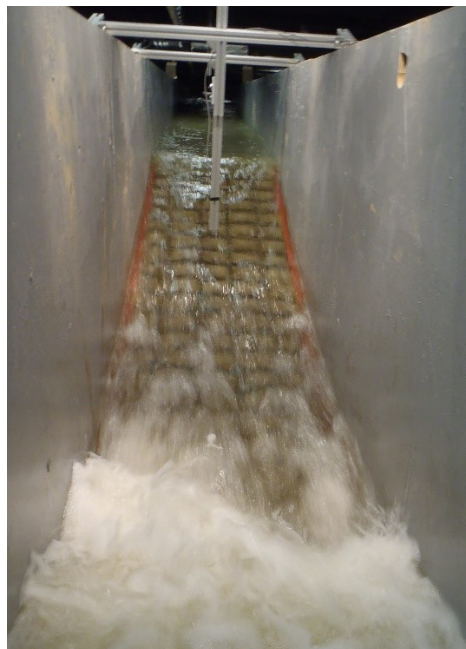
As with previous tests with this technique, the water surface is very turbulent and aerated during low flow state (Figure 4.106). It is not clear if this hydraulic condition initiates the erosion process. The topographic scan data showed erosion forming mid-slope after 4 hours of run time and fairly low discharge. The run was continued for 25.3 hours total and discharge was increased. During this period, the extent and depth of erosion continued under the mat. The mat did not wash out but was held in place however soil was able to erode and wash away from underneath the mat. The erosion scour and deposition was observed to translate downslope during the test.

Figure 4.106. View from downstream looking up at slope during 24.35 to 25.33 hour run. Mid-slope mound has been eroded and flat upper slope has stabilized and new mound at toe of slope is causing aeration.

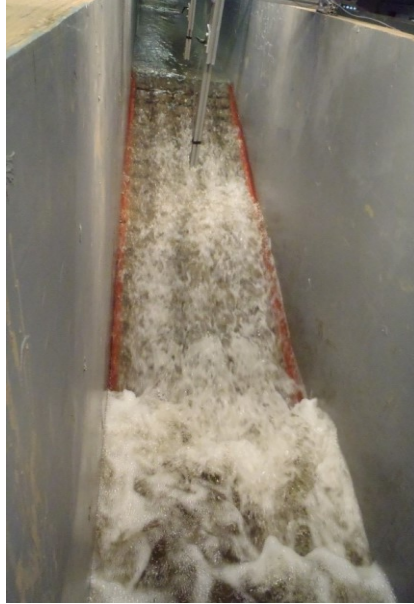
Figure 4.107. View from downstream looking up at slope during 4-6 hour run. Note the depression and subsequent aggradation at mid-slope causing aeration.

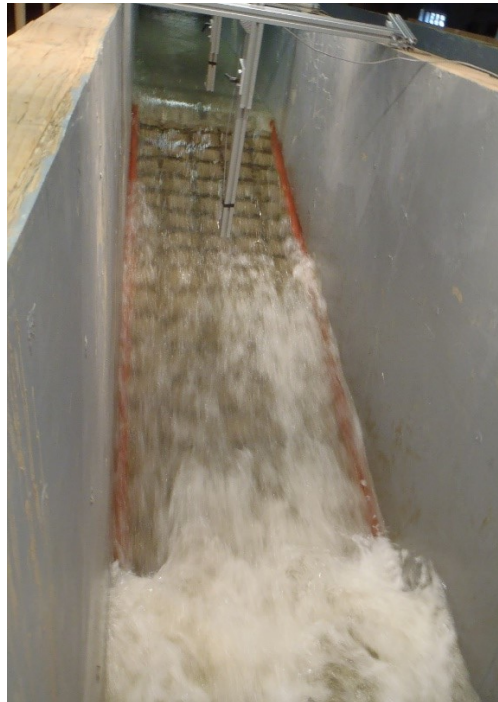
Figure 4.108. View from downstream looking up at slope during 17.25-20.25 hour run. The slope did not drastically change over 10 hours of run time from the first sign of erosion.

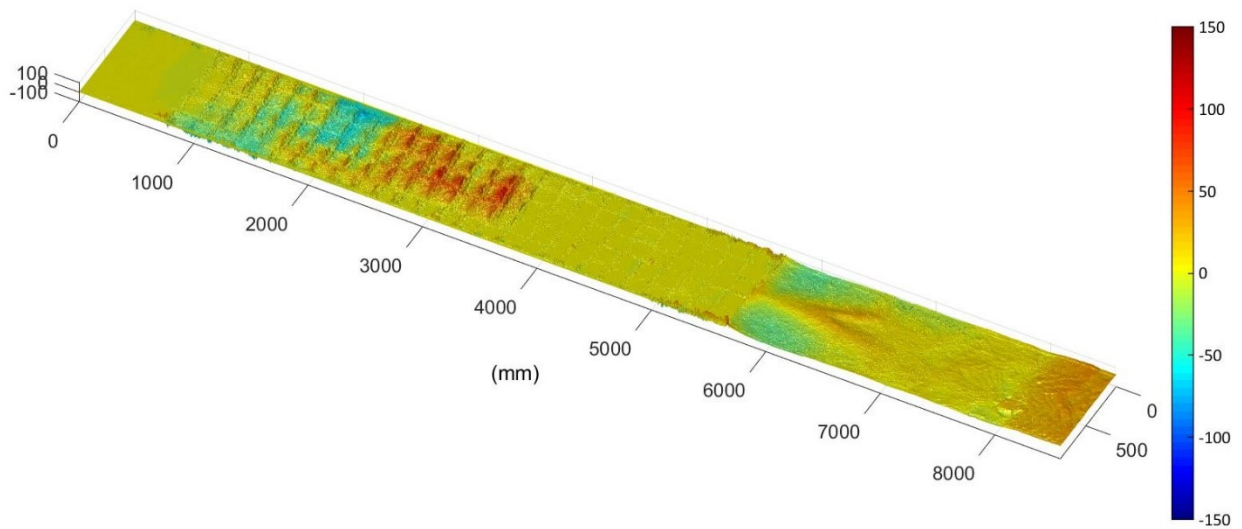
Erosion was first detected in the topographic elevation data after four hours of run time. Each time the flow rate increased, interesting sequences of erosion followed by periods of stabilization characterized the test. The distinct erosion events propagated downstream starting at mid-slope and translating down to the toe of the slope over 25 hours of run time.

Figure 4.111. Topographic difference plot from zero to four hours of run time. This increments saw a measurable change in slope elevation with a depression at mid-slope and aggradation immediately after.

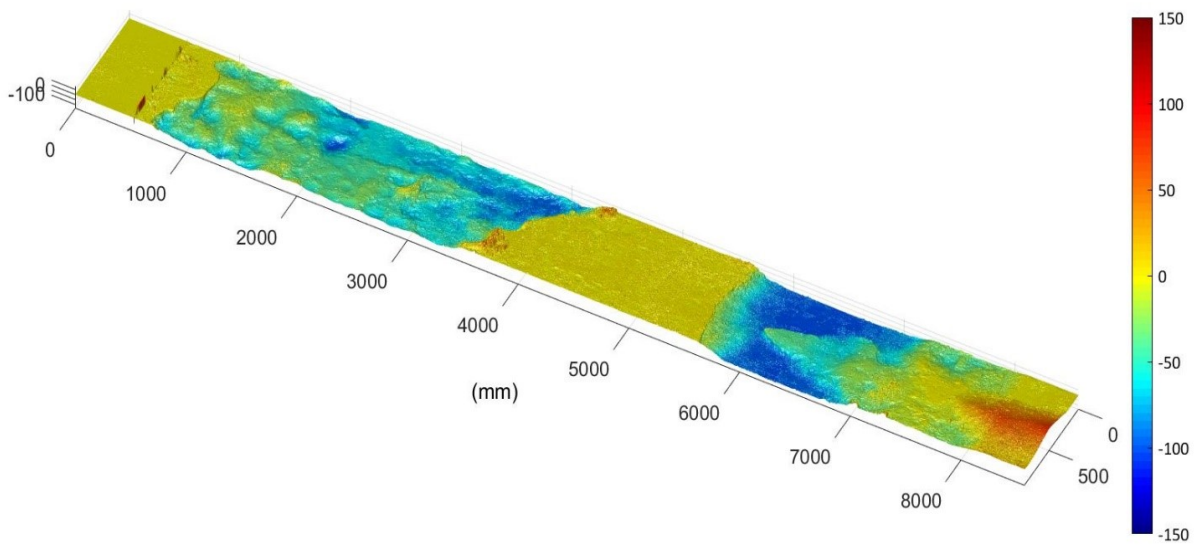
Figure 4.113. Topographic difference plot from initial bare soil vs. final bare soil after 25.33 hours of run time. Note the similarity to the previous figure in the location of the depression and the intact portion of the soil near the shoulder-slope transition.

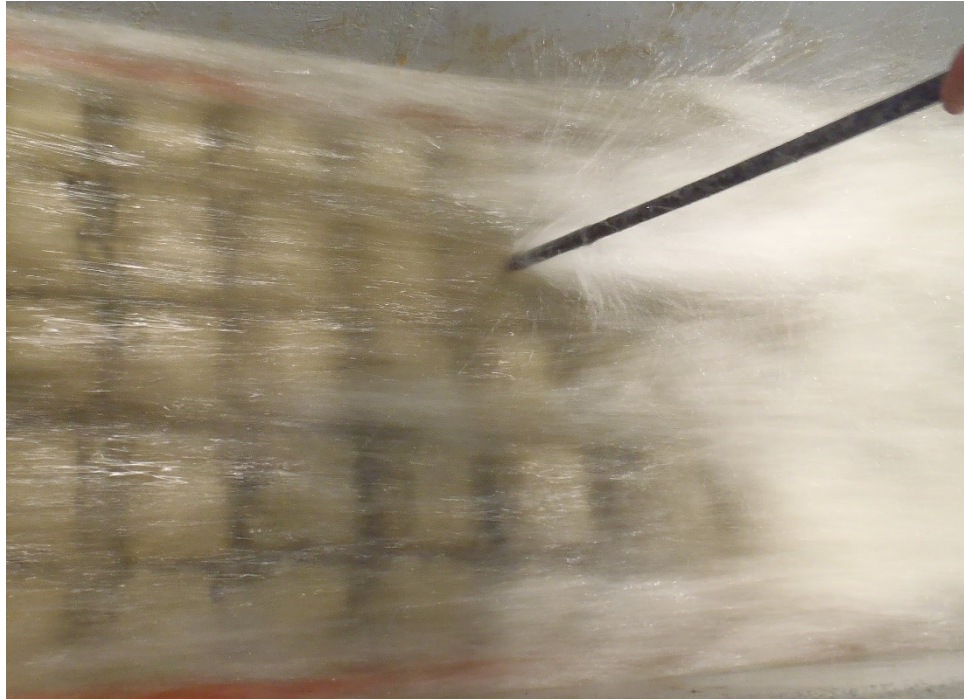
A similar lack of contact event occurred on the second 4H:1V test of the flexible concrete geogrid mat (Figure 6.2). The concrete mat separated from the slope surface despite the weight of the concrete block grid. There were no staples fastening the flexible concrete geogrid mat because it was assumed that the weight of the material would hold it against the slope surface. At a high flow of 0.72-ft over the crest, the velocity was fast enough to create uplift and the soil beneath was exposed and eroded near the toe of the slope.

Figure 6.2. Flexible concrete geogrid mat tested on the 4H:1V slope at 9.90 ft³/s and approximately 25 hours of run time. Concrete blocks may be pushed down with a probe rod 3-4 inches before touching the slope surface $\frac{3}{4}$ of the way down the slope.

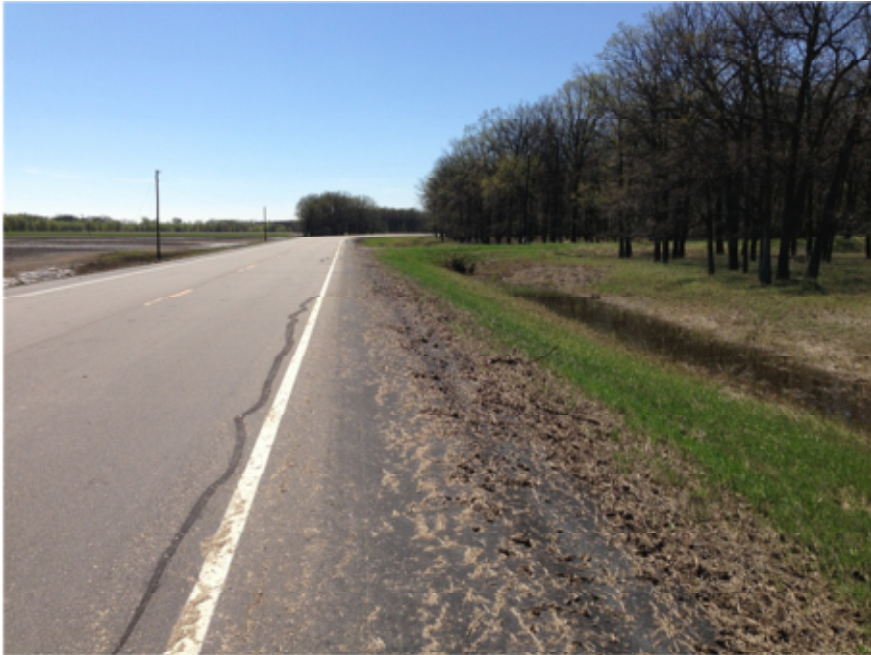
The site was inspected for damage once the flood water receded. Figures 6 and 7 show the site condition on May 23, 2013. There was no significant erosion noted.

UPSTREAM LOOKING WEST

UPSTREAM LOOKING EAST

Figure 6. Inspection – May 23, 2013 at the Marshall County Site

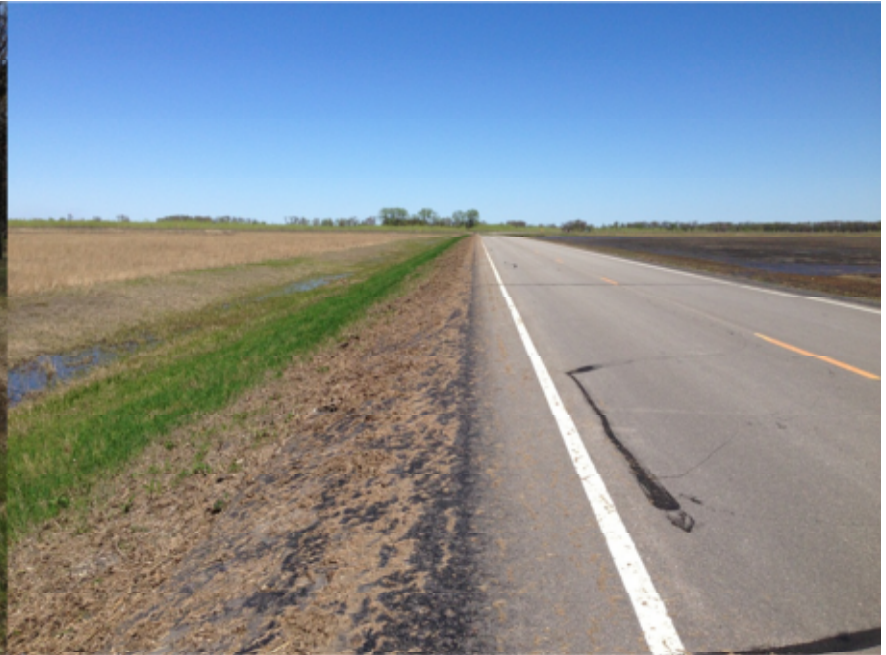
DOWNSTREAM LOOKING WEST

DOWNSTREAM LOOKING EAST

Figure 7. Inspection – May 23, 2013 at the Marshall County Site

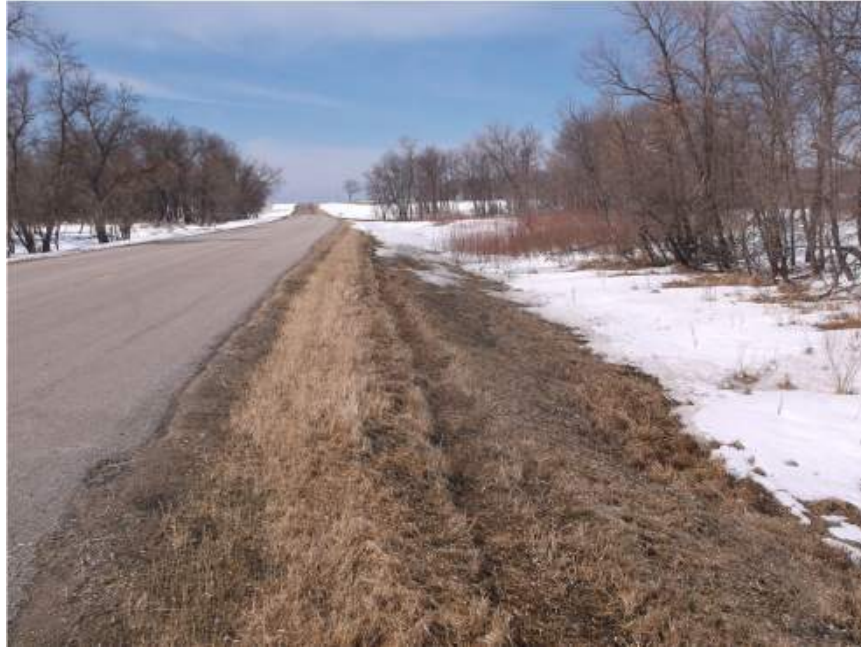
Existing Shoulder Conditions in Kittson County
