Comprehensive Field Evaluation of Asphalt Patching Methods and Development of Simple Decision Trees and a Best Practices Manual

Department of Civil Engineering
University of Minnesota Duluth

June 2017

Research Project
Final Report 2017-25

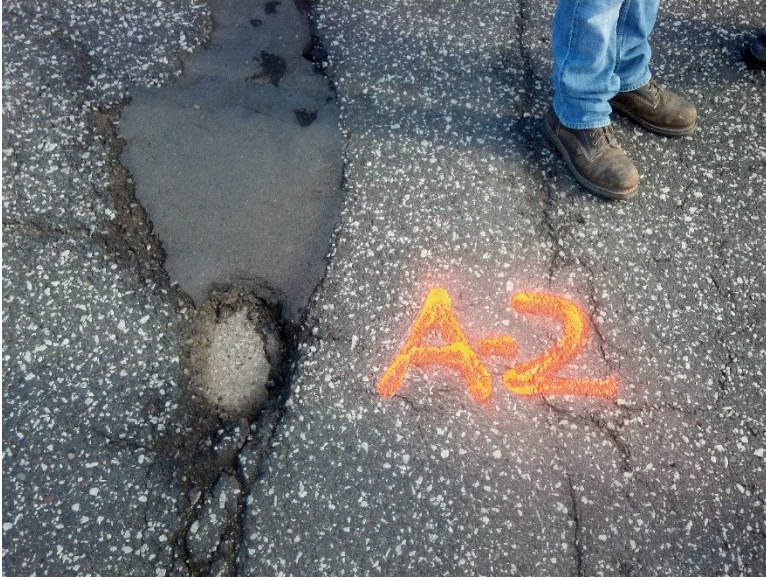
Figure 3.2 Pothole A-2 prior to Patching (After Cleaning).

Pothole A-2: This pothole was located in the non-wheel path of the driving lane. The pothole lies along a large transverse crack with the north face of the pothole being a previously placed patch material as shown in Figure 3.2. The pothole was prepped by sweeping. The size of the pothole was 13 inches x 9 inches x 2 inches.

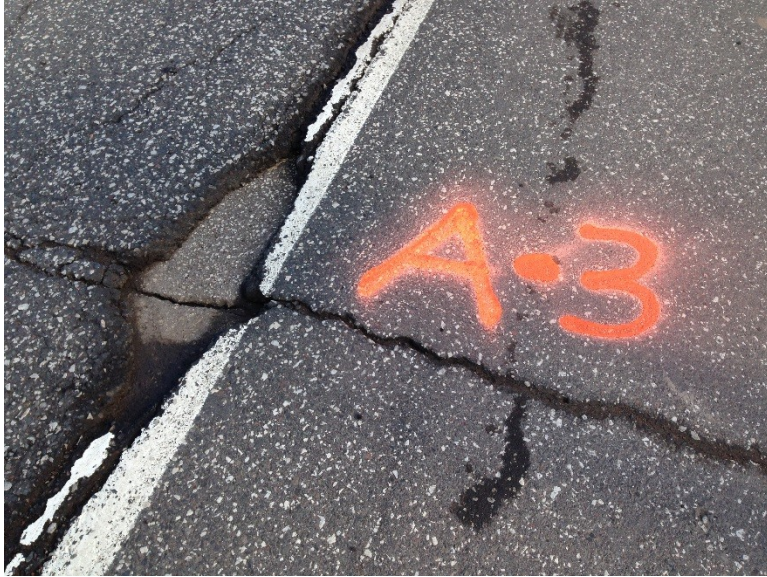
Figure 3.3 Pothole A-3 prior to Patching (After Cleaning).

Pothole A-3: This pothole was located along the shoulder joint. The pothole lies along an existing longitudinal crack in the overlay with a reflective transverse crack crossing through the pothole as shown in Figure 3.3. The pothole was prepped using compressed air. The size of the pothole was 37 inches x 13 inches x 2 inches.

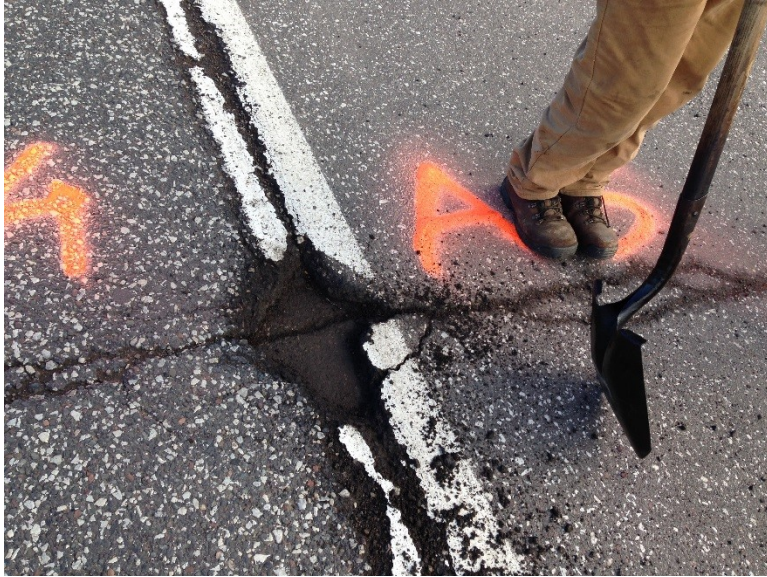
Figure 3.5 Pothole A-5 prior to Patching (After Cleaning).

Pothole A-5: This pothole was located along the shoulder joint. The pothole lies along an existing longitudinal crack in the overlay with a reflective transverse crack crossing through the pothole as shown in Figure 3.5. The pothole was prepped using compressed air. The size of the pothole was 17.5 inches x 13 inches x 1.5 inches.

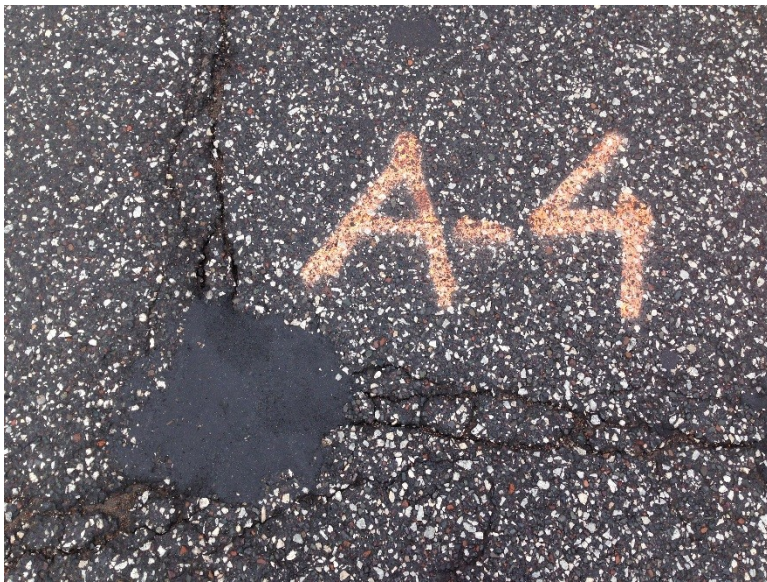
Figure 3.21 Image used for A-4 Retention Calculation (4/29/14).

Pothole A-4: Two different site visit dates were used to calculate the retention of material. The dates of comparison are April 29, 2014 (Figure 3.21) and July 9, 2014 (Figure 3.22). During that 71 day time span, the patch lost was approximately 13% of its surface area. The material lost was mostly extra patch material overlaying the existing road. The entire pothole was still patched and protected from moisture.

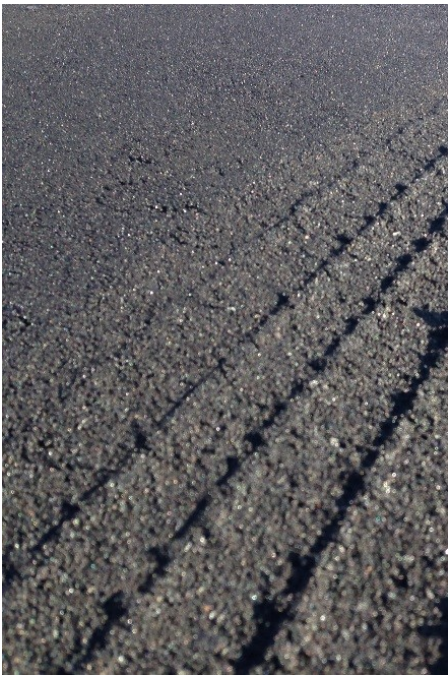
Figure 3.33 Settlement (Dishing) of Pothole B-2 an Hour after Compaction.

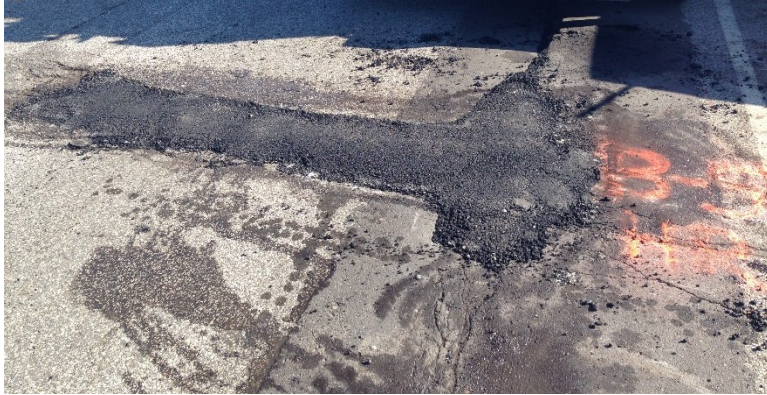
Figure 3.34 Pothole B-5 after Patching.

It may be stated that unlike the site A, all potholes were milled using a skid steer and cleaned using compressed air. Potholes B-1 through B-4 were patched using cold mix with a mix temperature of 50°F. Potholes B-5 and B-6 were patched using hot recycled asphalt. The material was 100% recycled millings from a previous project. The millings were heated to 295°F using the Stepp SRM 10-120 machine. While heating an additional 1.5 gallons of asphalt binder was added to the pug mill per 1,000 pounds of millings. Once the patches were placed they were tamped using a single plate compactor. After compaction, the potholes were flush with the roadway. Figure 3.31 to Figure 3.35 show some photographs of patched potholes. It may be stated that within the first hour, several of the potholes had settled below the roadway surface. Pothole B-2 (Figure 3.33) was about ½ inch below the roadway surface within an hour. It takes fifteen to twenty minutes to complete a pothole from milling to compaction. The patch material placed in pothole B-6 (Figure 3.35) was the first mix to come out of the SRM 10-120 hopper. It cooled more rapidly than the mix placed in B-5 (Figure 3.34) and appeared to be drier.

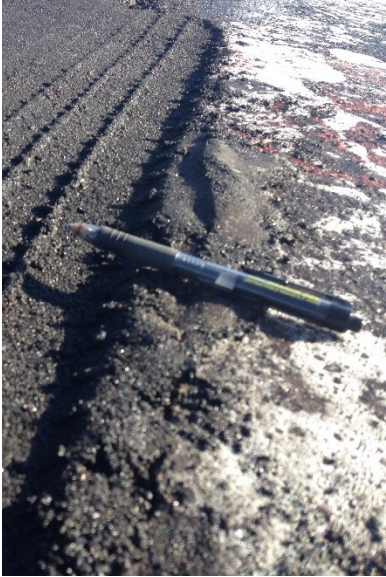
The cold mix patches at Site-B performed similar to Site-A. One difference at this site was the existence of significant dishing. After compaction, the potholes were flush with the roadway, however within the first hour several of the potholes had settled below the roadway surface. The depressed material is along the right edge of the crack. Pothole B-2 which suffered the most dishing was about ½ inch below the roadway surface within an hour (Figure 3.38).

The reason for this depression was due to the depth of the patch filled. Cold mix has a small aggregate size paired with a slow curing asphalt binder. These two factors prevent the patch material from forming a stiff structure. When the pothole depth is too large, like Pothole B-2, the patch material cannot support itself. This did not occur at Site-A, because all potholes had a depth less than two inches. Dishing is common in these patches along the edges due to the inability for hand compactor machinery to properly compact along the interface. The compactor rests on the existing roadway during the compaction process preventing a complete compaction along the patch interface. Over time this area compresses under self-weight and creates the dished area shown in Figure 3.38 through Figure 3.41. After three days the patches appeared to reach their steady state compaction level. Minimal material was lost after those three days.

Figure 3.38 Settlement (Dishing) of Pothole B-2 an Hour after Compaction.

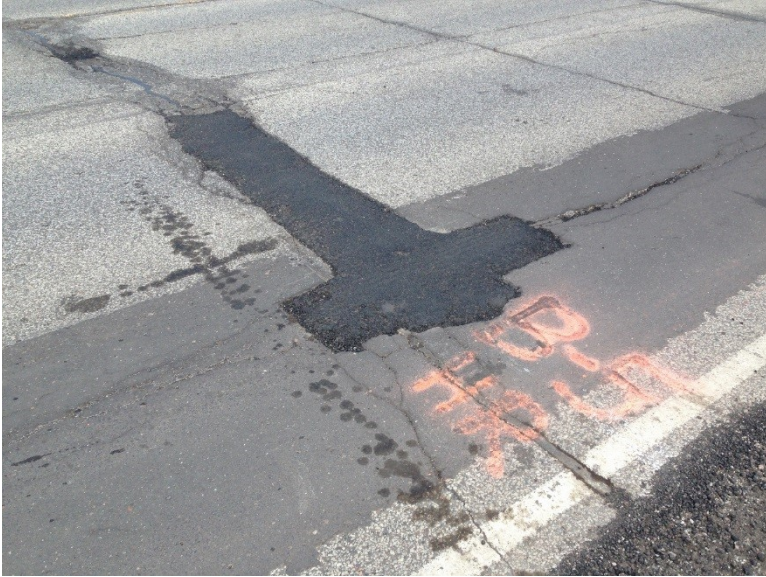
The placement of patch material actually facilitated further damage to the roadway. The damage occurring appears similar to pumping action that is common with concrete panels. As traffic loads travel across the patch area there is not an efficient load transfer causing vertical movement of the patch material. This movement ejects water and fine material from underneath the patch and abrades the adjacent roadway. Comparing Figure 3.43 and Figure 3.44 illustrates that damage to the roadway in Patch B-5. Figure 3.47 provides a close view of this deterioration in Patch B-6.

Figure 3.43 Pothole B-5 (3 Days after Patching).

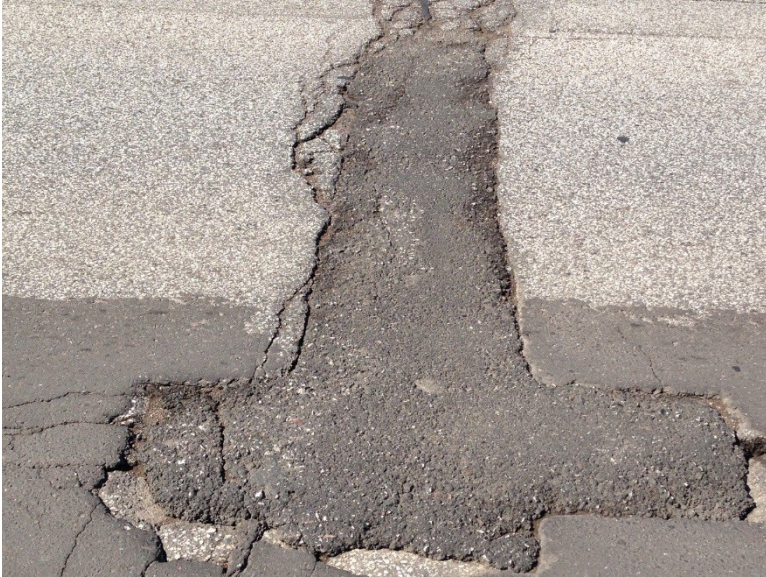
Figure 3.44 Pothole B-5 (146 Days after Patching).

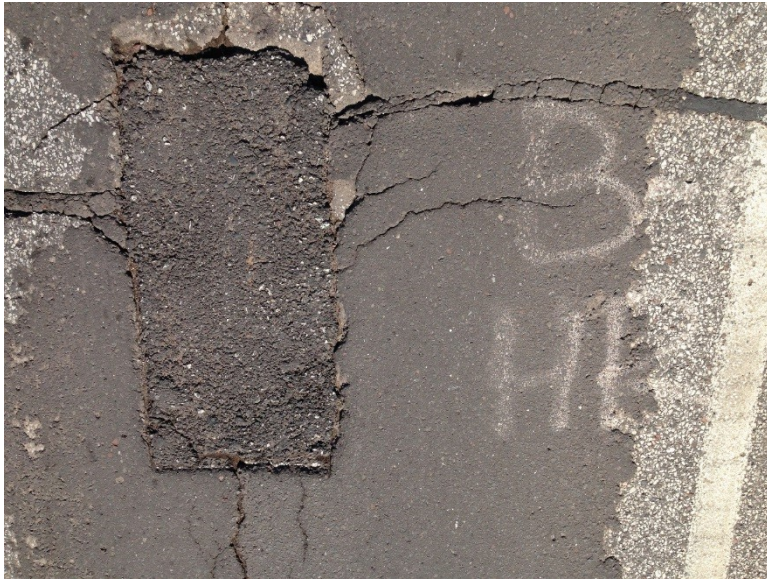
Figure 3.47 Pothole B-6 (146 Days after Patching).

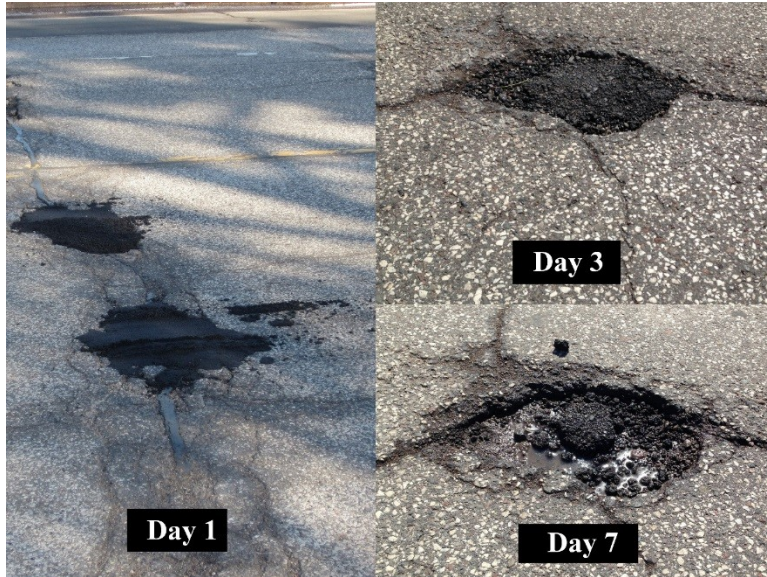
The importance of compaction is shown below in Figure 3.48. Extra hot recycled material was placed in smaller potholes in the wheel path. The potholes were not prepped before patching material was placed, and the material was only compacted under live traffic. As shown in Figure 3.48, the material was removed from the pothole after seven days. This serves as evidence that proper pothole preparation and patching material compaction can be the difference between a successful patch and a waste of resources. The last site visit conducted on December 4, 2014 (237 days after installation) showed that patches were affected by the first few uses of snow plows in the winter months.

Figure 3.48 Uncompacted Hot Recycled Material in Wheel Path.

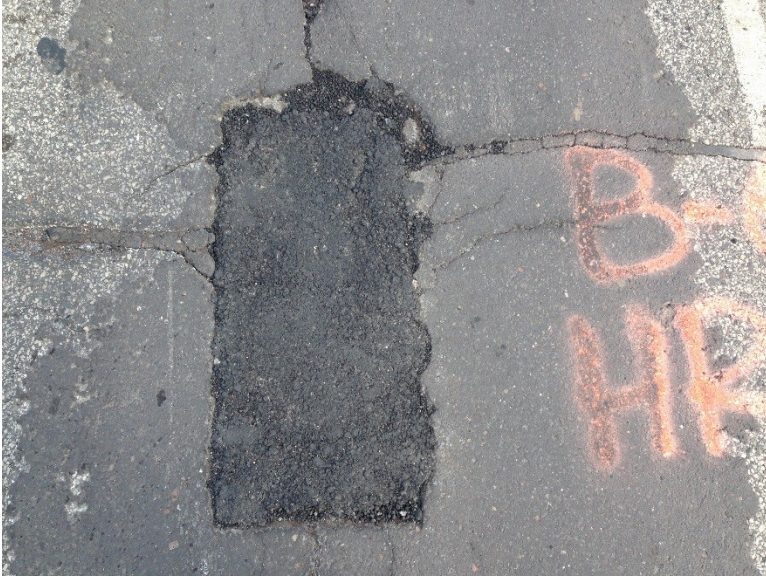
Two different site visit dates were used to calculate the retention of hot recycler material. The dates of comparison are April 14, 2014 (Figure 3.49) and July 9, 2014 (Figure 3.50). Unlike the two cold mix patches from Site-A, this patch lost a significant amount of material over time. The dry material previously discussed broke down over time and was removed from the pothole area. During this time (86 days) 19% of the patch material was lost. This percent only accounts for the material lost around the edge of the patch. The figures show that some material was also lost due to surface raveling.

Figure 3.49 Image Used for B-6 Retention Calculation (4/14/14).

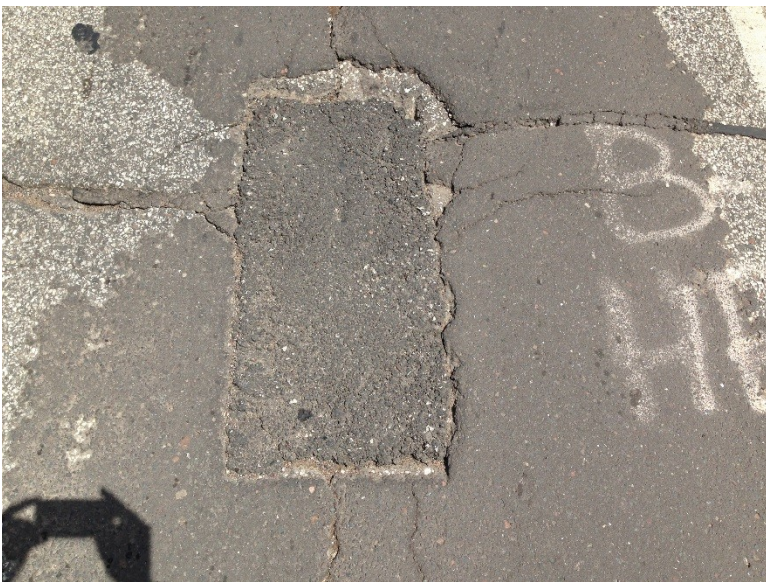
Figure 3.50 Image Used for B-6 Retention Calculation (7/9/14).

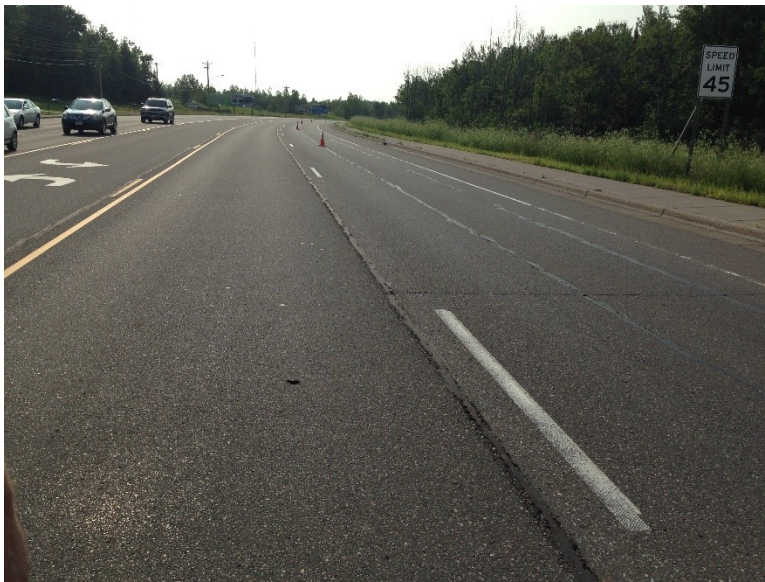
This roadway was distressed along the longitudinal joint (near centerline). The joint was a continuous crack with an average width of three inches. The crack was filled with sealer and raveling was present along the crack edges. Three locations (designated as D-1 through D-3) along the longitudinal crack were chosen to monitor the performance of hot mix asphalt patching materials.

Figure 3.55 Longitudinal Crack along Trinity Road.

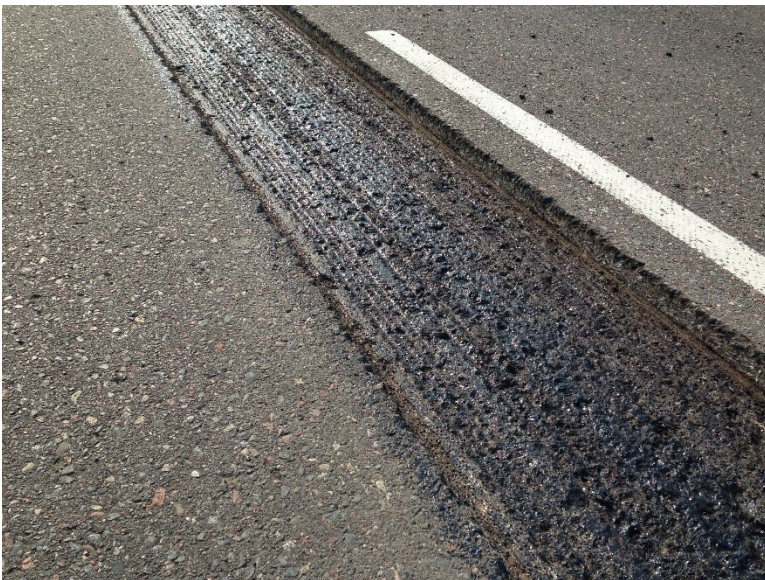
Figure 3.57 Milled Trench.

As shown in Figure 3.57 and Figure 3.58, one issue with the mill and fill operation in Site D was the tacking process used: (i) insufficient amounts of tack was applied to the milled trench and (ii) trucks placing HMA needed to place the truck's wheels into the trench in order to line up where the HMA was discharged. This led to the dirt and debris from truck wheels into the trench which covered some of the tack. Also tack stuck to the truck wheels at many locations further reduced the amount of effective tack. Without a sufficient tack coating, a strong bond at the interface of the patch will not occur, leading to possible delamination or freeze-thaw damage due to water infiltration. Figure 3.63 through Figure 3.65 provide three photographs of the patched locations taken 35 days after the installation of the patching. The patch interface at that time is shown below in Figure 3.66. Improper compaction may also lead to dished areas where hydroplaning and icy surfaces can occur.

- Complete coverage of the patch area with an approved tack material is recommended.
- When the HMA delivery vehicle drives directly in the milled area, debris from the tires covers the tack material rendering it non-functional. This should be avoided if at all possible.
- Compaction should be as thorough as possible to ensure patch longevity. Vibratory steel rollers should be employed to achieve this.

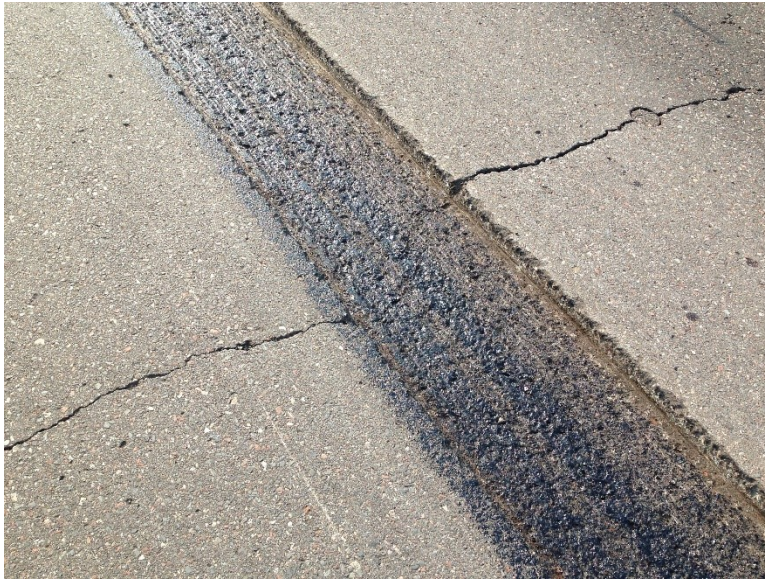
Pothole D-3: This pothole was located in the non-wheel path of the passing lane. The pothole lies along a large longitudinal crack with a transverse crack running through the middle of the pothole area. The pothole was prepped with a milling machine. The size of the milled pothole was 108 inches x 20 inches x 2 inches. The fill was placed and compacted well. The location before milling can be seen in Figure 3.55 and Figure 3.56.

Figure 3.58 Milled Trench with Transverse Crack (Pothole D-3 Location).

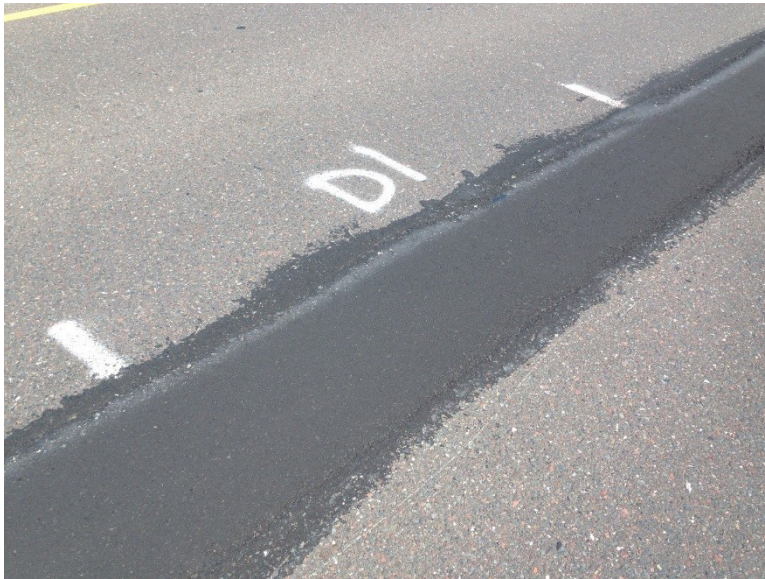
Figure 3.63 Pothole D-1 (35 Days after Patching).

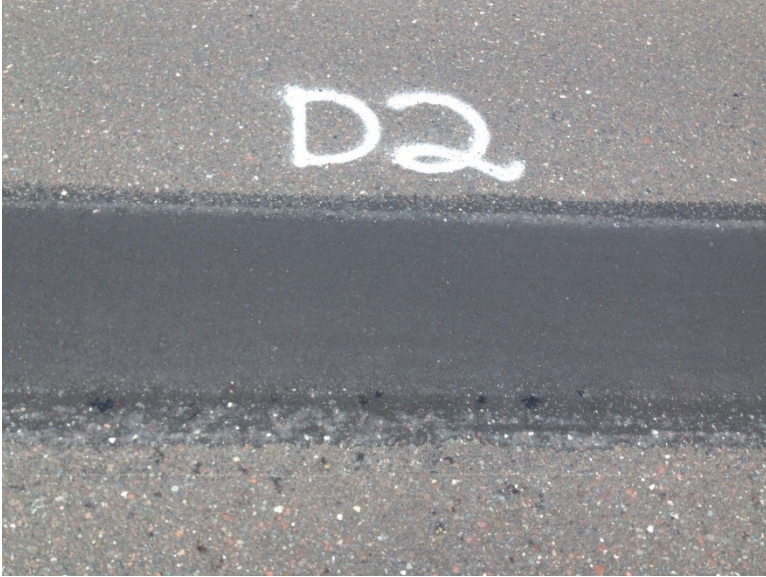
Figure 3.64 Pothole D-2 (35 Days after Patching).

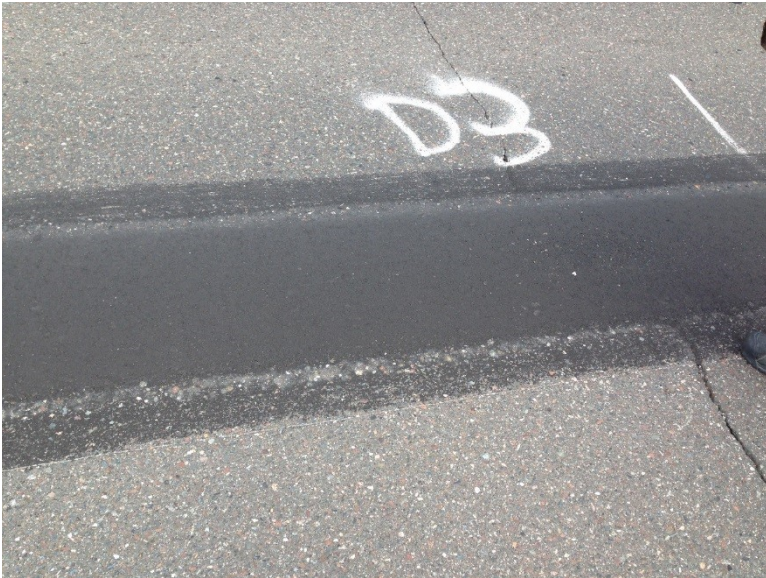
Figure 3.65 Pothole D-3 (35 Days after Patching).

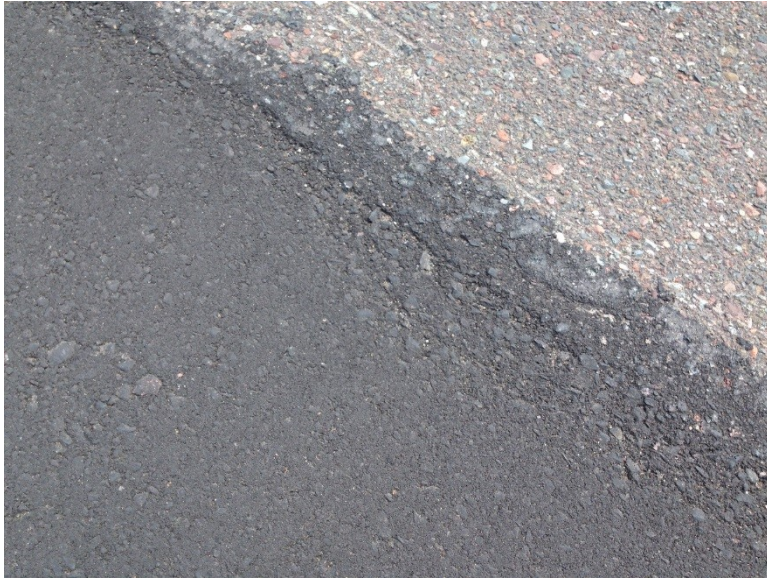
Figure 3.66 Patch Interface (35 Days after Patching).

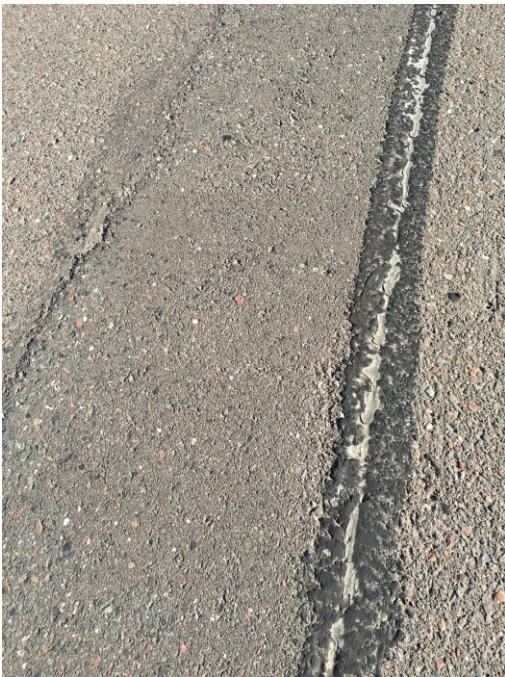
Site visits conducted on July 29, 2015 and October 20, 2015 revealed that severity of the raveling did not increase in second year of service. See Figure 3.69 and Figure 3.70. It was also discovered that the cracks that had propagated through and along the edges of the patches had been sealed sometime during the summer of 2015 (Figure 3.70 and Figure 3.71). This probably helped in arresting the raveling in the year two.

Figure 3.70 Pothole D-2 (426 Days after Patching).

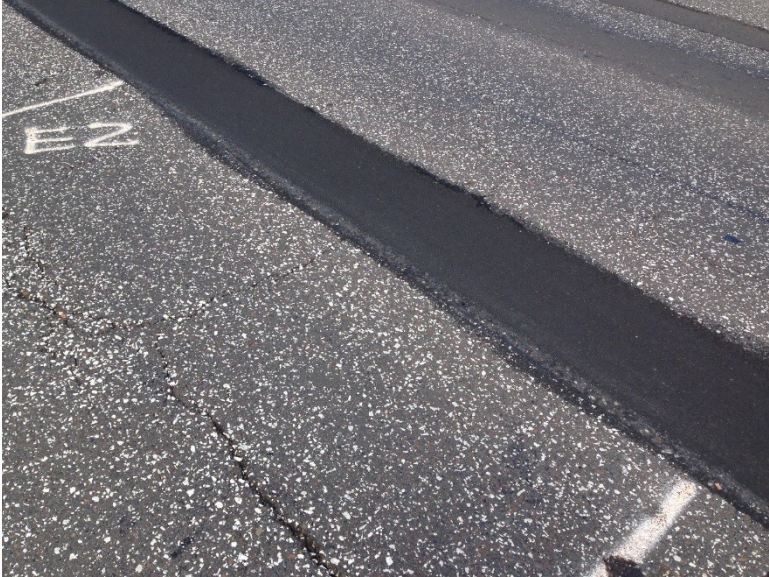
Figure 3.78 through Figure 3.85 provide a visual of how HMA mill and fill patches aged over time at Site E. This site illustrated the importance of proper patching method identification as well as the need for quality workmanship during the patching process. At this site, it was common to see longitudinal cracks parallel to the patch (Figure 3.81 and Figure 3.83). For patch work to be successful, it is imperative that maintenance is performed with quality workmanship. An example of poor workmanship is shown in Figure 3.80 where proper compaction was not applied near the edge of the patch. A final site visit for

Figure 3.78 Pothole E-2 (28 Days after Patching).

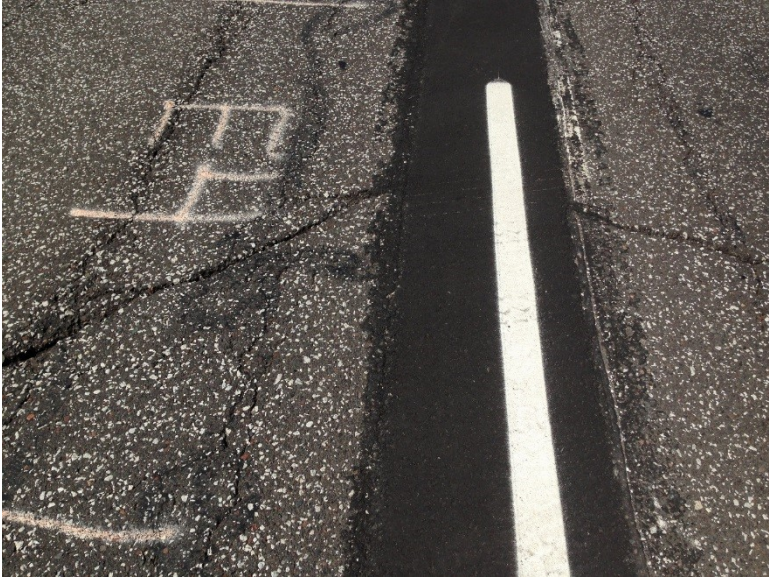
Figure 3.79 Pothole E-4 (28 Days after Patching).

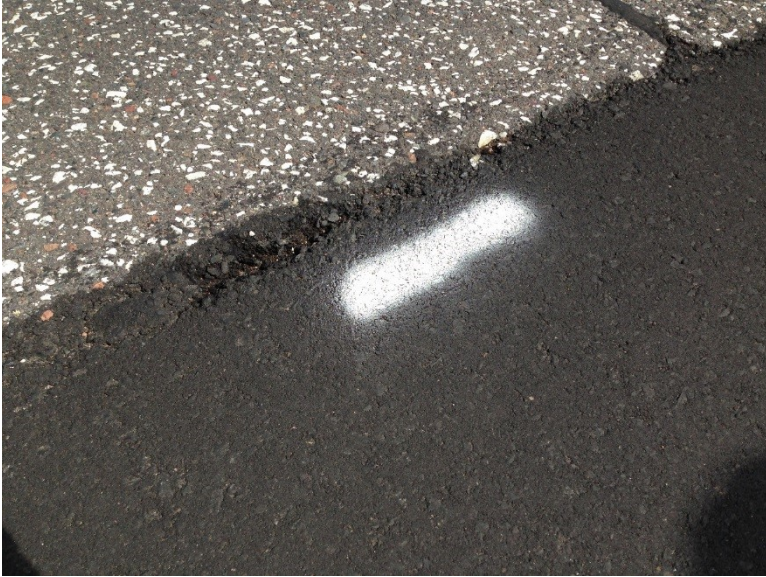
Figure 3.80 Poorly Compacted Interface (28 Days after Patching).

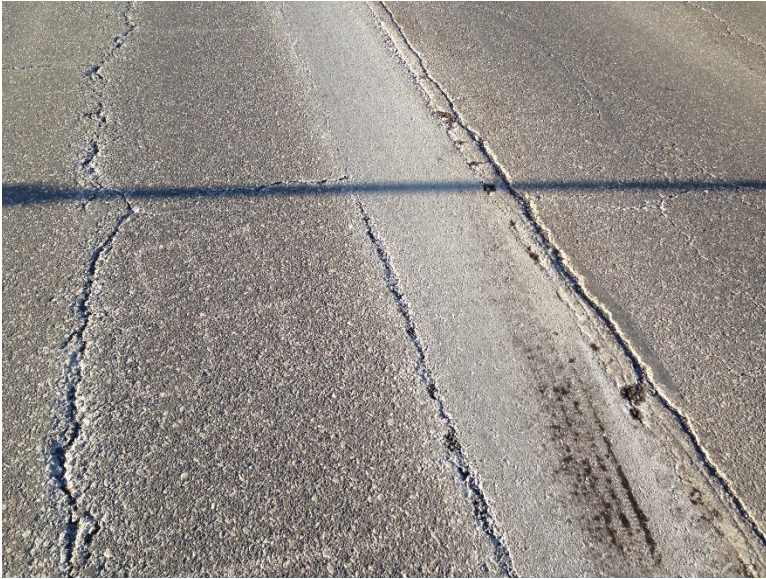
the year was made on December 4, 2014. Figure 3.82 to Figure 3.85 show that a significant amount of damage had occurred to the patch material including cracks and raveling along the patch interface.

Figure 3.84 Pothole E-5 (119 Days after Installation).

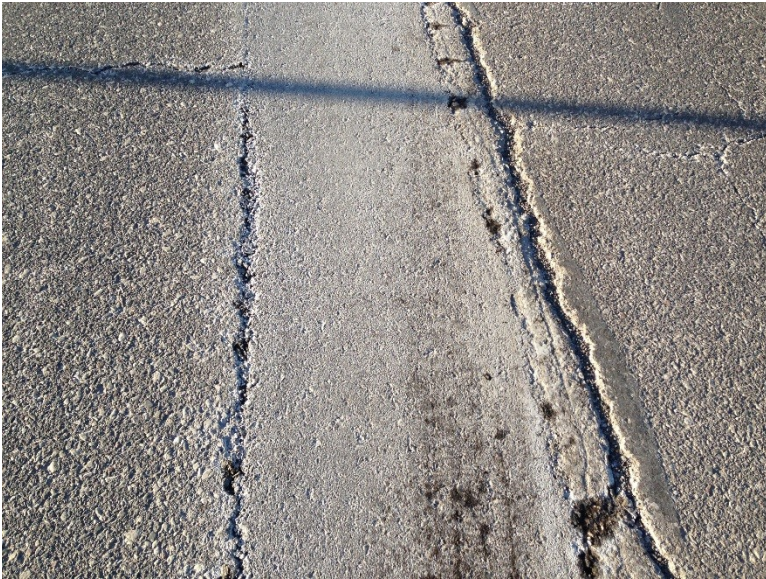
Figure 3.85 Close View of Distresses on Pothole E-5 (119 Days after Installation).

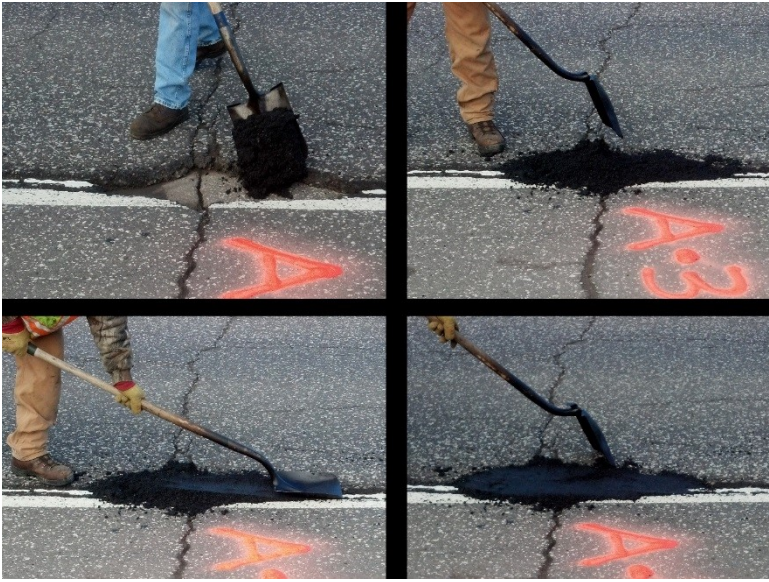
Figure B5: Cold Mix Placement and Compaction Using Only a Shovel.

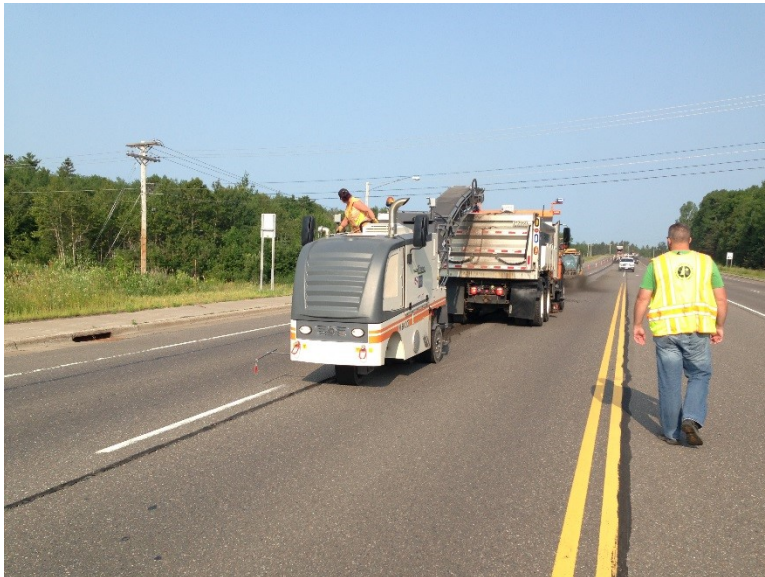
Figure B9: Mill and Fill Step 1.

Step 1: Milling machine mills out Trench along distressed area.

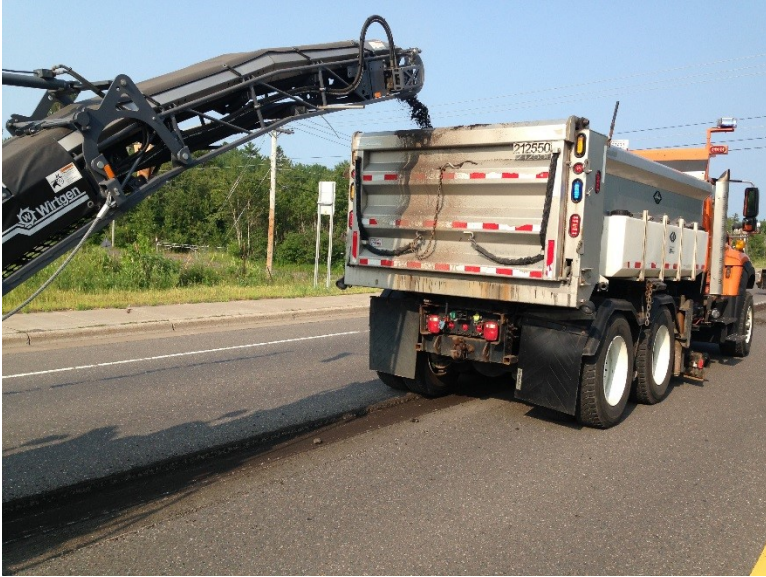
Figure B10: Milled Material is placed in a Truck to be Hauled Away.

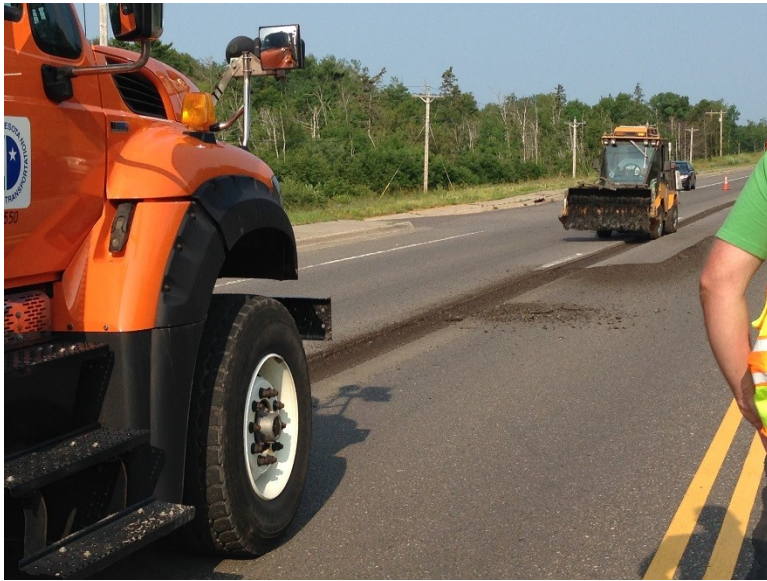
Figure B11: Mill and Fill Step 2.

Step 2: Trench is swept clean of remaining debris.

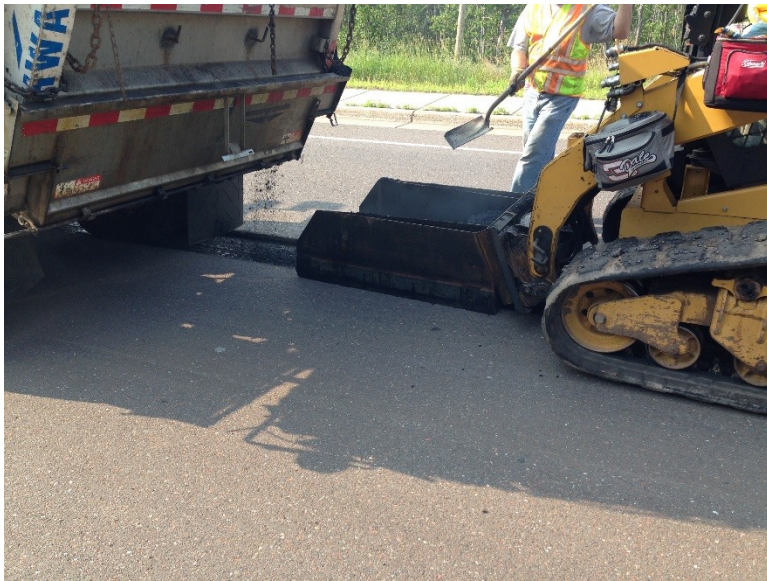
Figure B12: Mill and Fill Step 3.

Step 3: Windrows of fill material are placed in the milled trench and leveled out by a skidsteer.

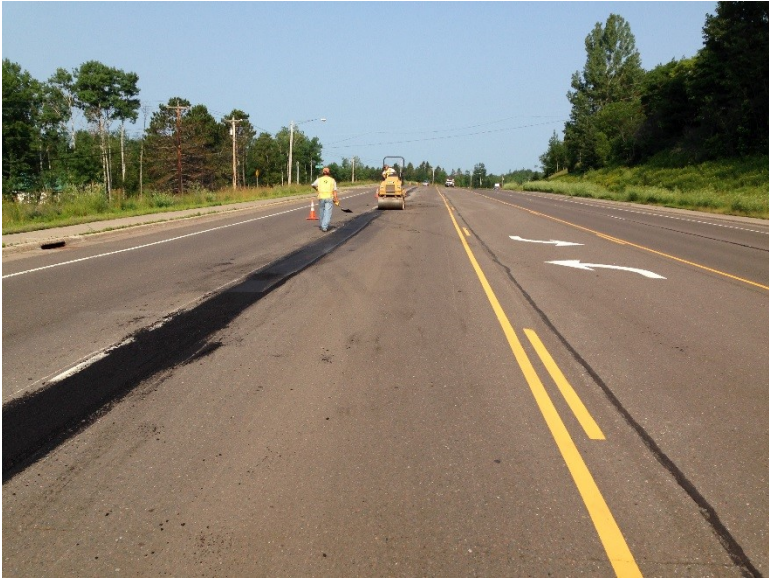
Figure B13: Mill and Fill Step 4.

Step 4: A steel drum roller compacts the fill material to complete the patch.
