GEOTECHNICAL ASPECTS OF THE 2016 KAIKŌURA EARTHQUAKE ON THE SOUTH ISLAND OF NEW ZEALAND

ABSTRACT

The magnitude Mw7.8 'Kaikōura' earthquake occurred shortly after midnight on 14 November 2016. This paper presents an overview of the geotechnical impacts on the South Island of New Zealand recorded during the post-event reconnaissance.

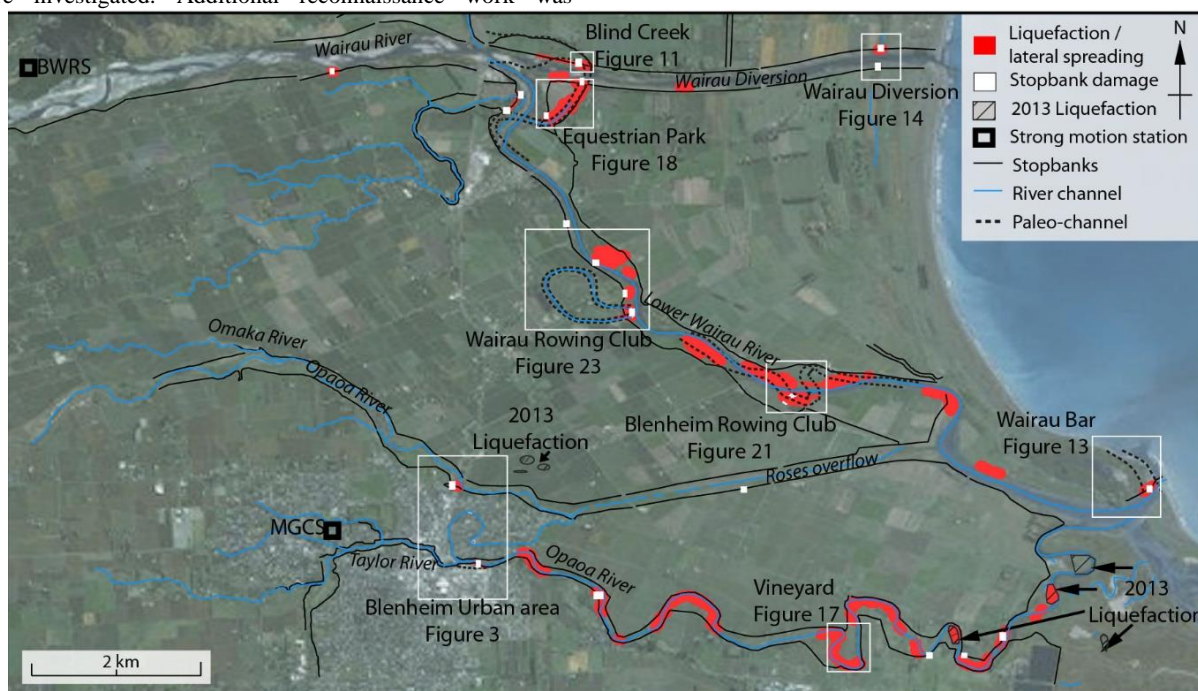
Figure 2: Overview of liquefaction damage in Blenheim and the Wairau Plains resulting from the 2016 $M_w7.8$ Kaikōura earthquake and 2013 $M_w6.6$ Lake Grassmere earthquake (Approx. coord. of centre of image: -41.495° , 173.980°).

Of the 180 km of stopbanks in the region, ~2.5 km (cumulative) were damaged to varying degrees during the earthquake at locations (shown in Figure 2) associated with paleo channels or swamps. Damaged sections were built on geologically younger deposits compared to the surrounding undamaged sections. Horizontal and vertical displacements were found to vary significantly within the failure zone, and were accommodated through the development of systems of cracks, usually located on top of the stopbanks and running parallel to the stopbank. Accompanying phenomena, which were not observed in all cases, included the development of secondary systems of ground cracks and/or sand ejecta at the base of the stopbanks and orientated parallel to the riverbanks.

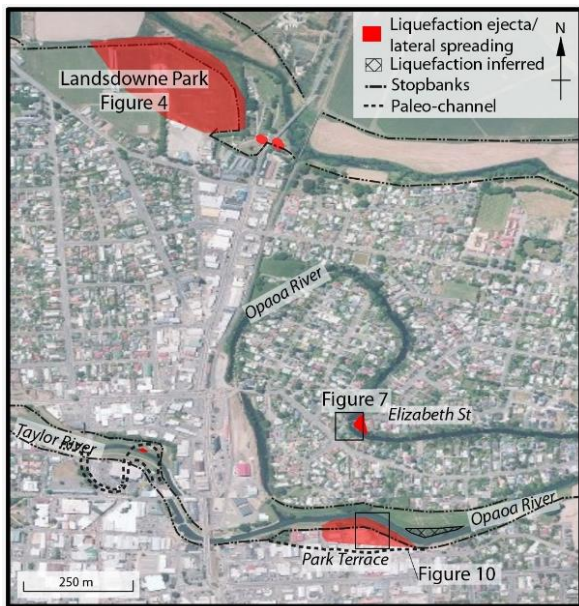
Figure 3: Overview of liquefaction related damage within the Blenheim urban area (Approx. coord. of centre of image: -41.507° , 173.962°).

Localised liquefaction and associated lateral spreading occurred during the Kaikōura earthquake proximal to the Opaoa River within Blenheim as outlined in Figure 3. Liquefaction and lateral spreading related damage was confined to the inner-banks of meander bends of the rivers or was associated paleo-channels; no damage was observed on the outer-banks of the meander bends. Localised liquefaction also occurred adjacent to the Taylor River within central Blenheim, in an area that was formerly within the river channel prior to modification and straightening in 1969 which subsequently reduced flow levels (Figure 3 [20]).

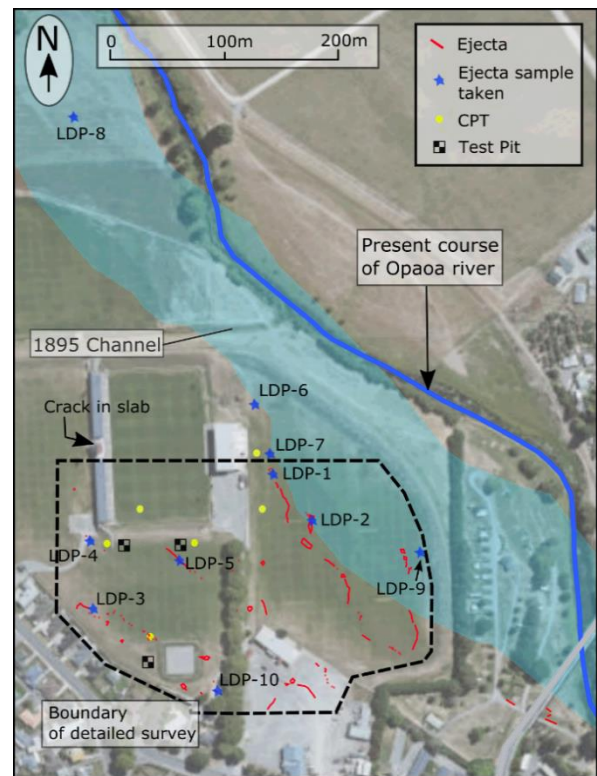
A detailed survey of ejecta was conducted in the southern half of Lansdowne Park; the location of ejecta features are shown in red in Figure 4. Sand boils were typically 1-2 m in diameter and in many cases formed lineaments of aligned sand boils (Figure 5). The ejecta material was largely bluish-grey in colour, but there were some features which were light brown in colour. No liquefaction ejecta was observed adjacent to the main stadium buildings; a single crack in the concrete foundation slab was the only observable damage (Figure 5b).

Figure 4: Ejecta deposits mapped within Lansdowne Park shown by red areas, and their relationship to the position of the 1895 channel of the Opaoa (Opawa) River (Approx. coord. of centre of image: -41.498° , 173.958°).

Historical maps from 1895 [22] indicate that the Opaao River formerly flowed across the northeast part of Lansdowne Park (1895 river channel is shown in blue in Figure 4). It is apparent that, with the exception of LDP-4, the samples of ejecta classified as medium sands fall along the edge of this river channel. The other liquefaction features either fall within the old river channels, or in the flood plain to the west of the 1895 river channel. It should be noted that additional liquefaction features were discovered outside the boundary of the detailed survey. However, the distribution of features was not mapped in detail with only the location of ejecta samples indicated. Additional liquefaction ejecta features were discovered within paleo-channels in the former flood plain to the west of the park, while lateral spreading and grey sand ejecta were observed to the east. These features also align with the 1895 river channel. The occurrence of liquefaction and lateral spreading in paleo channels is common and was observed in the 2011 Christchurch earthquake, where paleo channels running through the city caused localised damage and manifestations of liquefaction [17].

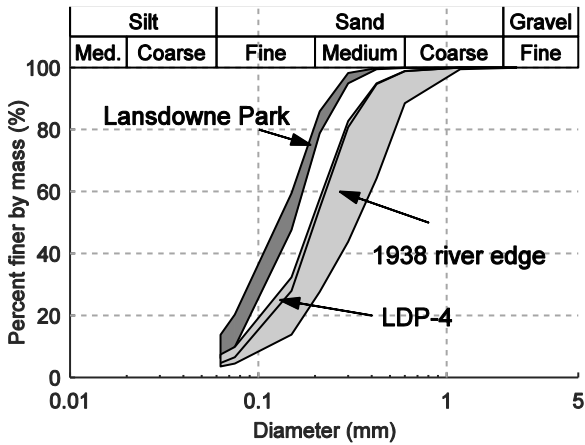
Wet sieve analyses (carried out in general accordance with ASTM D422-63 [21]) were performed on 10 ejecta specimens from across Lansdowne Park (locations are marked in Figure 4 with blue stars). The particle size distributions (PSD), which are summarised in Figure 6, can be separated into two groupings, LDP-3, 5, 8, 9 and 10 being relatively similar fine sands, while the samples LDP-1, 2, 4, 6 and 7 were medium sands.

Figure 6: Particle size distributions of the ejecta obtained from Lansdowne Park.

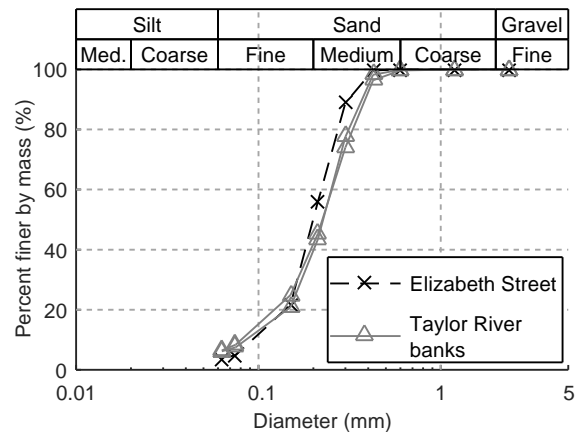
The log from a hand auger performed adjacent to the river indicates that the soil profile is comprised of a light brown silt with some sand to a depth of 1.2 m, underlain by fine blueish grey sand to 1.4 m, and blueish grey fine-medium sand below that, with the water table at a depth of 1 m. Proximal to the house the water table was at a depth of 2 m, with the bluish grey fine-medium sand encountered at 2.4 m depth. The ejecta were uniformly composed of grey fine-medium sand, and the PSD of these ejecta are shown in Figure 8. Also shown in this figure is the PSD of samples taken from the Taylor River, which has similar fines content and general characteristics as the Elizabeth Street samples.

Figure 8: Particle size distribution of ejecta samples in the Blenheim CBD area (Taylor River: TR-1 & TR-2 and Elizabeth Street: EC-1).

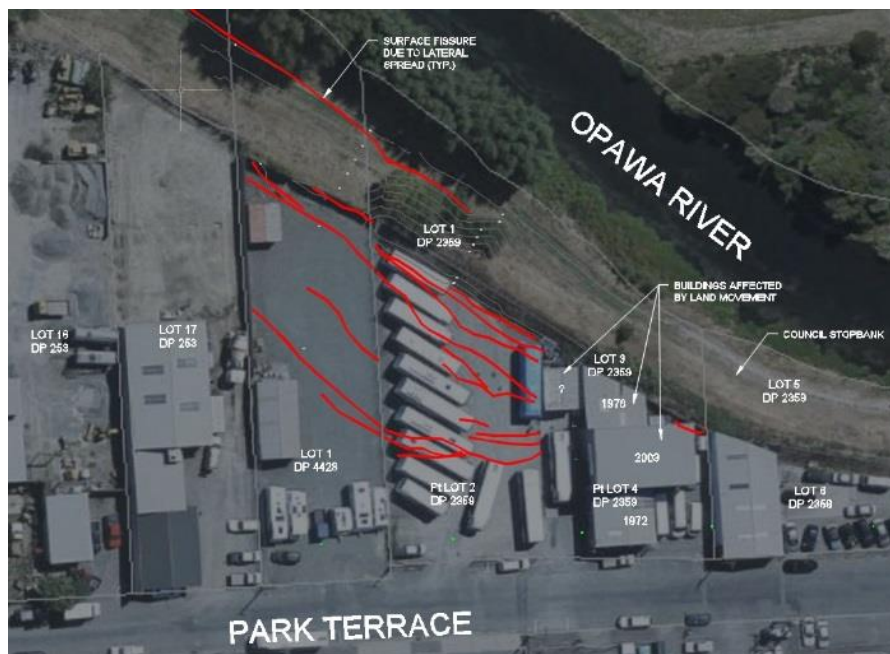
Figure 10: Summary of liquefaction manifestations at the Park Terrace site (Approx. coord. of centre of image: -41.5123° , 173.9650°).

Ejecta material was confined to the floodplain, and lateral spread-induced cracks orientated sub-parallel to the river bank were evident. Cracks ranged in width from 1 to 30 cm and were associated with 1 to 5 cm of vertical settlement. Crack widths decreased with increasing distance from the apex of the inner meander bend and became discontinuous along the river bank further upstream. The total lateral spreading displacements in this area were typically less than 50 cm. Fine-medium grey sand ejecta up to 10 cm thick and infilling the lateral spreading cracks were observed (Figure 9a). A hand auger performed adjacent to the river (on the floodplain) indicated that the soil profile at this site includes a silty sand

Cracking continued into the properties on Park Terrace that border the stopbank (Figure 9b). Permanent ground deformation, differential settlement of structures, separation between foundation slabs and the surrounding ground, and damage to the stopbanks were observed at these properties and a summary of the location of the cracks are shown in Figure 10. The total crack widths were 1-1.5 m: 0.3 m in floodplain and 0.7 – 1.2 m in the fill. Historic photographs indicate that the position of the stopbank in 1959 lay approximately 20m north of Park Terrace. The affected properties shown in Figure 10 were constructed on an area of fill that raised the elevation of the zone between the historic stopbanks and present-day stopbanks, with the southerly extent of cracking just north of the position of the historic stop bank.

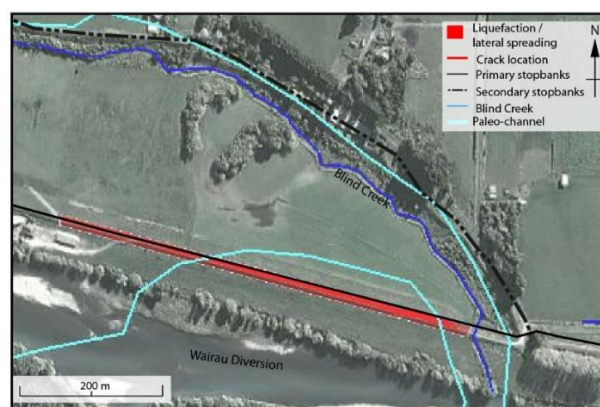
At Blind Creek (indicated in Figure 2), the primary stopbank is set back from the river outside of a cut-off meander bend of the river associated with river avulsion and the construction of the Wairau Diversion in the 1960's (Figure 11). A secondary set of stopbanks runs parallel to the current channel of the Wairau River. A 200-m long section of the secondary stopbank was heavily damaged during the earthquake (Figure 12a), which corresponds with the location of the historical bed of the Wairau River. Cracks exhibited a maximum width and depth of 1 m and indicates that movement occurred to the north and south, away from the major axis of the stopbanks (Figure 11). Sand boils were observed on the foundation soils surrounding the stopbank closer to the river's edge as well as on the northern side of the stopbank within the paleo-channel marked on the figure. Slumping of the stopbank was also observed where Blind Creek flows underneath the stopbank through a culvert.

Figure 11: Overview of damage to the stopbank at Blind Creek. (Approx. coord. of centre of image: -41.442° , 173.978°)

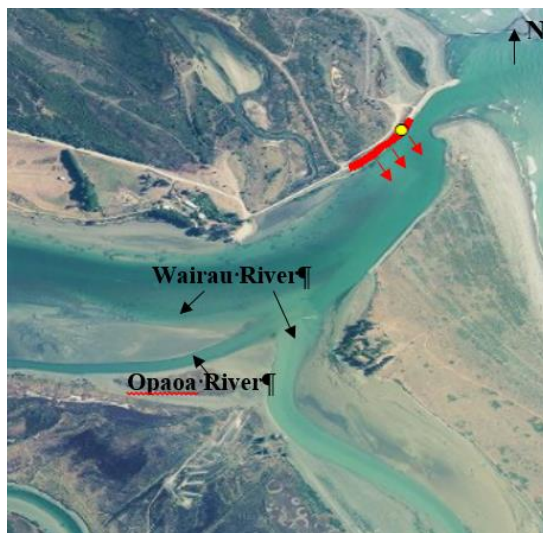
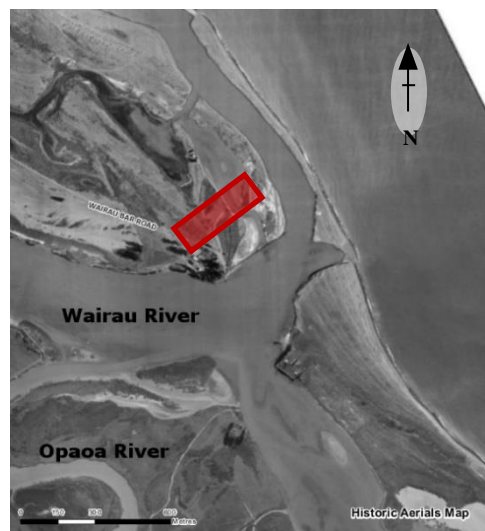
Lateral spreading and slumping were observed along a 100 m long section of the northern stopbank at the mouth of the Lower Wairau River (Wairau Bar; indicated in Figure 2). The damaged section corresponds to the position of the former river channel that existed prior to diversion and stopbank construction (Figure 2 and Figure 13). Cracks varied in width from 30 to 50 cm and exhibited vertical settlements of 20 to 120 cm (Figure 12b). No liquefaction ejecta was observed along the stopbank or in the mudflats exposed within the river channel. A series of lateral spreading cracks were observed along the inland edge of the stopbank within the paleo-channel and these were surrounded by fine grey sand ejecta.

Figure 13: Aerial photographs showing location of damage stopbank at the mouth of the Wairau River: (a) Current landscape; (b) Landscape in 1948. (Approx. coord. of centre of images: -41.504° , 174.058°) Marlborough District Council (2017).

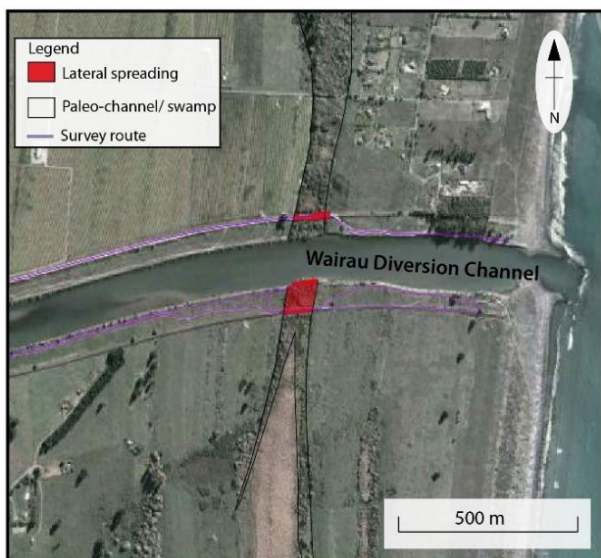
Lateral spreading-induced cracking was also observed along the northern and southern stopbanks of the Wairau Diversion and corresponds with the location of a paleo-stream channel recognizable by a depression in the landscape and by a change

in vegetation (Figure 14). Lateral spreading on the northern stopbank was characterised by cracking ranging in width from approximately 30 to 50 cm and exhibiting 10 to 50 cm of vertical settlement (Figure 15). Localised cracking was observed at the base of stopbank proximal to the river. Lateral spreading along the southern stopbank resulted in cracking ranging in width from ~2 to 10 cm with 1-2 cm of vertical settlement. Lateral spreading was also observed along the river bank. No liquefaction ejecta was observed on either stopbank.

Figure 14: Overview of damage to the stopbank along the Wairau Diversion with the location of the paleo-channel and swamp indicated. (Approx. coord. of centre of image: -41.440° , 174.022°)

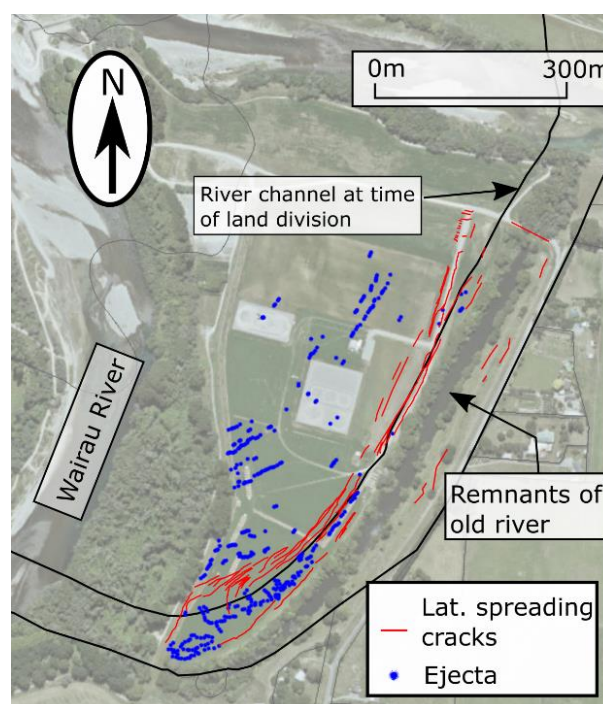
Lateral spreading was accompanied by widespread ejecta across the site (Figure 18) with the volume of ejecta most severe in the southern part of the park where the ground elevation was the lowest (Figure 19). It should be noted that the observations in Figure 18 are only considered complete in the grassy area of the park. As shown, lateral spreading is aligned with the position of the Wairau River at the time when the property boundaries were being drawn. Lateral spreading cracks ranged in width from ~ 10 -70 cm and exhibited vertical displacements up to 70 cm. Total lateral movements towards this old river channel was of the order of 1 – 2m. Soil profiles derived from hand augers in this area of cracking showed silty sand to a depth of approximately 1.5m below which was clean sand that changed from brown to a bluish-grey colour at around 2.8 m depth.

Figure 18: Lateral spreading and ejecta at Marlborough Equestrian Park (Approx. coord. of centre of image: -41.445° , 173.976°).

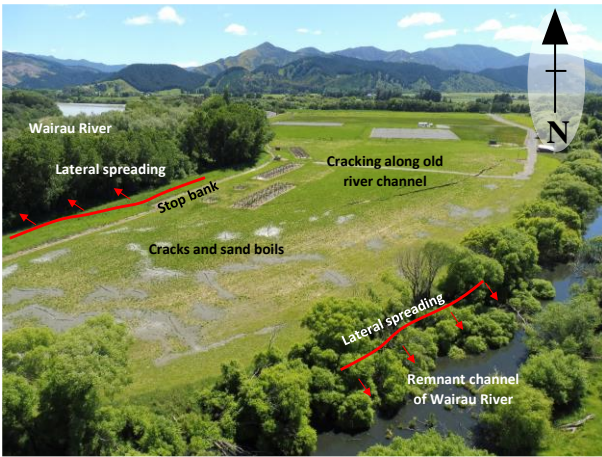
Figure 19: Aerial view of Marlborough Equestrian Park and summary of liquefaction induced damage (-41.4474°, 173.9768°, facing NE). Photo: Marlborough District Council.

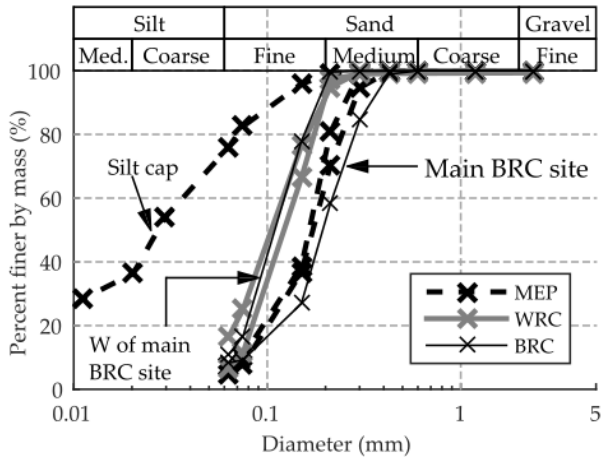
Liquefaction ejecta was present across much of the Equestrian Park. Historic photos [20] indicate that the position of the Wairau River moved significantly in the past 100 years. Accordingly, buried river channels are likely present across the park which explains the widespread ejecta at this site. Particle size distribution characteristics of ejecta samples are summarised in Figure 20. Specifically, the PSD of the ejecta silt layer that capped the underlying fine-medium sand ejecta are shown in this figure. The segregation of the particles of different sizes occurs during the fluidization and deposition of the liquefied soil.

Figure 20: Particle size distributions of ejecta samples from along the Wairau River (MEP=Equestrian Club, BRC=Blenheim Rowing Club, WRC=Wairau Rowing Club).

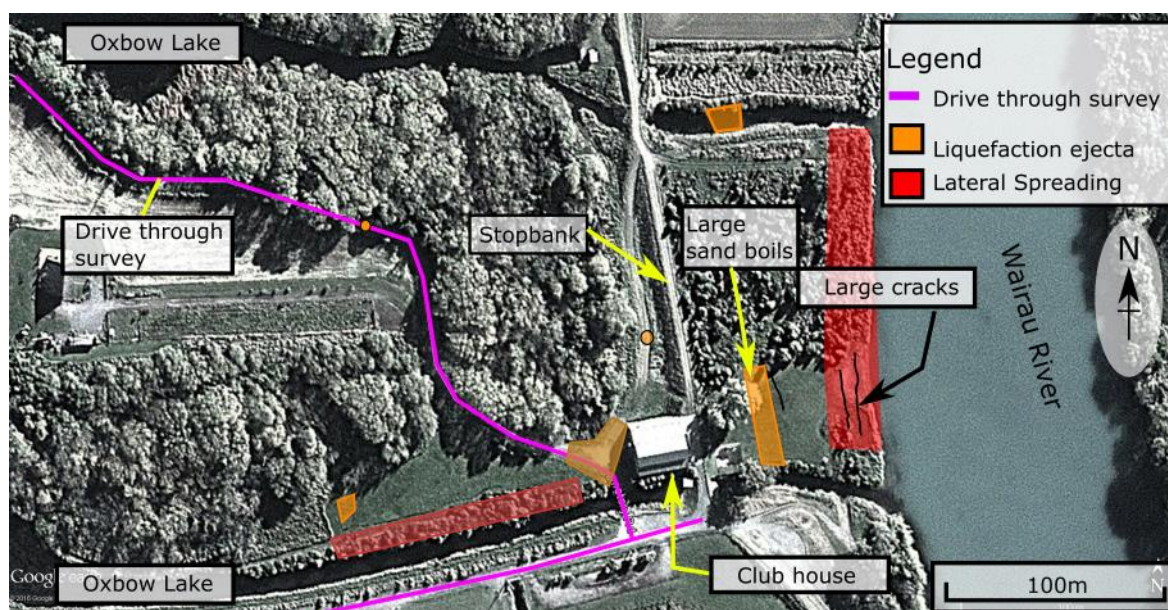
Severe lateral spreading was observed close to the river at the Wairau Rowing Club, located adjacent to the southern bank of the Wairau River (Figure 2). A key feature of this site (Figure 23) is the Grovetown Lagoon, an ox-bow lake cut off from the main channel during a flood in 1861. Drainage channels have been cut through the north and south paleo channels. The grassy area visible to the east and west of the club house in Figure 23 marks the position of the old river channel. A stopbank runs approximately N-S through the site, and the 3-level clubhouse was built so that it extends into the west side of the stopbank and has its second floor level with the crest of the stopbank. East of the clubhouse, the land (above the paleo channel) gently slopes down to the river.

Figure 23: Summary of observations at Wairau Rowing Club (Approx. coord. of centre of image: -41.476° , 173.984°).

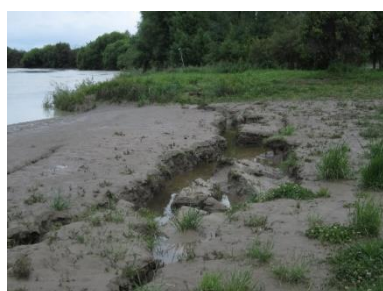
Cracks ranged in width from 1-2 m (also representative of the cumulative lateral displacements at this site), and were associated with up to 50 cm of vertical settlement (Figure 24). A significant volume of ejecta vented into the drainage channels, but this was removed soon after the earthquake to restore the channel. A line of sand boils orientated parallel to the river was additionally observed ~ 70 m inland from the river in the grassy area between the drainage channels. The sand boils transitioned into an ~ 10 cm wide lateral spreading crack within the surrounding vegetation. Numerous minor to moderate sand boils were also observed around the rowing club building on the west side of the stopbank. Lateral spreading cracks also formed along the southern drainage channel (i.e. within the paleo channel) proximal to the rowing club house (Figure 23). Particle size distribution characteristics of ejecta samples (collected from both sides of the stopbank) are summarised in Figure 20, and were comprised of finer sand than samples from both the Blenheim Rowing Club and the Equestrian Club sites.

Figure 24: Lateral spreading cracks adjacent to the Wairau River at the Wairau Rowing club (a) -41.4765° , 173.9862° , taken facing S; (b) -41.4761° , 173.9860° , taken facing S.

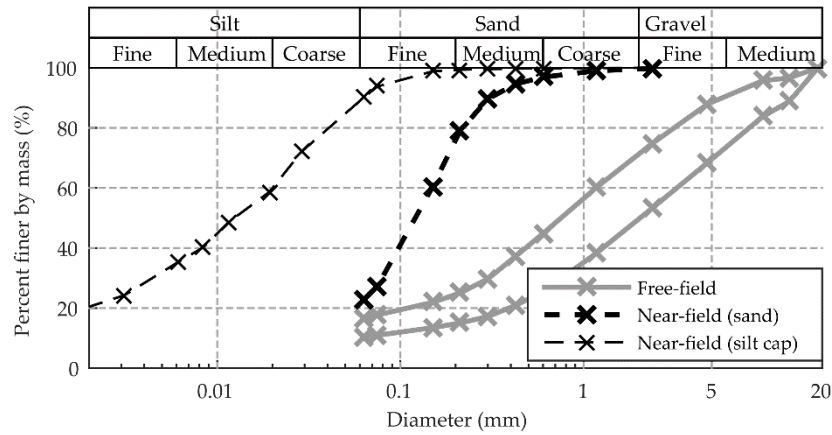
Figure 27: Particle size distributions of ejecta at Needles Creek Bridge.

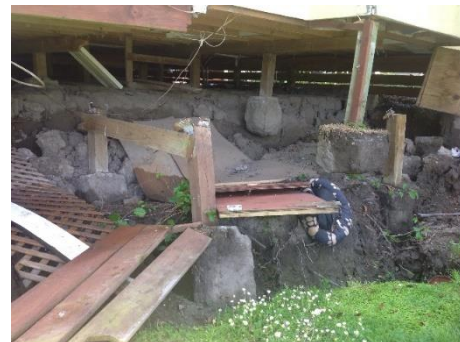
Figure 31: Complete loss of support to foundations at W end of house on Beach Road (-42.3851° , 173.6783°). (a) taken facing NE, (b) taken facing SE, (c) taken facing S.

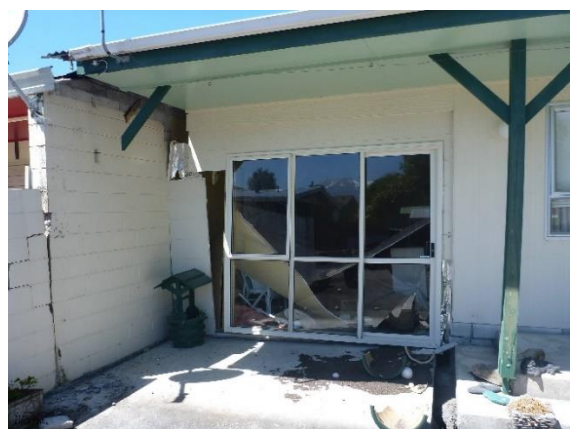
Figure 32: (a) Vertical gaps developed in a semi-detached house (taken facing S). Note: cracks are roughly parallel to Lyell creek (b) Gapping on the W side of the house (taken facing E). Note rotation of walls and posts caused by the differential slab movements (-42.3857° , 173.6784°).

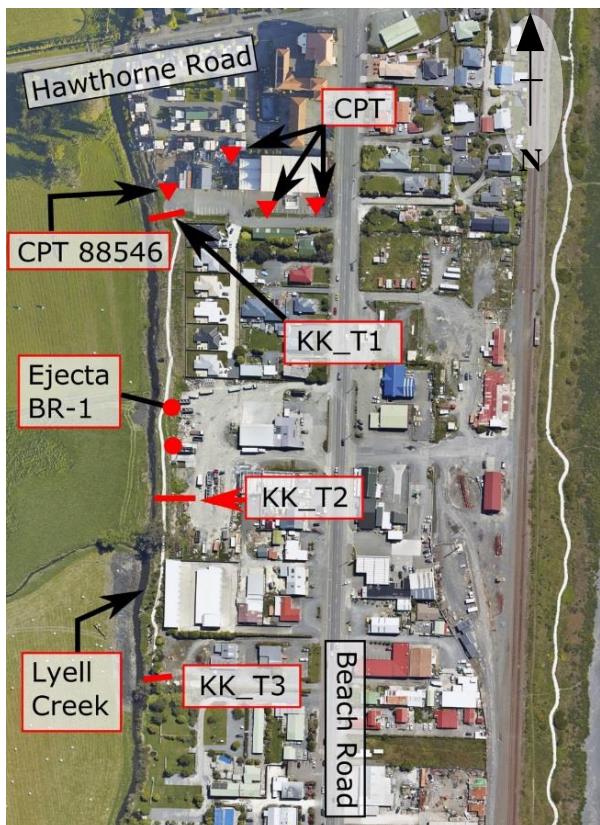
The magnitudes of permanent lateral ground displacements were estimated by summing up measured ground fissures along three lines (transects: KK_T1, KK_T2, and KK_T3, Figure 35) on the east side of Lyell Creek. The transects were carried out between the river channel and the last clearly

identifiable crack along the heading being traversed. The transects were oriented perpendicular to Lyell Creek and parallel to the direction of ground movement, with KK_T1 being close to where CPT 88546 was performed and the site shown in Figure 34. The other two transects were located ~150 m (KK_T2) and 300 m (KK_T3) to the south. Consistent with observations elsewhere along the creek, the cracks at the transect locations extended between 10-20 m from the river. Cumulative measured horizontal ground crack widths were in the range of 0.6–1.2 m, while cumulative vertical displacements were between 0.4-0.8 m.

Figure 35: Location of CPT and Transects along Lyell Creek (Approx. coord. of centre of image: -42.391°, 173.679°. Basemap: LINZ).

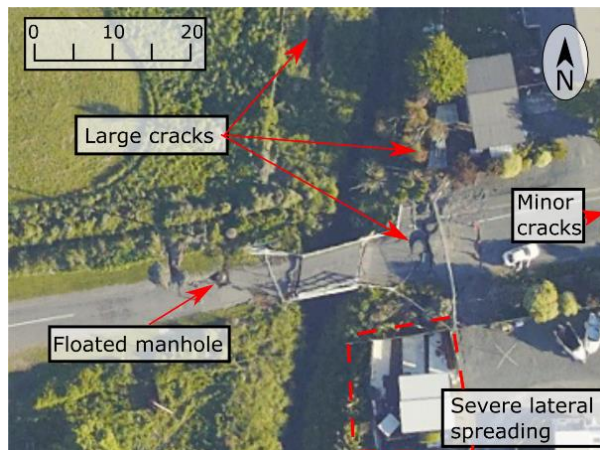
The lateral ground displacements at Lyell Creek heavily affected the Hawthorne Road bridge, which is pictured in Figure 37 and Figure 38. At this location, lateral ground movements towards the river were of the order of 1m, and concentrated within 15m of the river channel. This short-span bridge showed distress at both ends, with clear rotation of both abutments reminiscent of the “back-rotation” observed in Christchurch during the 2010-2011 earthquake sequence [24, 28]. The deformations occurring at the abutments resulted in large movement of the bridge deck, both in plan (creating the gap shown in Figure 38c), and vertically at the eastern abutment (Figure 38e). The deck beams detached from their anchor points and displaced significantly, as shown in Figure 38f. It should be noted that the bridge orientation is slightly skewed (in plan) relative to the creek, and it is possible that the large deck displacements arise partly from the bridges’ skew. Despite the large cracks which were visible (particularly on the east side of the bridge), no liquefaction ejecta was observed in the surrounding soil, while a borelog from a nearby water well indicated that the soil profile is typically fine-grained.

Figure 37: Overview of Lyell Creek bridge crossing at Hawthorne Road (Approx. coord. of centre of image: -42.389°, 173.677°).

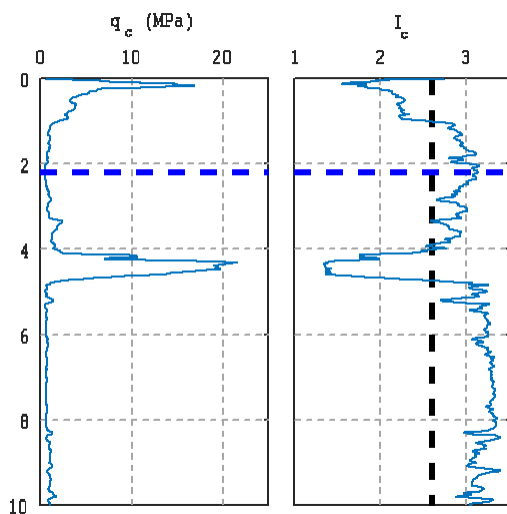
Figure 36: CPT_88546 sounding 15 m east of Lyell Creek (-42.3901°, 173.6777°. NZGD [26]).

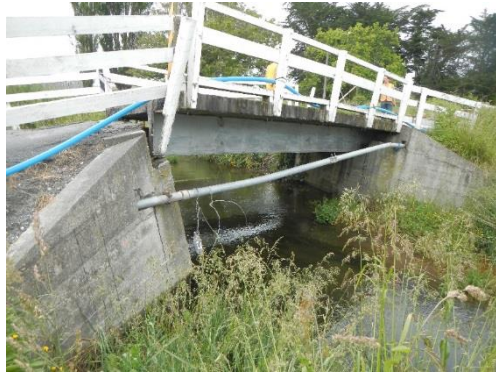
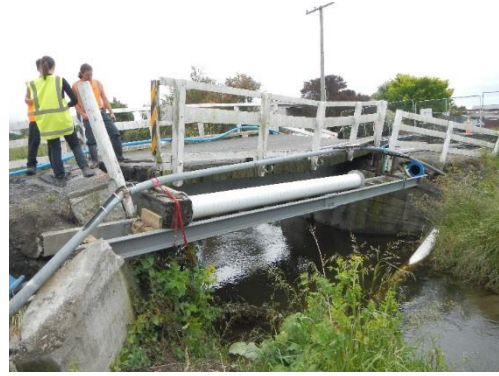
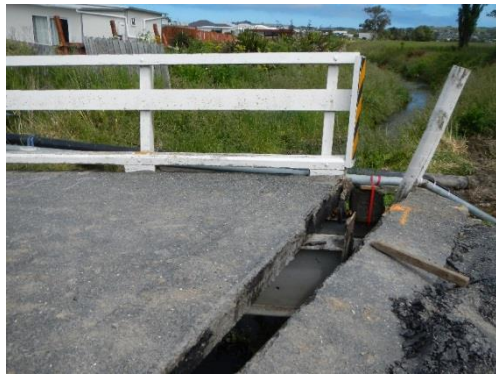
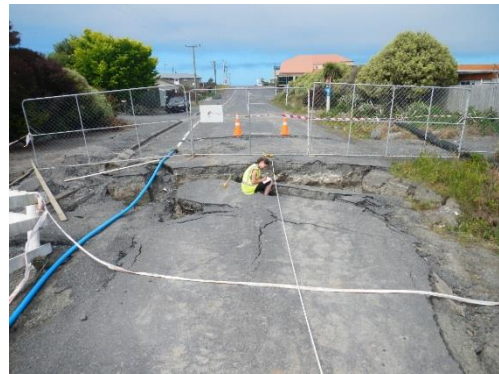
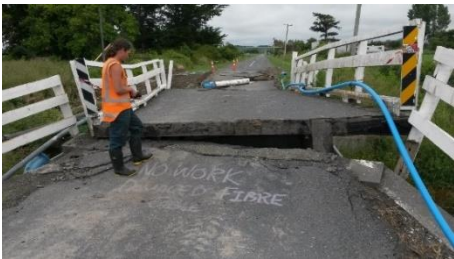
Figure 38: Severe damage at Hawthorne Road bridge (-42.389°, 173.677°): (a) North side of Hawthorne Rd. bridge. Note the abutment rotations and the deck displacements; (b) South side of Hawthorne Rd. Bridge; (c) Gap between deck slab and west abutment (taken facing S); (d) Cracking in the eastern approach to the bridge (taken facing E); (e) Vertical displacement of deck slab (taken facing W); (f) Pull-out of deck beam restraint at the east abutment (taken facing W); and (g) Twisting of the deckbeam (taken facing W).

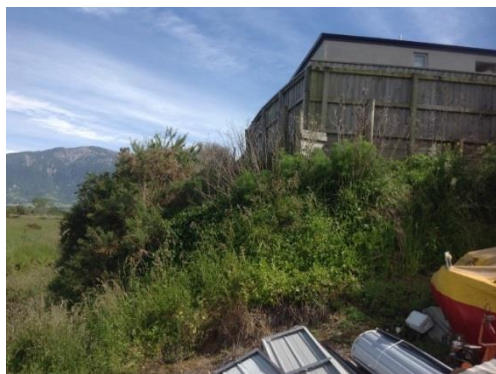
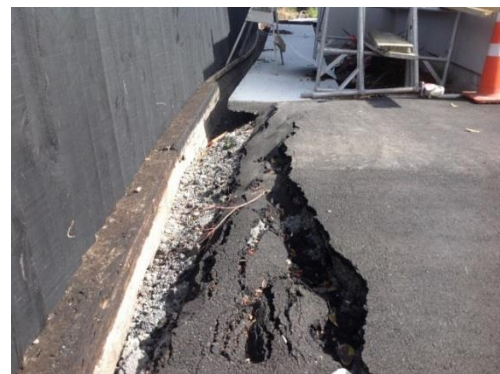
Two instances of retaining wall failures were observed towards the southern end of Lyell Creek (Figure 39). In both cases, the retaining walls were timber structures and had visibly bulged towards the creek, with cracking apparent in the retained soil behind the wall.

Figure 39: (a) Failure of a retaining wall on Beach Road (-42.3973°, 173.6798°, taken facing N). (b) Cracks behind the retaining wall on Beach Road (-42.3971°, 173.6798°, taken facing N).

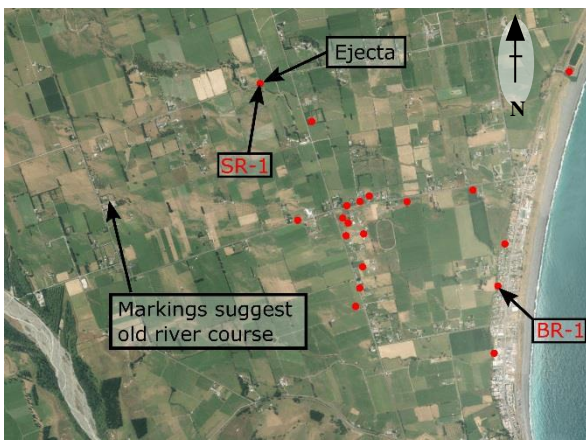
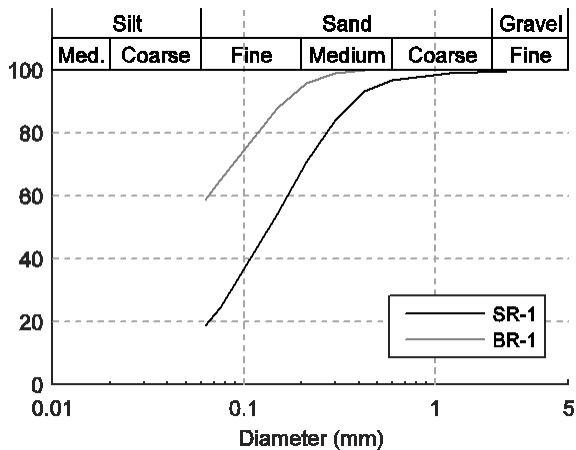
shown in Figure 41b and is noticeably much finer, classifying as Silt (ML) per ASTM D2487-11 [27], than the ejecta collected at other sites in Kaikōura as well as sites in both the Waiaua and Blenheim areas.

Figure 41: (a) Positions of known liquefaction ejecta. SR-1 and BR-1 refer to locations where ejecta samples were obtained. (Approx. coord. of centre of image: -42.375°, 173.647°). Basemap: LINZ. (b) Particle size distributions of ejecta samples SR-1 and BR-1.

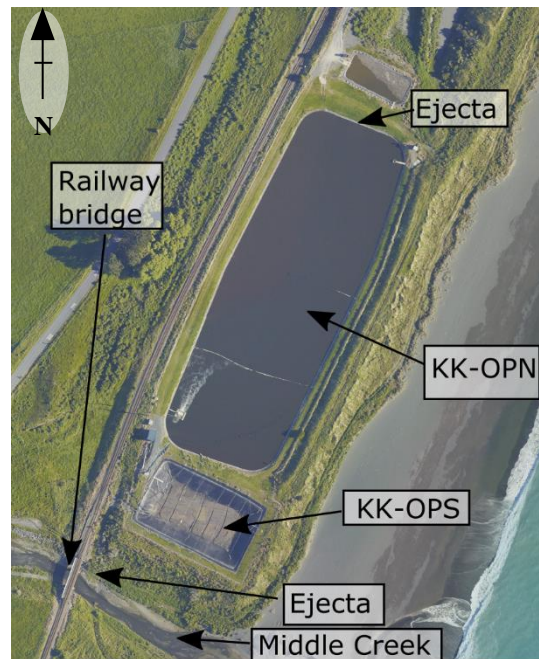
The wastewater treatment facility for Kaikōura is located north of the town, next to the beach. The earthquake caused differential settlements and ground cracking. Some ejecta was

recorded at the northern end of the main pond, while additional ejecta were observed just south of the facility, close to one of the piers of the railway bridge running along the west edge of the facility. The ground deformations at the site were sufficient to cause tearing in the liner of the most southerly pond (marked KK-OPS in Figure 43), as well as causing some of the aeration posts to fail and rotate inward toward the pond (Figure 44a and Figure 44b). Some failures in the concrete lining of the main pond were also observed as shown in Figure 44c.

Figure 43: Overview of Oxidation Ponds north of Kaikōura (Approx. coord. of centre of image: -42.366°, 173.688°. Basemap: LINZ).

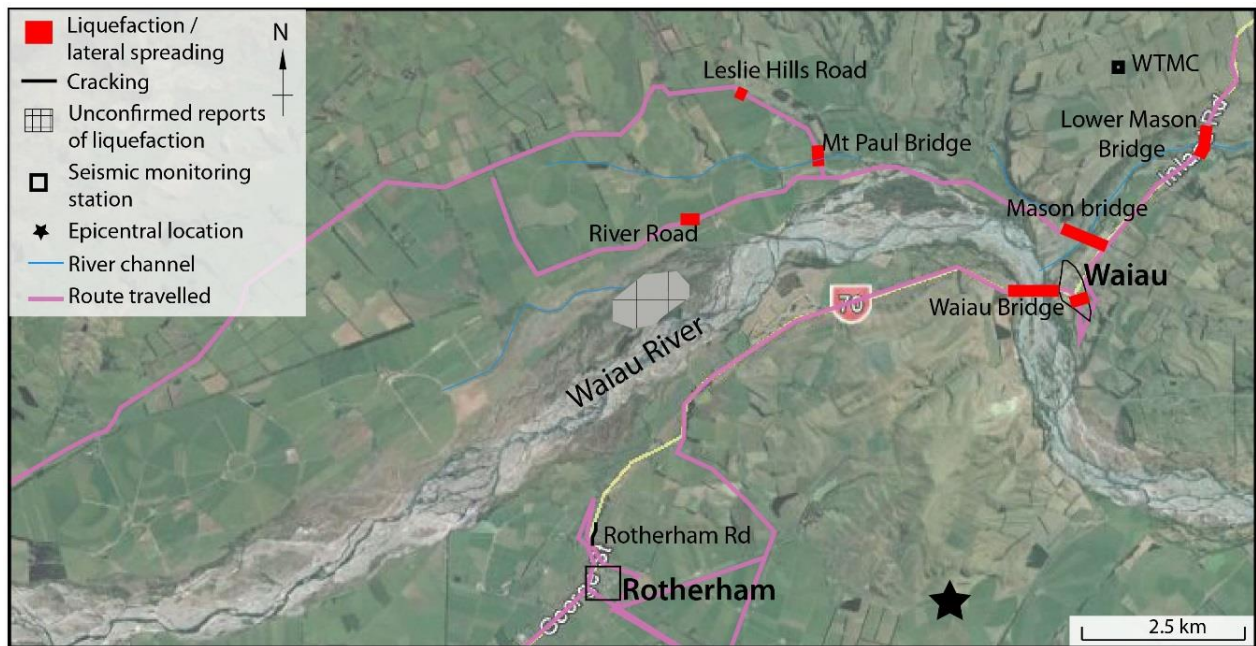
Figure 45: Map of the Waiau area indicating areas with liquefaction manifestation (Approx. coord. of centre of image: -42.658° , 173.005°).

Despite the high ground shaking experienced within the town, there were very few geotechnical impacts within the town of Waiau. Minor evidence of liquefaction was observed in a few places at the south of the town, though there were additional reports (which could not be verified) of more extensive liquefaction in a paddock between the town and the Waiau River at the southern end of the town. Liquefaction was observed in the agricultural areas close to the Waiau River, west of Waiau town. Aerial photography of this area (Figure 48) shows standing water and ejecta in the fields as well as on the roads and ground teams confirmed the presence of ejecta on the River Road at the location marked in Figure 45.

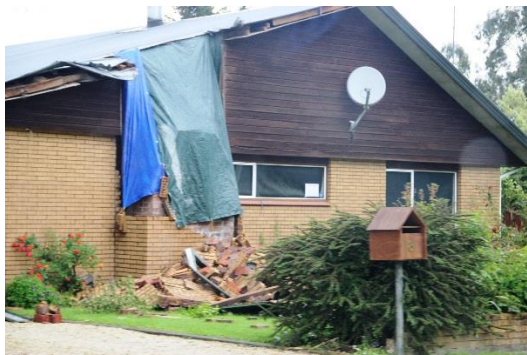
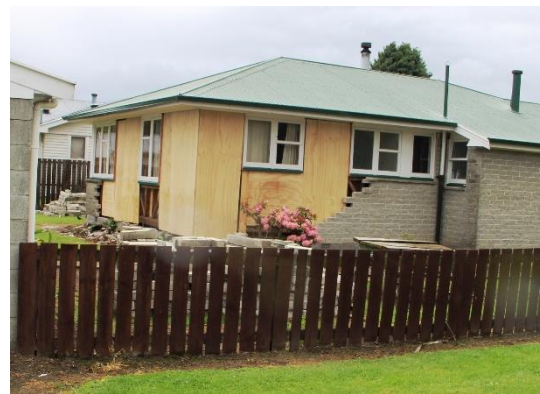
Damage to buildings and infrastructure in this region was largely caused by the high inertial loads. Due to the sparse population in the area, the building stock throughout the town of Waiau is largely single storey, light residential buildings that experienced damage to brick facades, unreinforced masonry walls, and fallen chimneys, examples of which are shown in Figure 46. The main damage to infrastructure in the region was to the multi-span bridges crossing the Waiau, Mason, and Wandle Rivers. At some of these bridges, the inertial loading caused severe structural damage as discussed by Palermo et al. [29]. Common geotechnical issues included settlement and outward cracking of the approaches, while abutment rotation and cracking was observed at a small number of bridges. Liquefaction was observed in some locations (shown in Figure 45), but was generally not widespread in the surveyed areas. Major liquefaction-induced lateral spreading was not observed by the reconnaissance teams but it may have contributed to some of the bridge abutment damage and road cracking.

Figure 46: Examples of damage to residential buildings in Waiau township (Approx. coord: -42.66° , 173.04°): (a) fallen chimney; (b) damage to brick façade.

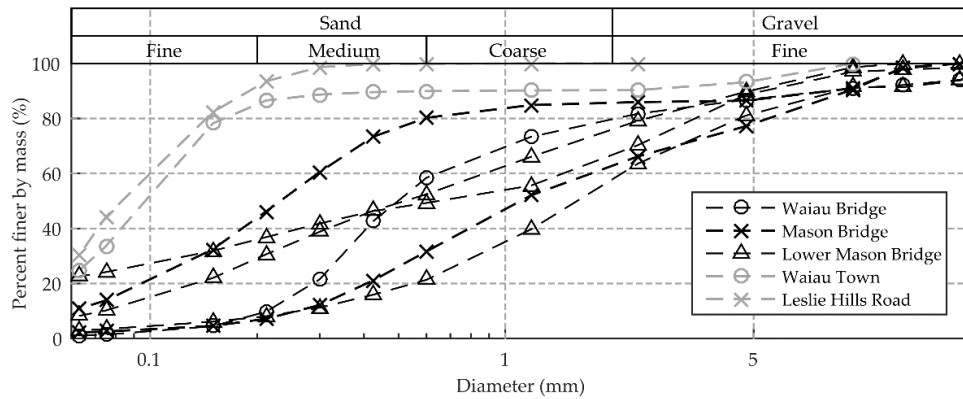
Samples of ejecta were taken from a sand boil within Waiau town, as well as a minor sand boil close to the fault rupture on Leslie Hills Road. The particle size distributions of these samples are shown in Figure 49 and indicate the ejecta material is relatively clean fine sand. Also shown in this figure are the gradings associated with ejecta material found near the

Figure 49: Particle size distribution of ejecta samples collected across the Amuri and Emu Plains.

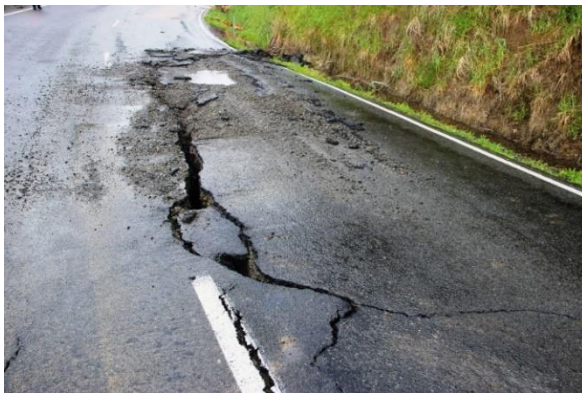
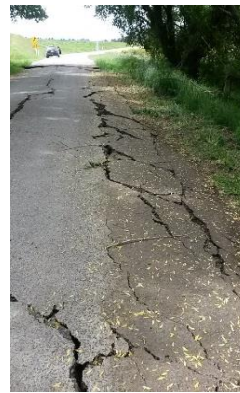
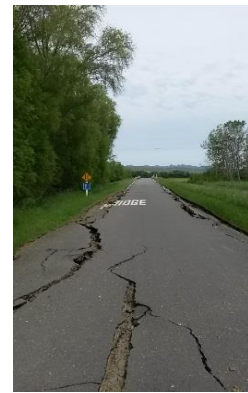
Ground cracks were periodically observed on the roads leading towards Waiau, particularly on the rural farming roads north of the Waiau River. Ground cracks were most often relatively well aligned with the road and most commonly ran along the outer edges of the road. In some cases, cracks were 20-30 cm wide, and several metres long. Examples of the ground cracking encountered are shown in Figure 50, and are representative of the most severe observed damage of this type. Within the town of Waiau, a number of cracks were observed both parallel and perpendicular to the road. These cracks typically had little impact on the serviceability of the road, being only a few centimetres wide in most cases and with similarly small vertical offsets.

Figure 50: Cracks parallel to the road. (a) crack on SH70, north of Rotherham (-42.690°, 173.946°, taken facing NE); (b) cracks on Leslie Hills Road just after small bridge crossing (-42.639°, 172.915°, taken facing E); crack on Leslie Hills Road close to fault rupture area (-42.634°, 172.992°, taken facing S).
