This article demonstrates how the inclusion of partial discharge as a measurement parameter ensures a more reliable diagnosis of insulation condition in transformer bushings. Comparative diagnostic tests showed that the partial discharge measurements best enabled the detection of bushing defects, which the other methods were not able to detect alone.

# Effective bushing diagnosis using partial discharge testing

# Partial discharge measurements effectively detect failure-causing defects

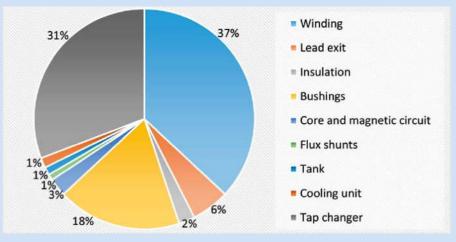
Figure 1. Failure location in transformers manufactured after 1980 (342 failures, U ≥100 kV) [1]

1 %. Dielectric failures were the most significant in all transformer classes [1]. The windings, bushings and lead exits are affected by this failure mode. It is known that bushings are responsible for approximately 14 % of major transformer failures regardless the type of their insulation system — resin-bounded paper (RBP), resin-impregnated paper (QIP) [1]. The failure rate is even higher, approximately 18 %, when the analysis is limited to transformers manufactured after 1980, Fig. 1.

# The rate of transformer failures caused by bushings is even higher, approximately 18 %, when the analysis is limited to transformers manufactured after 1980

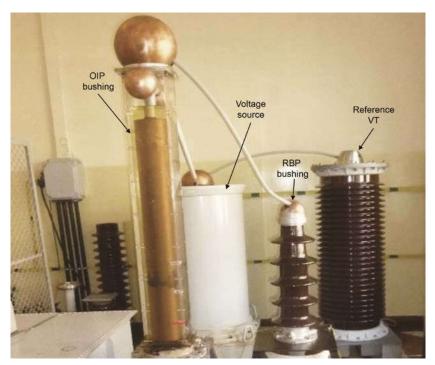
Figure 4. Test set-up for OIP and RBP bushings insulation evaluation

The set-up for the PD measurements carried out in the lab is presented in Fig. 4. Two bushings of different insulation systems and rated voltages were tested:

- A 110 kV, 24-year-old OIP bushing: the porcelain cover was removed in order to simulate different condition defects and to observe the insulation behaviour under electrical stress (bubbling, surface discharge). The removal of the porcelain cover has a quantitative influence on the bushing capacitance (the new capacitance is regarded as "good" condition capacitance).
- A 52 kV new RBP bushing with design flaws
