# An Evaluation of Nantucket's Town Facilities

An Interactive Qualifying Project  
submitted to the Faculty of  
WORCESTER POLYTECHNIC INSTITUTE  
in partial fulfillment of the requirements for the  
degree of Bachelor of Science

Gregg Tivnan  
Nantucket Town Manager's Office

Larry Kester  
Nantucket Department of Public Works

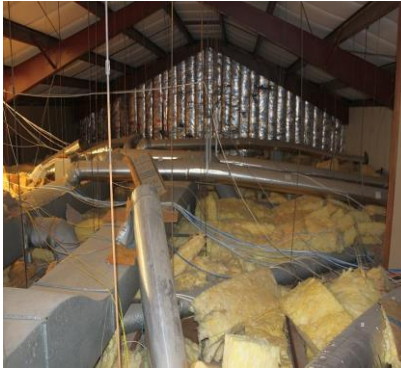
structural integrity of the building, jeopardize the safety of building occupants, and/or severely diminish the energy efficiency of the building. Key stakeholders interviewed about these facilities expressed the need for significant renovations, or entire rebuilds, in the very near future. Figures 23, 24, and 25 below illustrate some of the very poor structural and physical conditions that are characteristic of the facilities in this level.

Figure 24: Messy attic at PLUS

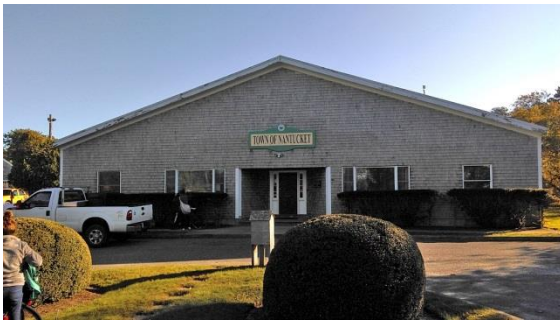
Figure 26: PLUS

The PLUS Building, located at 2 Fairgrounds Road, was constructed in 1969. The building is a pre-engineered warehouse and garage, consisting of a steel frame. As suggested by its name, it is currently used for Town Planning and Land Use purposes. The primary issues of concern that we identified include:

- Metal shell is rusted and uninsulated (in 48<sup>th</sup> year of intended 50 year lifespan) (see Figure 27);
- Building uses inefficient electric heat;
- Lack of moisture control and garage design makes building ill-suited for storing important files;
- 20 full time employees and one seasonal employee jammed into front-end of facility with less than 4,000 square feet for offices, meeting space and conference rooms, bathrooms, and copying room (see Figure 28);
- Inadequate meeting space to review and sign plans and documents;
- Non accessible bathrooms;

- High roof that causes heat loss due to larger temperature gradient; and,
- Front entrance is not wheelchair accessible due to large step and lack of automatic doors (see Figure 29).

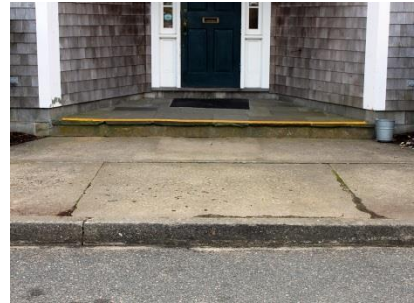
Figure 29: Non-ADA compliant entrance

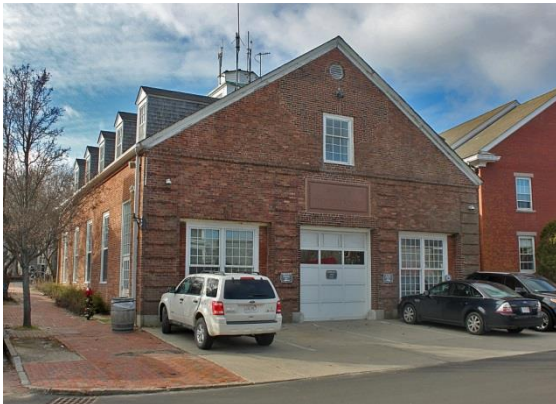
Figure 31: 20 South Water St

The facility located at 20 South Water Street, was constructed in 1929. Having served as both a fire and police station in times past, the building is constructed with a masonry frame. It currently hosts the Sheriff's Office, holding cells, and an administrative office, and serves as venue for various community events. The town has previously considered demolishing the building, but the HDC denied the request as it is a structure of historical significance. The primary issues of concern that we identified include:

- Currently occupied by only three full-time employees (only use approximately 1000 of the 5200 square feet);
- Drywall deteriorating and insulation falling through ceilings and walls;
- Exposed electrical wires and uninsulated pipes;
- Multiple holes in walls and floors;
- Significant water damage on ceilings/walls, especially second floor (see Figures 32 & 33);
- One of two staircases is condemned according to Facility Manager, Larry Kester;
- Many unused/unidentified wiring systems still in place (see Figure 34); and,
- Outside trim and windows are deteriorating (i.e. rust and rotting wood).

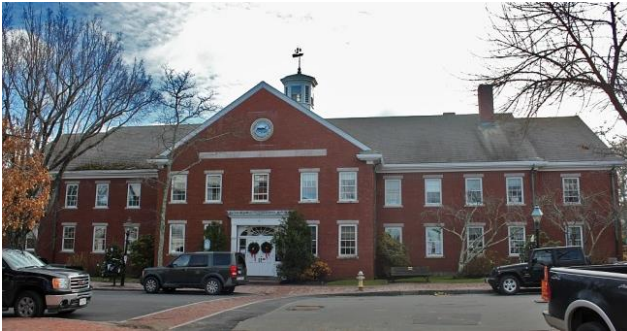
Figure 35: Town Building

Nantucket's Town Building, located at 16 Broad Street, was built in 1964. The building, constructed with a masonry frame, is one of Nantucket's most frequently used and visited buildings. It currently hosts the Town Procurement Office, Town Clerk, Town Administration, Registry of Deeds, Registry of Motor Vehicles, Courthouse, and Energy Office. The primary issues of concern that we identified include:

- Leaking water circulators;
- Boiler room floor does not drain properly;
- Asbestos is present in the building's slate tiles, stucco ceiling, and radiator backing boards (*Report for Hazardous Materials Identification Survey at the Town Hall Nantucket, Massachusetts, 2014*);
- The building's only security system is located in the upstairs courtroom area;
- Significant lack of waiting space throughout building - waiting people often spill out on stairs, within the court security area, and outside of the building;
- Lack of meeting space – only two conference rooms (one is private and the other comfortably fits about eight) (see Figure 36);
- Some windows cause noticeable heat loss to office spaces; and,
- Lack of parking, notably in summer months (see Figure 37).

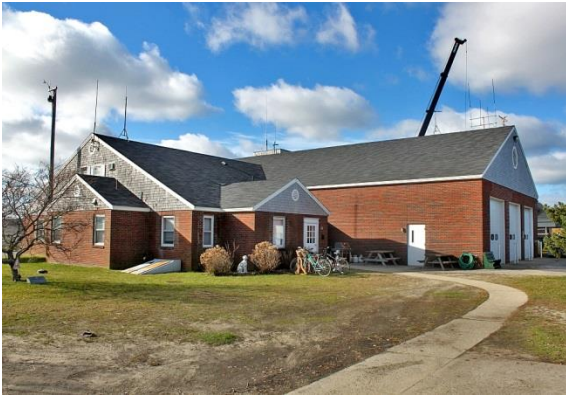
Figure 39: Fire Station

The central fire station, located at 131 Pleasant Street, was constructed in 1979. The building is composed of a wood frame and brick veneer. With its island-central location, hence its name, this building serves the island's main fire station. The primary issues of concern that we identified include:

- Fume extraction system is broken and needs significant repair; and,
- Garage bays are filled to capacity with emergency vehicles and equipment (see Figure 42).

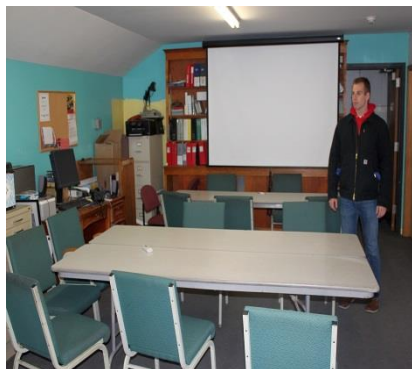
- Current sleeping quarters are at maximum capacity (see Figure 40);
- Upstairs office space was originally designed as a storage area, has only one means of egress, and is not handicap accessible (see Figure 41);

Figure 41: Cramped office space

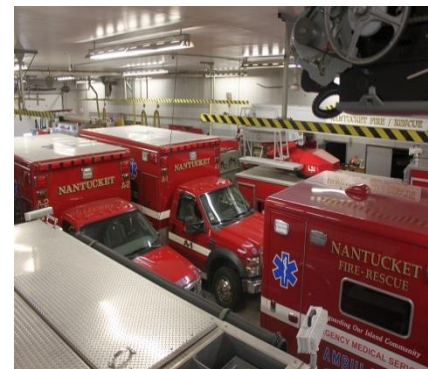
Figure 42: Packed garage bays

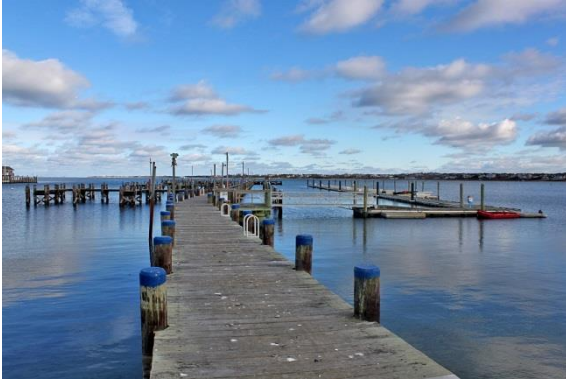
Figure 43: Town Pier

Nantucket's Town Pier, located behind the Harbormaster Building at 38 Washington Street, was constructed in the 1980's and '90's. Constructed entirely of wood, with the exception of steel pylons used to anchor the floating docks, the pier serves as Nantucket's primary destination and docking point for private boats. The primary issues of concern that we identified include:

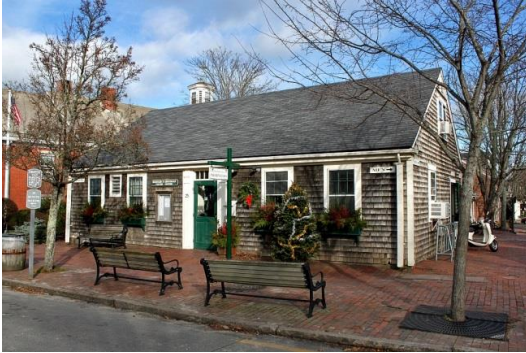
Figure 50: Visitor Services

Nantucket's Visitor Services building, located at 25 Federal Street, was constructed in 1950 and has a wood frame. The building serves as a primary source of island information for newcomers and people who are unfamiliar with all of the island's offerings. Important aspects of this facility that we identified include:

The Level II facilities had less severe issues which we recommend be addressed in the next 3-5 years. Visitor Services needs more energy efficient, handicap accessible doors, as well as interior doors to increase privacy and control noise, better communal space, and a more

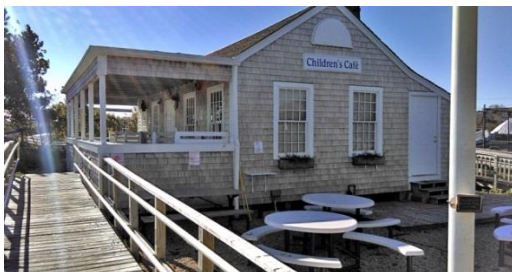
Figure 52: Children's Beach

Children's Beach and Concession, located at 15 Harborview Way, was constructed in 1970 and has a wood frame. This facility provides food, beverages, bathrooms, and seating for those using Children's Beach, or the facility's playground equipment, stage, or grass area. The primary issues of concern that we identified include:

- Needs new side shingles in some areas;
- Building is located in a flood zone, but is sufficiently raised off of the ground;
- Two bathrooms located in building are inadequate for their frequent seasonal usage;
- Location of sewer pipe and connection to sewer main are unknown - this will largely inhibit the DPW's ability to address related issues in a timely manner;
- Location of irrigation lines within grass area are unknown - tent stakes, etc. are inadvertently driven into these lines, and damages go unnoticed for days or weeks;
- Security issues with area surrounding the building - vagrant citizens often take advantage of the poorly lit area; and,
- Playground is outdated and in need of replacement - of large concern is its wood construction, which poses a splinter hazard to users.

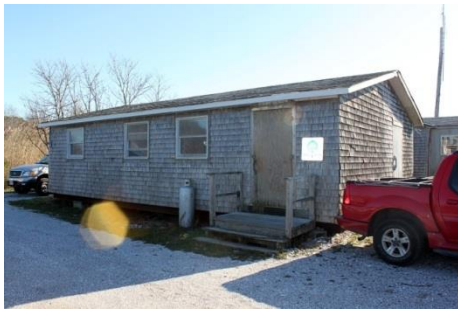
Figure 53: DPW Sheds

The DPW's sheds, located on DPW property at 188 Madaket Road, were built in 1978. These wood-framed buildings, some of which are portable, serve as space for both storage and employee functions. The primary issues of concern that we identified include:

efficient heating system to prevent pipe freezing. The DPW needs more garage storage space for equipment and entirely new sheds. Unheated portable schoolhouses are currently being used as sheds and employee communal areas. The Children's Beach and Concession should install a new metal playground to avoid splinter hazards, as well as more adequate lighting and security cameras to discourage loitering. We recommend that the Harbormaster Building bathrooms be upgraded and/or rebuilt. These bathrooms are used by hundreds of people per day in the summer months, but are currently not aesthetically pleasing.

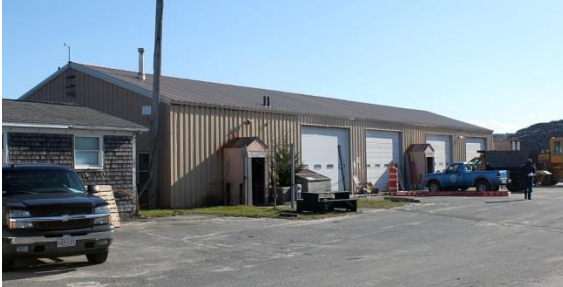
Figure 55: DPW Garages

The DPW's garages, located on DPW property at 188 Madaket Road, were built in 1978, with the exception of the Fleet Maintenance Garage being built in 2001. These garages, varying between wood and steel frames, store DPW vehicles, equipment, and serve as maintenance areas for both of these. Important aspects of this facility that we identified include:

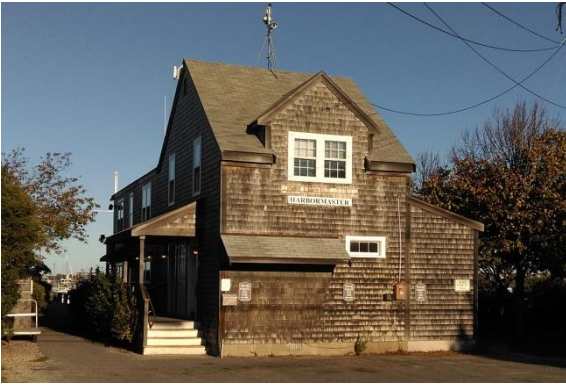
Figure 58: Harbormaster

Nantucket's Harbormaster Building, located at 34 Washington Street, was constructed in 1988 and consists of a wood frame. The building hosts public bathrooms, offices and meeting space for the Harbormaster and dock workers, and storage space for various marine and lifeguard equipment. Important aspects of this facility that we identified include:

- Building contains public bathrooms - used by up to 500 people on an average summer day; mostly from private boats that dock at the town moorings;
- Bathrooms are entirely usable and ADA compliant, but do not offer an aesthetically pleasing first impression of the island (see Figure 59);
- Communal staff space overflows in summer season;
- Building is used as office space for harbormaster, lifeguards, and dock boys;
- Lack of emergency power - in a power outage, the Harbormaster must bring her personal generator to the building to maintain contact with police station, including radios and surveillance cameras;
- Building floods frequently, especially during storms (see Figure 60);
- East facing doors and windows on second floor leak water and are rotting (see Figure 61); and
- ADA ramp railing needs to be replaced.

Also, we recommend that the Harbormaster Building bathrooms be upgraded and/or rebuilt in the next 3-5 years. As mentioned in the Findings section, these bathrooms are used by hundreds of people per day in the summer months, and serve many people with a first impression of the island; currently, they are not be as aesthetically pleasing as they should be.

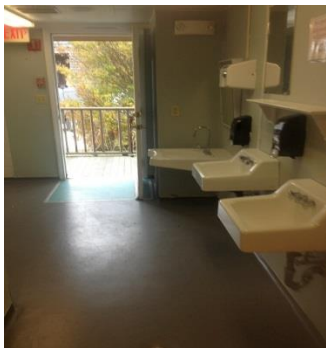
Figure 59: Female bathrooms

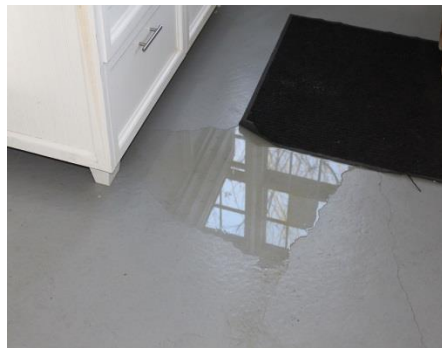
Figure 60: First floor flooding

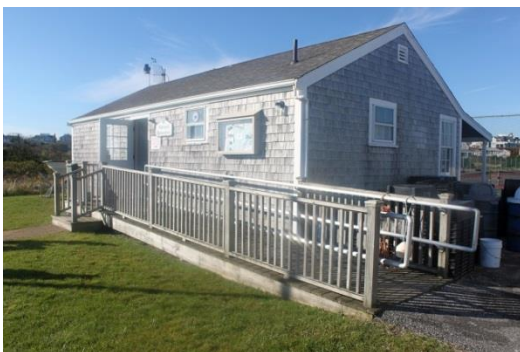
**Figure 65: Natural Resources Department**

Nantucket's Natural Resources Building is located at 2 Bathing Beach Road. The entire building has a wood frame, with its main structure being built in 1950, and a series of additions being added at later points in time. The building hosts office and storage space for the Town's Natural Resources Department. Important aspects of this facility that we identified include:

- Comprised of a series of three additions;
- Only one office for four full-time employees;
- Severely inadequate storage space for permit files - one wall of the bathroom is lined with filing cabinets;

- Building is located in a flood zone - does not usually flood due to pitch of land up to doors; and,
- Parking lot often floods during storms.

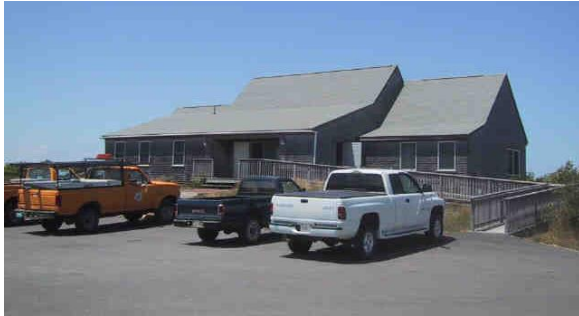
Figure 66: DPW Administration

The DPW's Administrative Building, located on DPW property at 188 Madaket Road, was constructed in 1998 and consists of a wood frame. This building serves as the administrative center for the DPW and is located next to the island's landfill. Important aspects of this facility that we identified include:

- Built more recently than many of the town's other facilities;
- Structure is in overall good condition;
- Cathedral ceiling in main entrance causes issues with heating - space heaters are often used to keep employees warm;
- Sufficient office space for the current staff in the building, however, space will be very tight should the facility reach its intended capacity;
- Oil and diesel storage tanks on the property are 18 years old - will need to be replaced within the next two years;
- Building's close proximity to other DPW buildings and landfill is convenient for employees; and,
- One leak area in the ceiling of the DPW Director's office due to a bad seal where two sections of the building, having two different heights, conjoin.

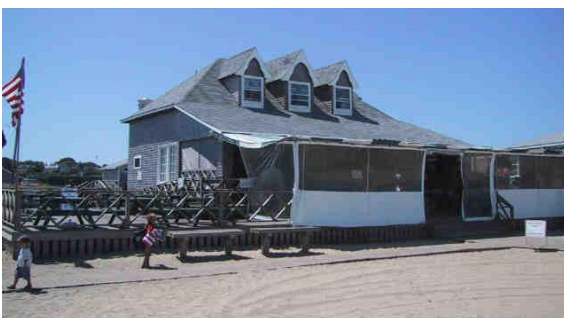
Figure 67: Jetties Beach Concession

Jetties Beach Concession, located at 4 Bathing Beach Road, was constructed in 1890 and consists of a wood frame. This facility provides food, beverages, bathrooms, and seating for those using Jetties Beach. The building also hosts a bar on its water-facing side. Important aspects of the facility that we identified include:

- Building has very few issues and is in generally good condition;
- Some railings are showing signs of wear, but are still in fair condition; and,
- Kitchen ceiling is showing signs of wear and aging - water stains, grease, and mold.

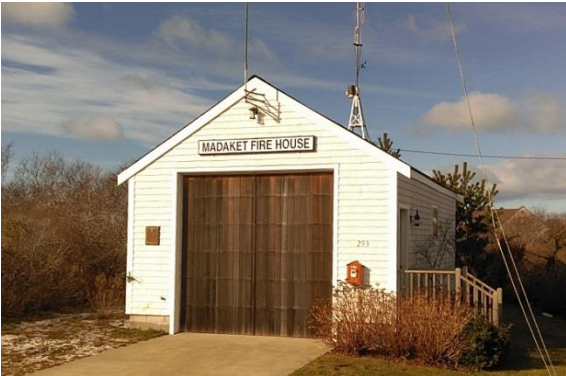
Figure 68: Madaket Fire Station

The Madaket Fire Station, located at 293 Madaket Road, was built in 1981 and consists of a wood frame. This building serves as one of two satellite stations to the Central Fire Station, and houses a single fire truck and various firefighting equipment. Important characteristics of this facility that we identified include:

- Seldom used by fire department;
- Inadequate parking - only one, overgrown parking space exists; and,
- Siding and roofing recently replaced and in good condition.

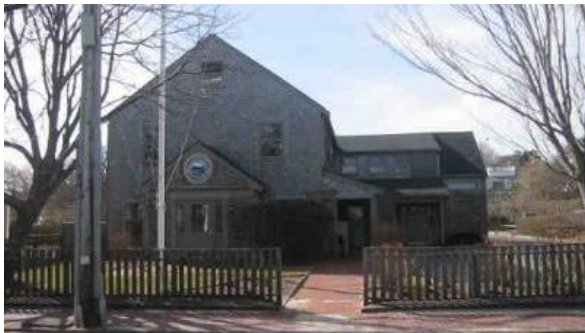
Figure 69: Finance Building

Nantucket's Finance Building, located at 37 Washington Street, was constructed in 1977 and consists of a wood frame. This building, located just out of the downtown area, currently hosts office and storage spaces for the Town's Finance Department. Important characteristics of this facility that we identified include:

- Overall good condition with very few significant problems;
- Building lacks a second staircase;
- Lack of sufficient storage space - minimal remaining storage space in attic; boxes of paperwork are stacking up on top of file cabinets on second floor;
- Inadequate meeting space/ communal area - the only meeting space is located in a portion of an employee's office;
- Building contains no break area; and,
- Inadequate parking during summer due to parking lot being shared with public.

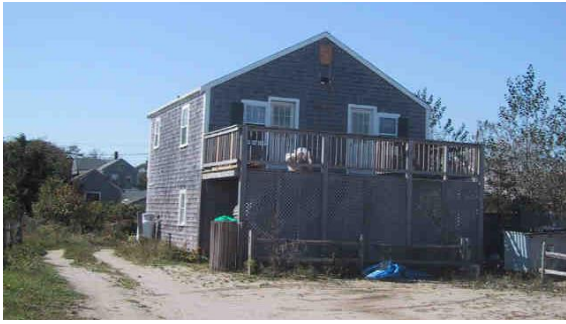
Figure 71: Female Lifeguard Housing

The Female Lifeguard Housing, located at 109 Washington Street, was constructed in 1970 and consists of a wood frame. This building hosts the Harbormaster's female lifeguards in the summer months. Important aspects of this facility that we identified include:

- Inadequate space to serve its purpose - designed to house four people but houses eight;
- Kitchen was just redone and is in great condition;
- Walls are not well-insulated - not an issue seeing as it is only used in the summer; and,
- Aging upper deck.

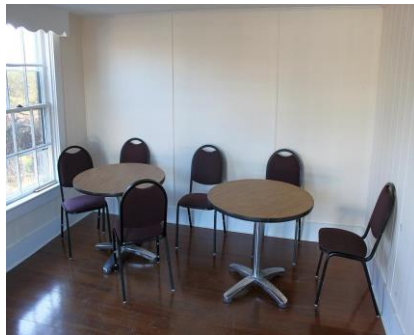
Figure 73: Remodeled dining area in male lifeguard housing

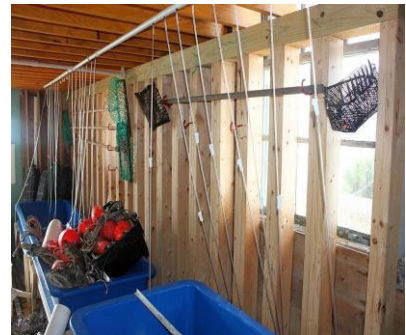
Figure 74: Rebuilt wall frame in Shellfish Lab

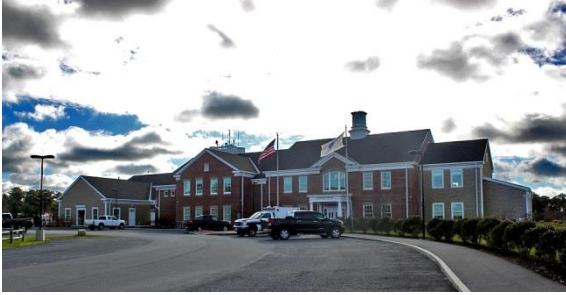
Figure 75: Public Safety Facility

Nantucket's Public Safety facility, located at 4 Fairgrounds Road, was constructed in 2010. This building hosts the Nantucket Police Department, as well as two community meeting rooms. Notable characteristics of this facility that identified include:

- Building is in like-new condition with no obvious issues;
- Includes a new public community room and training room - both of which are frequently booked; and,
- Contains 107 security cameras, data and dispatch rooms that can be protected from fire for two hours.

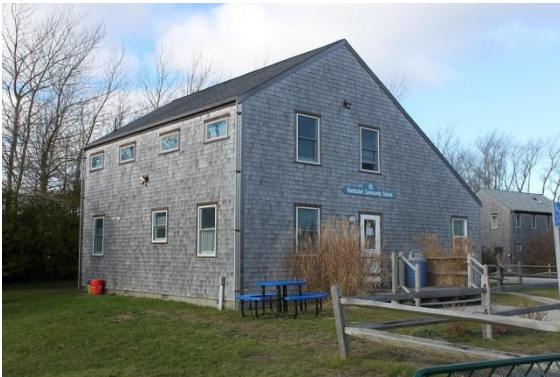
Figure 76: Community School

Nantucket's Community School, located at 34 First Way, is constructed with a wood frame. The building currently hosts continuing education and teen program centers. Notable characteristics of this facility that we identified include:

- Building is currently unfit to fulfill its purpose - will be undergoing renovations in very near future that will address existing issues;
- Currently used as a continuing education and teen program center - renovations will transform it to include the Early Childhood Center; and,
- Building location is ideal - it is in close proximity to the public schools.

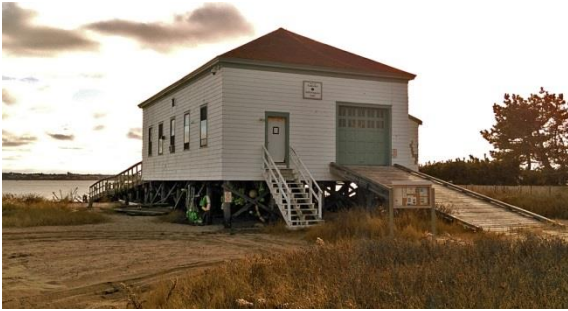
Figure 77: Shellfish Laboratory

The Shellfish Research Laboratory, located at Brant Point next to the light house, consists of a steel structure and wood framing. The building is used for shellfish research and breeding, and has a boat ramp and storage spaces for related activities. The primary issues of concern that we identified include:

- In off-season, underside of building is used as a space for storing equipment - this area is extremely cluttered and hazardous to people walking around in it (see Figure 78);
- Boat loading dock was recently redone and is in excellent condition;
- Black mold present on building shell, interior windows, and steel beams (see Figure 79);
- No seals around interior supporting pillars (steel) - ground is visible in gaps surrounding pillars (see Figure 80);
- No sealed doors upstairs - this creates the largest facility problem for the shellfish biologist, because it prohibits sterilization and temperature control for optimal shellfish breeding; however,
- Plans are in place for a complete renovation.

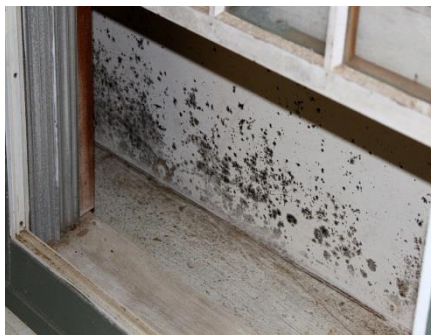
Figure 79: Black mold

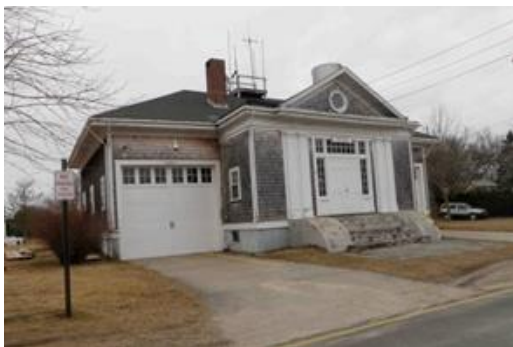
Figure 81: Siasconset Fire Station

The Siasconset Fire Station, located at 10 West Sankaty Road, was built in 1930 and consists of a wood frame. This building serves as one of two satellite stations to the Central Fire Station. It houses one fire truck and one tanker, and provides storage space for fire department equipment. Important characteristics of this facility that we identified include:

- Front door and windows in need replacement and/or paint - they are all in disrepair and are not weatherproofed;
- Concrete front steps in need of replacement (see Figure 82);
- No parking (see Figure 83);
- Front steps, front door, garage bay doors, and windows all need replacement - they are all in disrepair and are not weatherproof; however,
- Plans are in place to request funding for many additional alterations within the next year and,
- Building is currently undergoing repairs - roof and gutters are being replaced.

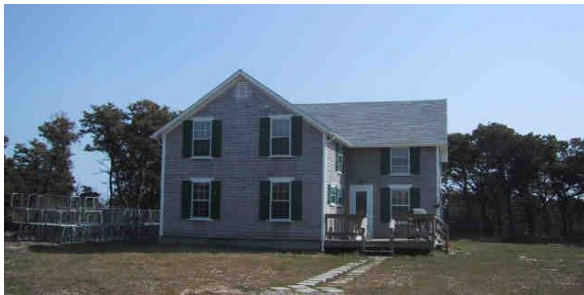
Figure 84: Male Lifeguard Housing

The Male Lifeguard Housing, located at 47 Okorwaw Avenue, was built in 1900 and consists of a wood frame. This building hosts the Harbormaster's male lifeguards in the summer months, and the surrounding property serves as storage space for lifeguard equipment. Important aspects of this facility that we identified include:

- Building is in overall good condition with very few problems;
- Interior of building was recently refurbished and is in excellent condition;
- Up to twelve people live in the building during the summer months;
- Due to high occupancy, the septic tank must be pumped multiple times during summer months; and
- Use of indoor shower is prohibited due to concern with overwhelming the septic tank.
