# Maintaining the Integrity of Structural and Fire Protection Systems and Building Documentation in Historic Buildings: Washburn Shops Case Study

# Washburn Shops Case Study

in partial fulfillment of the requirements for the  
Degree of Bachelor of Science  
in Civil Engineering by

Date:  
March 1<sup>st</sup> 2012

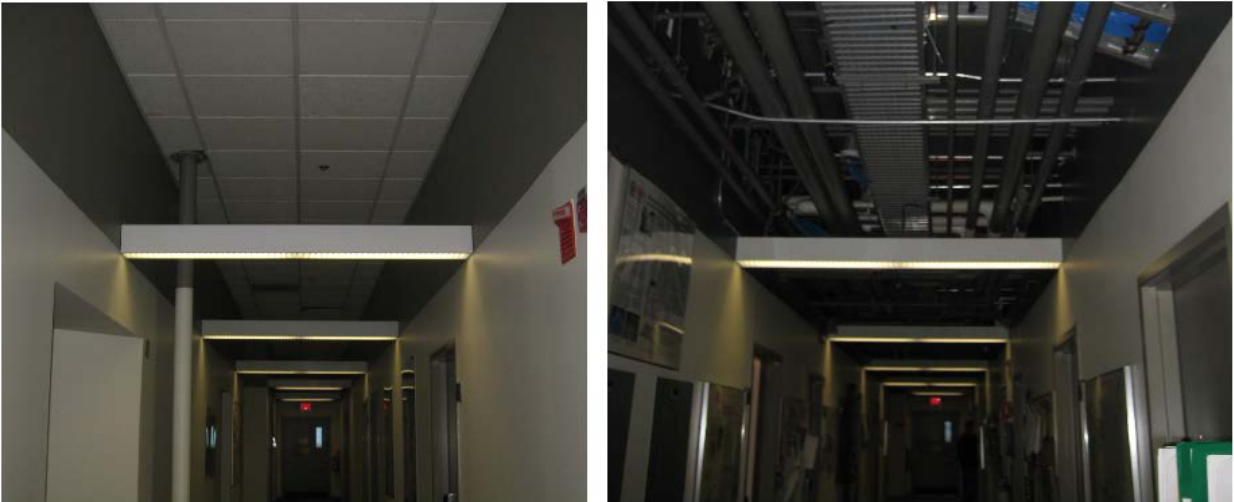
Figure 54: Washburn Ceilings (third floor on left, second floor on right)

The hallways within the addition of Washburn show very different sprinkler position between floors. On the third floor, sprinklers are included in the suspended ceiling, but in the second floor, the sprinklers are some-what hidden within the pipes and ducts of the overhead area that does not have a suspended ceiling. Figure 54 helps to compare these two situations.

The sprinklers on the third floor are visible and no obstruction poses a threat for the sprinklers' spray pattern. However, the sprinklers on the second floor hallway are not even visible in this photo. A closer investigation was done to locate the position of these sprinklers. Figure 55 shows the same sprinkler but at different distances.

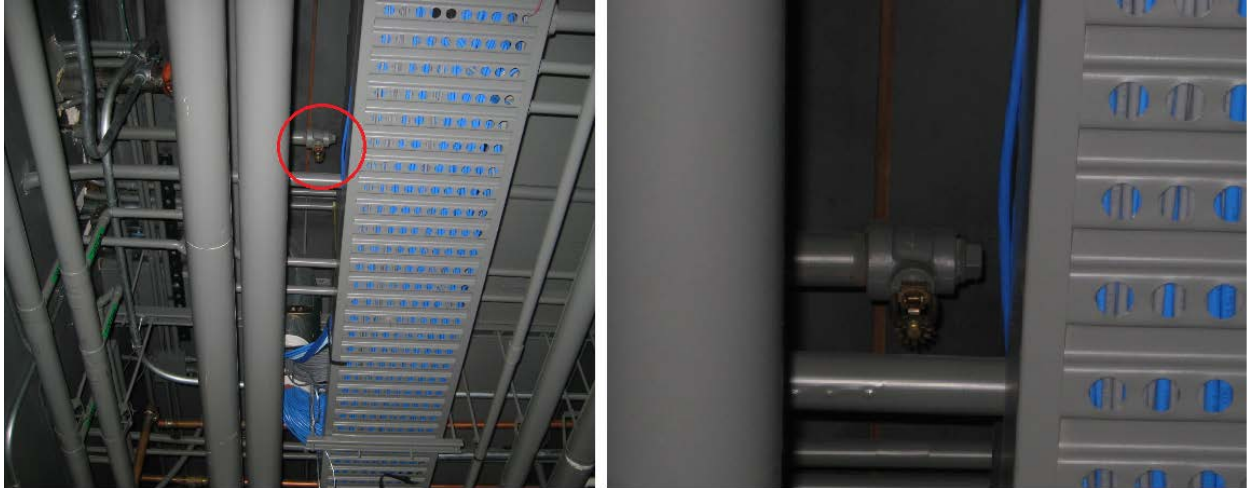
Figure 55: Sprinkler Obstruction in Second Floor Hallway Ceiling

Obstructions to the sprinkler are visible, considering the pipe runs directly below the sprinkler by a couple inches. This obstruction placement does not comply with *NFPA 13* 8.6.5.1.2 and 8.6.5.2.1.3 as explained in item 20 of Appendix 7.2 (Fire Protection System Checklist).

Many cases similar to Figure 55 were observed within Washburn, whether the sprinklers are too close to a pipe, beam, or lighting fixture. These cases also violate *NFPA 13* 8.6.5.1.2 and 8.6.5.2.1.3 (item 20 in Appendix 7.2). Examples of sprinklers with obstructions too close to the

Numerous sprinkler obstructions were identified in section 3.2.2 but the second floor hallway was the most concerning area because almost every sprinkler is obstructed by the network of pipes and vents below the sprinkler heads. Figure 55 is repeated as Figure 50 below to show an obstructed sprinkler within this hallway.

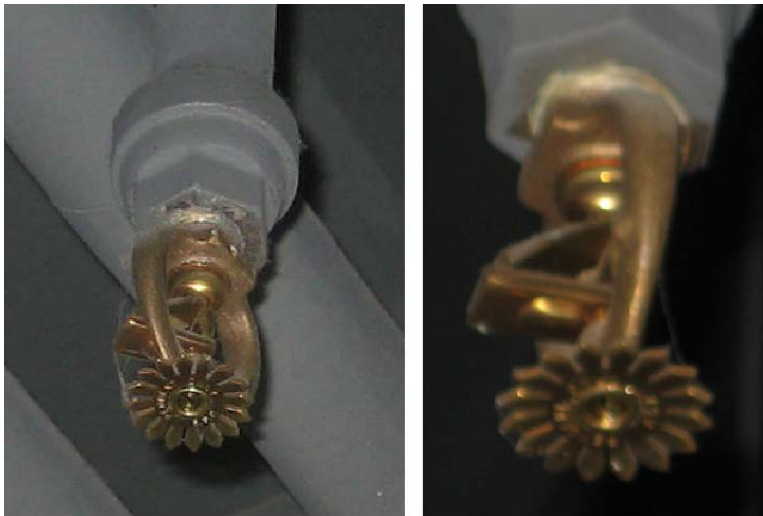
Figure 60: Sprinklers that need to be cleaned

Figure 60 and Figure 61 show examples of sprinkler heads that need to be cleaned. Proper care was also not taken when painting the pipes around the heads because some of the paint stuck to the deflectors. This paint and dirt can obscure the sprinkler spray pattern and thereby reduce the protection to the floor area below the sprinkler. These situations are out of compliance with *NFPA 13* Table 5.5.1 and item 39 in Appendix 7.2.

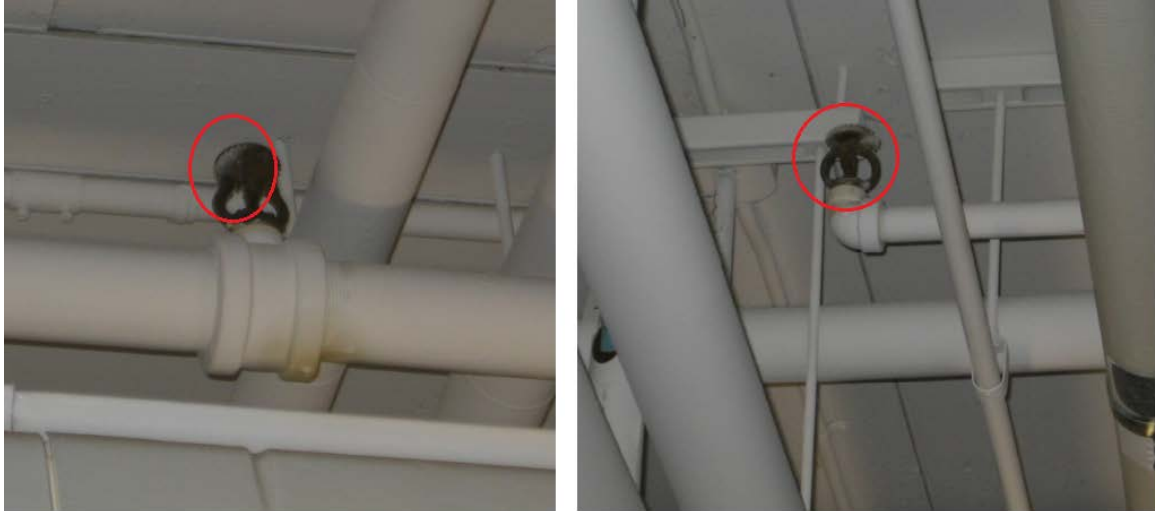
Figure 61: Paint on Sprinkler Deflectors

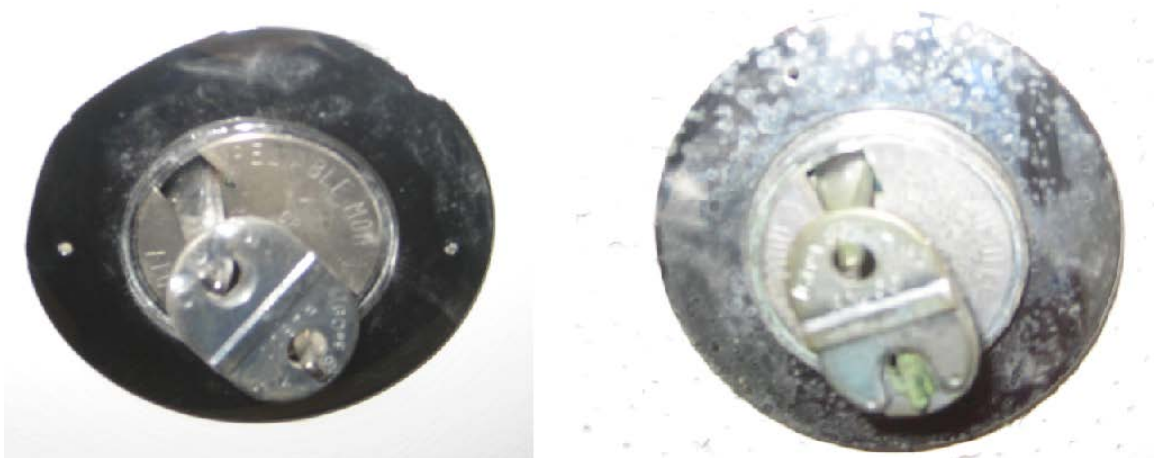
Figure 62: Fusible link askew on left sprinkler compared to right

Figure 62 shows that the sprinkler on the left has a fusible link that is at a different angle than the link for the sprinkler on the right. The sprinkler must have been hit, and no one has noticed

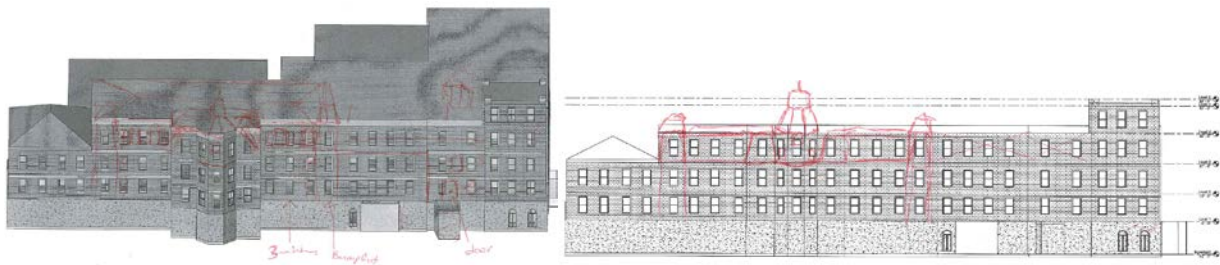
The problems and discrepancies with the WPI students' model are highlighted in Figure 69. The windows are of different type and the third floor begins the roof structure. The floor heights also vary from the WPI Department of Facilities' model.

Figure 69: Notes on WPI Students' Model Discrepancies

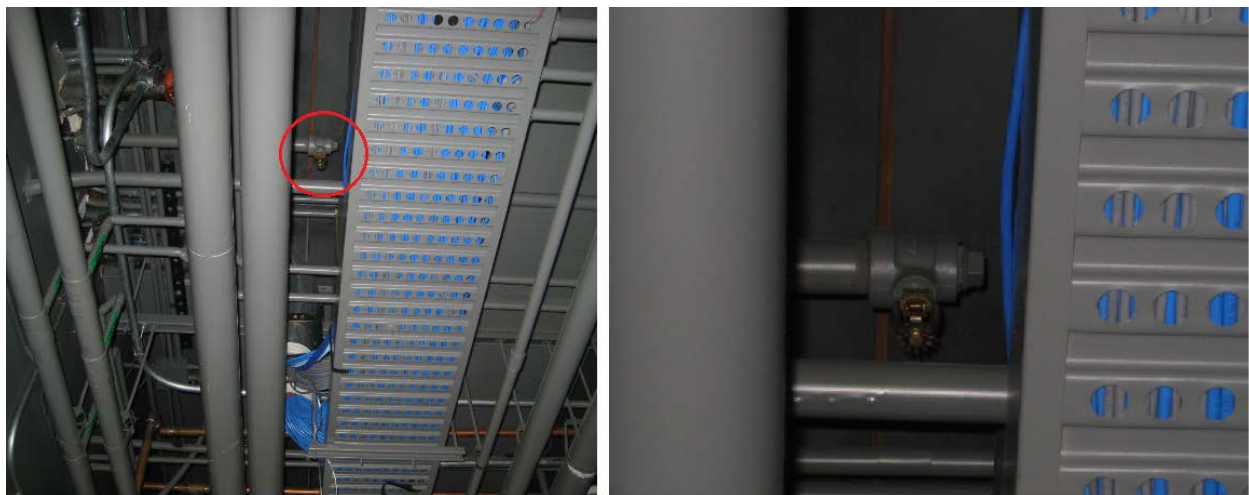
**Figure 82: Sprinkler Obstruction in Second Floor Hallway Ceiling**

As Figure 82 shows, a pipe almost directly below the sprinkler head would obstruct the spray pattern. *NFPA 13* Section 8.6.5.1.2 states that an obstruction less than 1 foot from a sprinkler head must be at the same height as the deflector or above. In order to alleviate the obstruction problem in this hallway, the goal would be to create a ceiling similar to the one on the third floor hallway as seen in Figure 83.

To create a ceiling equivalent to the third floor, the second floor requires a suspended ceiling. Along with this ceiling, sprinklers that drop down to the new ceiling level would have to be added to the system. This would allow for the concealed space above the ceiling to be protected with the current sprinklers and the floor space to have protection from the new, unobstructed sprinklers in the suspended ceiling. The suspended ceiling is necessary because without it, the new, dropped sprinklers would not perform properly. If a fire occurred, smoke would rise to the top of the ceiling setting off the current, obstructed sprinklers. The dropped sprinklers would not activate from the heat of the fire because there is no space for the heat to collect around the sprinkler, causing the heat to collect around the current, obstructed sprinklers. The current sprinklers cannot fully protect the area below because they are obstructed. Also, these obstructed sprinklers will cause an activation delay of the dropped sprinklers by cooling down the area around these sprinklers. Thus, the suspended ceiling would create a barrier for the smoke to remain only near the new drop sprinklers which can fully protect the floor area.

Seven new sprinklers would be added to account for the seven sprinklers that are obstructed by the current construction conditions. Figure 84 shows where the current sprinklers are located within this hallway. The full floor plan with the fire protection system is included as Appendix 7.6.

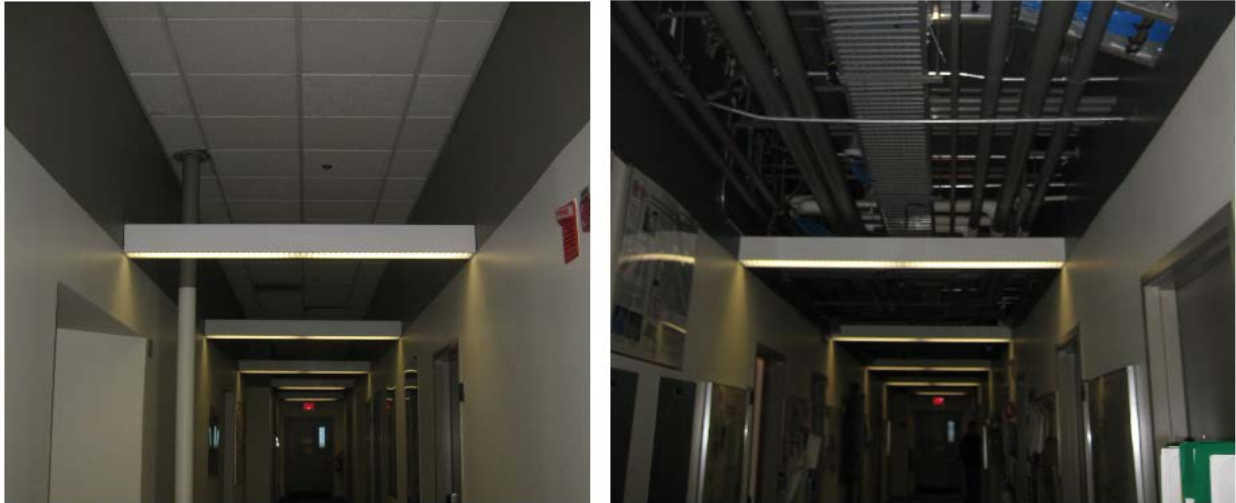
Figure 83: Washburn Ceilings (third floor on left, second floor on right)

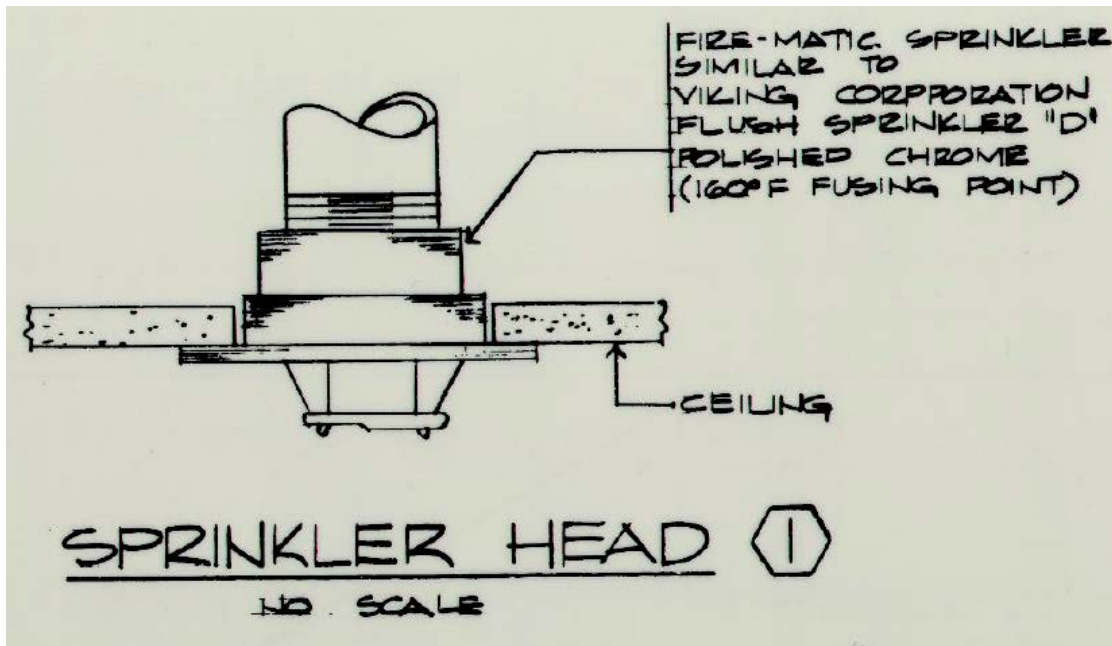
Figure 85: Sprinkler Head used in Third Floor Drop Out Ceiling

The sprinklers to be added can be installed to the side of where the current sprinklers are located. A potential problem for this installation would be that the number of pipes and conduit may not allow for a straight pipe vertically down. In this case, pipe elbows would be installed to redirect the water supply around the obstruction. The sprinklers would have to be at least 3 feet vertically from the current horizontal piping to be located below the existing network of pipes and ducts. The sprinklers that are currently installed in the third floor drop out ceiling would be used here. Figure 85 shows the plans of the selected sprinklers for this hallway.

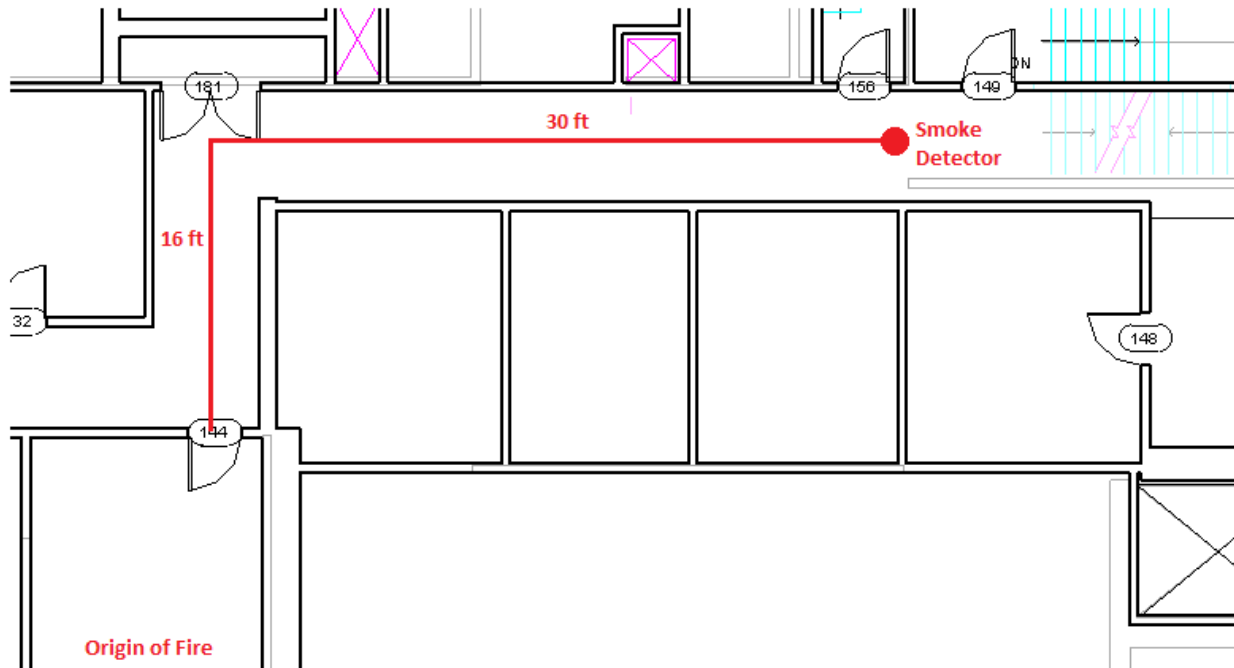
The placement of smoke detectors were obviously an issue in the roof renovation fire and raised concerns of the protection the existing detectors are offering the building. According to *NFPA 13* Sections 5.5.2.1 and 5.7.3.2.3.1, smoke detectors can be at most 30 feet from each other and concealed spaces above the ceiling should be protected with detectors. Figure 86 repeats Figure 66 and shows the distance the smoke had to travel in the hallway during the fire (this does not consider the distance between detectors).

Figure 86: Distance to Nearest Smoke Detectors in 2011 Rood Renovation Fire

Although the current spacing between detectors exceeds the permissible value, Washburn does comply with other detector placement codes just as having smoke detectors placed on either side of fire doors. For the new design, it is proposed that the detectors at the fire doors remain in place and additional detectors be installed with an appropriate spacing along the hallway to meet the code requirements. Figure 87 illustrates sufficient placement of detectors on the third floor. The other floors of Washburn have a similar layout to this one and thus the detectors can be placed almost identically to Figure 87.

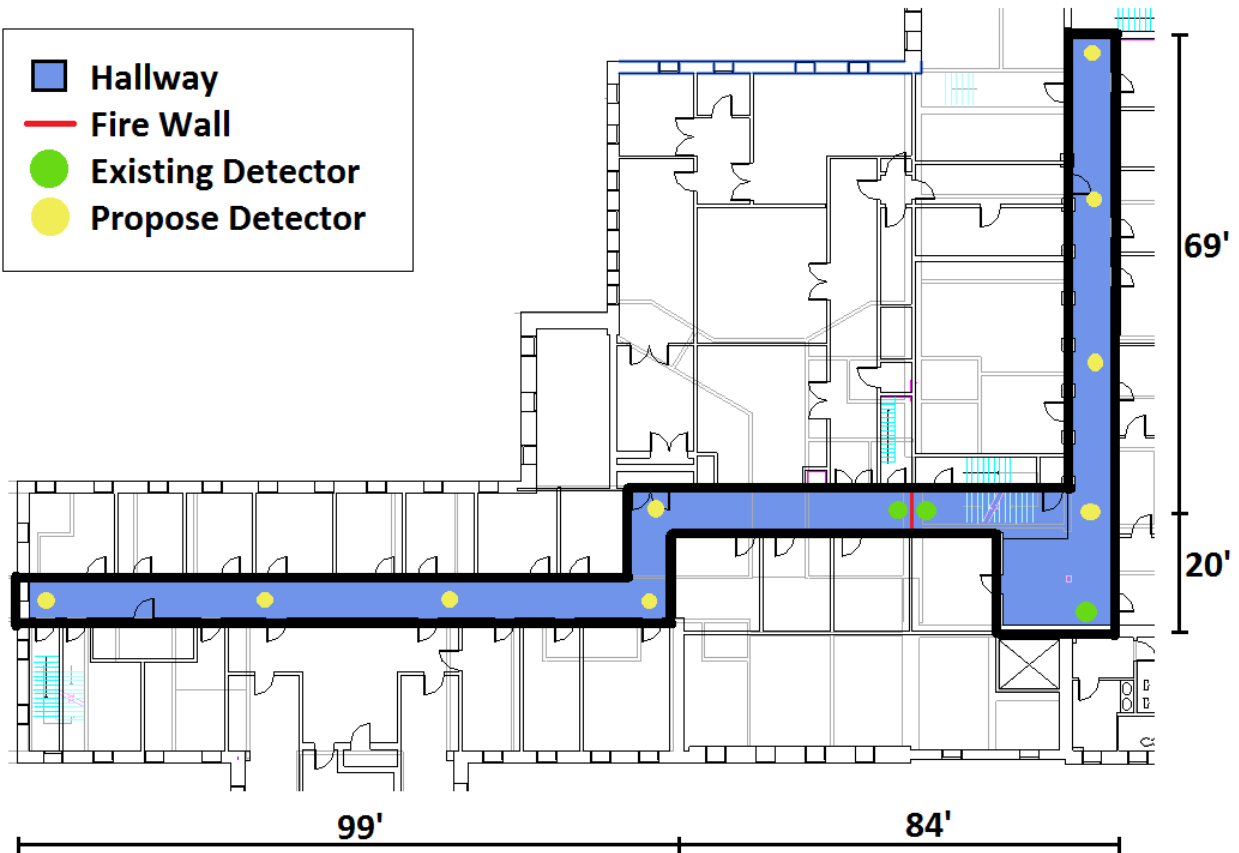
Figure 87: Proposed Placement of Smoke Detectors on Third Floor

The required number and placement of detectors should also account for the fact that detectors are needed below and above the suspended ceilings that were proposed above as part of the correction for the obstructed sprinkler heads. Therefore 18 new detectors are needed per floor hallway.

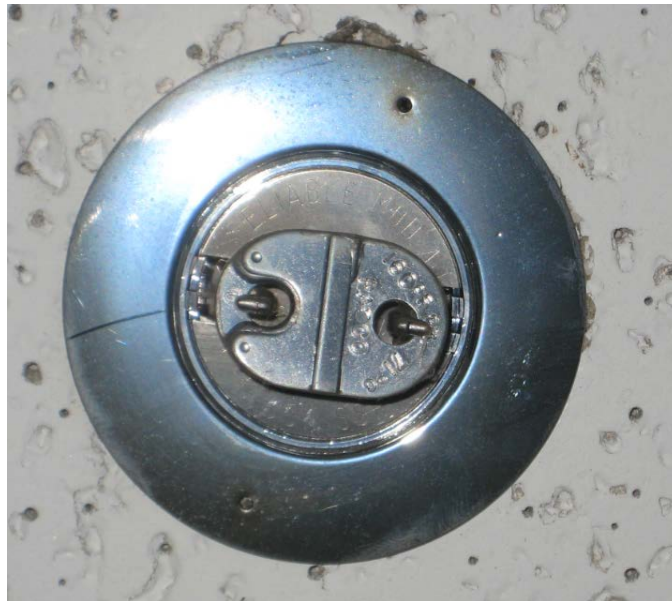
Item #	Element	Code Reference	Code Text	Interpretation	Compliant	Current Conditions
			are met, ordinary- and intermediate-temperature sprinklers shall be used throughout buildings	ducts may need a higher temperature rating but other should be ordinary or intermediate.		suspended ceiling complied. See Figure 89.
6	Area of Coverage	8.5.2.2.2	The maximum area of coverage of any sprinkler shall not exceed 400ft <sup>2</sup>	A sprinkler can protect a maximum of 400 ft <sup>2</sup>	Yes	Inspected sprinklers were closer than necessary
7	Deflector Orientation	8.5.4.2	Deflectors of sprinklers shall be aligned parallel to ceilings, rods, or the incline of stairs.	Deflectors are parallel to surface above sprinklers	Yes	All deflectors inspected were parallel. See Figure 88.
8	Distance from Walls	8.6.3.2.1	The distance from sprinklers to walls shall not exceed one-half of the allowable distance between sprinklers	Sprinklers must be between 4 inches and half of maximum allowable distance	Yes	All sprinklers inspected followed this spacing from wall.

Figure 89: Temperature Rating (item 5)

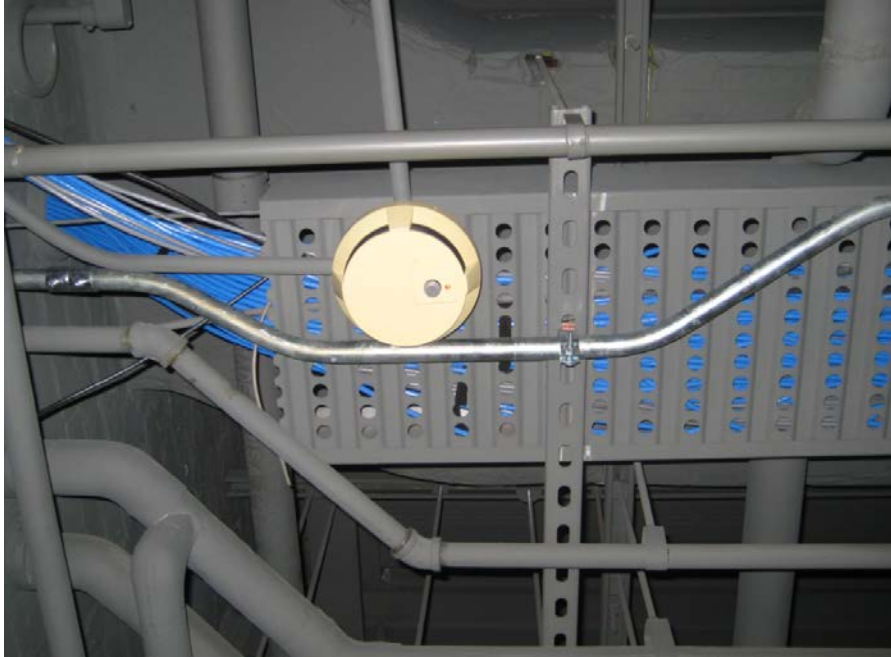
5.5.1	Unless tested and listed for recessed mounting, detectors shall not be recessed into the mounting surface.		Yes	All detectors inspection were flush with surface. See Figure 90.
15	Location of Devices	5.5.2.1	When inaccessible areas contain combustible materials, unless specified in 5.5.2.1.2, they shall be made accessible and shall be protected by a detector(s).	Combustible materials in concealed spaces need to be protected by detectors.	No	Concealed spaces above ceiling are not protected by detection devices (Horanzy, 2011) based on the 2011 fire.
17	Smoke-Sensing Detector Location	5.7.1.9*	The location of smoke detectors shall be based on an evaluation of potential ambient sources of smoke, moisture, dust, or	Smoke detector location is based on evaluation of environmental conditions.	No	Does not consider ceiling conditions based on the 2011 fire.

Figure 90: Smoke detector mounted and not recessed (item 14)

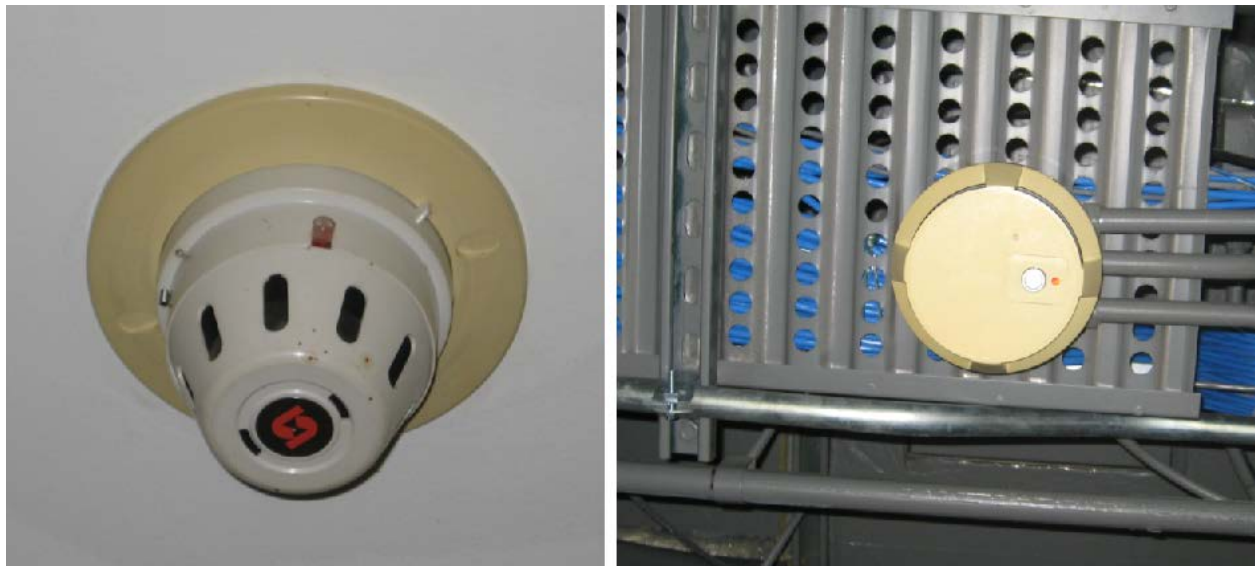
Item #	Element	Code Reference	Code Text	Interpretation	Compliant	Current Conditions
						gauges are accessible (Horanzy, 2011)
14	Installation of Devices	5.4.4	Initiating devices shall be supported independently of their attachment to the circuit conductors.	Devices need to be installed with proper support, accessibility, distance from ceiling	Yes	Proper mounting support for detectors was determined. See Figure 91.

Item #	Element	Code Reference	Code Text	Interpretation	Compliant	Current Conditions
			fumes, and electrical or mechanical influences to minimize nuisance alarms.			
18	Smoke-Sensing Detector Specification	5.7.2.1*	Smoke detectors shall be marked with their nominal production sensitivity and tolerance (percent per foot obscuration), as required by the listing.	Smoke detectors must be marked with sensitivity and tolerance.	N/A	Could not read detectors from floor visual inspection. See Figure 91.
19	Smoke-Sensing Detector Spacing	5.7.3.2.3.1*	In the absence of specific performance-based design criteria, smoke detectors shall be permitted to be located using 30 ft spacing.	Smoke detectors shall be spaced 30 ft apart	No	Smoke detectors are spaced over 30 ft apart

Figure 91: Marked Smoke Detectors (items 18 and 23)

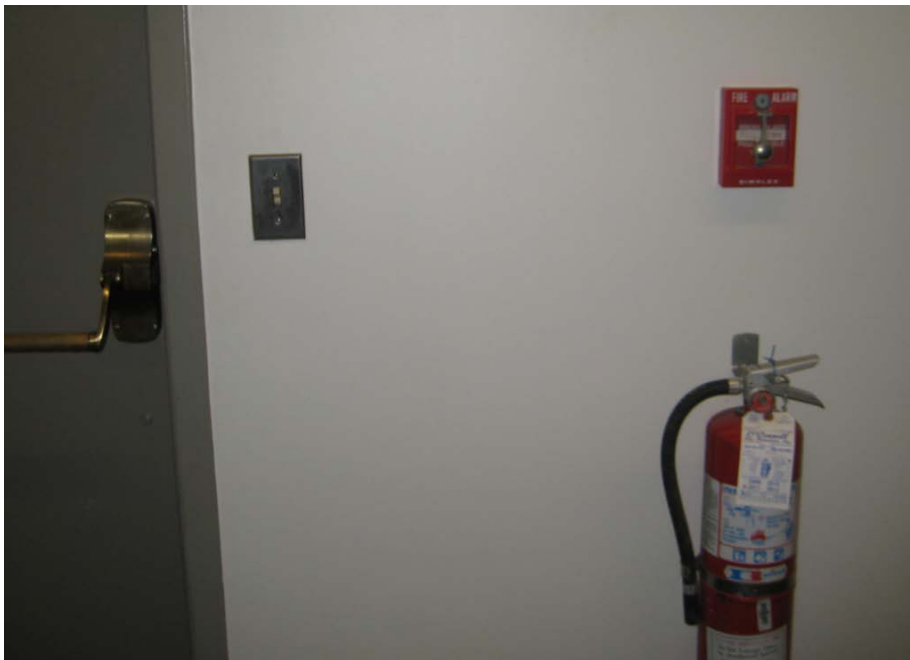
5.13.6	Manual fire alarm boxes shall be located within 5 ft of the exit doorway opening at each exit on each floor.	Manual pull stations must be at each exit on each floor and $\leq 5$ ft from the exit.	No	Most exits comply but main entrance does not. See Figure 92.

Figure 92: Pull station more than 5 ft from entrance (item 21)

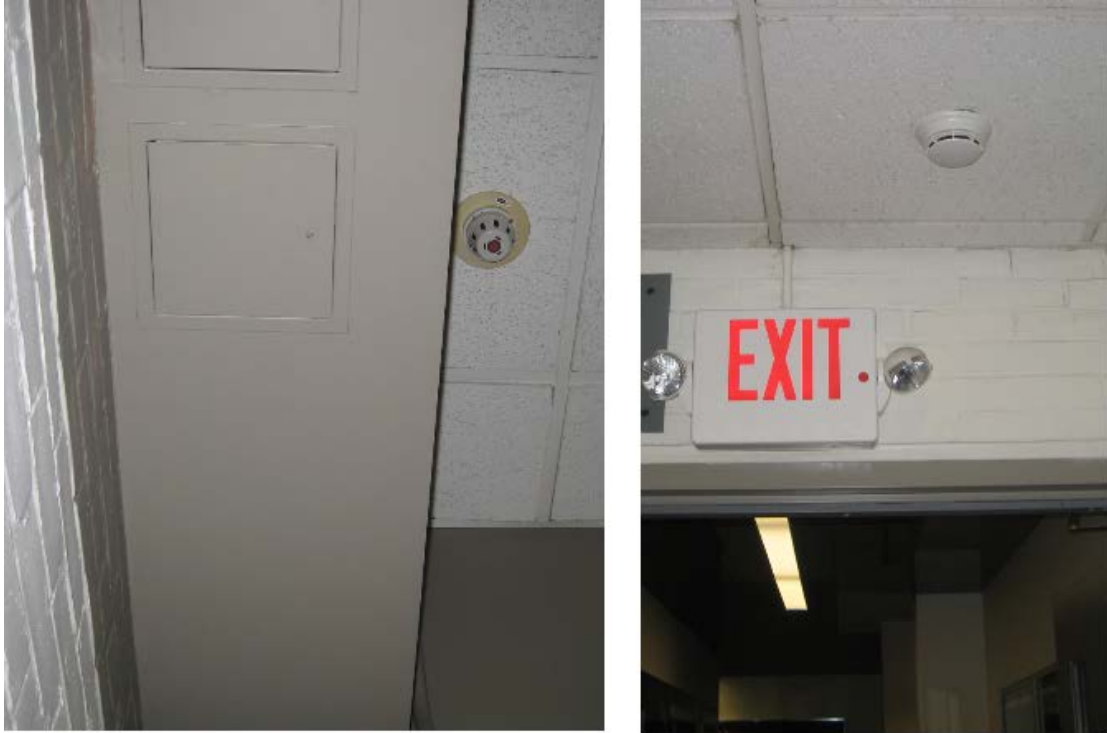
Item #	Element	Code Reference	Code Text	Interpretation	Compliant	Current Conditions
			shall not be used in lieu of providing detection within the room.			
21	Manual Fire Alarm Box Location	5.13.4	The operable part of each manual fire alarm box shall be not less than 3.5 ft and not more than 4.5 ft above the floor.	Manual pull stations must be $\geq 3.5$ ft and $\leq 4.5$ ft from the floor	Yes	Inspected manual pull stations comply. See Figure 92.

Figure 93: Pull station correct height and distinguishable (items 21 and 22)

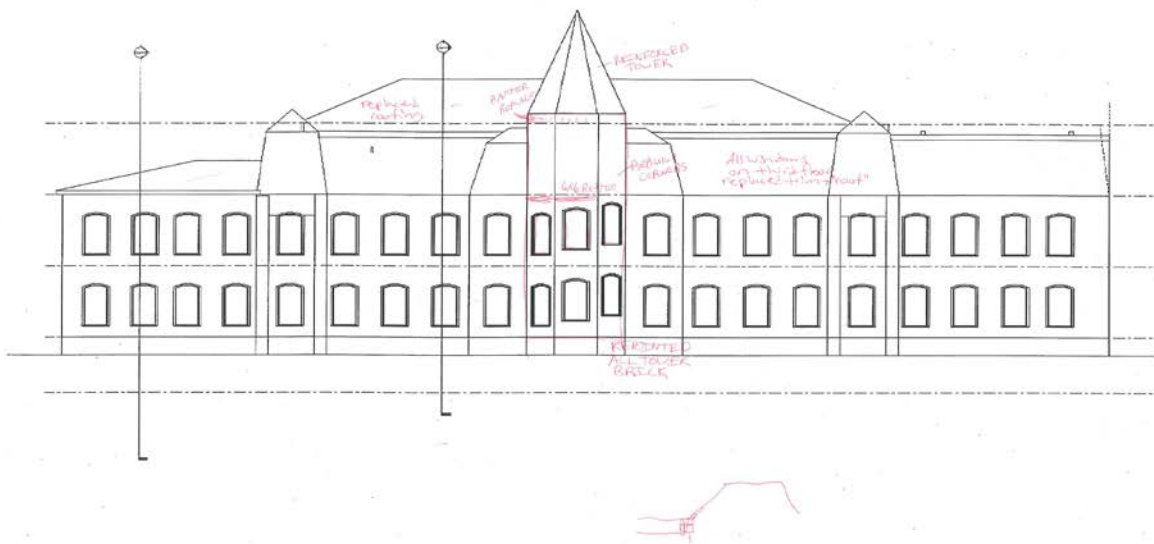
Drawing #1  
1 1/2 Meeting w/ Dave  
Cutler Associates

- Tower gutter section- Drawing #1
  - 2 6" x 6" beams, replaced with 6x6 pressure treated
- Backside of Tower
  - Rafters
  - Like a shelf- replaced with pressure treated

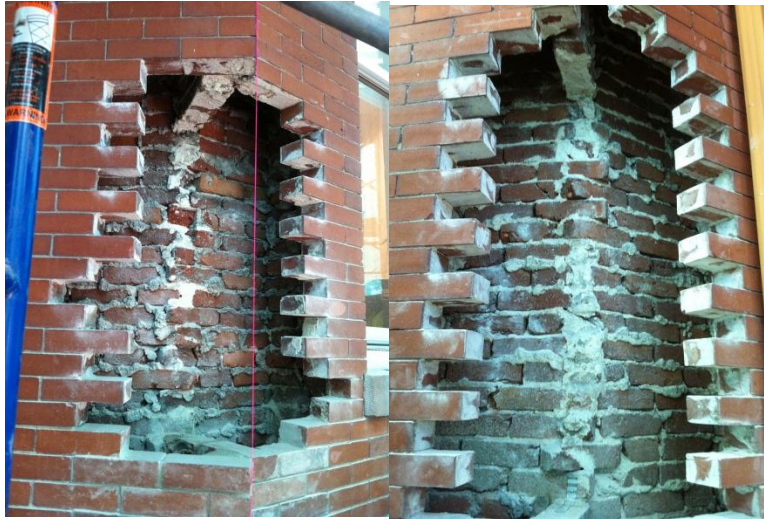
interior brick walls (Salter, 2011). The most concerning questions that arise from this situation are thermal and seismic stability. The tower walls were the only ones to be reinforced with bracing and these did not see any added insulation. Currently, the masonry walls of the original building only have a supporting column between each window and the addition's masonry walls are completely hollow between the windows (Guertin, 2011). A cross-section of the tower's masonry walls are shown in Figure 5.

Figure 5. Washburn Tower Masonry Wall Cross-Sections

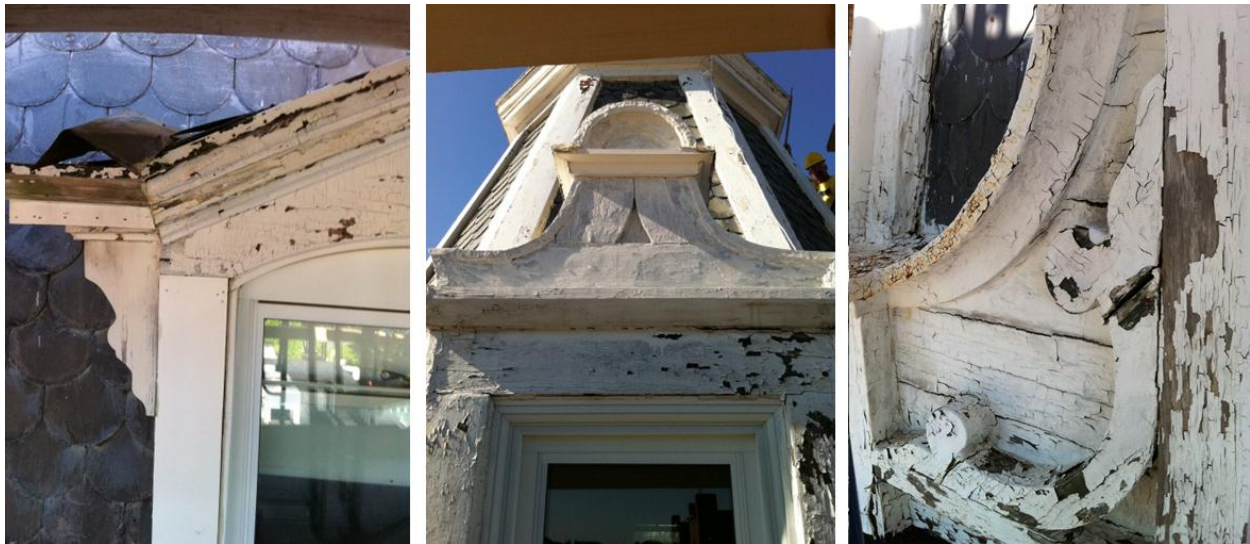
The majority of the renovation work made changes to the upper portions of Washburn. The roof was entirely re-slatted, the top row of windows were replaced but kept the “divided light” style, and 31 window eaves were rebuilt with zinc coated copper. The before and after conditions of the windows is illustrated in Figure 6 and Figure 7.

Figure 6. Pre-renovation Window Conditions

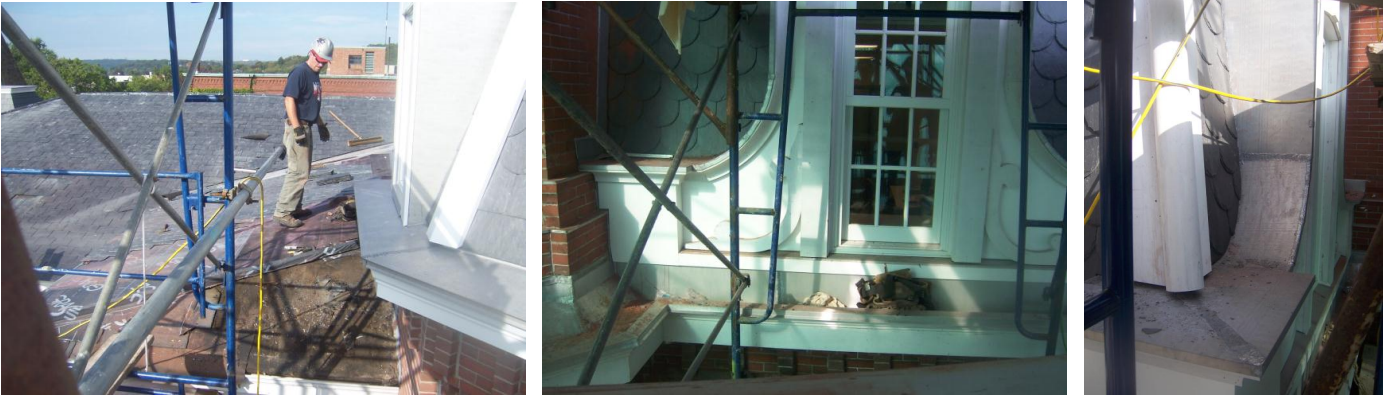
Figure 7. Window Renovation Work

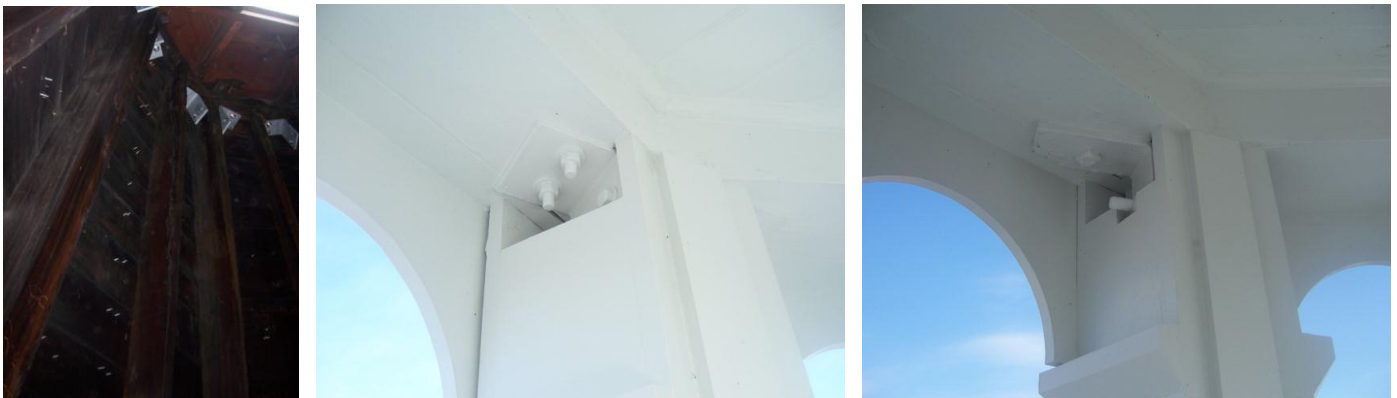
Five of the arches along the top of the building had to be completely rebuilt during the renovation because of extreme cracking and age. More will most likely need to be replaced in the future. The wood roof structure itself was deemed to be strong however one beam in the tower was replaced due to rotting. The mansard roof also had rotting sections and falling concrete that were refurbished. The tower needed to be reinforced, and bracing was installed along the inside framing. Figure 8 details the new bracing as well as the old (Guertin, 2011).

Figure 8. Views of Tower Bracing

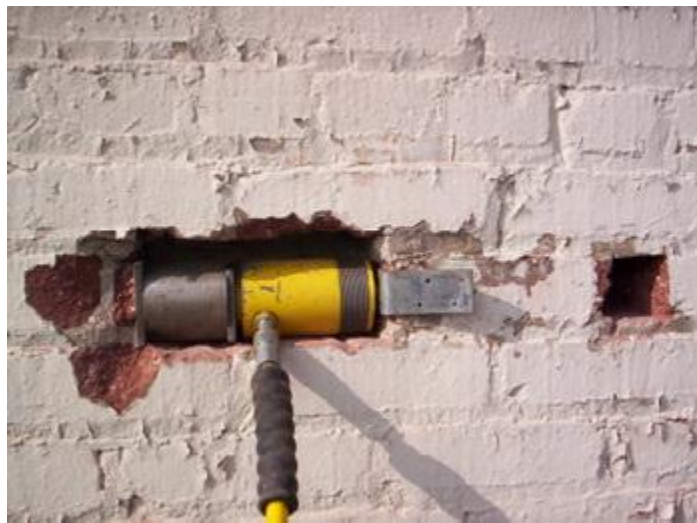
Figure 18. In-place Shear Test

If  $v_{to}$  is less than 30 pounds per square inch or 207kPa, then the mortar shall be re-pointed and retested (International Code Council 2007). Section A106.3.3.6 regulates the minimum quality of masonry and states that  $f_{sp}$  shall be a minimum of 50 psi (Cowen, 2011).

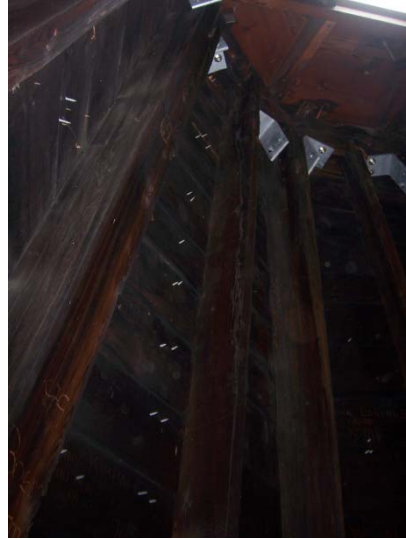
tower was replaced due to rotting. The mansard roof also had rotting sections and falling concrete that were refurbished. The tower needed to be reinforced, and bracing was installed along the inside framing. Figure 22 details the new bracing as well as the old (Guertin, 2011).

Interior of Tower with New Brackets

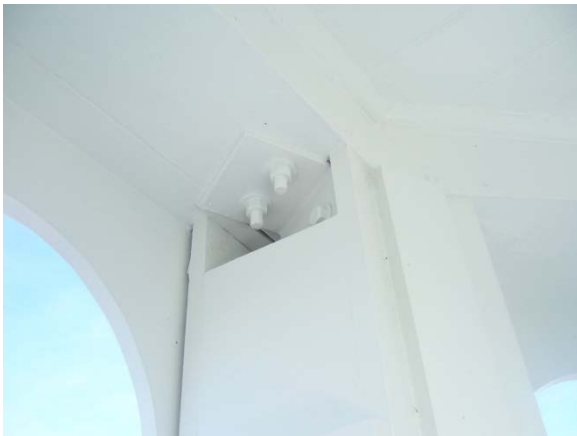
New Exterior Tower Bracket

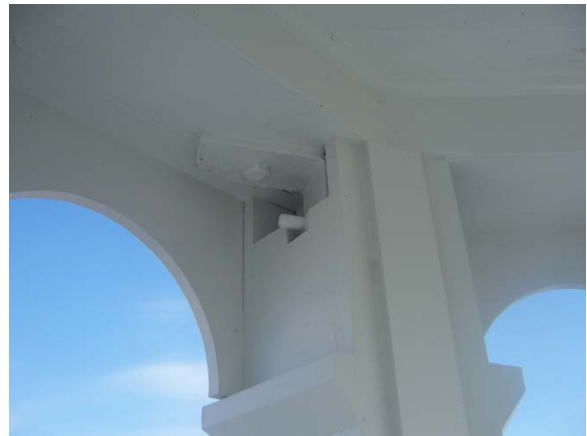
Old Exterior Tower Bracket
