The Collapse of the Alto Río Building during the 27 February 2010 Maule, Chile, Earthquake

Cheng Song,^{a)} Santiago Pujol,^{a)} M.EERI, and Andrés Lepage,^{b)} M.EERI

The Alto Río Building, a 15-story building located in Concepción, Chile, collapsed during the 2010 Maule earthquake. Construction of the building was completed in 2009 following the Chilean building code of 1996. The building was provided with reinforced concrete structural walls (occupying nearly 7% of the floor area) to resist lateral and vertical loads. The walls failed in the first story, causing the overturning of the entire building. This paper provides detailed field observations and discusses plausible causes of the collapse. [DOI: 10.1193/1.4000036]

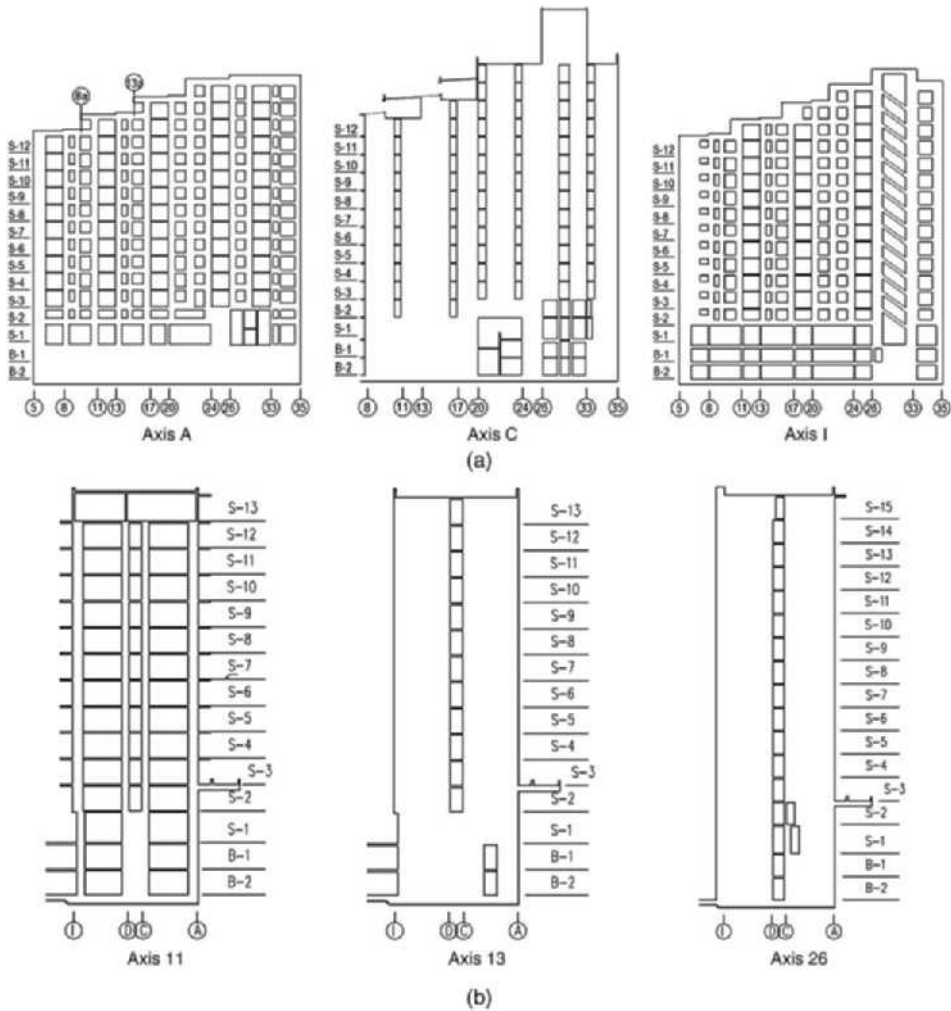
The elevations of walls along axes 8, 13, and 20 were U-shaped (Figure 3). In the first story, these walls were continuous (except for the wall along axis 20, which had a 0.6 m (2 ft) perforation between axes C and D; Figure 2) and ran from axis A to axis I' (which was 0.4 m (1.3 ft) to the west of axis I). In the second story, each of these walls was divided in two segments by a 1.2 m (4 ft) wide central hallway. One segment ran from axis A to axis C. The other segment ran from axis D to axis I (not I'), with the exterior 0.4 m of the wall not being supported by a wall underneath. This 0.4 m (1.3 ft) wall segment ran from axis I to axis I' and acted as a connection between the wall and the east facade of the building, a grid of reinforced concrete pilasters and spandrels that did not reach the ground (Figure 3, axis I). The elevation of the wall along axis 35 was rectangular and had no openings. Two separate walls,

Figure 3. Elevation views: (a) NS elevations (view from west) and (b) EW elevations (view from north).

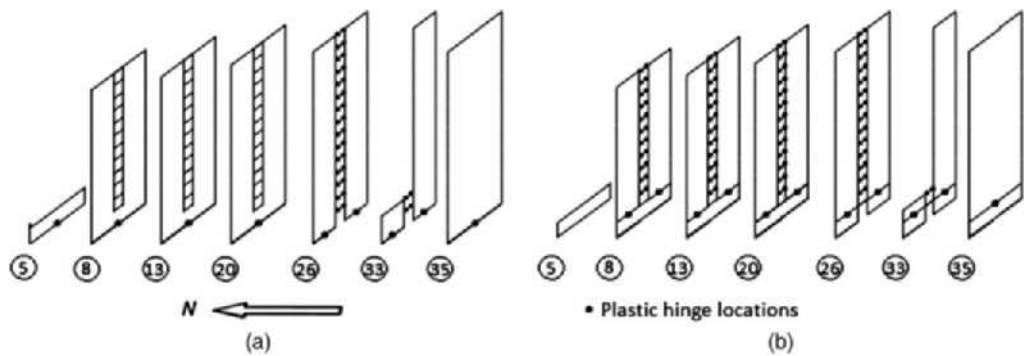
Figure 14. Limiting mechanisms (flanges not shown for clarity) used in analyses A through D (Table 4): (a) First-story failure mechanism; (b) second-story failure mechanism. Photo credit: E. Fierro and A. Iruretagoyena.

direction of load (Table 4). Limit analyses of the mechanisms with wall hinges in the second story produced base-shear coefficients ranging from 0.29 to 0.44 (Table 4). For all analysis groups and loading directions, independent from the assumptions made, analyses assuming the first story to be the critical story produced results that were consistently larger than the results from analyses assuming that the second story was the critical story. The ratio of the estimated strength of first-story collapse mechanisms to the estimated strength of second-story collapse mechanisms ranges from 1.12 to 1.39.

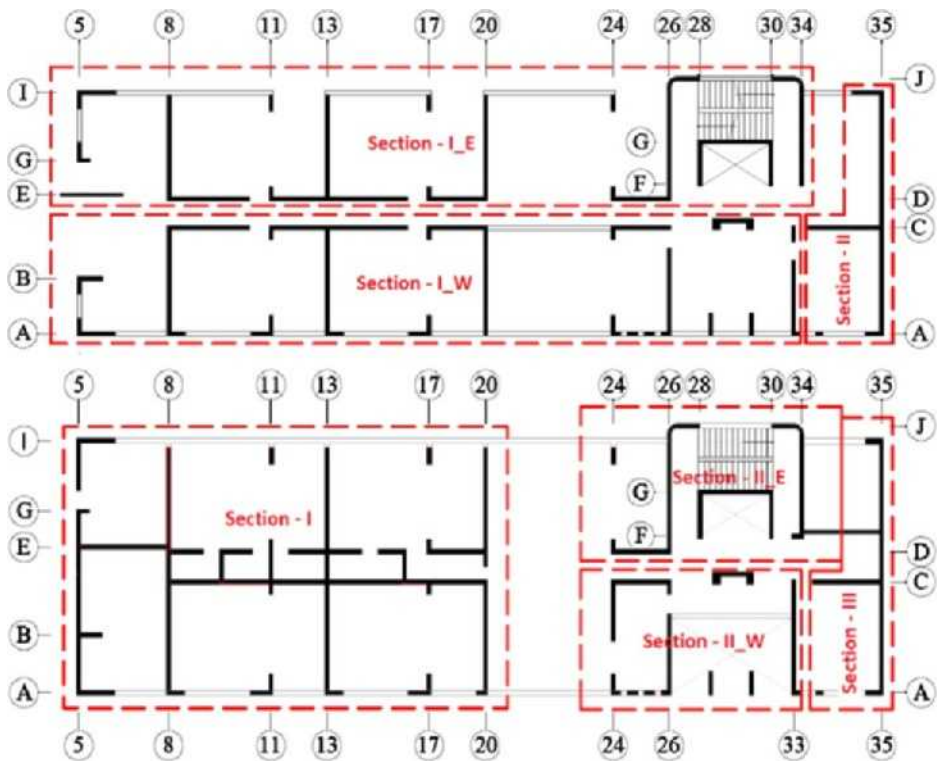
Representative moment-curvature relationships computed for analysis group A are shown in Figure 16. These relationships suggest that the sections considered could reach yielding before limiting concrete strains would develop.

Figure 15. Sections used in analyses A through D (Table 4). Second story is shown above and first story is shown below. Photo credit: E. Fierro and A. Iruretagoyena.

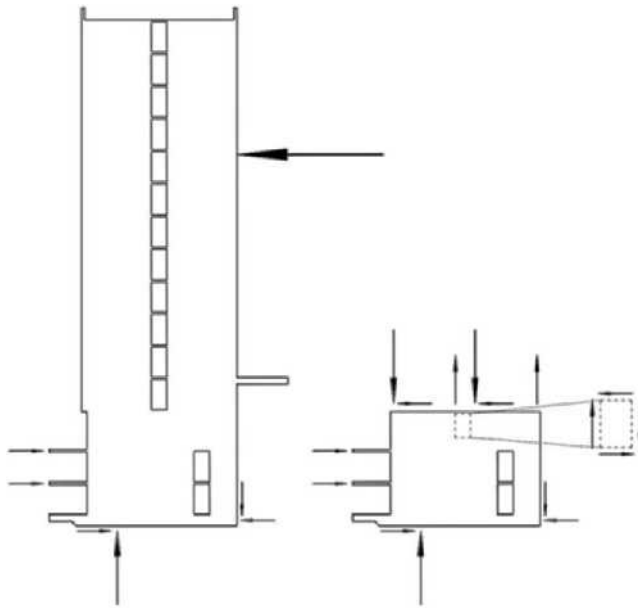
Moehle et al. (2011) have stated that very large shear forces can develop in “solid walls below or above a row of openings.” This statement points directly at the boxed region in Figure 17. This figure shows the forces applied by upper walls (separated by a stack of openings) to a continuous or solid wall at the base. The wall panel directly below the openings is expected to resist fractions of the vertical forces applied by wall boundaries working in tension and compression next to the openings above. These force fractions have opposite sense and result in shear distortion of the wall segment under the openings.

Figure 17. Idealized forces near the base of the wall along axis 13. (Note: the horizontal force at the top of the panel under high shear is assigned to the slab.)

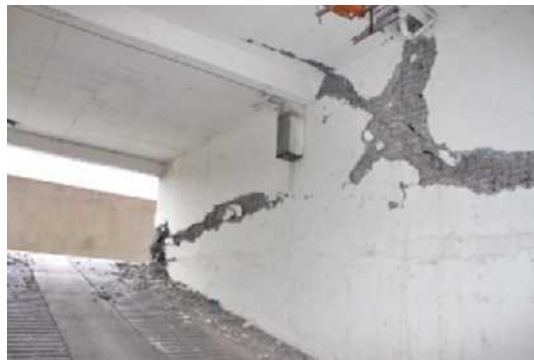
Damage in wall segments located under a “row” or stack of openings was observed in at least two other buildings surveyed after the 2010 Maule Earthquake: Centro Mayor, in Concepción (see Figure 18); and Torre Mayor, in Chillán. In both of these buildings, the boundary reinforcement next to the openings was anchored in the solid wall below the stories with openings (Figure 19). In Alto Río, all boundary reinforcement was anchored into the foundation (two stories below grade; Figure 19). Alto Río also had walls perpendicular to the panel presumed to have failed in shear (along axes C and D). The consequences of these differences deserve careful study. The task is not simple because we have found no experimental data to

Figure 18. Wall panel with inclined cracks under stack of openings and between anchorage zones of boundary reinforcement from upper stories, Centro Mayor Building, Concepción. Photo credit: J. Moehle, <http://nees.org/resources/3111>.)

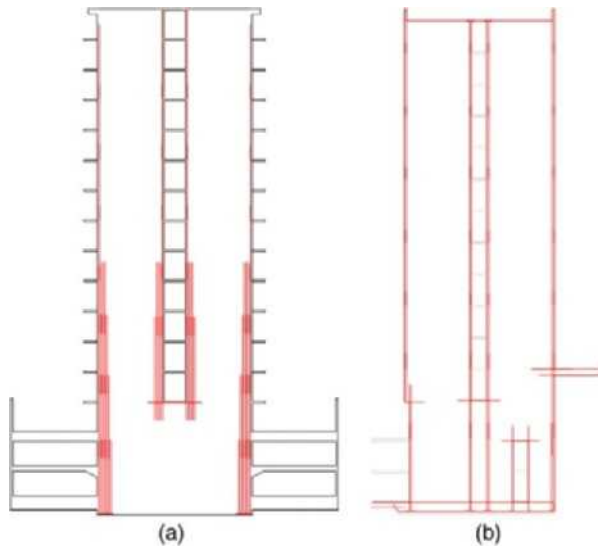
Figure 19. Distribution of wall boundary reinforcement: (a) Centro Mayor Building; (b) Alto Río Building.

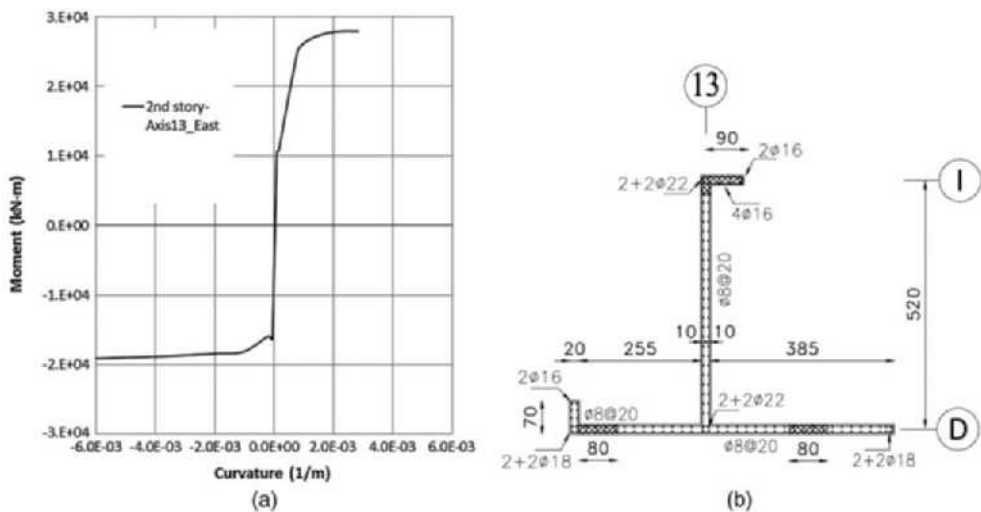
that stress concentrations related to discontinuities may have caused compression failures near the top of first-story walls. Walls with T-shaped sections in the second story had limited ductility (Figure 20) and discontinuities (re-entrant corners, flange cutoffs, and wall openings, Figures 2 and 3) that may have created stress concentrations near their bases.

Figure 20 shows a moment-curvature relationship computed for a section at the base of the second floor. The computed yield ($\varphi_y = 0.001$ 1/m) and limit curvatures ($\varphi_u = 0.003$ 1/m) are sufficient to justify a rotational capacity of at least 1% on the basis of conventional assumptions (Wallace and Moehle 1992):

Figure 20. Wall along Axis 13, base of second story: (a) Computed moment-curvature relationship; (b) cross section (dimensions in cm). Notes: Shaded areas were ignored because they were unsupported; positive values correspond to eastward forces; assumed axial load equal to approximately 5% of the product of concrete strength times gross area (all other required assumptions described in section on limiting flexural strength).

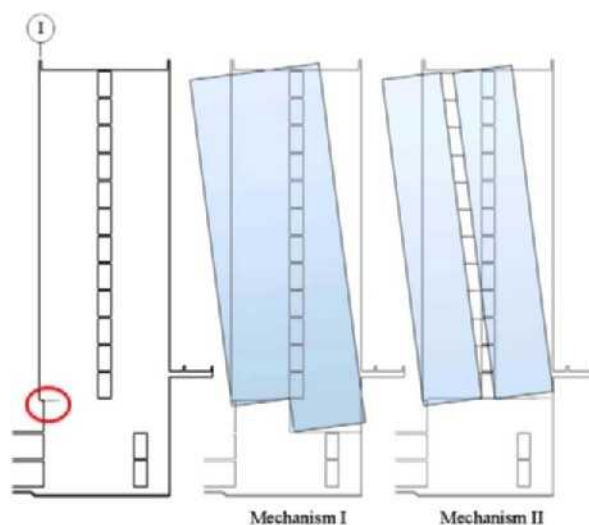
It has been suggested (IDIEM 2010) that the discontinuities along axis I and the re-entrant corners and flange cutoffs in walls along axes 8, 13, and 20 caused failure in compression of wall sections near the top of the first story on the east side of the building (Figure 22). This plausible failure is more likely to have led to collapse mechanism II than collapse mechanism I because mechanism II is weaker. But field evidence indicates that mechanism II did not occur. Mechanism I could have governed if the wall segments under hallways were damaged by shear and/or the bases of the first-story walls on the west side of the building were weakened in tension by splice failures at the bottom of the first story.

Figure 22. Idealized failure mechanisms associated with a presumed failure caused by geometric discontinuities along axis I.

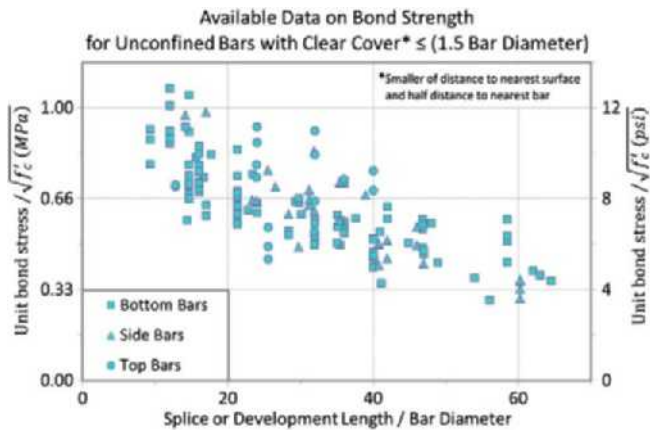
Figure 24 shows that, for splices with *more than* 40 bar diameters in length and no more than 1.5 bar diameters in clear cover (or 3 bar diameters in clear spacing), and considering the scatter in the data, it is possible to find cases in which the static bond strength—for monotonic loads—is *less than* $(^{1/3}) \sqrt{f'_c}$ in MPa ($4\sqrt{f'_c}$ in psi).

Figure 24. Monotonic, static bond strength of unconfined deformed bars with relatively small cover (data reported by ACI 408 2001 and [Seliem et al. 2009](#)).

This estimate and the data in Figure 24 suggest that the hypothesis that bond failure took place in lap splices is plausible. The measurements in Figure 24 were obtained in static and monotonic tests. In Alto Río, the bars resisted dynamic load reversals.

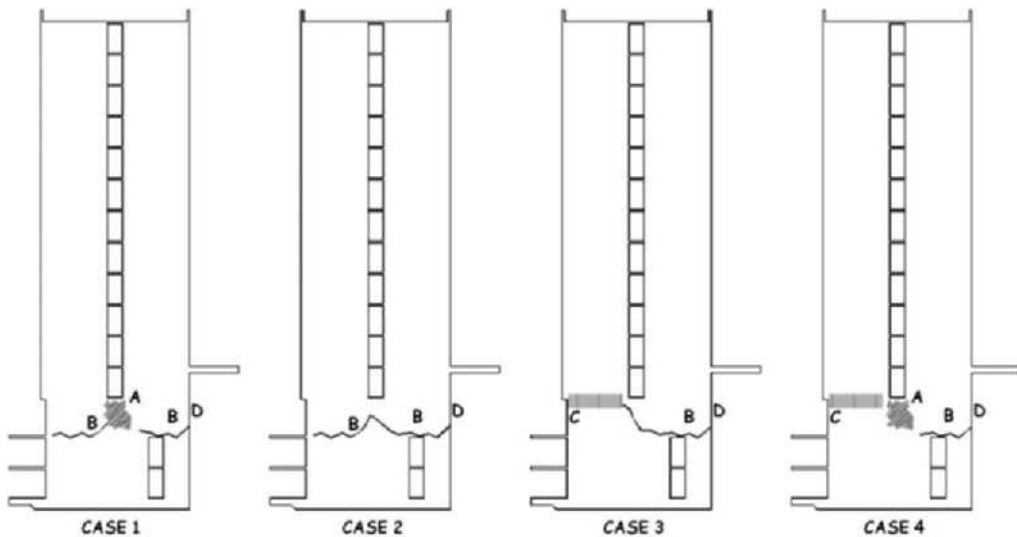
In the preceding sections four types of local failure that may have led to collapse described: (A) shear failure of the wall panels under stacks of wall openings (hatched area in Figure 25); (B) fracture of bars at sections with low reinforcement ratios (marked by zig-zag lines in Figure 25); (C) stress concentration at re-entrant corners and flange cutoffs in walls (dotted areas in Figure 25), and (D) failure of unconfined lap splices. None of these local failures explains by itself the collapse and the state of the structure after the collapse. Four combinations of failure types A through D are listed in Table 7. It is plausible that any of these combinations may have led to the collapse and the state of the structure after the collapse. At this point the evidence is not sufficient to pick one combination with confidence. But the field evidence does show two clear facts: on the west side of the building the failure surface was close to the base of first-story walls and all the vertical reinforcement on that side of the building failed in tension (failure cause B) or bond (failure cause D).

Figure 25. Combinations of local failures that may have led to collapse.
