**CRACK SURVEYS OF LOW-CRACKING
HIGH-PERFORMANCE CONCRETE
BRIDGE DECKS IN KANSAS
2011-2013**

**A Report on Research Sponsored by
CONSTRUCTION OF CRACK-FREE BRIDGE DECKS
TRANSPORTATION POOLED-FUND PROGRAM
PROJECT NO. TPF-5(174)**

**Structural Engineering and Engineering Materials
SL Report 13-6**

**THE UNIVERSITY OF KANSAS CENTER FOR RESEARCH, INC.
LAWRENCE, KANSAS
December 2013**

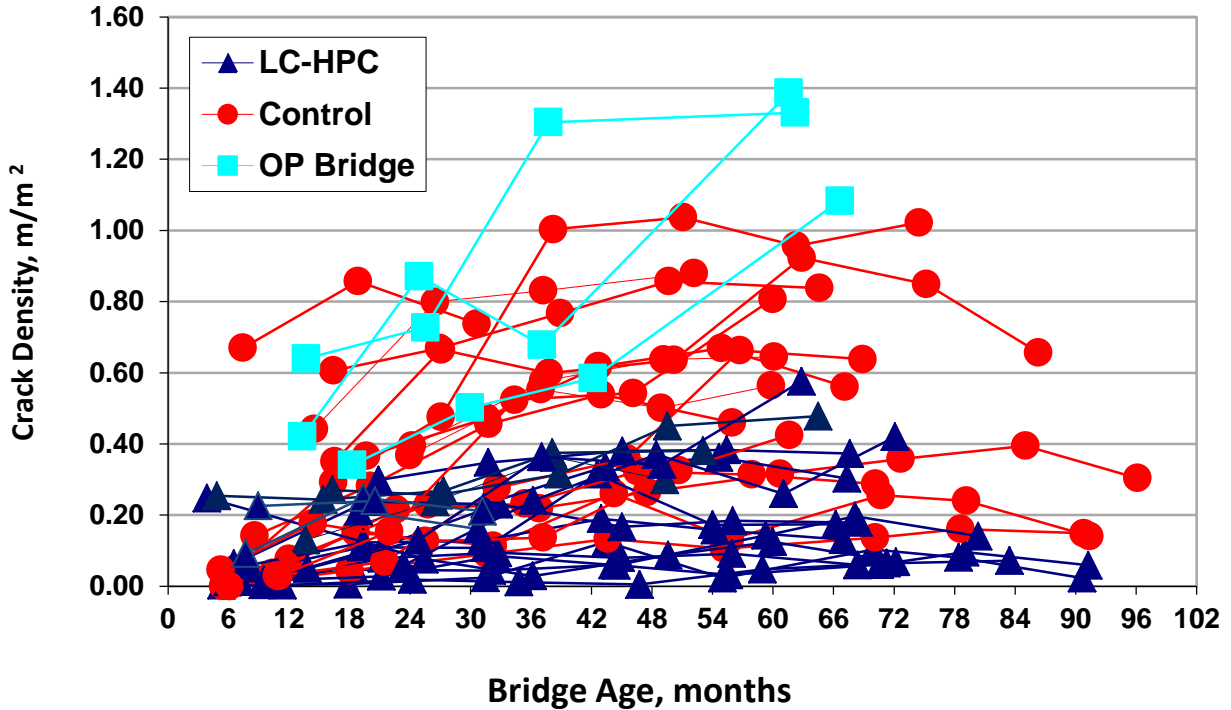
Figure 2: Crack Densities of LC-HPC and Control Decks

decks in the project are shown in Figure 2. In-depth comparisons of LC-HPC and control decks follow.

As shown in the individual comparisons of the LC-HPC and control decks, at the same age, with few exceptions, the LC-HPC decks exhibit less cracking than the control decks. Crack densities for surveys completed in 2011, 2012, and 2013 are shown in Tables 4, 5, and 6, respectively. These tables also indicate for each LC-HPC/Control pair, which bridge had the lower crack density in that survey year. Because of differences in the dates of placement, comparisons based on the year of the survey do not match the age of the decks in all cases. In 2011, of the thirteen LC-HPC bridge decks with a corresponding control deck, eleven had lower crack densities than their control counterpart. In 2012, of the twelve LC-HPC bridge decks with a corresponding control deck (due to the overlay of Control-5), eleven had lower crack densities than their control counterpart. It is apparent that the LC-HPC bridge decks are performing significantly better than their respective control decks. This is also demonstrated in Figure 2,

which provides a plot of crack densities versus age for the bridge decks in the study. The OP Bridge was not constructed in accordance with several provisions of the LC-HPC specifications, and therefore does not represent either an LC-HPC or a control deck. To date, the highest crack density on an LC-HPC bridge deck is 0.576 m/m² (LC-HPC-13 at 62.9 months; see Figure 80). The highest crack density on a control deck is 1.037 m/m² (Control-7 Placement 1 at 51.1 months). Overall, in the three *survey years* included in this report, there are only 3 instances in which an LC-HPC bridge had a higher crack density than its control counterpart: LC-HPC-2 and LC-HPC-8 in 2011, and LC-HPC-2 in 2012. Finally, although LC-HPC-2 appears to have a higher crack density than Control-1/2 by examination of Tables 4 through 6, Figure 13 shows that, on the whole, LC-HPC-2 performs just as well as, if not better than, Control-1/2.

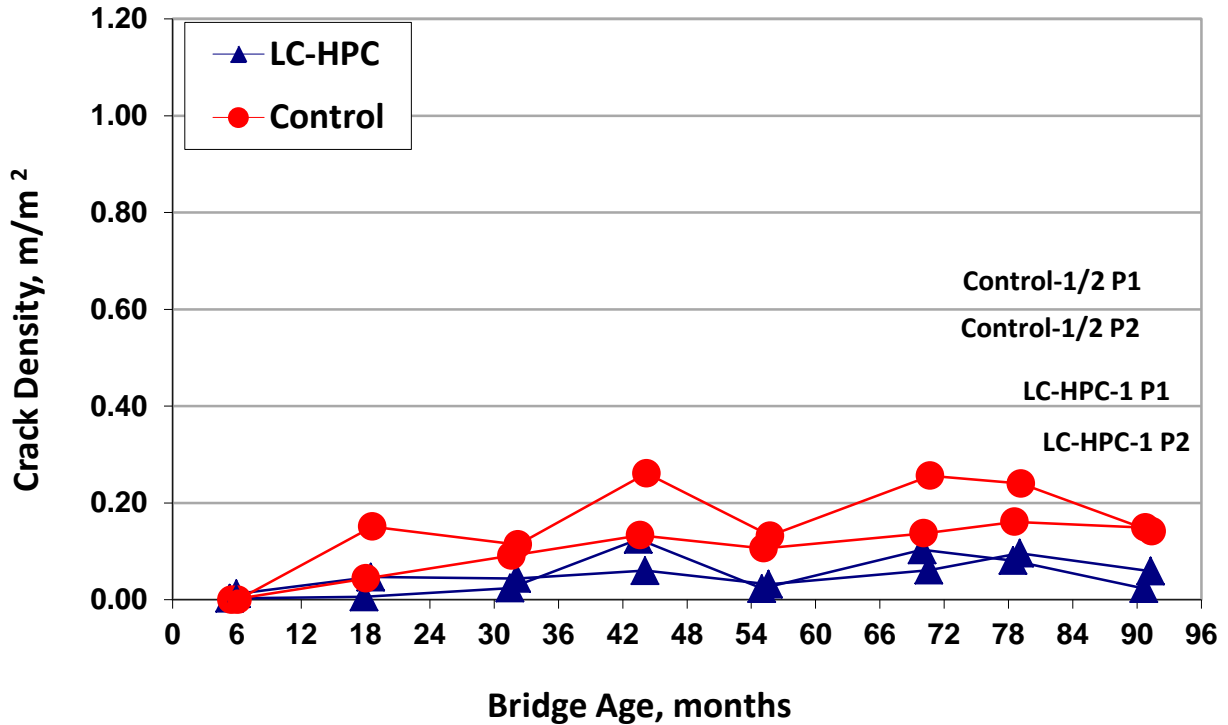
Figure 9: LC-HPC-1 and Control-1/2 Crack Densities

corners of the bridge. Figure 9 compares cracking on Control-1/2 to LC-HPC-1 over time. Crack densities on both placements of Control-1/2 have been consistently higher than densities on both placements of LC-HPC-1 over time.

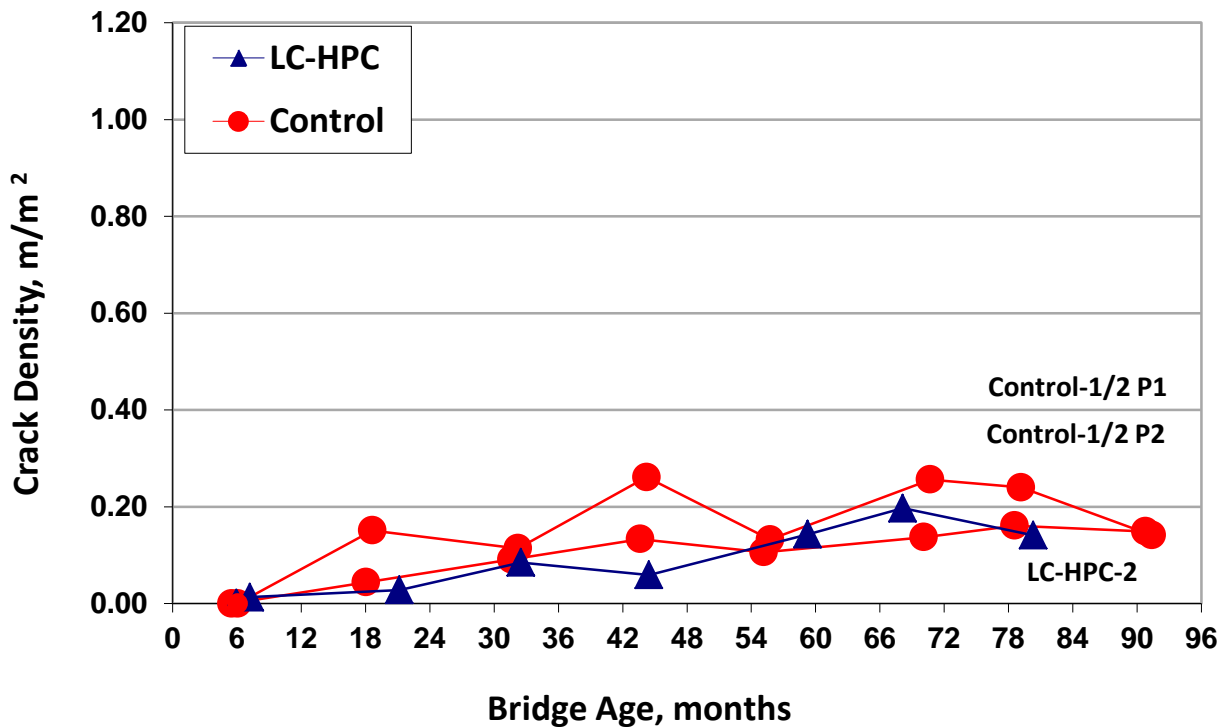
Figure 13: LC-HPC-2 and Control-1/2 Crack Densities

prominent in the negative moment region above the pier, with small cracks extending from the northern edge of the deck and distributed throughout the entire deck. The crack map for Survey 6 shows many small cracks throughout the deck that were not captured in any previous surveys, likely the result of mistaking aggregate boundaries for cracks. Figure 13 compares cracking on LC-HPC-2 to Control-1/2 over time. It is evident that cracking on LC-HPC-2 has increased over time, experiencing a sharp rise after 42 months, and has moved closer in value to the crack densities for Control-1/2 in recent years.

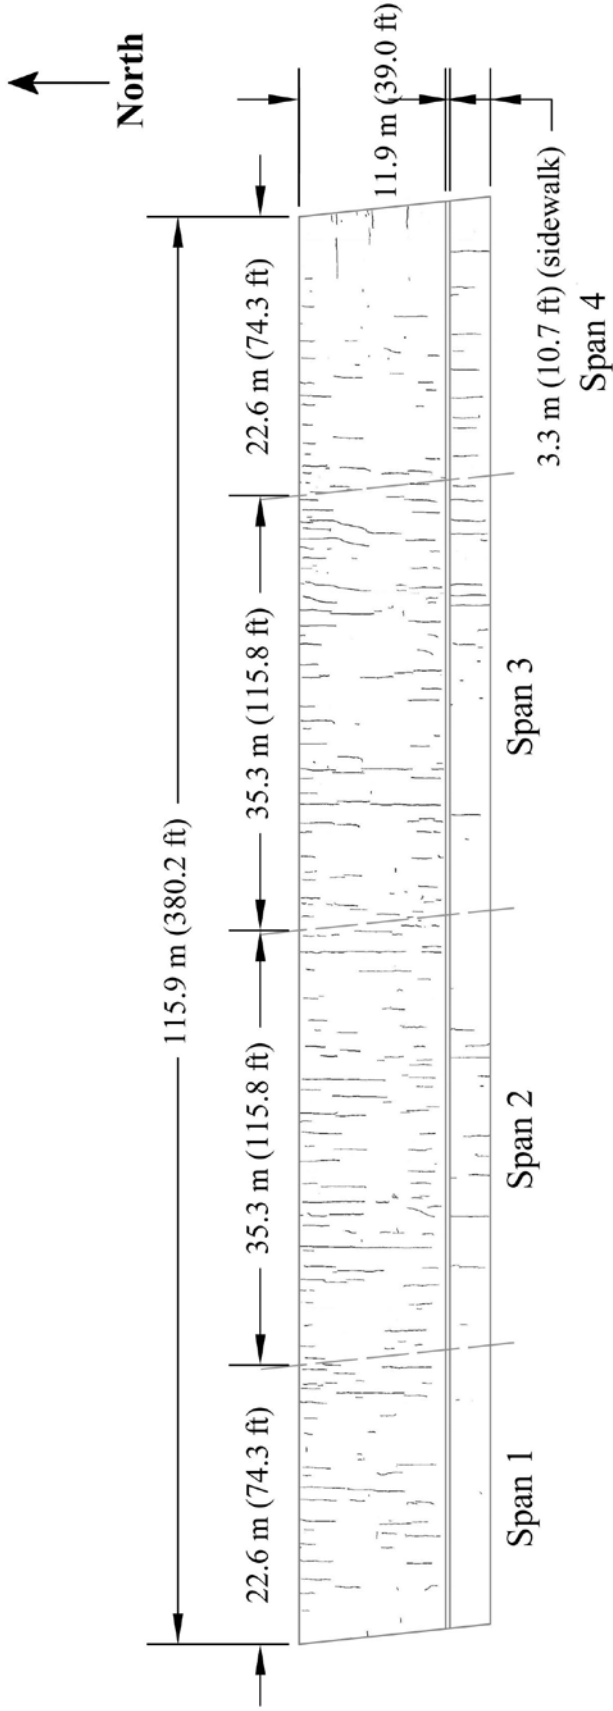
Figure 19: Control-3 (Survey 6)

Span 4: 0.211 m/m²

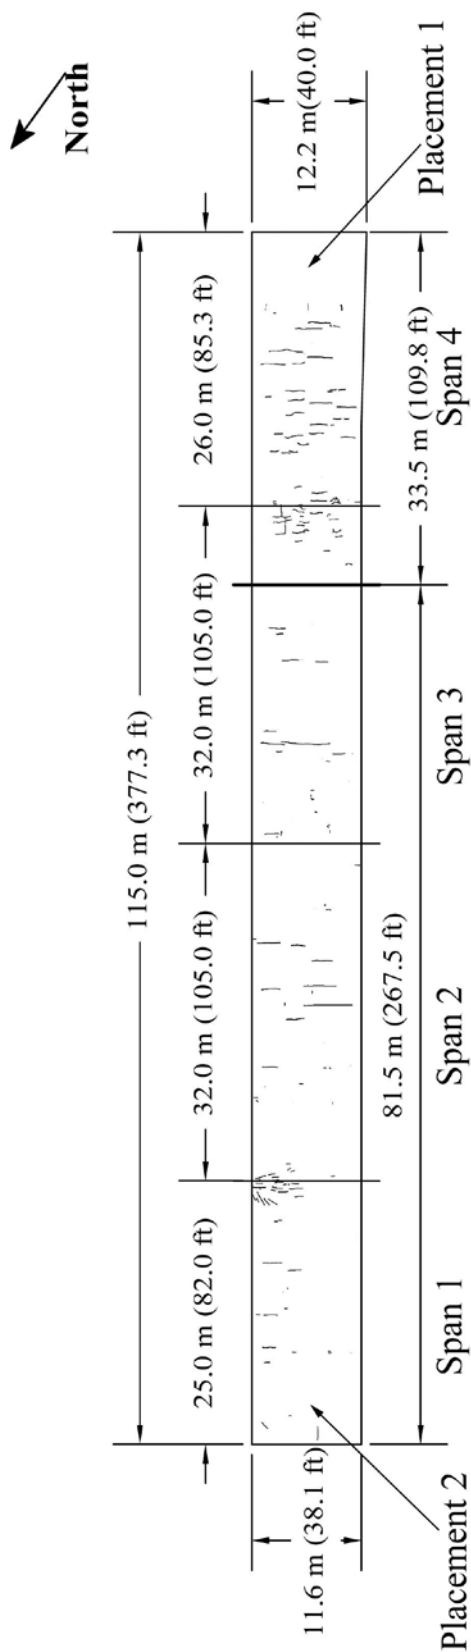
Figure 21: LC-HPC-4 (Survey 4)

LC-HPC-4 was constructed in two placements three days apart. The results of Survey 4 at 45.0 and 44.9 months, Survey 5 at 56.0 and 55.9 months, and Survey 6 at 68.5 and 68.4 months are included in this report. Crack maps for Surveys 4, 5, and 6 are shown in Figures 21, 22, and 23. At ages of 45 months for Placement 1 and 44.9 months for Placement 2, the overall crack density was 0.107 m/m², with Placement 1 having a density twice that of Placement 2 (0.167 m/m² and 0.080 m/m²). This represents a decrease from the crack densities measured in Survey 3 at 32.8 months for Placement 1 and 32.7 months for Placement 2: 0.146 m/m² overall, 0.261 m/m² for Placement 1, and 0.094 m/m² for Placement 2 (Pendergrass et al. 2011). At ages of 56 months for Placement 1 and 55.9 months for Placement 2 (Survey 5), the overall crack density was 0.120 m/m², an increase from Survey 4, but still lower than the crack density measured in Survey 3. Furthermore, the crack density of Placement 1 is still twice as large as the density of

Bridge Number: 46-339 Unit 1 (LC-HPC-4)	Bridge Length: 115.0 m (377.3 ft)	Bridge Age:
Bridge Location: Flyover Ramp US-69S to I-435W	Bridge Width: 11.6 m (38.1 ft)	Placement 1: 45.0 months
Construction Date:	Skew: 0°	Placement 2: 44.9 months
Placement 1 (South): 9/29/2007	Number of Spans: 4	Crack Density: 0.107 m/m ²
Placement 2 (North): 10/2/2007	Span 1: 25.0 m (82.0 ft)	Placement 1: 0.167 m/m ²
Crack Survey Date: 6/30/2011	Span 2: 32.0 m (105.0 ft)	Placement 2: 0.080 m/m ²
	Span 3: 32.0 m (105.0 ft)	Span 1: 0.080 m/m ²
	Span 4: 26.0 m (85.3 ft)	Span 2: 0.088 m/m ²
	Number of Placements: 2	Span 3: 0.088 m/m ²
		Span 4: 0.174 m/m ²

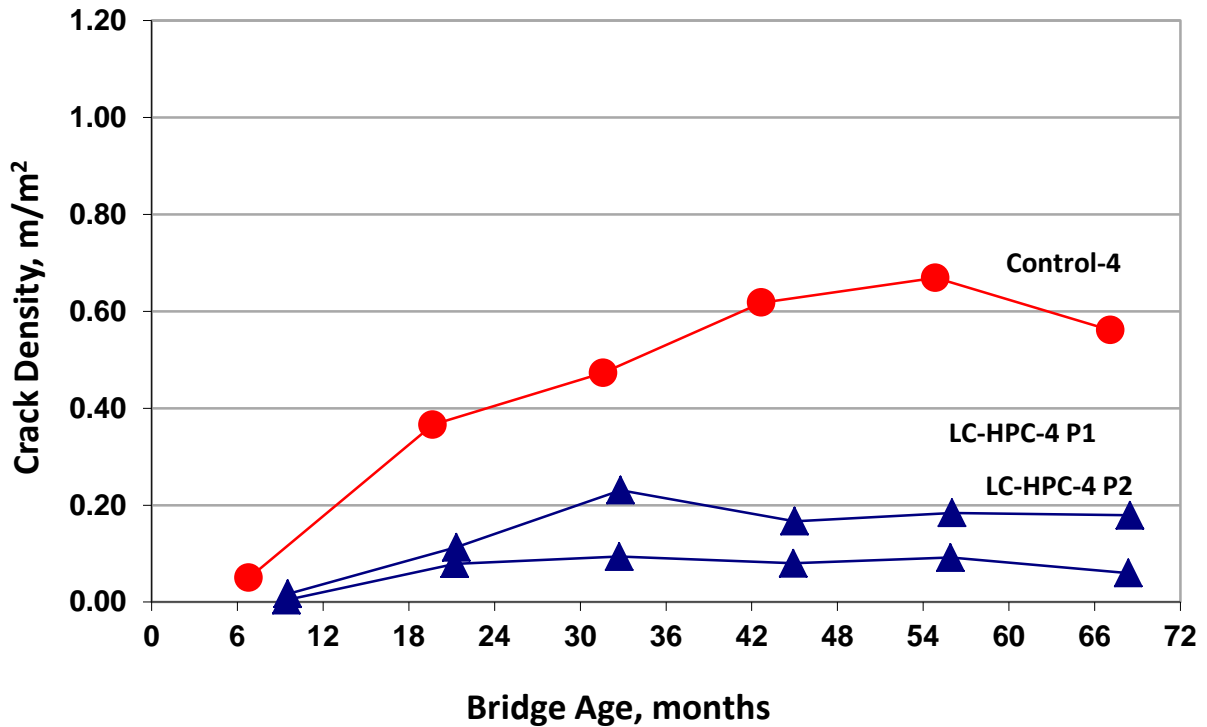
Figure 27: LC-HPC-4 and Control-4 Crack Densities

The results of Surveys 4, 5, and 6, at 42.7, 54.9, and 67.1 months, are included in this report. The crack densities of Control-4 measured in Surveys 4 and 5, shown in Figures 24 and 25, were 0.618 m/m^2 and 0.669 m/m^2 , respectively. These densities represent a significant increase from the value measured in Survey 3 at 31.6 months of 0.473 m/m^2 (Pendergrass et al. 2011). These densities are also much larger than the crack densities of LC-HPC-4 at 45.0 and 56.0 months. The crack density at 67.1 months was 0.561 m/m^2 (see Figure 26), a decrease from the crack densities measured in Surveys 4 and 5. However, this density is still much greater than the overall crack density of LC-HPC-4 at 68.5 months of 0.105 m/m^2 . Control-4 has significant transverse cracking near the piers of the bridge. Above the second pier from the west, there is longitudinal and transverse cracking. There is also significant longitudinal cracking along the northern edge of the deck, which is likely due to a small portion of the bridge deck that is cantilevered out over the exterior girder. Figure 27 compares crack densities on Control-4 to crack densities on LC-HPC-4 over time. Clearly, cracking on Control-4 has been significantly greater than on either placement of LC-HPC-4 over time. While LC-HPC-4 seems to have had relatively stable cracking over its life, Control-4 has had a general trend of increased cracking.

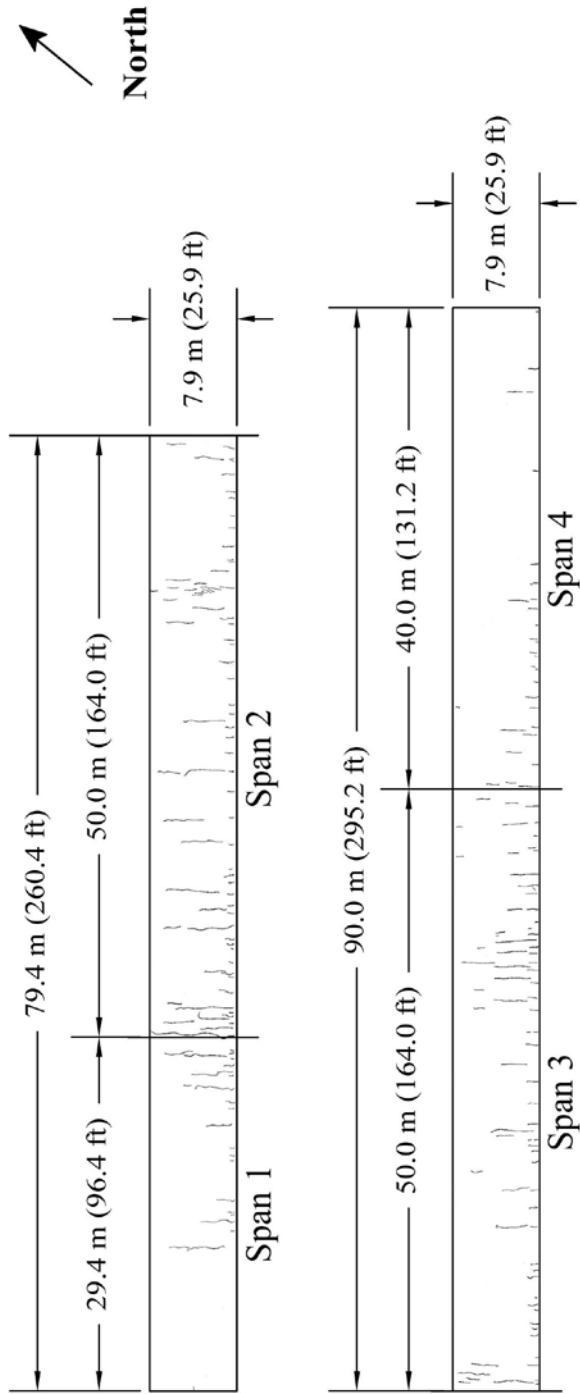
Figure 28: LC-HPC-5 (Survey 4)

The results of Surveys 4, 5, and 6 of LC-HPC-5, at 43.0, 54.2, and 67.0 months, are included in this report. The crack density of LC-HPC-5 at 43.0 months was 0.190 m/m², shown in Figure 28, represents an increase from the Survey 3 result at 31.1 months, 0.128 m/m² (Pendergrass et al. 2011). The crack densities from Surveys 5 and 6 show decreases from Survey 4. The crack density for LC-HPC-5 at 54.2 months was 0.158 m/m², as shown in Figure 29. The crack density for LC-HPC-5 at 67.0 months was 0.131 m/m², as shown in Figure 30. Due to the small amount of cracking in the deck, overlooking just a few cracks can make an impact in the crack density, and is likely the cause of this decrease. Most of the cracks are transverse, propagating from the south side of the deck. The south side is superelevated, which

Bridge Number: 46-340 Unit 1 (LC-HPC-5)
Bridge Location: Flyover Ramp US-69 to I-435 W
Construction Date: 11/14/2007
Crack survey Date: 6/14/2011

Bridge Length: 169.4 m (555.7 ft)
Bridge Width: 7.9 m (25.9 ft)
Skew: 0°
Number of Spans: 4
Span 1: 29.4 m (96.4 ft)
Span 2: 50.0 m (164.0 ft)
Span 3: 50.0 m (164.0 ft)
Span 4: 40.0 m (131.2 ft)
Number of Placements: 1

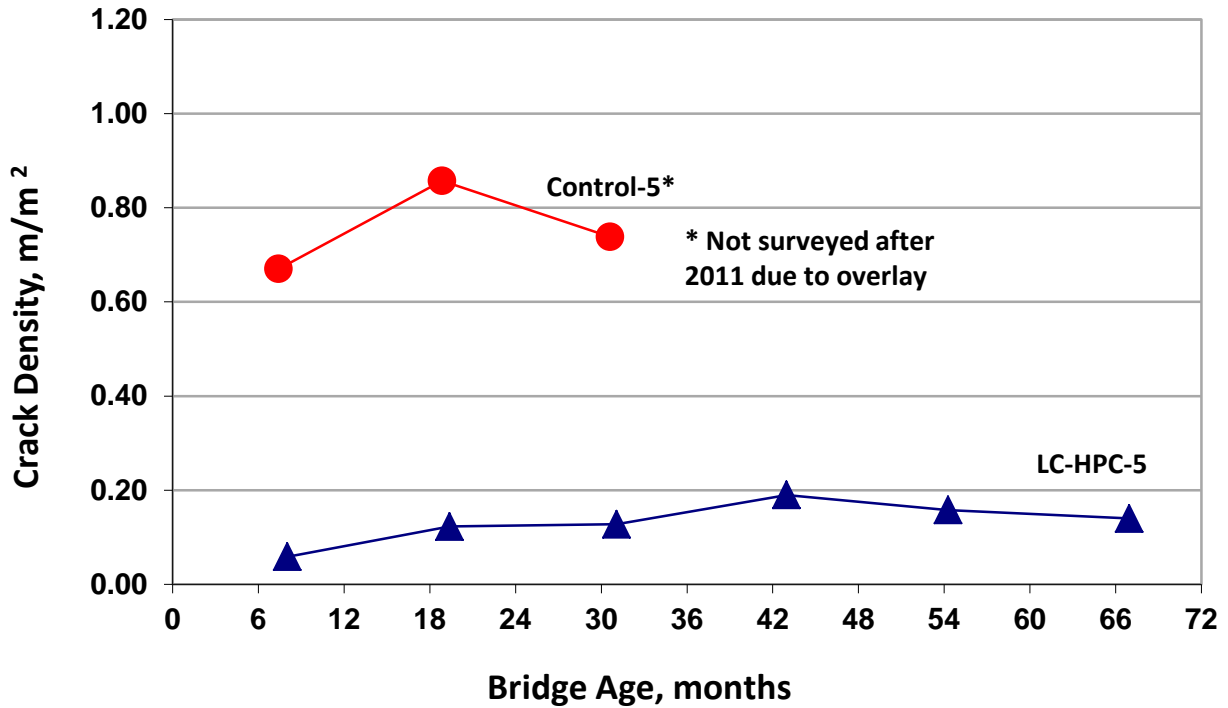
Figure 32: LC-HPC-5 and Control-5 Crack Densities

The results of Survey 3 for Control-5 at 30.6 months are included in this report. Because of the high crack density, an overlay was applied to the bridge in 2012, after which crack surveys ceased being conducted. As shown in Figure 31, the crack density of Control-5 at 30.6 months was 0.738 m/m^2 , a decrease from the crack density at 18.9 months of 0.857 m/m^2 (Pendergrass et al. 2011). Control-5 has an extremely high crack density with long transverse cracks every few feet for the length of the bridge. The crack density increases near the piers and some longitudinal cracks are present near the piers and propagate from the abutments. Figure 32 compares crack densities on Control-5 to crack densities on LC-HPC-5 over time. Even with only three survey data points for Control-5, it is clear that LC-HPC-5 has performed much better than Control-5. Overall, crack densities appear to be more than four times larger on Control-5 than on LC-HPC-5.

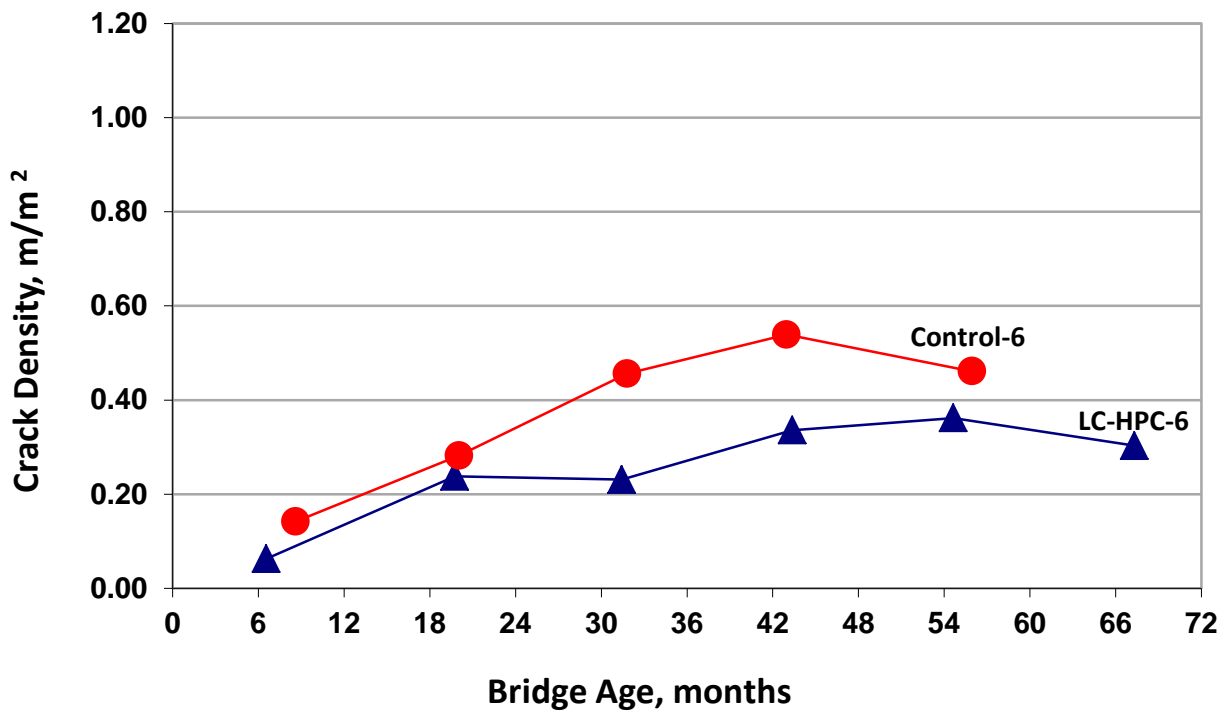
Figure 39: LC-HPC-6 and Control-6 Surveyed Crack Densities

and 0.539 m/m^2 , respectively, are over 60% higher than the crack density at 20.0 months of 0.282 m/m^2 (Pendergrass et al. 2011). These densities are also larger than crack densities of LC-HPC-6 at 31.4 and 43.3 months. Survey 5, as shown in Figure 38, indicated a decrease in crack density to 0.460 m/m^2 . This density, however, is still greater than the overall crack density of LC-HPC-6 at 54.6 months, 0.362 m/m^2 . Most cracks on Control-6 are transverse, many of which are concentrated near the piers. A portion of span 4 has a single longitudinal crack through the center of the deck, and there are small longitudinal cracks propagating from both abutments. Figure 39 compares cracking on Control 6 to cracking on LC-HPC-6 over time. It can be seen that Control 6 consistently has more than LC-HPC-6. Both Control 6 and LC-HPC-6 experienced a similar rate of increase in crack density at early ages.

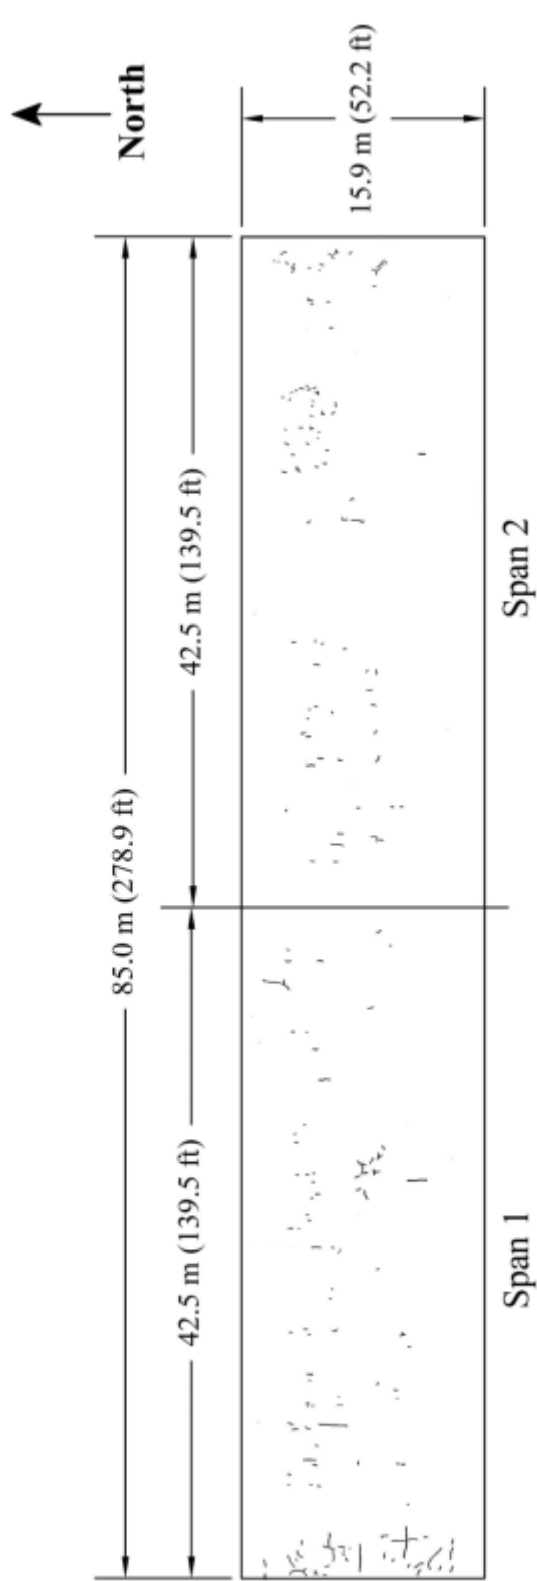
Figure 40: LC-HPC-7 (Survey 5)

The results of Surveys 5, 6, and 7 of LC-HPC-7, at 58.9, 71.3, and 83.4 months, are included in this report. The crack density of LC-HPC-7 at 58.9 months is 0.048 m/m^2 , as shown in Figure 40. This represents an increase from Survey 4 at 46.8 months, when the deck had a crack density of just 0.005 m/m^2 (Pendergrass et al. 2011). The crack density of LC-HPC-7 at 71.3 months was 0.065 m/m^2 , as shown in Figure 41. The crack density of LC-HPC-7 at 83.4 months was 0.072 m/m^2 , as shown in Figure 42. LC-HPC-7 has some of the lowest crack densities of all of the bridges in the project. There are some small-to-medium length longitudinal cracks near and propagating from the west abutment and the remainder of the cracks are very short and distributed along the entire length of the bridge.

Bridge Age: 58.9 months
Crack density: 0.048 m/m²
Span 1: 0.062 m/m²
Span 2: 0.033 m/m²

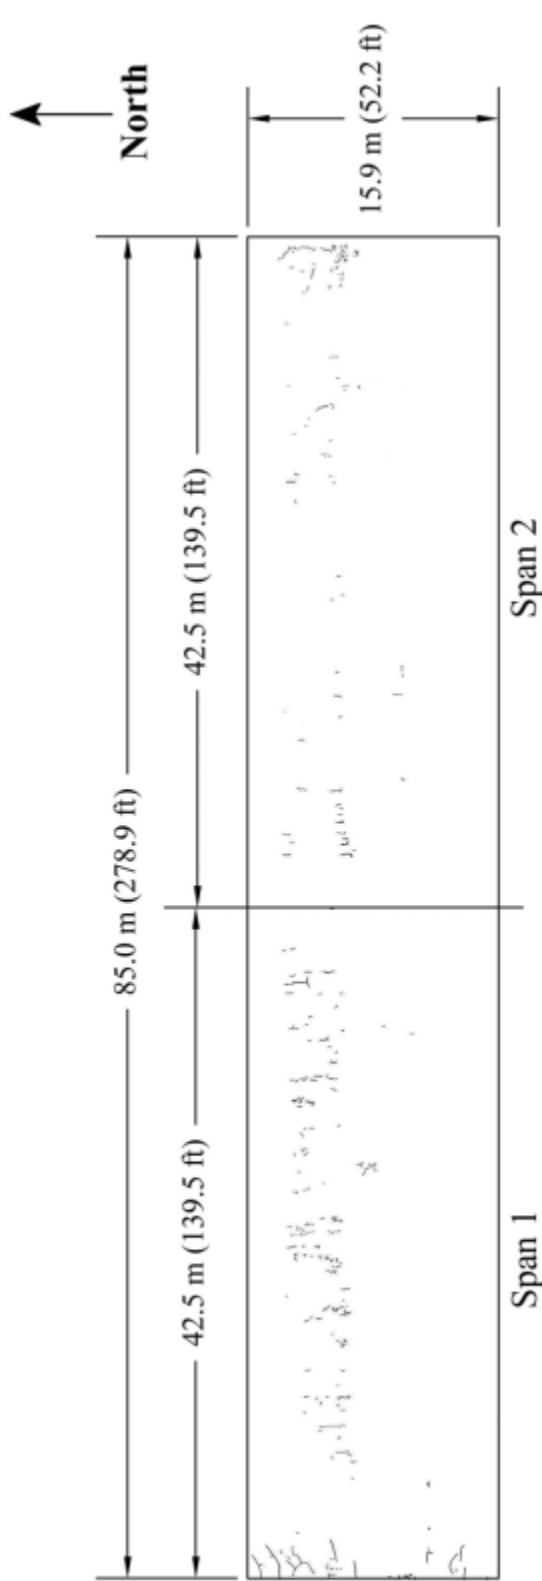
Figure 41: LC-HPC-7 (Survey 6)

Bridge Number: 43-33 (LC-HPC-7)	Bridge Length: 85.0 m (278.9 ft)	Bridge Age: 71.3 months
Bridge Location: Co. Rd. 150 over US-75	Bridge Width: 15.9 m (52.2 ft)	Crack density: 0.065 m/m ²
Construction Date: 6/24/2006	Skew: 0°	Span 1: 0.088 m/m ²
Crack survey Date: 6/1/2012	Number of Spans: 2	Span 2: 0.036 m/m ²
	Span 1 (West): 42.5 m (139.5 ft)	
	Span 2 (East): 42.5 m (139.5 ft)	
	Number of Placements: 1

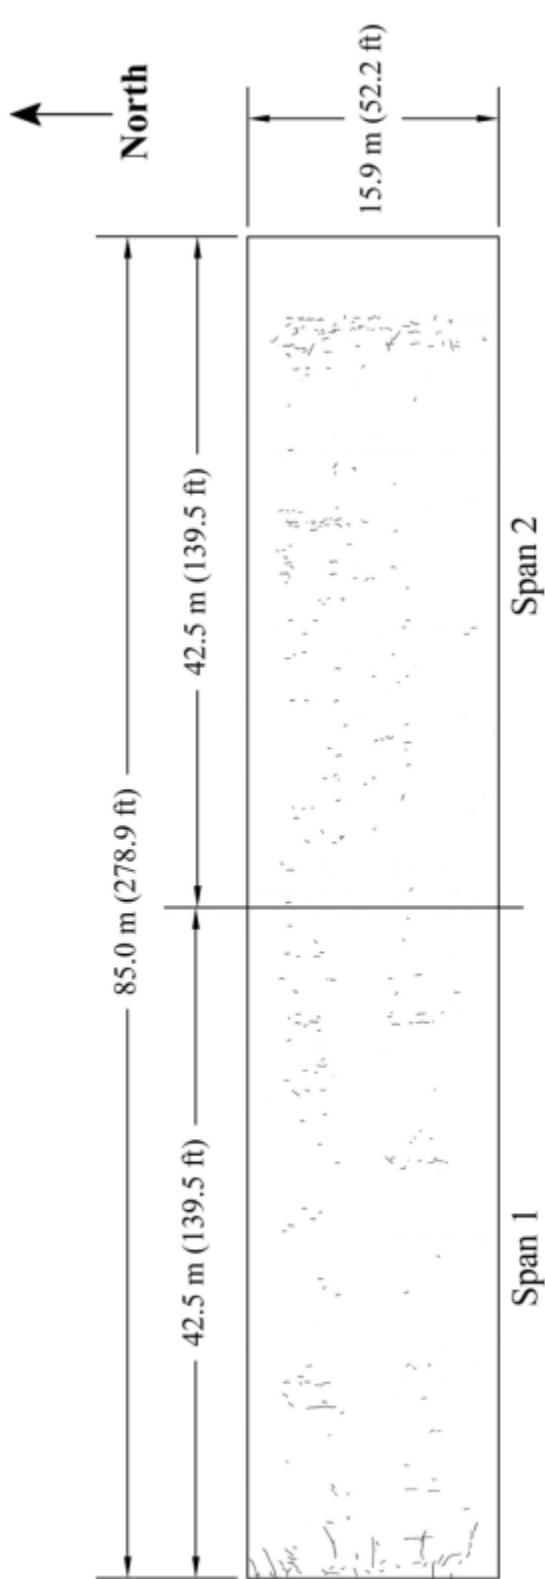
Figure 42: LC-HPC-7 (Survey 7)

Bridge Number: 43-33 (LC-HPC-7)	Bridge Length: 85.0 m (278.9 ft)	Bridge Age: 83.4 months
Bridge Location: Co. Rd. 150 over US-75	Bridge Width: 15.9 m (52.2 ft)	Crack density: 0.072 m/m ²
Construction Date: 6/24/2006	Skew: 0°	Span 1: 0.080 m/m ²
Crack survey Date: 6/7/2013	Number of Spans: 2	Span 2: 0.064 m/m ²
	Span 1 (West): 42.5 m (139.5 ft)	
	Span 2 (East): 42.5 m (139.5 ft)	
	Number of Placements: 1

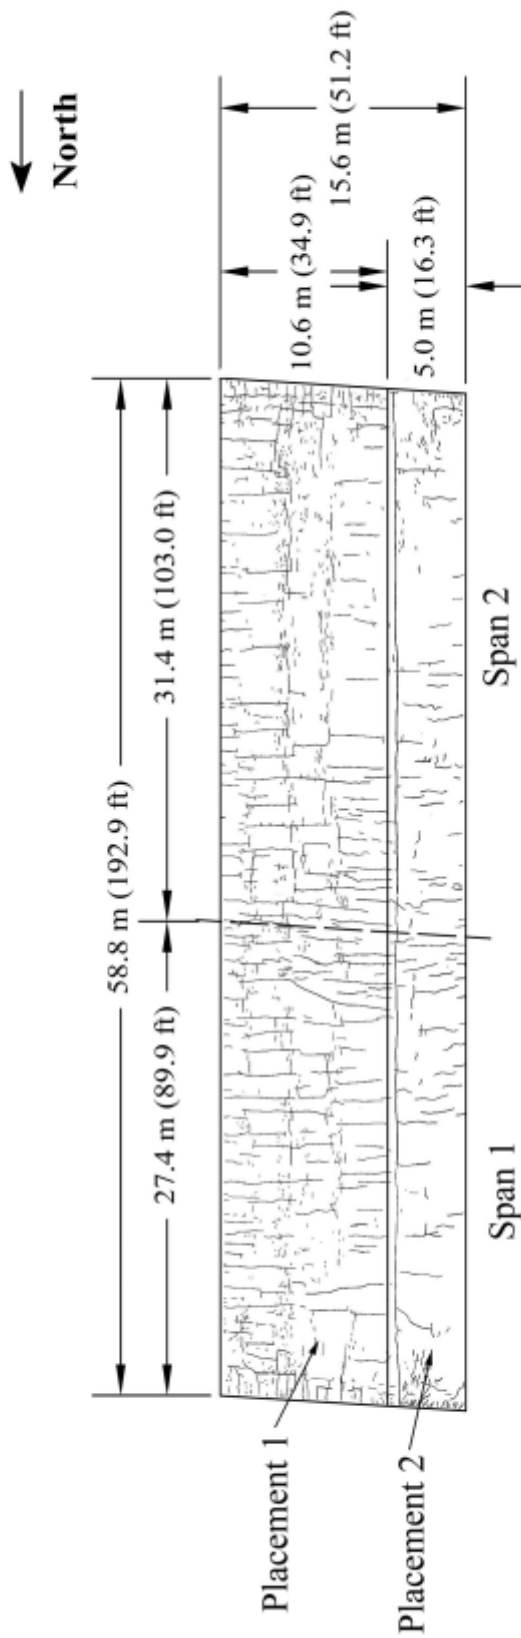
Figure 43: Control-7 (Survey 5)

Control-7 was constructed in two placements, six months apart. The results of Survey 5 at 62.3 and 56.7 months and Survey 6 at 74.5 and 68.9 months are included in this report. The crack density of Placement 1 measured in Survey 5 was 0.957 m/m^2 (see Figure 43), while Placement 2 had a crack density of 0.663 m/m^2 , nearly double the crack density of Placement 2 from Survey 4. The overall crack density was 0.856 m/m^2 . Although the crack density of Placement 1 decreased from Survey 4, there was an overall increase in cracking from Survey 4, for which the crack densities were 1.037 m/m^2 , 0.359 m/m^2 , and 0.819 m/m^2 for Placement 1, Placement 2, and overall, respectively (Pendergrass et al. 2011). The crack densities measured during Survey 6 were 1.022 m/m^2 at 74.5 months for Placement 1 and 0.638 m/m^2 at 68.9 months for Placement 2 (see Figure 44). The overall crack density resulting from Survey 6 was 0.899 m/m^2 . These values are slightly smaller than the corresponding crack densities from Survey 5. All of the surveys have shown much higher cracking for Control-7 than for LC-HPC-7.

Bridge Number: 46-334 (Control-7)	Bridge Length: 58.8 m (192.9 ft)	Bridge Age:
Bridge Location: NB Antioch over I-435	Bridge Width: 15.6 m (51.2 ft)	Placement 1: 62.3 months
Construction Date:	Skew: -3.3°	Placement 2: 56.7 months
Placement 1 (East): 3/29/2006	Number of Spans: 2	Crack density: 0.856 m/m ²
Placement 2 (West): 9/15/2006	Span 1 (North): 27.4 m (89.9 ft)	Span 1: 0.897 m/m ²
Crack survey Date: 6/7/2011	Span 2 (South): 31.4 m (103.0 ft)	Span 2: 0.824 m/m ²
	Number of Placements: 2	Placement 1: 0.957 m/m ²
		Placement 2: 0.663 m/m ²

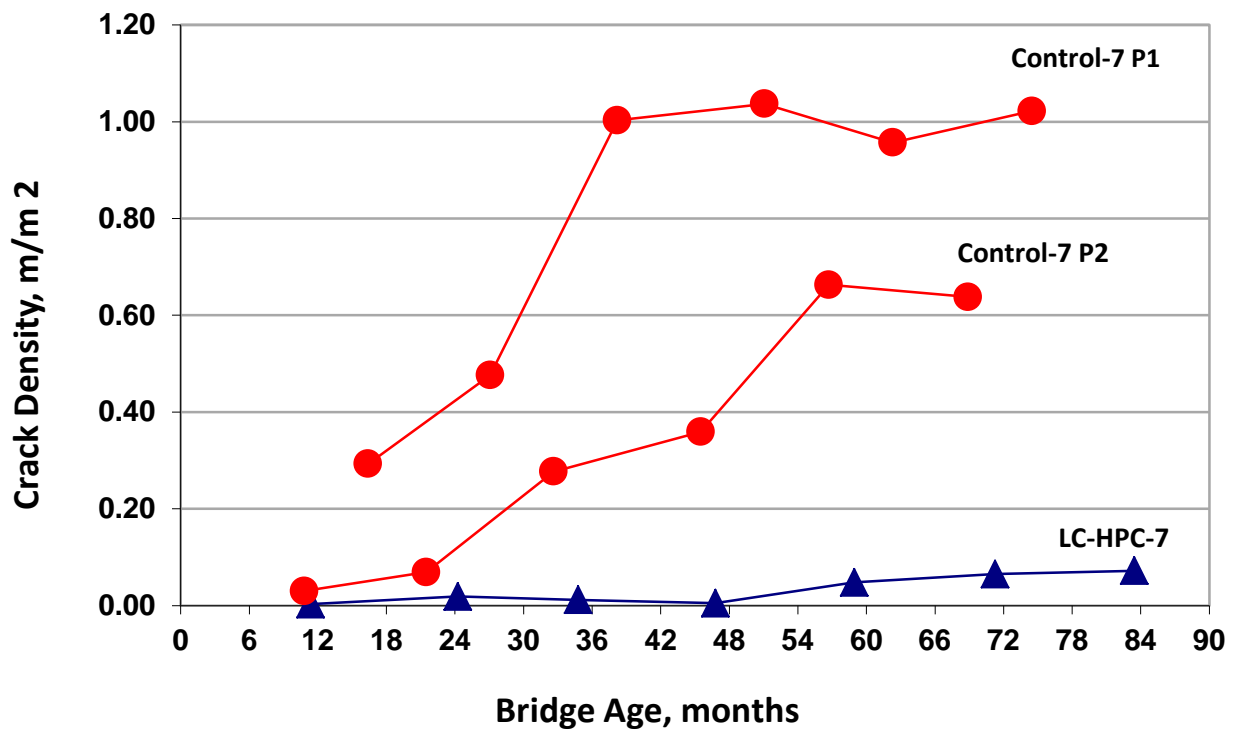
Figure 45: LC-HPC-7 and Control-7 Crack Densities

Placement 1 has transverse cracks throughout, but the cracks are more concentrated near the pier. There are also longitudinal cracks propagating from both abutments and small longitudinal cracks running the length of the deck. Placement 2 has a continuous longitudinal crack parallel and adjacent to the joint, as well as some transverse cracking and small longitudinal cracks propagating from both abutments. Figure 45 compares cracking on Control 7 to cracking on LC-HPC-7 over time. Throughout both bridge lives, LC-HPC-7 has had significantly less cracking than either placement of Control 7. While Control 7 experienced sharp increases in cracking between 12 months and 60 months of age, cracking on LC-HPC-7 has been relatively stable, experiencing relatively small increases after 48 months.

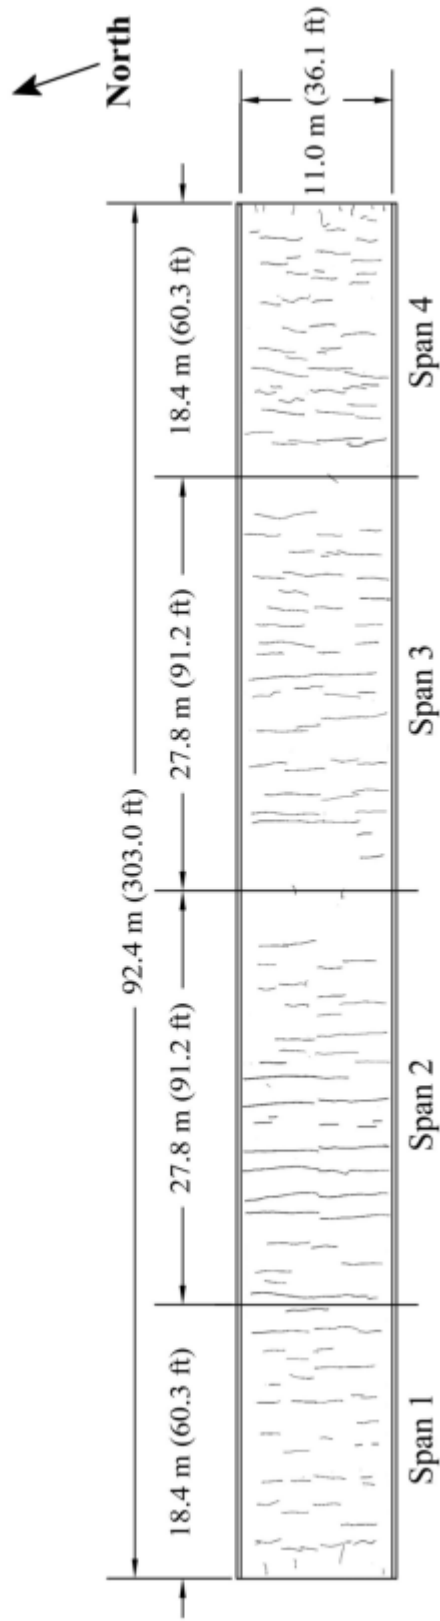
Figure 46: LC-HPC-8 (Survey 3)

The results of Surveys 3, 4, and 5 of LC-HPC-8 at 45.0, 55.4, and 67.7 months, respectively, are included in this report. LC-HPC-8 is one of two LC-HPC bridges in this study with precast, prestressed concrete girders. The crack density of LC-HPC-8 at 45.0 months was 0.380 m/m^2 , shown in Figure 46, represents an increase from Survey 2 at 31.8 months, when the crack density was 0.348 m/m^2 (Pendergrass et al. 2011). Cracking has been stable since, with values of 0.383 m/m^2 at 55.4 months (Figure 47) and 0.373 m^2 at 67.7 months (Figure 48). Most of the cracks are long transverse cracks, evenly spaced along the deck. There is less cracking near the center pier, which could be a result of camber and increased girder shrinkage. There is also a small amount of longitudinal cracking at each abutment.

Bridge Age: 45.0 months
Crack density: 0.380 m/m²
Span 1 (West): 0.310 m/m²
Span 2 (West): 0.408 m/m²
Span 3 (East): 0.369 m/m²
Span 4 (East): 0.412 m/m²

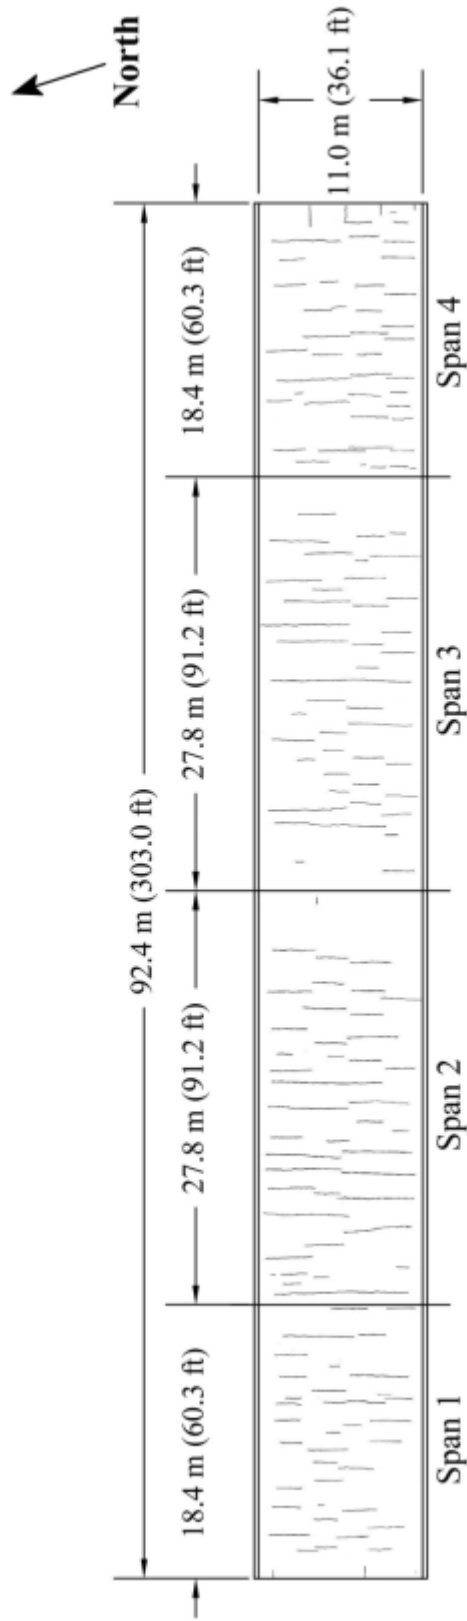
Figure 47: LC-HPC-8 (Survey 4)

Bridge Age: 55.4 months
Crack density: 0.383 m/m²
Span 1 (West): 0.341 m/m²
Span 2 (West): 0.400 m/m²
Span 3 (East): 0.357 m/m²
Span 4 (East): 0.425 m/m²

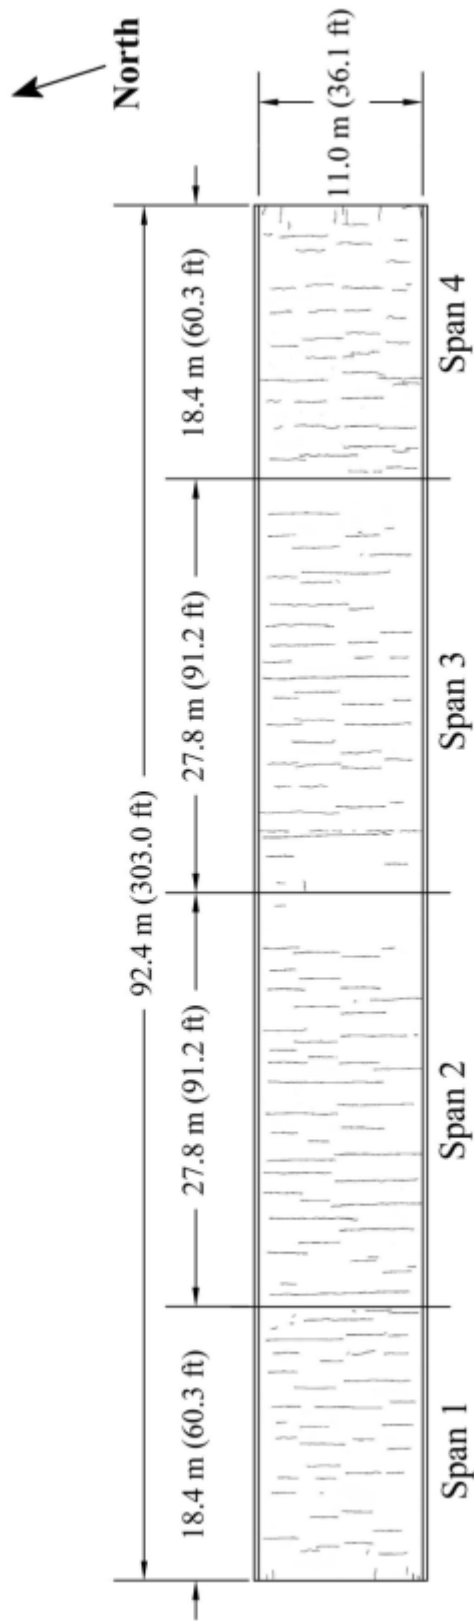
Figure 48: LC-HPC-8 (Survey 5)

Bridge Age: 67.7 months
Crack density: 0.373 m/m²
Span 1 (West): 0.351 m/m²
Span 2 (West): 0.406 m/m²
Span 3 (East): 0.350 m/m²
Span 4 (East): 0.357 m/m²

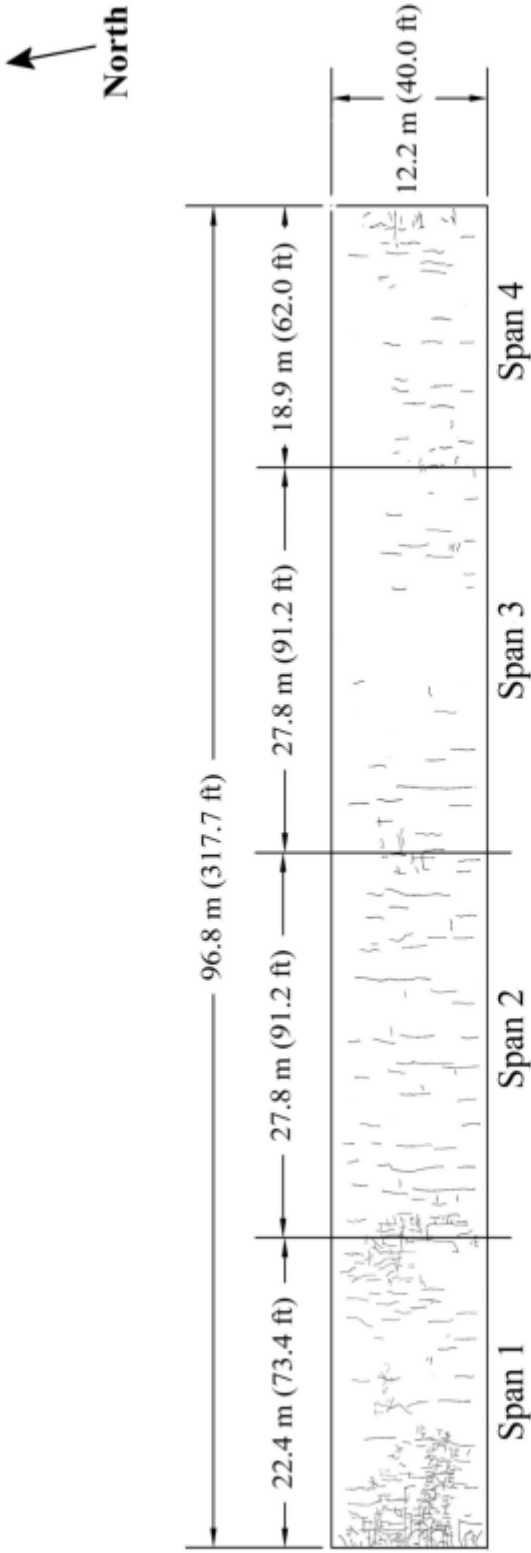
Figure 49: Control-8/10 (Survey 4)

Like LC-HPC-8 and LC-HPC-10, Control-8/10 is a monolithic deck cast on precast, prestressed girders. The results of Surveys 4, 5 and 6 at 50.6, 61.6, and 75.5 months, respectively, are included in this report. The crack density of Control-8/10 at 50.6 months was 0.326 m/m^2 , as shown in Figure 49. This crack density is more than double the value from Survey 3 at 37.2 months, 0.137 m/m^2 (Pendergrass et al. 2011). The crack density has continued to increase with values of 0.425 m/m^2 and 0.581 m/m^2 , respectively, measured during Surveys 5 and 6. The crack maps from Surveys 5 and 6 are shown in Figures 50 and 51. The cracking on Control-8/10 consists of a small number of medium-length transverse cracks, as well as a large number of smaller cracks. Map cracking is prevalent on Control-8/10, particularly near the west abutment, where map cracking has increased drastically over the past three surveys. Control 8/10 had less cracking at 50.6 months than LC-HPC-8 at 45.0 months, but has had more cracking in the two most recent surveys. Figure 52 compares cracking on Control 8/10 to cracking on LC-

Bridge Number: 54-59 (Control-8/10) **Bridge Length:** 96.8 m (317.7 ft) **Bridge Age:** 50.6 months
Bridge Location: K-52 over US-69 **Bridge Width:** 12.2 m (40.0 ft) **Crack density:** 0.326 m/m²
Construction Date: 4/16/2007 **Skew:** 0° **Number of Spans:** 4
Crack survey Date: 7/5/2011 **Span 1:** 22.4 m (73.4 ft) **Span 2:** 27.8 m (91.2 ft) **Span 3:** 27.8 m (91.2 ft) **Span 4:** 18.9 m (62.0 ft)
Number of Placements: 1
Span 1: 0.655 m/m²
Span 2: 0.334 m/m²
Span 3: 0.135 m/m²
Span 4: 0.212 m/m²

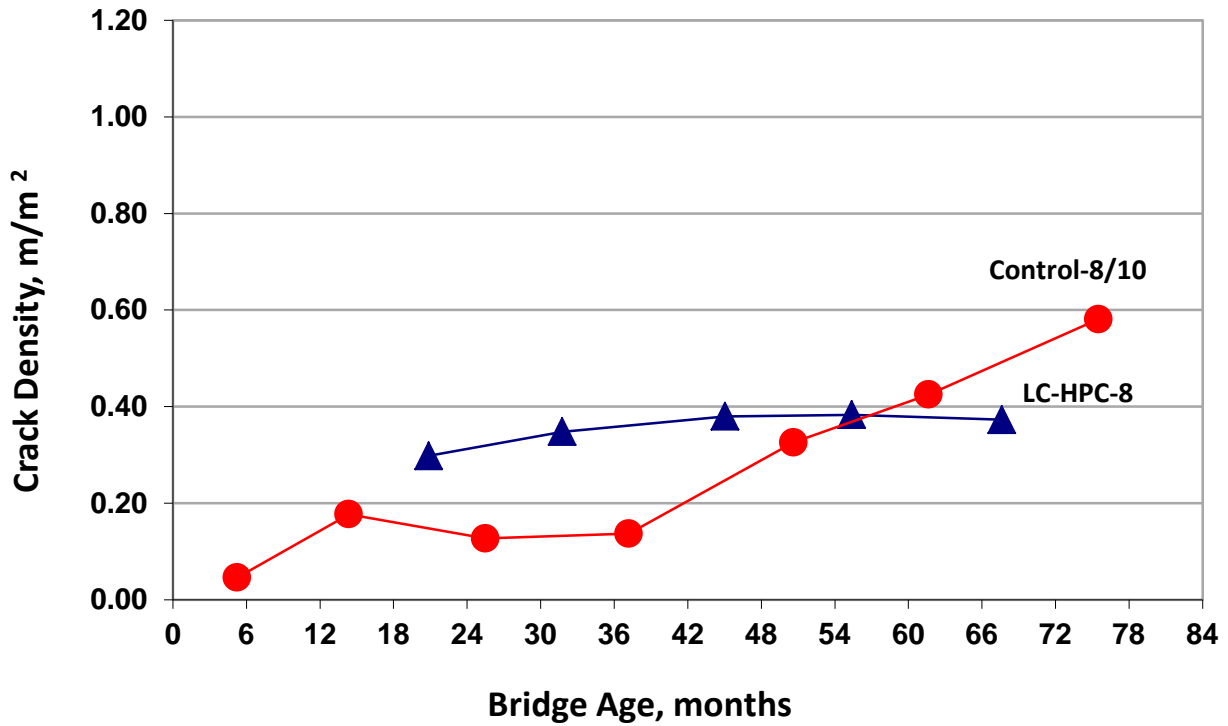
Figure 52: LC-HPC-8 and Control-8/10 Crack Densities

over time. LC-HPC-8 is one of the only decks in the project which has experienced significantly higher cracking than its control deck. However, Control 8/10 has experienced a marked rise in crack density after 36 months of age and is now experiencing more cracking than LC-HPC-8.

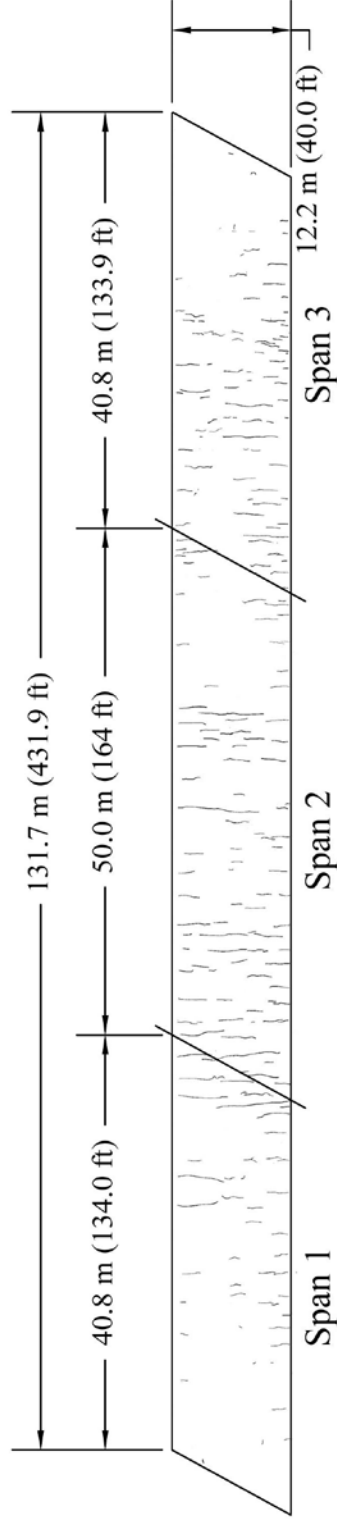
Figure 53: LC-HPC-9 (Survey 2)

The results of Surveys 2, 3, and 4 of LC-HPC-9, at 26.5, 38.3, and 49.3 months, are included in this report. The crack density of LC-HPC-9 at 26.5 months was 0.237 m/m², shown in Figure 53, represents an increase from the previous survey at 13.3 months, for which the crack density was 0.130 m/m² (Pendergrass et al. 2011). The crack density at 38.3 months increased to 0.362 m/m² (Figure 54) and dropped back to 0.299 m/m² at 49.3 months (Figure 55). The cracking is mainly transverse. There is very little cracking near the abutments.

Bridge Age: 26.5 months
Crack density: 0.237 m/m²
Span 1 (South): 0.174 m/m²
Span 2 (Middle): 0.281 m/m²
Span 3 (North): 0.221 m/m²

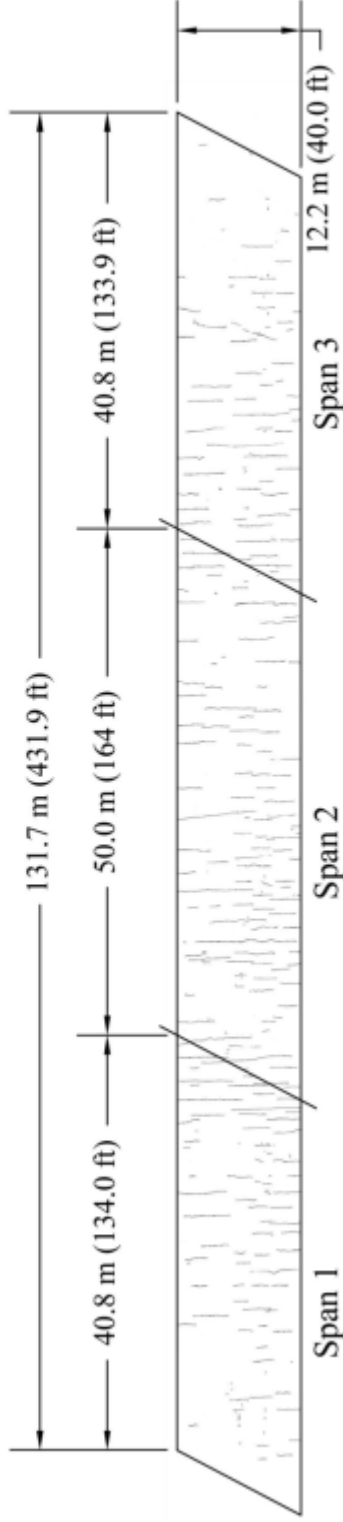
Bridge Number: 54-57 (LC-HPC-9)
Bridge Location: NB US-69 over
 Marair Des Cygnes Rv
Construction Date: 4/15/2009
Crack survey Date: 5/24/2013

Bridge Length: 131.7 m (431.9 ft)
Bridge Width: 12.2 m (40.0 ft)
Skew: -27.7°
Number of Spans: 3
Span 1 (South): 40.8 m (134.0 ft)
Span 2 (Middle): 50.0 m (164.0 ft)
Span 3 (North): 40.8 m (133.9 ft)
Number of Placements: 1

Bridge Age: 49.3 months
Crack density: 0.299 m/m^2
Span 1 (South): 0.281 m/m^2
Span 2 (Middle): 0.353 m/m^2
Span 3 (North): 0.243 m/m^2
