**CRACK SURVEYS OF LOW-CRACKING
HIGH-PERFORMANCE CONCRETE
BRIDGE DECKS IN KANSAS
2011-2013**

**A Report on Research Sponsored by
CONSTRUCTION OF CRACK-FREE BRIDGE DECKS
TRANSPORTATION POOLED-FUND PROGRAM
PROJECT NO. TPF-5(174)**

**Structural Engineering and Engineering Materials
SL Report 13-6**

**THE UNIVERSITY OF KANSAS CENTER FOR RESEARCH, INC.
LAWRENCE, KANSAS
December 2013**

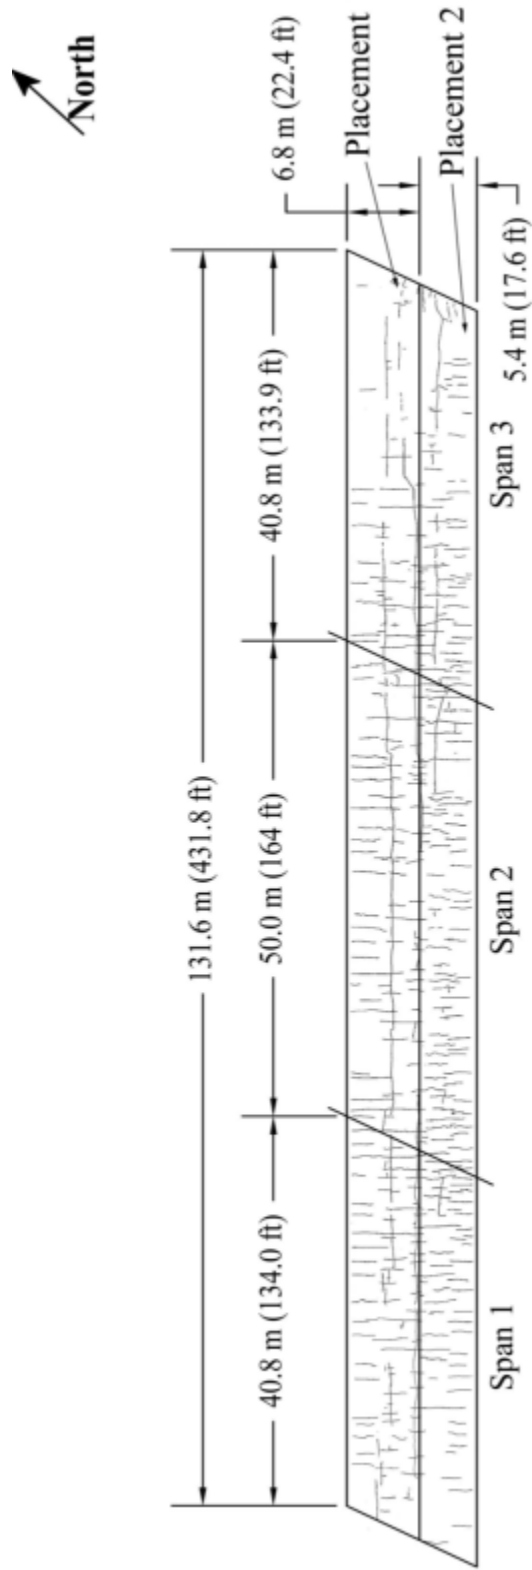
Figure 56: Control-9 (Survey 2)

Control-9 was constructed in two placements eight days apart. The results of Survey 2 at 37.0 and 37.2 months, Survey 3 at 48.9 and 49.1 months, and Survey 4 at 59.8 and 60.1 months are included in this report. At 37.2 months, Placement 1 had a crack density of 0.553 m/m^2 (see Figure 56). Placement 2 had a crack density of 0.577 m/m^2 at 37.0 months, and the overall crack density resulting from Survey 2 was 0.568 m/m^2 . This represents an increase from Survey 1 for which the crack densities were, respectively, 0.395 m/m^2 , 0.368 m/m^2 , and 0.390 m/m^2 for Placement 1, Placement 2, and the overall crack density (Pendergrass et al. 2011). Placement 1 had a crack density of 0.637 m/m^2 at 49.1 months and Placement 2 had a crack density of 0.501 m/m^2 at 48.9 months (see Figure 57). The overall crack density was 0.577 m/m^2 . The crack densities measured during Survey 4 were 0.645 m/m^2 at 60.1 months for Placement 1 (see Figure 58) and 0.564 m/m^2 at 59.8 months for Placement 2, resulting in an overall crack density of 0.609 m/m^2 . Both placements have long transverse cracks throughout, with fewer near the abutments. Both placements have continuous longitudinal cracks running nearly the entire length of the bridge, as well as some longitudinal cracking propagating from the abutments. Crack densities have been consistently higher for Control-9 than for LC-HPC-9 over the past three surveys. Figure 59 compares cracking on Control 9 to cracking on LC-HPC-9 over time. LC-HPC-9 has maintained a crack density lower than either placement of Control 9 over time. LC-HPC-9 and Control 9 experienced similar increases in crack density early on, but LC-HPC-9 has less overall cracking because of its significantly lower initial density.

Bridge Number: 54-58 (Control-9)	Bridge Length: 131.6 m (431.8 ft)	Bridge Age:
Bridge Location: NB US-69 over Marair Des Cygnes Rv	Bridge Width: 12.2 m (40.0 ft)	Placement 1: 37.2 months
Construction Date:	Skew: -27.2°	Placement 2: 37.0 months
Placement 1 (West): 5/21/2008	Number of Spans: 3	Crack density: 0.568 m/m ²
Placement 2 (East): 5/29/2008	Span 1 (South): 40.8 m (134.0 ft)	Placement 1: 0.553 m/m ²
Crack survey Date: 6/28/2011	Span 2 (Middle): 50.0 m (164.0 ft)	Placement 2: 0.577 m/m ²
	Span 3 (North): 40.8 m (133.8 ft)	Span 1 (South): 0.571 m/m ²
	Number of Placements: 2	Span 2 (Middle): 0.624 m/m ²
	Placement1(West): 6.8 m (22.4 ft)	Span 3 (North): 0.486 m/m ²
	Placement2 (East): 5.4 m (17.6 ft)

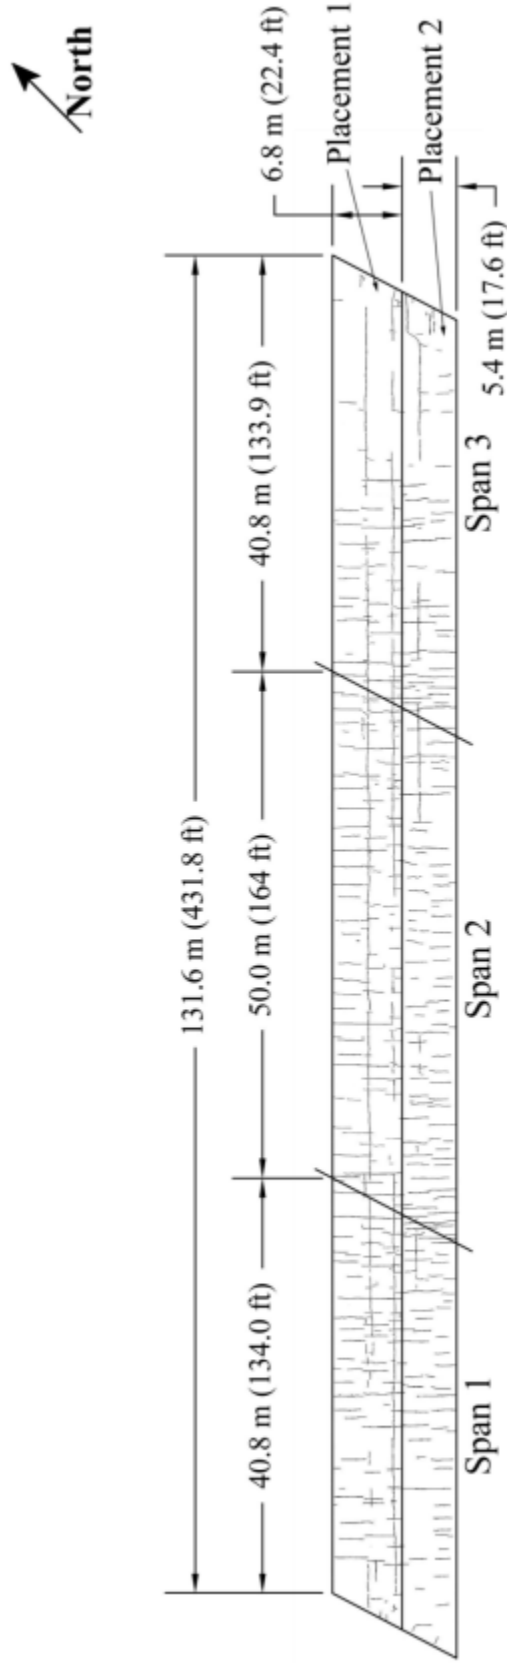
Figure 57: Control-9 (Survey 3)

Bridge Number: 54-58 (Control-9)
Bridge Location: NB US-69 over Marair Des Cygnes Rv
Construction Date:
 Placement 1 (West): 5/21/2008
 Placement 2 (East): 5/29/2008
Crack survey Date: 6/25/2012

Bridge Length: 131.6 m (431.8 ft)
Bridge Width: 12.2 m (40.0 ft)
Skew: -27.2°
Number of Spans: 3
Span 1 (South): 40.8 m (134.0 ft)
Span 2 (Middle): 50.0 m (164.0 ft)
Span 3 (North): 40.8 m (133.8 ft)
Number of Placements: 2
Placement1(West): 6.8 m (22.4 ft)
Placement2 (East): 5.4 m (17.6 ft)

Bridge Age:
 Placement 1: 49.1 months
 Placement 2: 48.9 months
Crack density: 0.577 m/m²
 Placement 1: 0.637 m/m²
 Placement 2: 0.501 m/m²
Span 1 (South): 0.574 m/m²
Span 2 (Middle): 0.651 m/m²
Span 3 (North): 0.486 m/m²

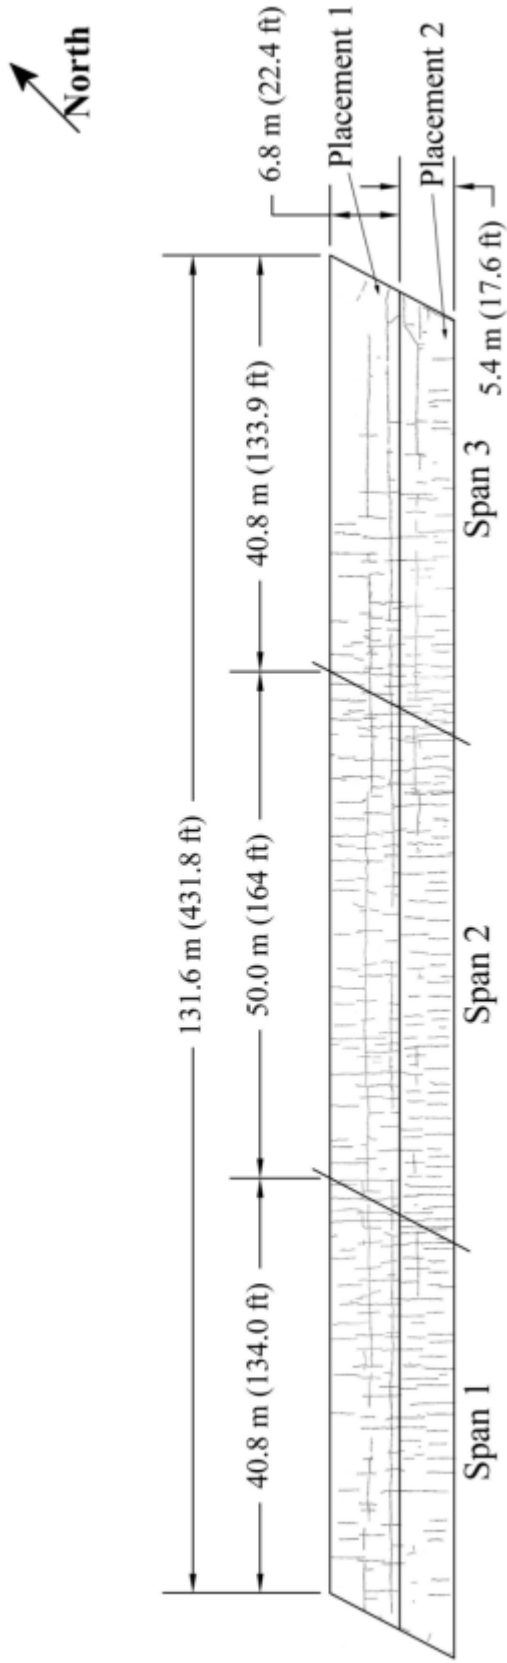
Figure 58: Control-9 (Survey 4)

Bridge Number: 54-58 (Control-9)
Bridge Location: NB US-69 over
 Marair Des Cygnes Rv
Construction Date:
 Placement 1 (West): 5/21/2008
 Placement 2 (East): 5/29/2008
Crack survey Date: 5/24/2013

Bridge Length: 131.6 m (431.8 ft)
Bridge Width: 12.2 m (40.0 ft)
Skew: -27.2°
Number of Spans: 3
Span 1 (South): 40.8 m (134.0 ft)
Span 2 (Middle): 50.0 m (164.0 ft)
Span 3 (North): 40.8 m (133.8 ft)
Number of Placements: 2
Placement1(West): 6.8 m (22.4 ft)
Placement2 (East): 5.4 m (17.6 ft)

Bridge Age:
 Placement 1: 60.1 months
 Placement 2: 59.8 months
Crack density: 0.609 m/m²
 Placement 1: 0.645 m/m²
 Placement 2: 0.564 m/m²
Span 1 (South): 0.601 m/m²
Span 2 (Middle): 0.699 m/m²
Span 3 (North): 0.508 m/m²

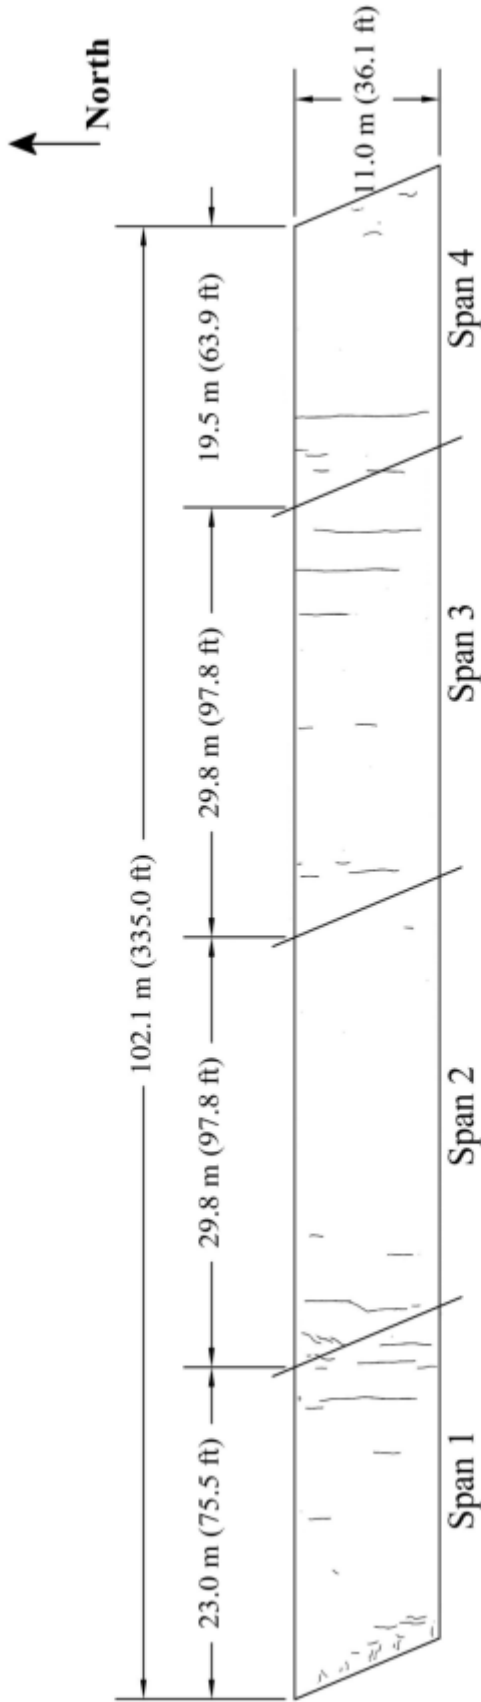
Figure 60: LC-HPC-10 (Survey 3)

The results for Surveys 3, 4, and 5 of LC-HPC-10, at 49.6, 60.0, and 72.2 months, are included in this report. LC-HPC-10 is the second of two LC-HPC bridges with precast, prestressed concrete girders. At 49.6 months, the crack density of LC-HPC-10 was 0.088 m/m², as shown in Figure 60. This represents an increase from Survey 2 at 36.2 months, when the crack density was 0.029 m/m² (Pendergrass et al. 2011). The crack density of LC-HPC-10 was 0.125 m/m² at 60.0 months (Figure 61), but only 0.069 m/m² at 72.2 months (Figure 62). Most of the cracks are long transverse cracks near the outer two piers, with a small amount of cracking near the center pier and abutments. Figure 63 compares cracking on LC-HPC-10 to cracking on Control 8/10 over time. For most of its life, LC-HPC-10 has experienced less cracking than Control 8/10. LC-HPC-10 started out with a larger density than Control 8/10 because it was

Bridge Number: 54-60 (LC-HPC-10)
Bridge Location: E1800Rd over US-69
Construction Date: 5/17/2007
Crack survey Date: 7/5/2011

Bridge Length: 102.1 m (335.0 ft)
Bridge Width: 11.0 m (36.1 ft)
Skew: 21.3°
Number of Spans: 4
Span 1 (West): 23.0 m (75.5 ft)
Span 2 (West): 29.8 m (97.8 ft)
Span 3 (East): 29.8 m (97.8 ft)
Span 4 (East): 19.5 m (63.9 ft)
Number of Placements: 1

Bridge Age: 49.6 months
Crack density: 0.088 m/m²
Span 1 (West): 0.141 m/m²
Span 2 (West): 0.046 m/m²
Span 3 (East): 0.091 m/m²
Span 4 (East): 0.086 m/m²

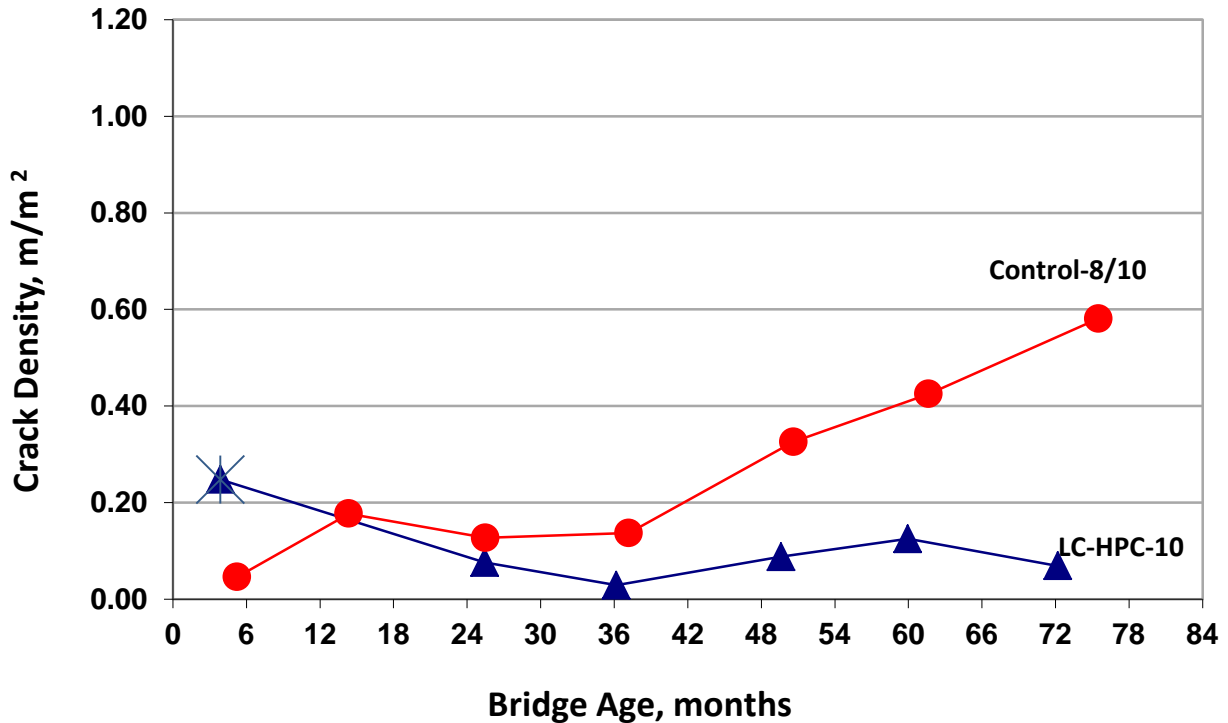
Figure 63: LC-HPC-10 and Control-8/10 Crack Densities

first surveyed when the deck was not grooved. Following grooving, the cracking was not as significant and fell below values on Control 8/10.

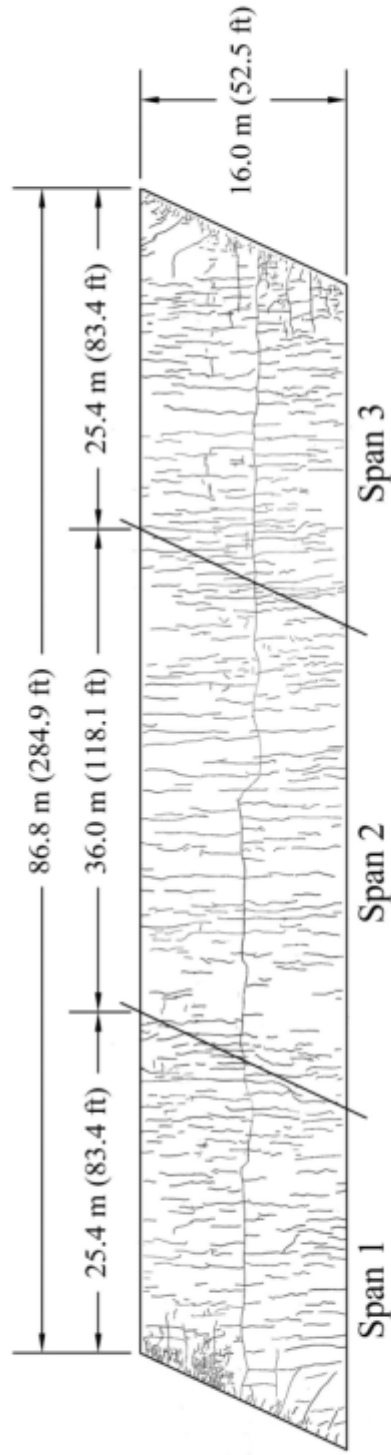
Figure 67: Control-11 (Survey 5)

The results of Surveys 5, 6, and 7 of Control-11, at 62.9, 74.2, and 86.3 months, are included in this report. The crack density of Control-11 at 62.9 months, 0.923 m/m^2 (Figure 67), was 45% higher than the value at 50.2 months, 0.636 m/m^2 (Pendergrass et al. 2011). The crack density of Control-11 decreased to 0.849 m/m^2 at 75.2 months (Figure 68), and decreased even further to 0.657 m/m^2 at 86.3 months (Figure 69). Cracking is higher on Control-11 than on LC-HPC-11 at similar ages. Specifically, Control-11 had a crack density of 0.923 m/m^2 at 62.9 months, which is three times the density of LC-HPC-11 at 61.0 months, 0.260 m/m^2 . Similarly, Control-11 had a crack density of 0.849 m/m^2 at 75.2 months, which is more than twice the density on LC-HPC-11 at 72.1 months, 0.420 m/m^2 . There are many small, narrow cracks on the deck that may have been overlooked in Surveys 6 and 7, leading to smaller crack densities. Most of the cracks are transverse, spread across the deck parallel to and above the reinforcement. There is a single longitudinal crack in the middle of the deck stretching across the entire length of the bridge, as well as smaller longitudinal cracks propagating from the abutments. Figure 70 compares cracking on Control 11 to cracking on LC-HPC-11 over time. While LC-HPC-11 has had less cracking than Control 11 over time, both decks have experienced significant swings in crack density.

Bridge Number: 56-155 (Control-11)
Bridge Location: US-50 over BNSF Railroad, Emporia, KS
Construction Date: 3/28/2006
Crack Survey Date: 6/23/2011

Bridge Length: 86.8 m (284.9 ft)
Bridge Width: 16.0 m (52.5 ft)
Skew: 24.3°
Number of Spans: 3
Span 1: 25.4 m (83.4 ft)
Span 2: 36.0 m (118.1 ft)
Span 3: 25.4 m (83.4 ft)
Number of Placements: 1

Bridge Age: 62.9 months
Crack Density: 0.923 m/m²
Span 1: 1.001 m/m²
Span 2: 0.804 m/m²
Span 3: 1.005m/m²

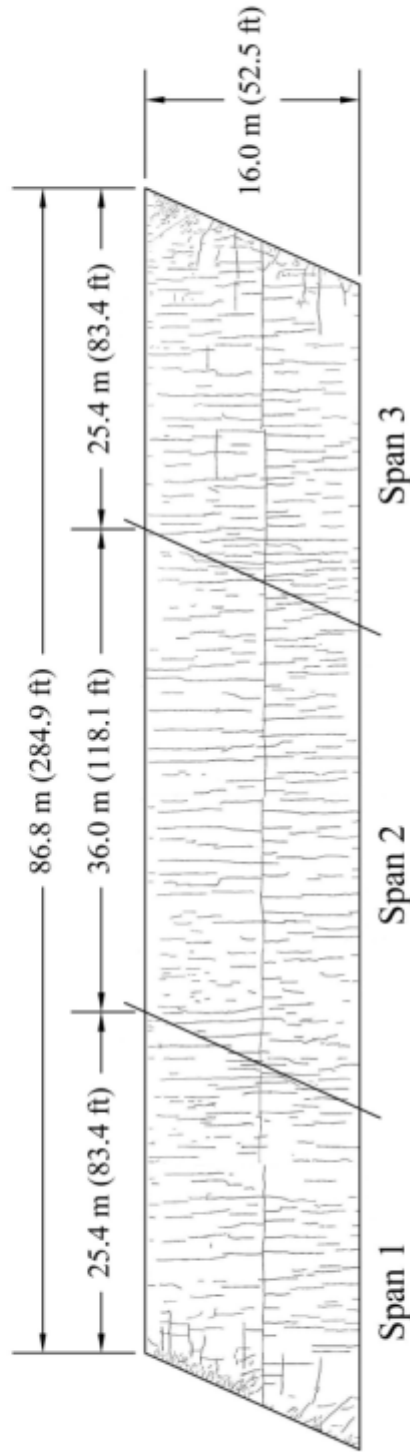
Figure 68: Control-11 (Survey 6)

Bridge Number: 56-155 (Control-11)

Bridge Location: US-50 over BNSF
Railroad, Emporia, KS

Crack Survey Date: 7/3/2012

Crack Density: 0.849 m/m²

Span 3: 0.945 m/m²

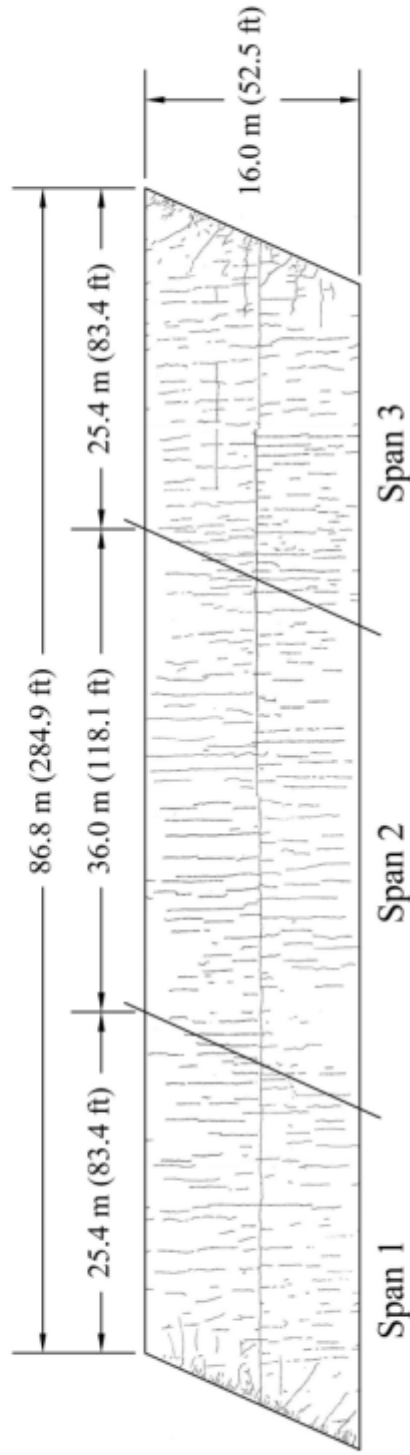
Figure 69: Control-11 (Survey 7)

Bridge Number: 56-155 (Control-11)
Bridge Location: US-50 over BNSF
 Railroad, Emporia, KS
Construction Date: 3/28/2006
Crack Survey Date: 6/6/2013

Bridge Length: 86.8 m (284.9 ft)
Bridge Width: 16.0 m (52.5 ft)
Skew: -24.3°
Number of Spans: 3
Span 1: 25.4 m (83.4 ft)
Span 2: 36.0 m (118.1 ft)
Span 3: 25.4 m (83.4 ft)
Number of Placements: 1

Bridge Age: 86.3 months
Crack Density: 0.657 m/m²
Span 1: 0.621 m/m²
Span 2: 0.608 m/m²
Span 3: 0.754 m/m²

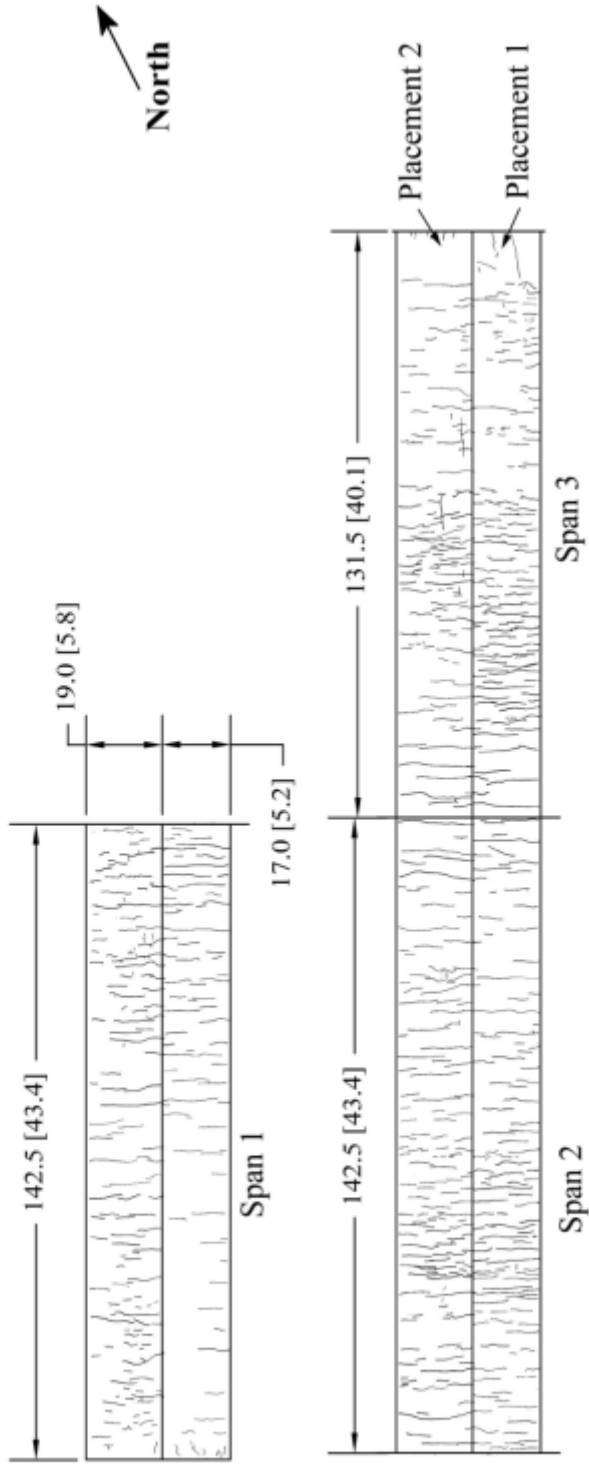
Figure 74: Control-12 (Survey 3)

Control-12, the southern half of the same bridge as LC-HPC-12, was also constructed in two placements, 12.4 months apart. The results of Survey 3 at 26.5 and 38.9 months, Survey 4 at 37.2 and 49.6 months, and Survey 5 at 52.2 and 64.6 months are included in this report. At 38.9 months, Placement 1 had a crack density of 0.767 m/m^2 (see Figure 74) and at 26.5 months, Placement 2 had a crack density of 0.799 m/m^2 , resulting in an overall crack density of 0.788 m/m^2 . This represents an increase from Survey 2, for which the crack densities were 0.669 m/m^2 , 0.442 m/m^2 , and 0.548 m/m^2 for Placement 1, Placement 2, and overall, respectively (Pendergrass et al. 2011). For Survey 4, Placement 1 had a crack density of 0.857 m/m^2 at 49.6 months and Placement 2 had a crack density of 0.831 m/m^2 at 37.2 months, resulting in an overall crack density of 0.843 m/m^2 (see Figure 75). These values are all larger than the corresponding crack densities from Survey 3. For Survey 5 at 64.6 months, Placement 1 had a crack density of 0.838 m/m^2 , and at 52.2 months, Placement 2 had a crack density of 0.880 m/m^2 , resulting in an overall crack density of 0.858 m/m^2 for Survey 5 (See Figure 76). This represents an increase from Survey 4 for Placement 2, but not for Placement 1, which had a crack density that remained unchanged from Survey 4. Control-12 consistently has had crack

Bridge Number: 56-057 (Control-12)	Bridge Length: 416.5' (126.95m)	Bridge Age:
Bridge Location: K-130 over Neosho Rv Unit 1	Bridge Width: 36' (10.97m)	Placement 1: 38.9 months
Construction Date:	Skew: 0°	Placement 2: 26.5 months
Placement 1(east): 4/1/2008	Number of Spans: 3	Crack Density: 0.788 m/m ²
Placement 2(west): 4/14/2009	Span 1 (West): 142.5' (43.43m)	Placement 1: 0.767 m/m ²
Crack Survey Date: 6/29/2011	Span 2 (Mid): 142.5' (43.43m)	Placement 2: 0.799 m/m ²
	Span 3 (East): 131.5' (40.08m)	Span 1: 0.636 m/m ²
	Number of Placements: 2	Span 2: 0.892 m/m ²
		Span 3: 0.829 m/m ²

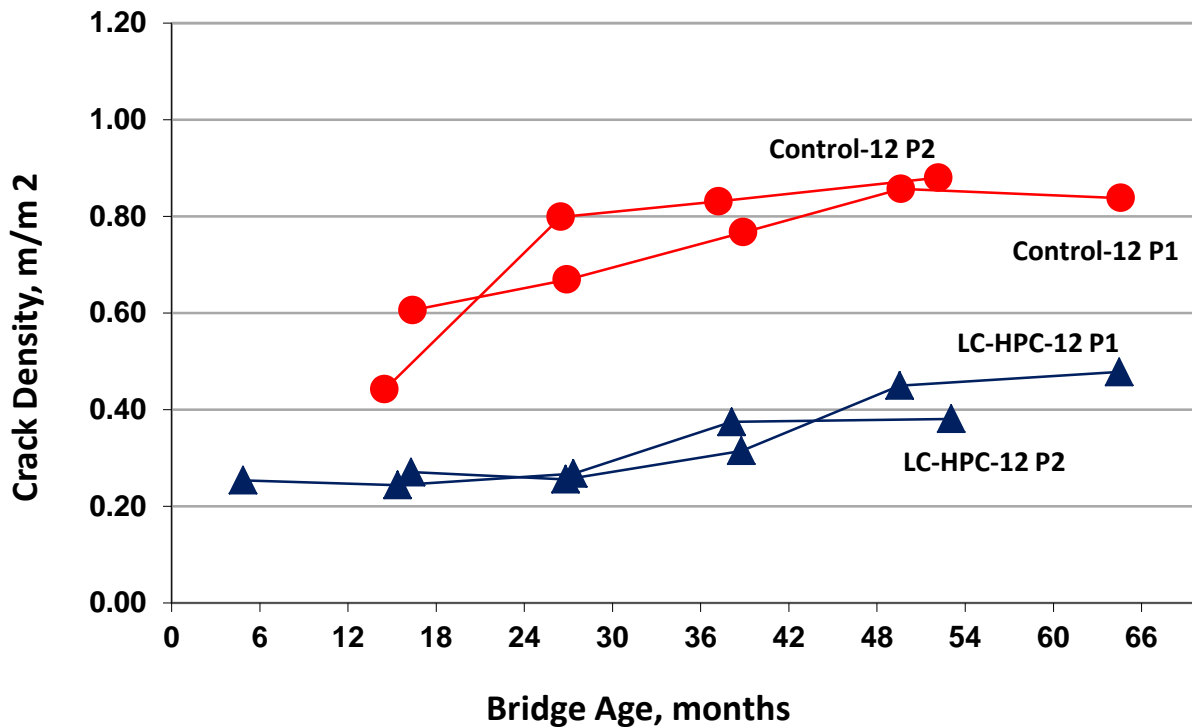
Figure 77: LC-HPC-12 and Control-12 Crack Densities

densities about twice those of LC-HPC-12. Long transverse cracks span the length of both placements, and there are small longitudinal cracks propagating from both abutments. Similar to LC-HPC-12, construction equipment was placed on Placement 1 during the construction of Placement 2. Figure 77 compares cracking on Control-12 to cracking on LC-HPC-12 over time. LC-HPC-12 has performed significantly better throughout the life of the decks. It appears that crack growth has begun to stabilize on both decks.

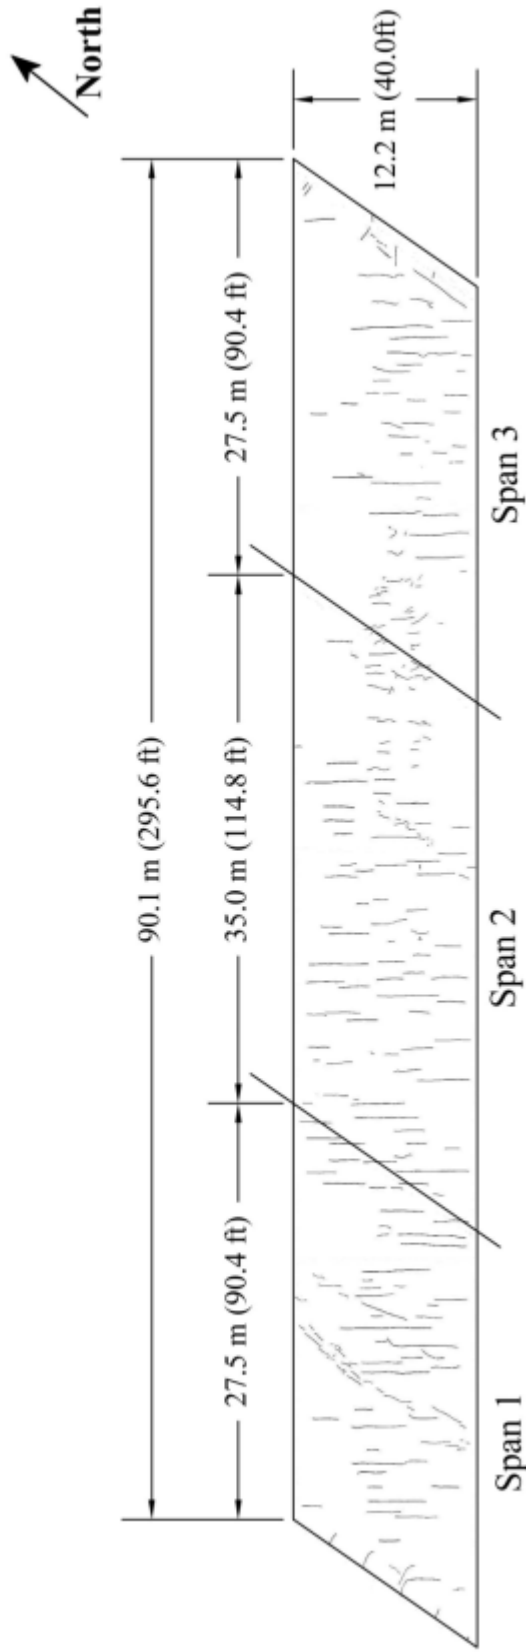
The results of Surveys 3, 4, and 5 of LC-HPC-13, at 37.1, 49.0, and 62.9 months, are included in this report. The crack density of LC-HPC-13 was 0.364 m/m² at 37.1 months (Figure 78), which represents an increase from 0.129 m/m² at 24.8 months (Pendergrass et al. 2011). The crack density of LC-HPC-13 at 49.0 months was 0.342 m/m² (Figure 79), and increased to 0.576

Bridge Number: 54-66 (LC-HPC-13)
Bridge Location: NB US-69 over
 BNSF RR, Linn County, KS
Construction Date: 4/29/2008
Crack survey Date: 5/29/2012

Bridge Length: 90.1 m (295.6 ft)
Bridge Width: 12.2 m (40.0 ft)
Skew: -34.8
Number of Spans: 3
Span 1 (West): 27.5 m (90.4 ft)
Span 2 (Middle): 35.0 m (114.8 ft)
Span 3 (East): 27.5 m (90.4 ft)
Number of Placements: 1

Bridge Age: 49.0 months
Crack density: 0.342 m/m²
Span 1 (West): 0.392 m/m²
Span 2 (middle): 0.342 m/m²
Span 3 (East): 0.291 m/m²

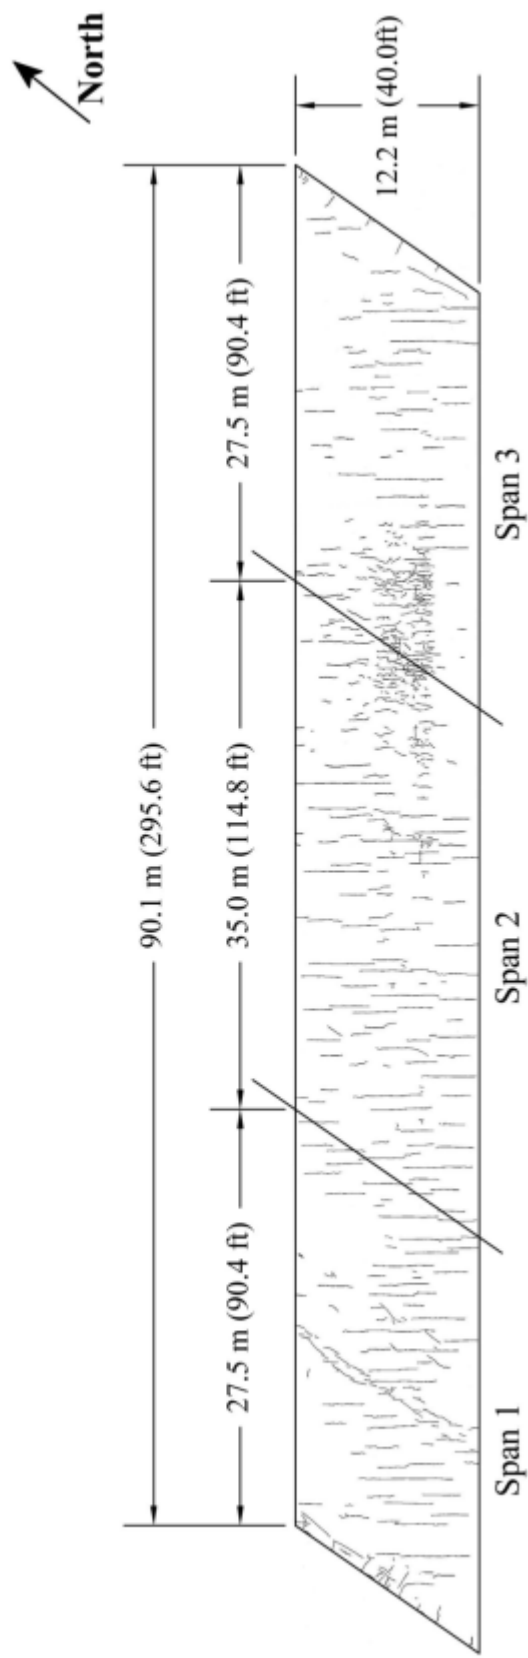
Figure 80: LC-HPC-13 (Survey 5)

m/m² at 62.9 months (Figure 80). Most of the cracks are transverse, parallel to and directly above the top reinforcement and, therefore, likely due to settlement and shrinkage. Map cracking is present above the second pier along with cracks that propagate perpendicular to the abutments and cracking parallel to the skew of the bridge in the center of the first span.

Bridge Number: 54-66 (LC-HPC-13)
Bridge Location: NB US-69 over
 BNSF RR, Linn County, KS
Construction Date: 4/29/2008
Crack survey Date: 7/25/2013

Bridge Length: 90.1 m (295.6 ft)
Bridge Width: 12.2 m (40.0 ft)
Skew: -34.8
Number of Spans: 3
Span 1 (West): 27.5 m (90.4 ft)
Span 2 (Middle): 35.0 m (114.8 ft)
Span 3 (East): 27.5 m (90.4 ft)
Number of Placements: 1

Bridge Age: 62.9 months
Crack density: 0.576 m/m²
Span 1 (West): 0.579 m/m²
Span 2 (middle): 0.604 m/m²
Span 3 (East): 0.536 m/m²

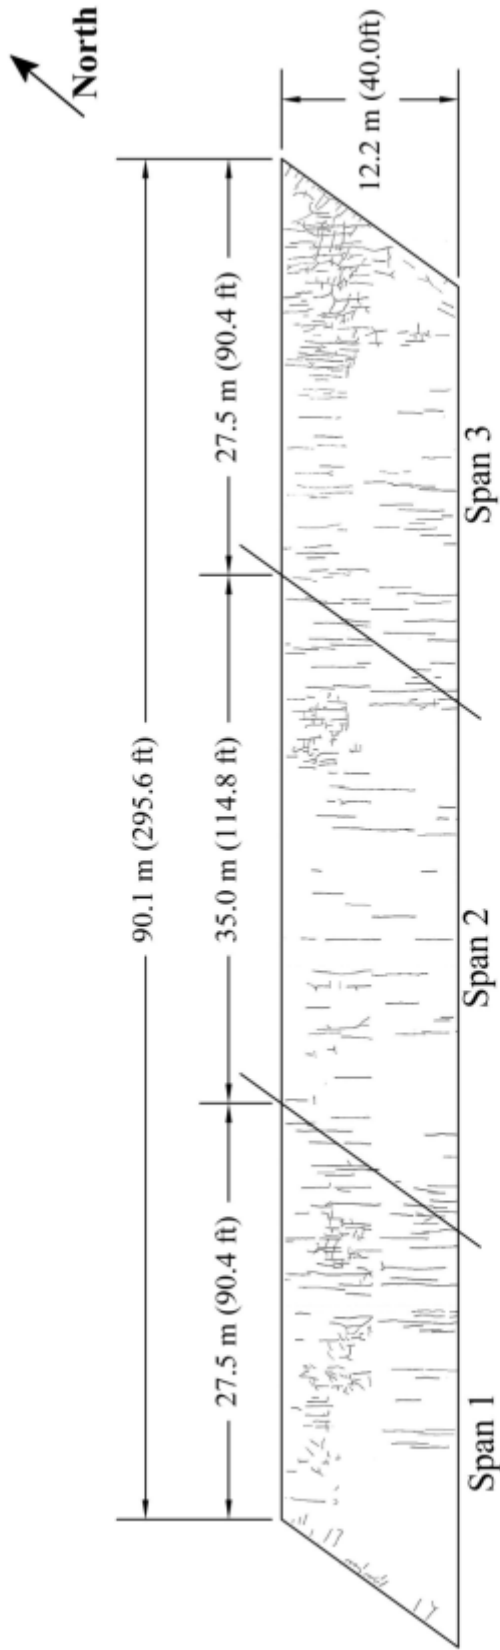
Figure 81: Control-13 (Survey 3)

The results of Surveys 3, 4, and 5 of Control-13, at 34.4, 46.1, and 60.0 months, are included in this report. The crack density of 0.524 m/m² at 34.4 months (Figure 81) represents an increase from the crack density of 0.154 m/m² measured in Survey 2 (Pendergrass et al. 2011) and is 44% higher than the density of LC-HPC-13 at 37.1 months, 0.364 m/m². The crack density of Control-13 at 46.1 months was 0.543 m/m² (Figure 82) and increased to 0.807 m/m² at 60.0 months (Figure 83), 59% and 40% higher, respectively, than densities on LC-HPC-13 at 49.0 and 62.9 months, 0.342 m/m² and 0.576 m/m². Significant map cracking is present at the east abutment, as well as in the middle of the first span. Transverse cracks have developed throughout the deck, with somewhat higher densities near the piers. Small cracks propagate perpendicular to the abutments. Figure 84 compares cracking on Control-13 to cracking on LC-HPC-13 over time. It is clear that LC-HPC-13 has experienced less cracking than Control-13 over the entire life of both bridges. Both decks have remarkably similar crack growth trends, with both decks experiencing an increase from 12 to 36 months, a plateau from 36 to 48 months, and another increase after 48 months. Cracking does not seem to have stabilized on either deck.

Bridge Number: 54-67
 (Control-13)
Bridge Location: SB US-69 over
 BNSF RR, Linn County, KS
Construction Date: 7/25/2008
Crack survey Date: 6/6/2011

Bridge Length: 90.1 m (295.6 ft)
Bridge Width: 12.2 m (40.0 ft)
Skew: -34.8
Number of Spans: 3
Span 1 (West): 27.5 m (90.4 ft)
Span 2 (Middle): 35.0 m (114.8 ft)
Span 3 (East): 27.5 m (90.4 ft)
Number of Placements: 1

Bridge Age: 34.4 months
Crack density: 0.524 m/m²
Span 1 (West): 0.568 m/m²
Span 2 (middle): 0.393 m/m²
Span 3 (East): 0.648 m/m²

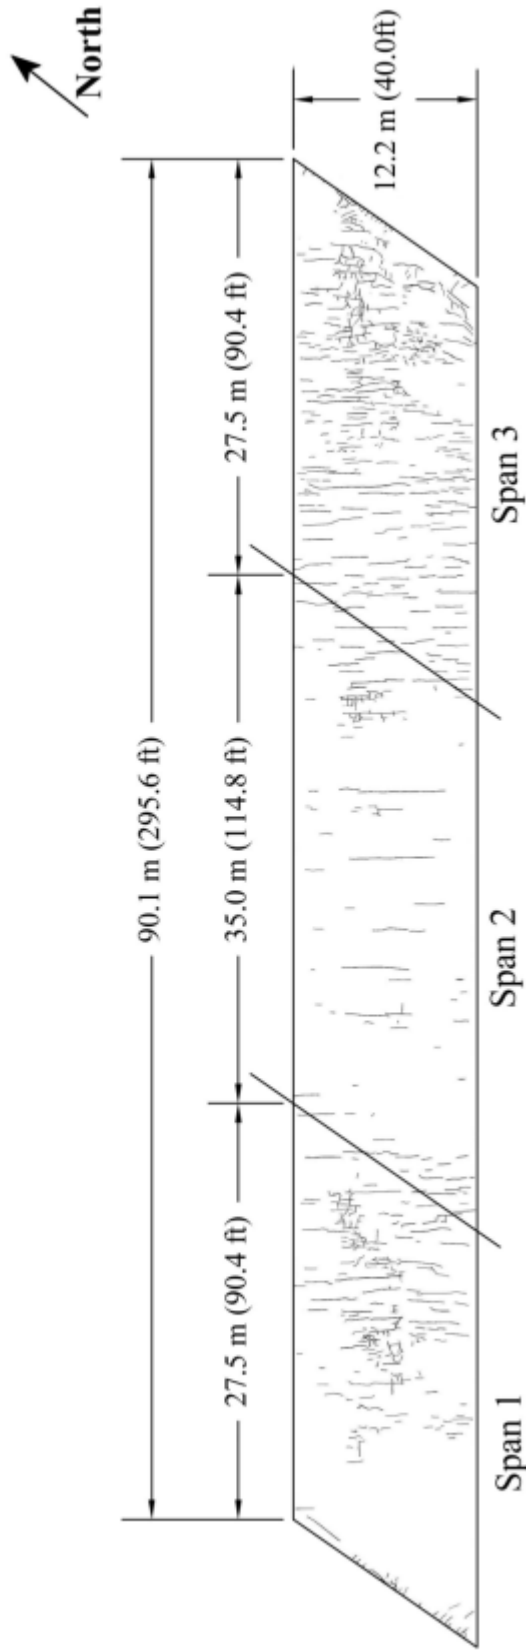
Figure 82: Control-13 (Survey 4)

Bridge Number: 54-67
(Control-13)
Bridge Location: SB US-69 over
BNSF RR, Linn County, KS
Construction Date: 7/25/2008
Crack survey Date: 5/29/2012

Bridge Length: 90.1 m (295.6 ft)
Bridge Width: 12.2 m (40.0 ft)
Skew: -34.8°
Number of Spans: 3
Span 1 (West): 27.5 m (90.4 ft)
Span 2 (Middle): 35.0 m (114.8 ft)
Span 3 (East): 27.5 m (90.4 ft)
Number of Placements: 1

Bridge Age: 46.1 months
Crack density: 0.543 m/m²
Span 1 (West): 0.494 m/m²
Span 2 (middle): 0.268 m/m²
Span 3 (East): 0.927 m/m²

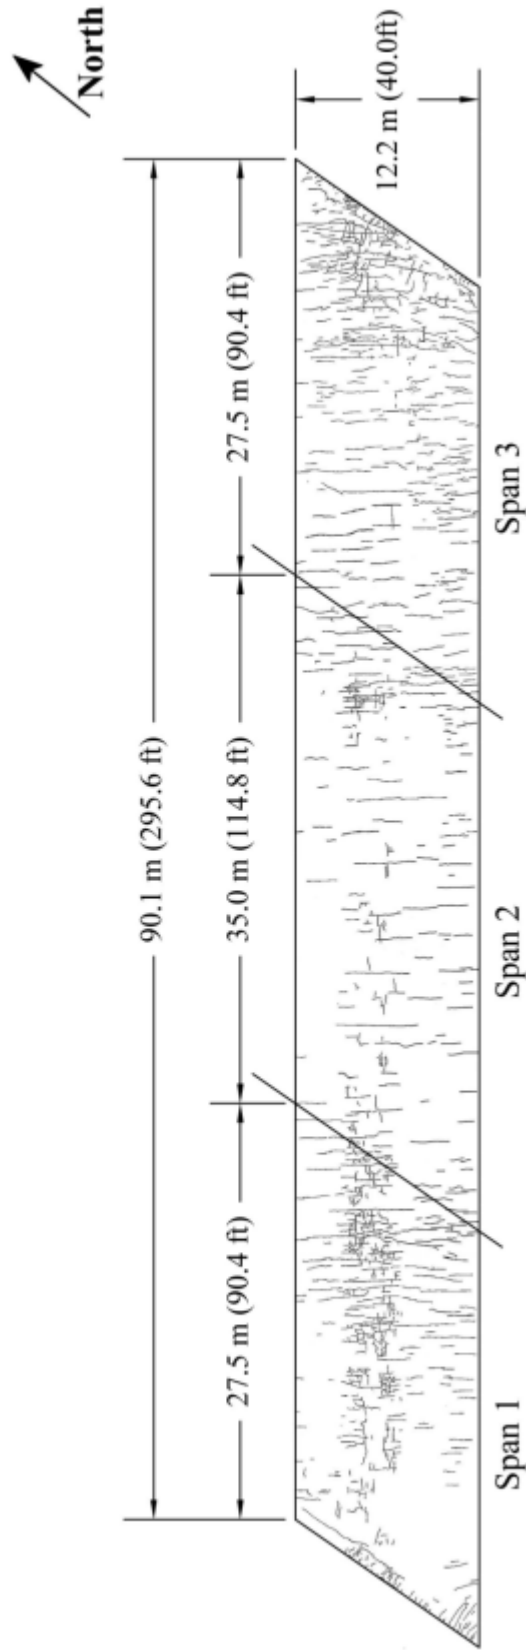
Figure 83: Control-13 (Survey 5)

Bridge Number: 54-67
(Control-13)
Bridge Location: SB US-69 over
BNSF RR, Linn County, KS
Construction Date: 7/25/2008
Crack survey Date: 7/25/2013

Bridge Length: 90.1 m (295.6 ft)
Bridge Width: 12.2 m (40.0 ft)
Skew: -34.8
Number of Spans: 3
Span 1 (West): 27.5 m (90.4 ft)
Span 2 (Middle): 35.0 m (114.8 ft)
Span 3 (East): 27.5 m (90.4 ft)
Number of Placements: 1

Bridge Age: 60.0 months
Crack density: 0.807 m/m²
Span 1 (West): 0.931 m/m²
Span 2 (middle): 0.524 m/m²
Span 3 (East): 1.043 m/m²

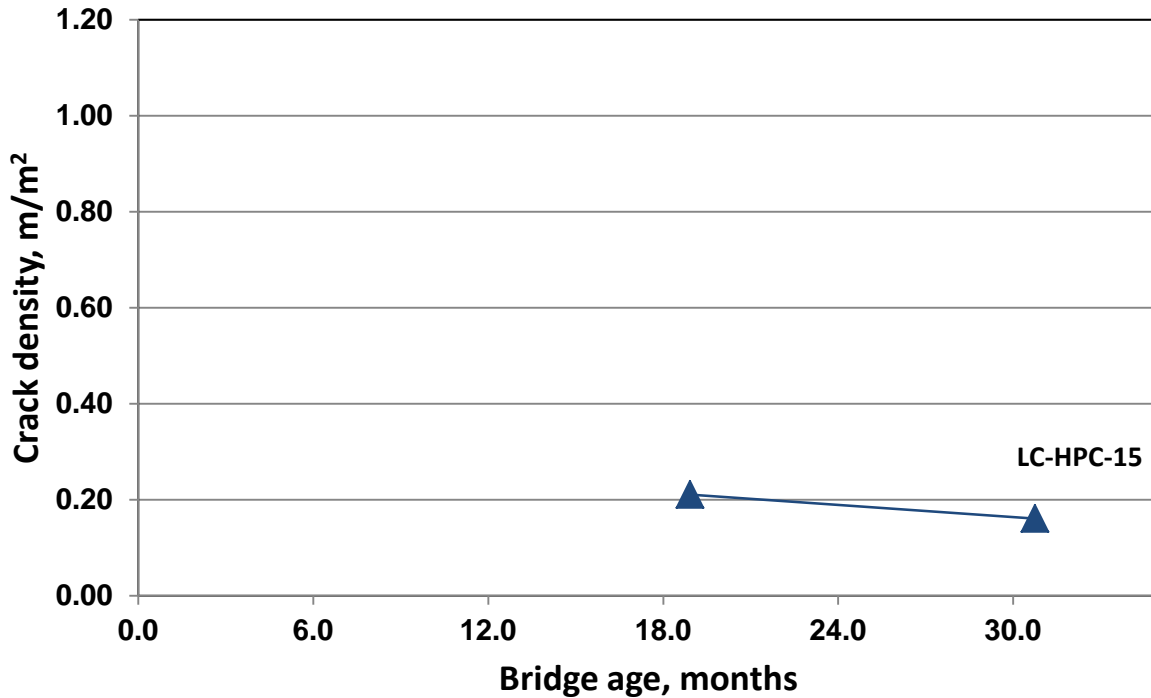
Figure 87: LC-HPC-15 Surveyed Crack Densities

The results of Surveys 1 and 2 of LC-HPC-15, at 18.9 and 30.8 months, are included in this report. The crack density was 0.211 m/m² at 18.9 months (Figure 85) and decreased to 0.161 m/m² at 30.8 months (Figure 86). The decrease in crack density is most likely due to several long transverse cracks in the first span that may have been overlooked. The cracks are transverse, mainly clustered near the pier and centers of the spans. Figure 87 shows cracking on LC-HPC-15 over time.

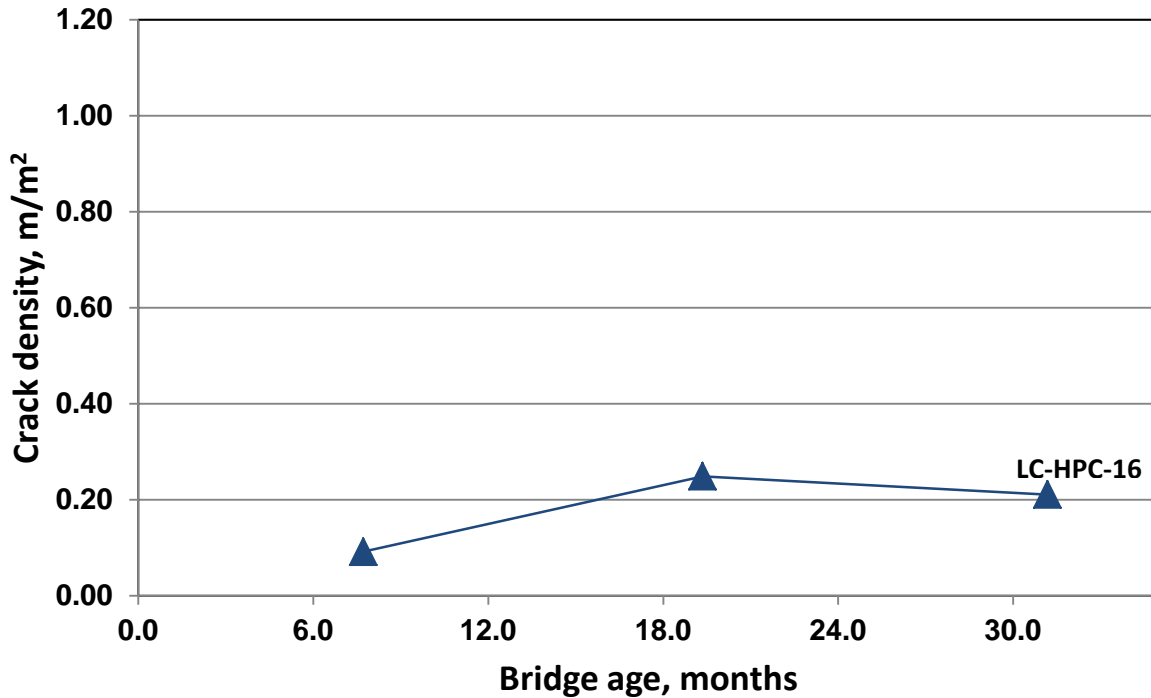
Figure 91: LC-HPC-16 Crack Densities

The results of Surveys 1, 2 and 3 of LC-HPC-16, at 7.70, 19.4 and 31.2 months, are included in this report. The crack density was only 0.092 m/m² at 7.70 months (Figure 88), and grew to 0.249 m/m² at 19.4 months (Figure 89). The crack density then decreased to 0.211 m/m² at 31.2 months (Figure 90). The cracks are transverse, mainly clustered near the pier and centers of the spans, similar to LC-HPC-15. Figure 91 shows cracking on LC-HPC-16 over time.

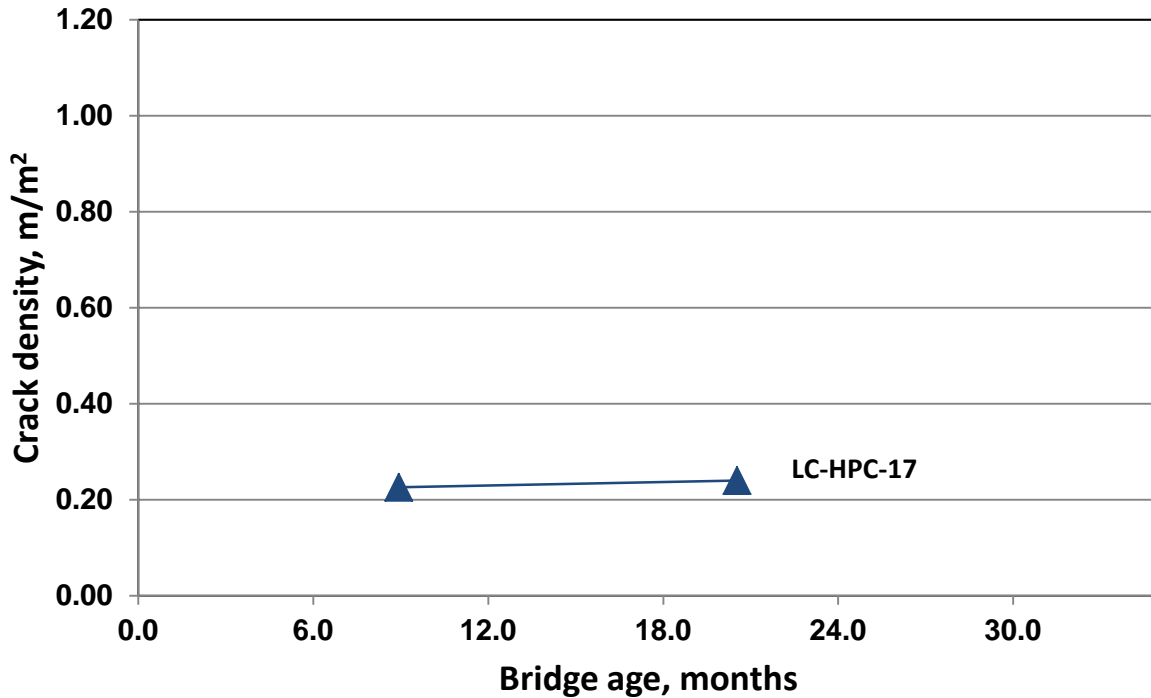
Figure 94: LC-HPC-17 Crack Densities

The results of Surveys 1 and 2 of LC-HPC-17, at 8.94 and 20.5 months, are included in this report. The crack density was 0.226 m/m² at 8.94 months (Figure 92), and increased to 0.240 m/m² at 20.5 months (Figure 93). The sidewalks on LC-HPC-17 were not surveyed because the concrete was stamped and colored, making it difficult to discern cracks. Similar to LC-HPC-15 and LC-HPC-16, there are transverse cracks near the pier and centers of the spans. There is also a small amount of longitudinal cracking at the west abutment. Figure 94 shows cracking on LC-HPC-17 over time.

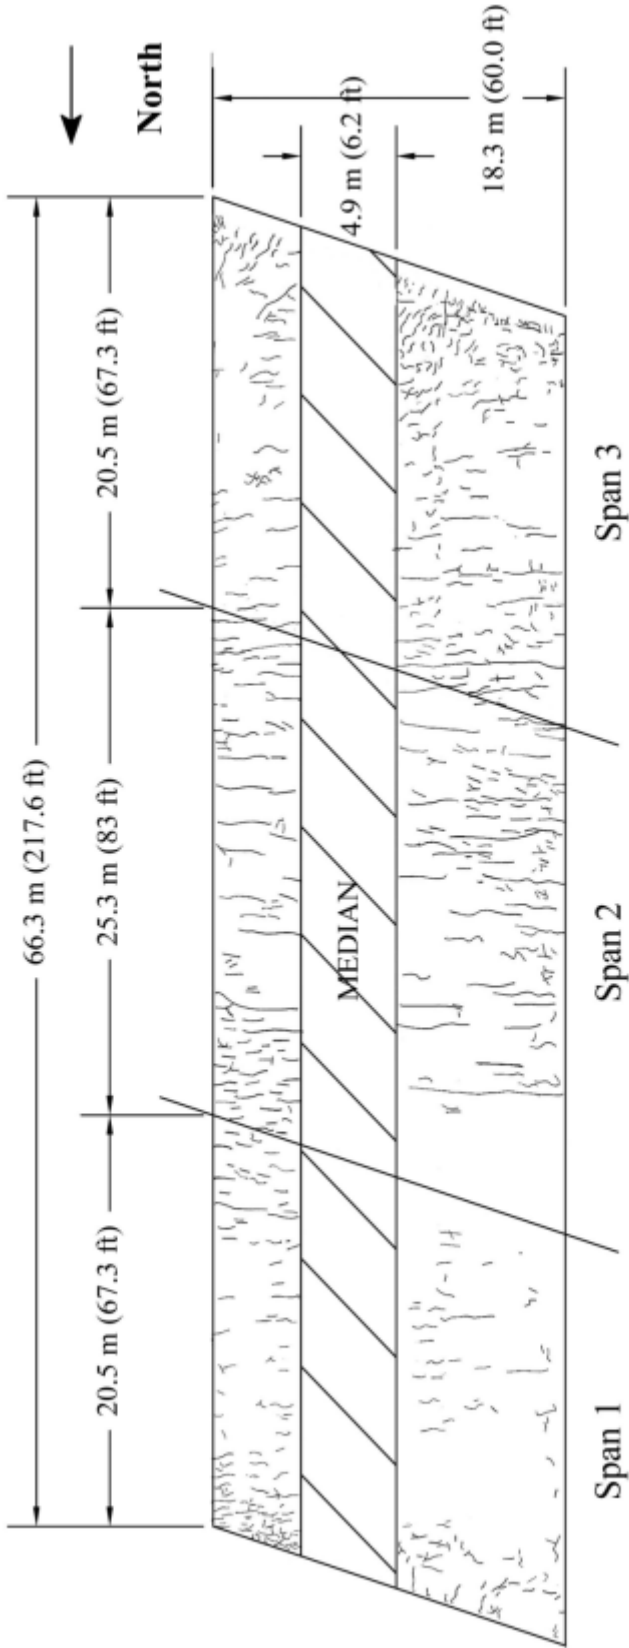
Figure 95: OP Bridge – Placement 1 (Survey 3)

The results of Surveys 3 and 4 of OP Bridge – Placement 1, at 42.2 and 66.6 months, are included in this report. The contractor did not follow and the owner did not enforce many of the key LC-HPC specifications (McLeod et al. 2009), causing the OP Bridge deck to have a much higher crack density than any of other decks bid under an LC-HPC specification. Placement 1 was constructed on two separate dates due to a concrete pumping problem. Thirty feet of concrete was placed before construction was halted because concrete was clogging the pump. This portion of the deck was removed and the entire deck, with the exception of the abutment, was placed on the second attempt. Some of the concrete used in the second attempt had a slump greater than 5 in. Consolidation of the concrete was inadequate, with coarse aggregate visible at the surface after removal of the vibrators. The vibrators were also removed too quickly, leaving holes in the concrete at the locations where the vibrators had been inserted. The contractor spent

a considerable amount of time bullfloating, bringing excess cement paste to the surface and leaving the concrete overfinished in many locations (Lindquist et al. 2008 and McLeod et al. 2009). The elapsed time between deck finishing and burlap placement exceeded the ten-minute limit throughout construction, mainly due to the overfinishing. The contractor used water from the fogging equipment as a finishing agent (McLeod et al. 2009). The crack density of OP Bridge – Placement 1 was 0.585 m/m^2 at 42.2 months (Figure 95), a slight increase from 0.502 m/m^2 at 30.0 months (Pendergrass et al. 2011). The crack density of OP Bridge – Placement 1 at 66.6 months more than doubled to 1.083 m/m^2 (Figure 96).

Bridge Number: 46-363 (OP Bridge - Placement 1)
Bridge Location: Metcalf Ave over Indian Creek, OP, Kansas
Construction Date: 12/19/2007
Crack Survey Date: 6/24/2011

Bridge Length: 66.3 m (217.6 ft)
Bridge Width: 18.3 m (60.0 ft)
Skew: -18°
Number of Spans: 3
Span 1: 20.5 m (67.3 ft)
Span 2: 25.3 m (83.0 ft)
Span 3: 20.5 m (67.3 ft)
Number of Placements: 1

Bridge Age: 42.2 months
Crack Density: 0.585 m/m²
Span 1: 0.410 m/m²
Span 2: 0.621 m/m²
Span 3: 0.718 m/m²

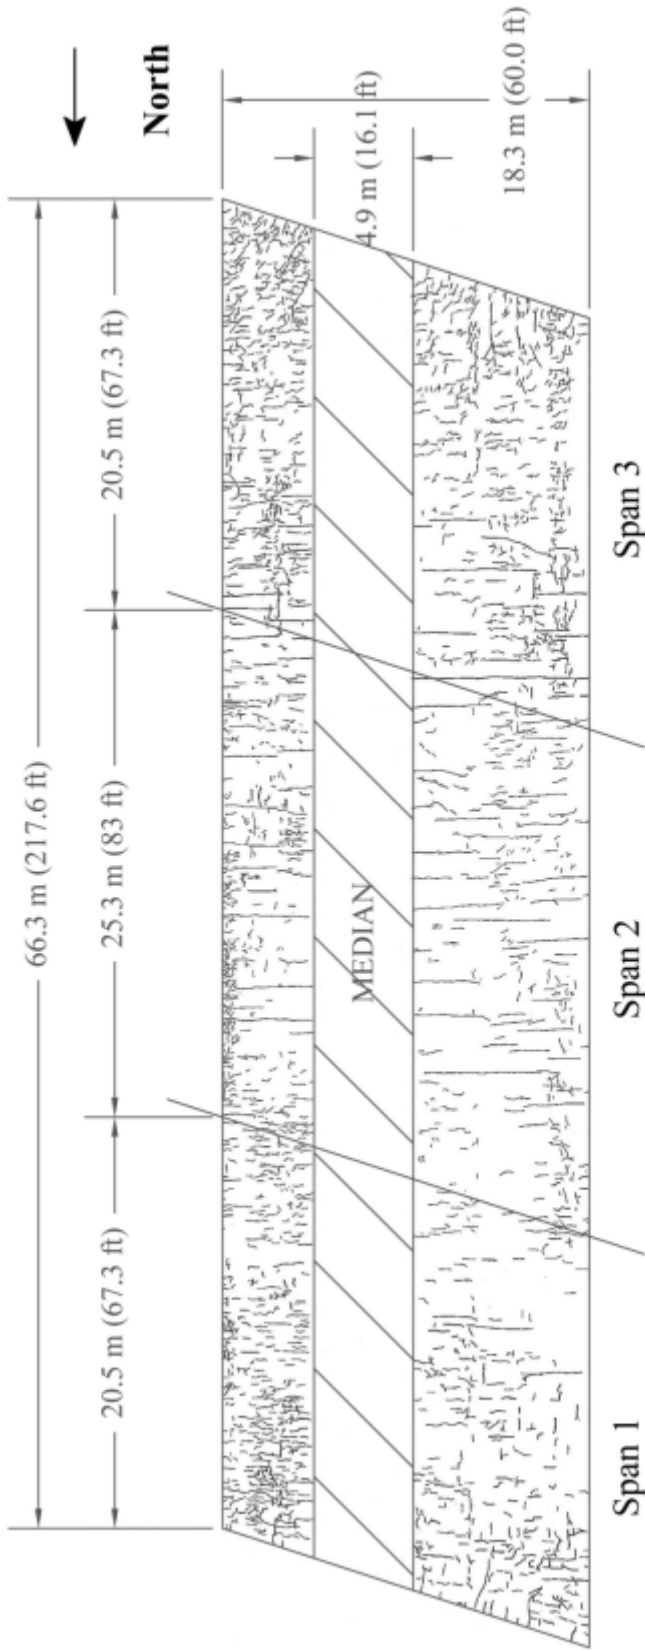
Bridge Number: 46-363 (OP Bridge - Placement 1)
Bridge Location: Metcalf Ave over Indian Creek, OP, Kansas
Construction Date: 12/19/2007
Crack Survey Date: 7/8/2013

Bridge Length: 66.3 m (217.6 ft)
Bridge Width: 18.3 m (60.0 ft)
Skew: -18°
Number of Spans: 3
Span 1: 20.5 m (67.3 ft)
Span 2: 25.3 m (83.0 ft)
Span 3: 20.5 m (67.3 ft)
Number of Placements: 1

Bridge Age: 66.6 months
Crack Density: 1.083 m/m²
Span 1: 1.040 m/m²
Span 2: 0.903 m/m²
Span 3: 0.985 m/m²
