**CRACK SURVEYS OF LOW-CRACKING
HIGH-PERFORMANCE CONCRETE
BRIDGE DECKS IN KANSAS
2011-2013**

**A Report on Research Sponsored by
CONSTRUCTION OF CRACK-FREE BRIDGE DECKS
TRANSPORTATION POOLED-FUND PROGRAM
PROJECT NO. TPF-5(174)**

**Structural Engineering and Engineering Materials
SL Report 13-6**

**THE UNIVERSITY OF KANSAS CENTER FOR RESEARCH, INC.
LAWRENCE, KANSAS
December 2013**

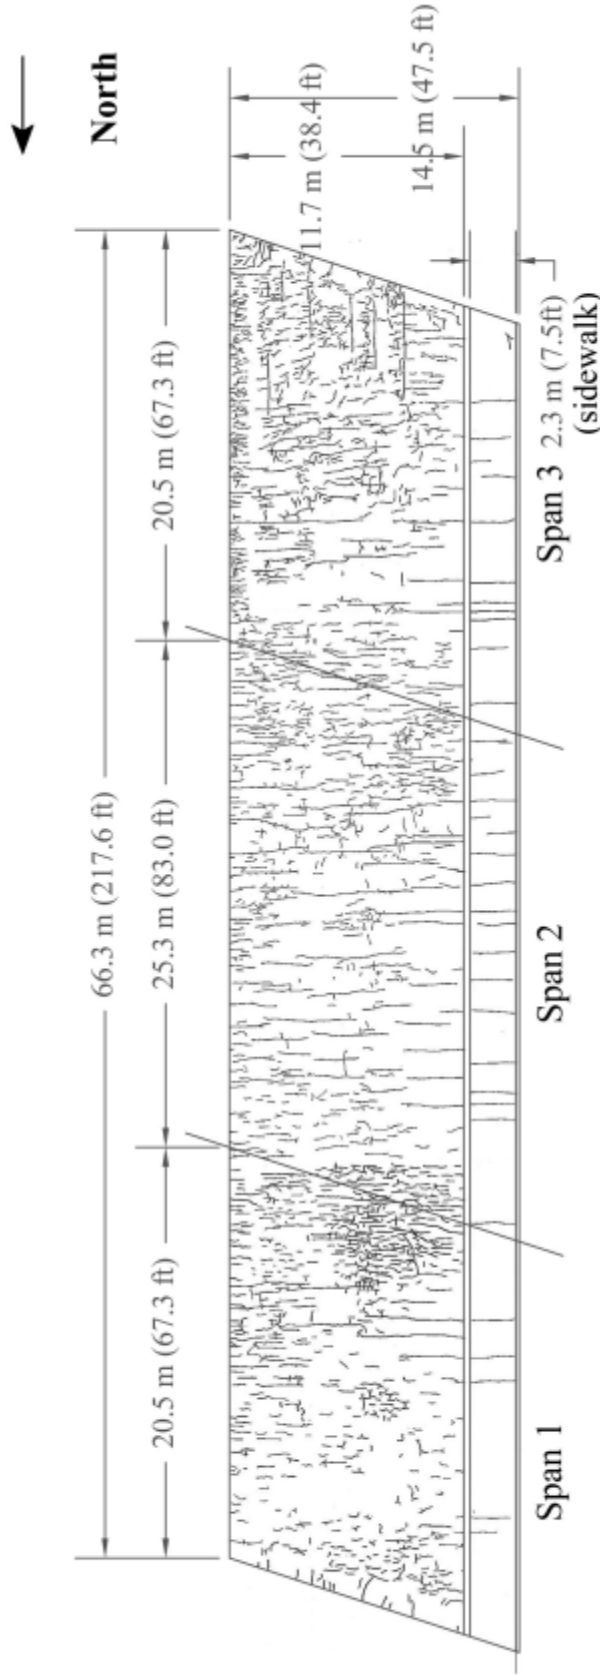
Figure 97: OP Bridge – Placement 2 (Survey 3)

The results of Surveys 3 and 4 of OP Bridge – Placement 2, at 37.7 and 62.2 months, are included in this report. Placement 2 for the OP deck faced many of the same problems during construction as Placement 1, again leading to much higher crack densities than the LC-HPC decks. The slump and air contents specified in the LC-HP concrete specifications were exceeded, and the high slump led to problems with settlement cracking over the reinforcement. There was heavy rain the night before placement, making it difficult for the concrete supplier to accurately determine the aggregate moisture contents (McLeod et al. 2009). A double-drum roller was used for finishing, possibly causing the concrete to be overworked and bringing excess cement paste to the surface. The specified ten-minute maximum elapsed time between finishing and burlap placement was consistently exceeded. Additionally, concrete was removed from a wingwall during a delay in concrete delivery and placed into the deck. The crack density was 1.303 m/m^2 at 37.6 months (Figure 97), almost double the crack density of 0.727 m/m^2 at 25.5 months (Pendergrass et al. 2011), and then increased to 1.331 m/m^2 at 62.2 months (Figure 98). Extensive map cracking has occurred throughout the deck, but mainly above the first pier and the

Bridge Number: 46-363 (OP Bridge - Placement 2)
Bridge Location: Metcalf Ave over Indian Creek, OP, Kansas
Construction Date: 5/2/2008
Crack Survey Date: 6/24/2011

Bridge Age: 37.7 months
Crack Density: 1.303 m/m²
Span 1: 0.940 m/m²
Span 2: 1.443 m/m²
Span 3: 1.500 m/m²

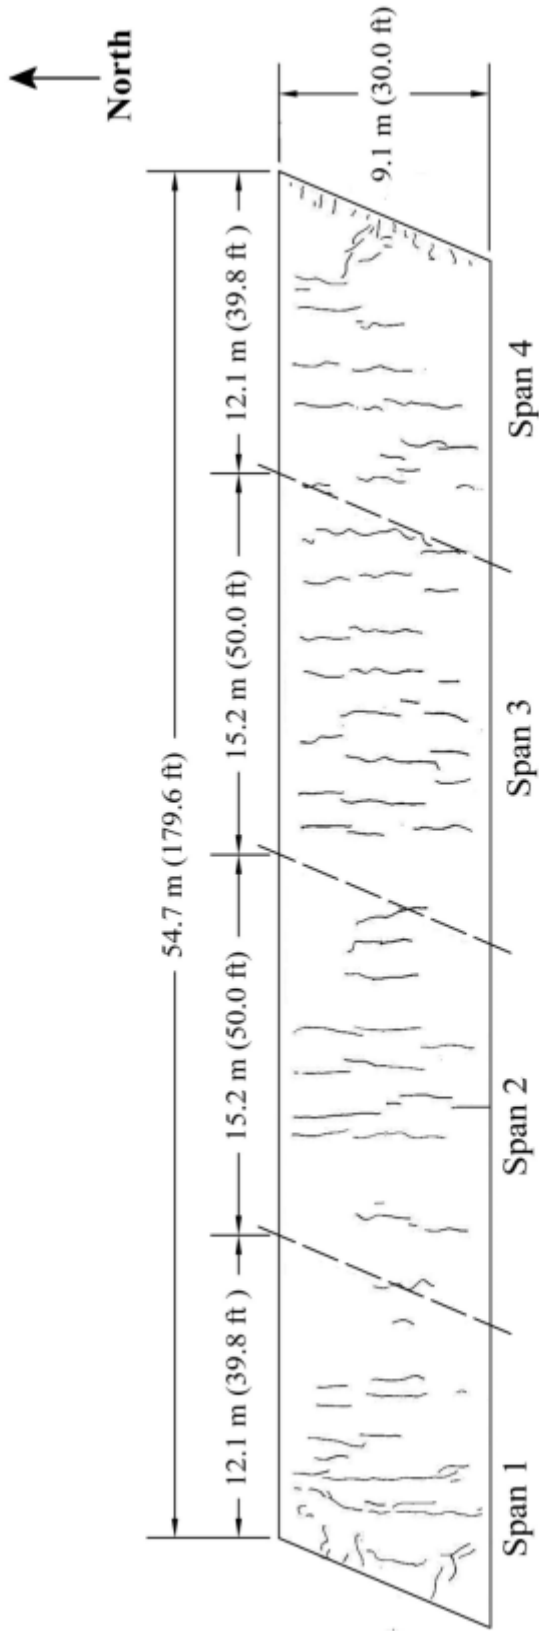
Figure 100: OP Bridge – Placement 3 (Survey 4)

The results of Surveys 3 and 4 of OP Bridge – Placement 3, at 37.1 and 61.6 months, are included in this report. Placement 3 had similar problems during construction as Placements 1 and 2, causing higher crack densities than the LC-HPC decks. The concrete used had very high slumps and high air contents. Additionally, it was observed that the reinforcement was not strongly supported, causing it to spring up and possibly increase the amount of settlement cracking. As with Placement 2, a double-drum roller was used for finishing. The time between finishing and burlap placement exceeded 10 minutes over most of the deck (Gruman et al. 2009). For Survey 3, the crack density was 0.678 m/m^2 at 37.1 months (Figure 99), less than the crack density at 24.9 months of 0.871 m/m^2 (Pendergrass et al. 2011). Many of the cracks in Placement 3 are small and may have been overlooked in Survey 3, leading to the lower crack density. The crack density more than doubled to 1.387 m/m^2 at 61.6 months (Figure 100). Transverse cracks have formed along the length of the deck, but the majority of cracks are very small. There are also short cracks extending from the eastern edge of the placement, and longitudinal cracks have formed at both abutments. Similar to Placement 2, the sidewalk of Placement 3 has experienced less cracking than the remainder of the placement. Figure 101 compares cracking for the three OP Bridge placements over time. It is evident that all three placements have experienced high crack growth, which can be attributed to the lack of adherence to the LC-HPC specifications

Bridge Number: 46-363 (OP Bridge - Placement 3)	Bridge Length: 66.3 m (217.6 ft)	Bridge Age: 61.6 months
Bridge Location: Metcalf Ave over Indian Creek, OP, Kansas	Bridge Width: 9.9 m (32.5 ft)	Crack Density: 1.387 m/m ²
Construction Date: 5/21/2008	Skew: -18°	Span 1: 1.248 m/m ²
Crack Survey Date: 7/8/2013	Number of Spans: 3	Span 2: 1.369m/m ²
	Span 1: 20.5 m (67.3 ft)	Span 3: 1.555 m/m ²
	Span 2: 25.3 m (83.0 ft)	
	Span 3: 20.5 m (67.3 ft)	
	Number of Placements: 1

during construction. While Placement 3 experienced an apparent decline in crack density between ages 24 and 38 months, it now has the highest crack density of the three placements.

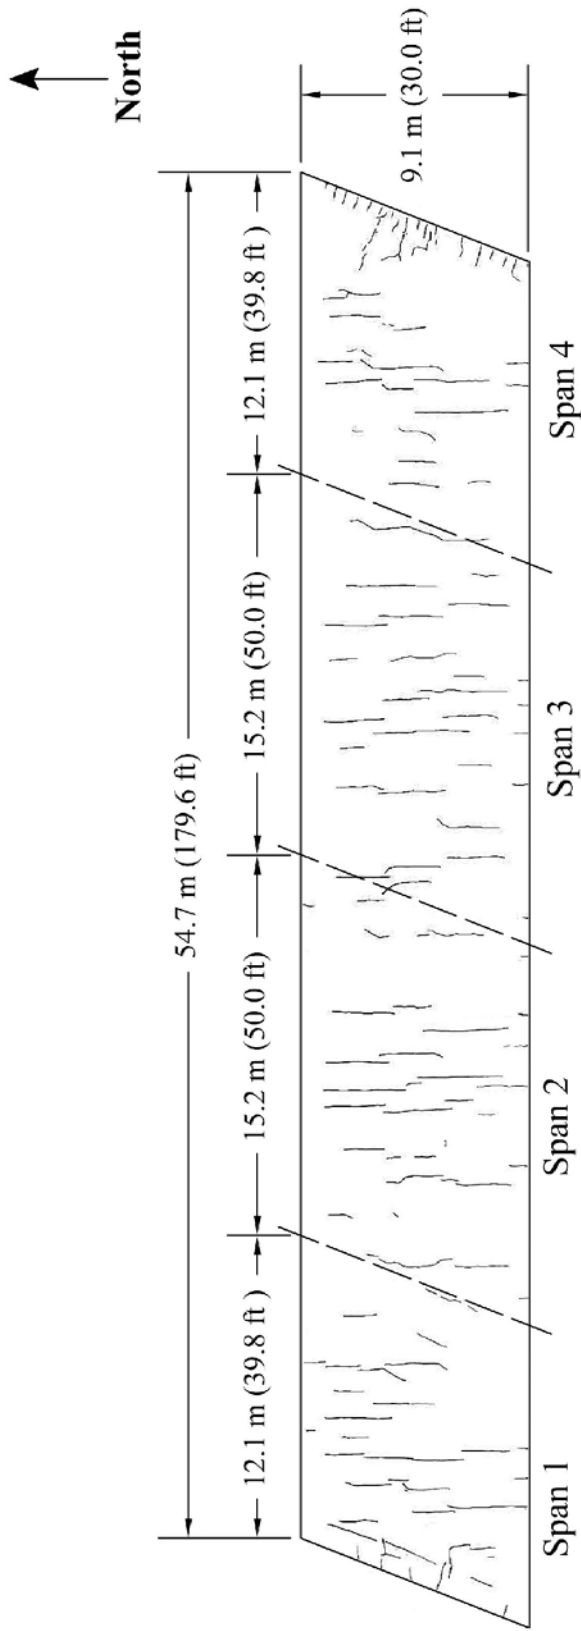
Figure 102: Control-Alt (Survey 6)

Bridge Number: 56-49 (Control-Alt)
Bridge Location: K-99 over I-335
Construction Date: 6/2/2005
Crack survey Date: 6/23/2011

Bridge Age: 72.6 months
Crack density: 0.358 m/m²

- Span 1 :** 0.417 m/m²
- Span 2 :** 0.309 m/m²
- Span 3 :** 0.367 m/m²
- Span 4 :** 0.346 m/m²

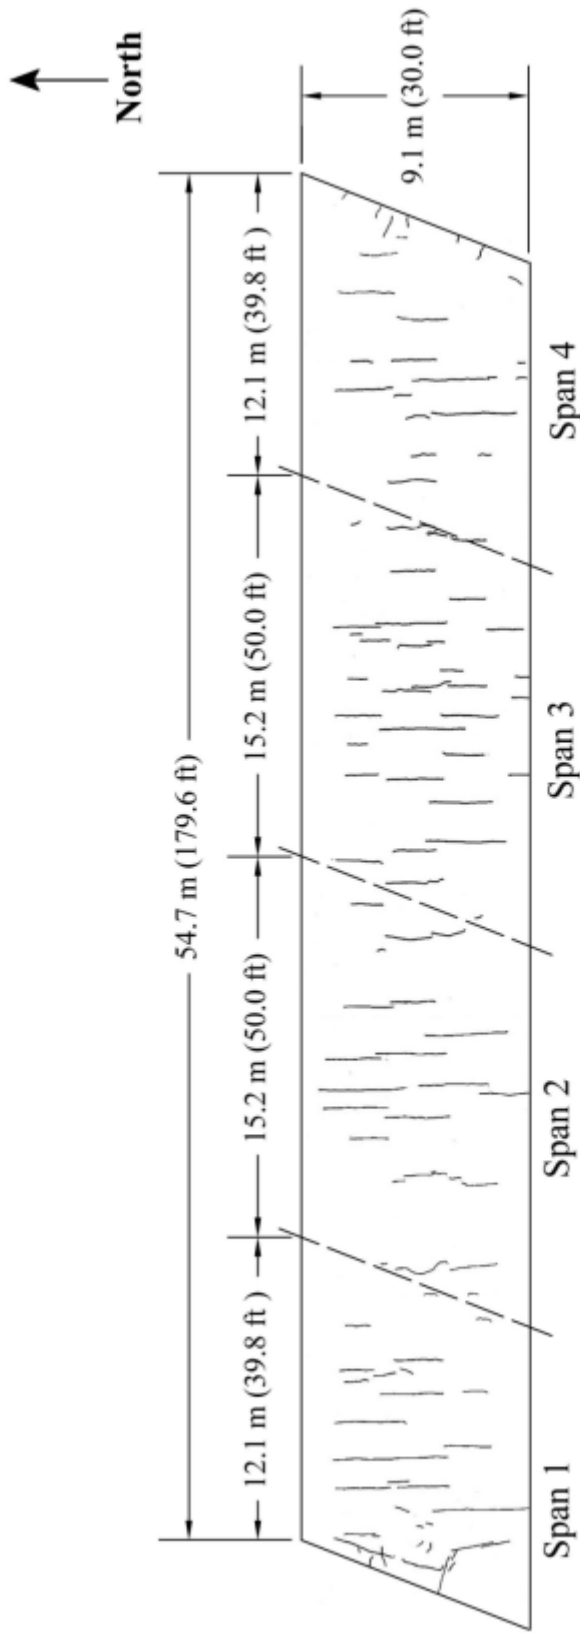
Figure 103: Control-Alt (Survey 7)

Bridge Number: 56-49 (Control-Alt)
Bridge Location: K-99 over I-335
Construction Date: 6/2/2005
Crack survey Date: 7/3/2012

Bridge Age: 85.0 months
Crack density: 0.395 m/m²
Span 1: 0.443 m/m²
Span 2: 0.365 m/m²
Span 3: 0.382 m/m²
Span 4: 0.389 m/m²

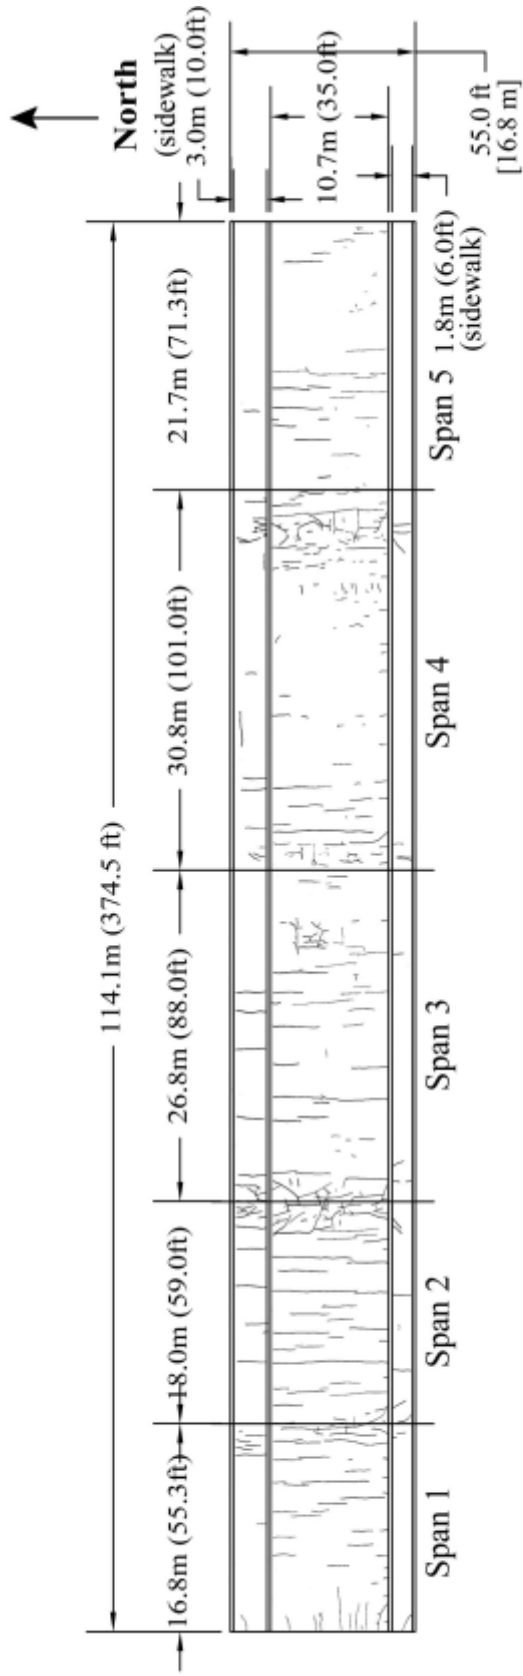
Figure 106: OP-Extra (Survey 3)

OP-Extra is a precast, prestressed concrete girder control bridge in Overland Park, KS constructed by the same contractor as the OP Bridge. The deck is monolithic. The results of Surveys 3, 4, and 5 of OP-Extra at 35.0, 46.7, and 59.2 months, are included in this report. The crack density was 0.344 m/m² at 35.0 months (Figure 106), representing an increase from the crack density measured in Survey 2, 0.302 m/m² (Pendergrass et al. 2011). At 35.0 months, the crack density of OP-Extra was slightly less than that of LC-HPC-8, another precast, prestressed concrete girder bridge, at a similar age. It was much greater than the density of LC-HPC-10 and Control-8/10,

Bridge Number: Overland Park extra
Bridge Location: 132nd street over
 US 69, OP, KS
Construction Date: 6/30/2008
Crack Survey Date: 5/27/2011 and
 6/3/2011

Bridge Age: 35.0 months
Crack Density: 0.344 m/m²
Span 1: 0.381 m/m²
Span 2: 0.551 m/m²
Span 3: 0.308 m/m²
Span 4: 0.324 m/m²
Span 5: 0.169 m/m²

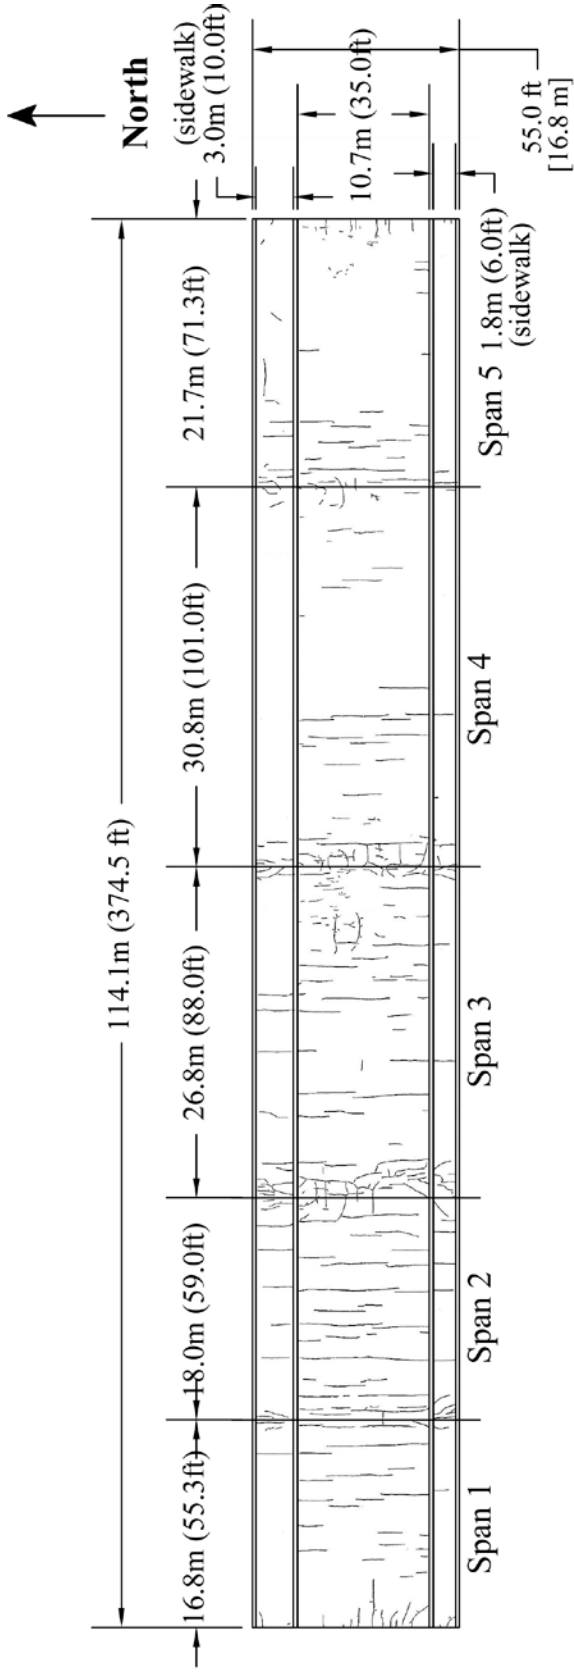
Figure 107: OP-Extra (Survey 4)

also precast, prestressed concrete girder bridges. The crack density was again 0.344 m/m^2 at 46.7 months (Figure 107), slightly higher than the crack density of Control-8/10 at a similar age (0.326 m/m^2), and remained lower than the density of LC-HPC-8 and higher than the density of LC-HPC-10 at similar ages (0.380 and 0.088 m/m^2). The crack density decreased to 0.300 m/m^2 at 59.2 months (Figure 108), less than the crack densities of Control-8/10 and LC-HPC-8 (0.425 and 0.383 m/m^2), but still greater than the crack density of LC-HPC-10 (0.125 m/m^2) at similar ages. OP-Extra has transverse cracking over nearly the entire deck, as well as longitudinal cracking above the piers and the west abutment. Figure 109 compares cracking on OP-Extra with cracking on LC-HPC-8, LC-HPC-10, and Control-8/10 over time. The deck has experienced relatively stable cracking, falling between 0.20 and 0.40 m/m^2 throughout its life. At about 60 months, cracking on LC-HPC-8 and Control-8/10 is very similar to that on OP-Extra, although the crack density on Control-8/10 is increasing rapidly. Cracking on LC-HPC-10 is consistently lower than that on OP-Extra.

Bridge Number: Overland Park extra
Bridge Location: 132nd street over
 US 69, OP, KS
Construction Date: 6/30/2008
Crack Survey Date: 5/22/2012

Bridge Age: 46.7 months
Crack Density: 0.344 m/m²
Span 1: 0.318 m/m²
Span 2: 0.531 m/m²
Span 3: 0.429 m/m²
Span 4: 0.215 m/m²
Span 5: 0.227 m/m²

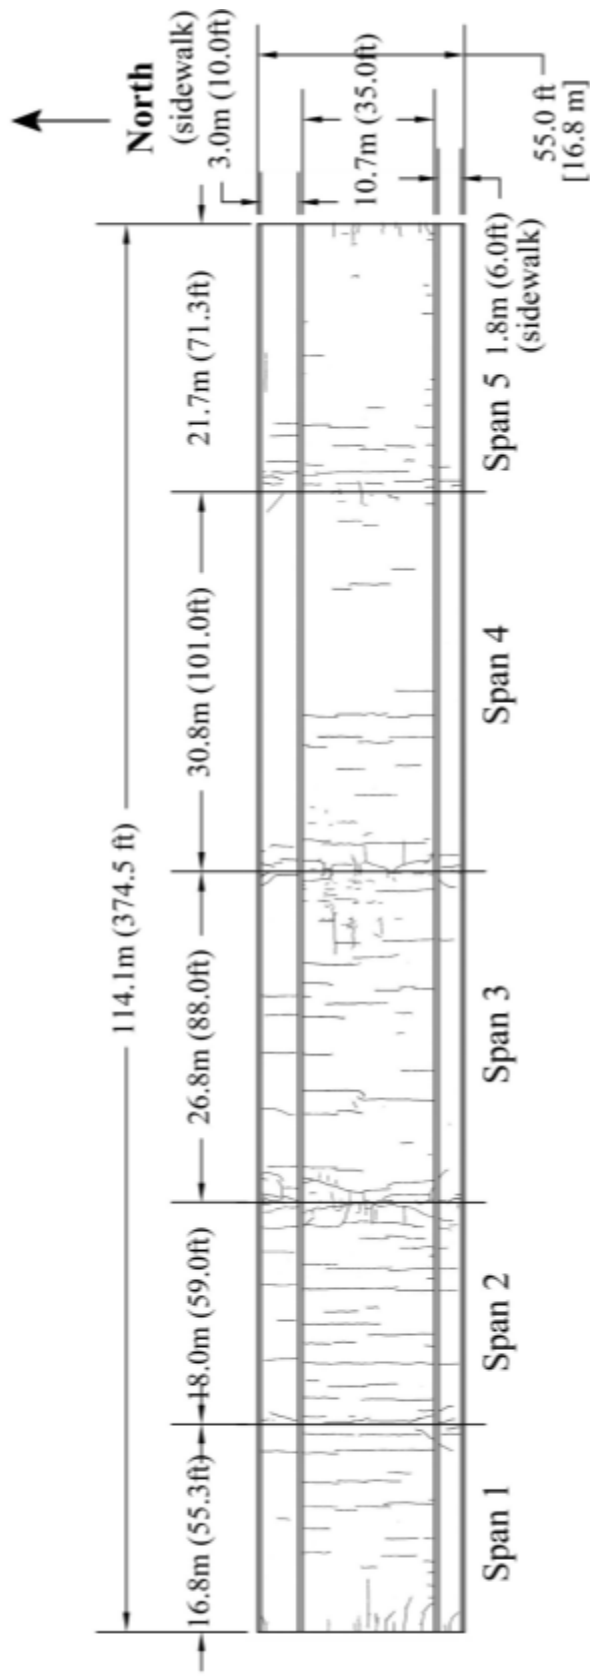
Figure 108: OP-Extra (Survey 5)

Bridge Number: Overland Park extra
Bridge Location: 132nd street over
 US 69, OP,KS
Construction Date: 6/30/2008
Crack Survey Date: 6/06/2013

Bridge Age: 59.2 months
Crack Density: 0.3 m/m²
 Span 1: 0.299 m/m²
 Span 2: 0.498 m/m²
 Span 3: 0.331 m/m²
 Span 4: 0.178 m/m²
 Span 5: 0.197 m/m²
