**POST RETROFIT ANALYSIS OF THE  
TUTTLE CREEK BRIDGE  
Br. No. 16-81-2.24**

**THE KANSAS DEPARTMENT OF TRANSPORTATION  
KDOT PROJECT NUMBER: KTRAN, KU-04-5**

**Structural Engineering and Engineering Materials  
SM Report No. 88  
January 2007**

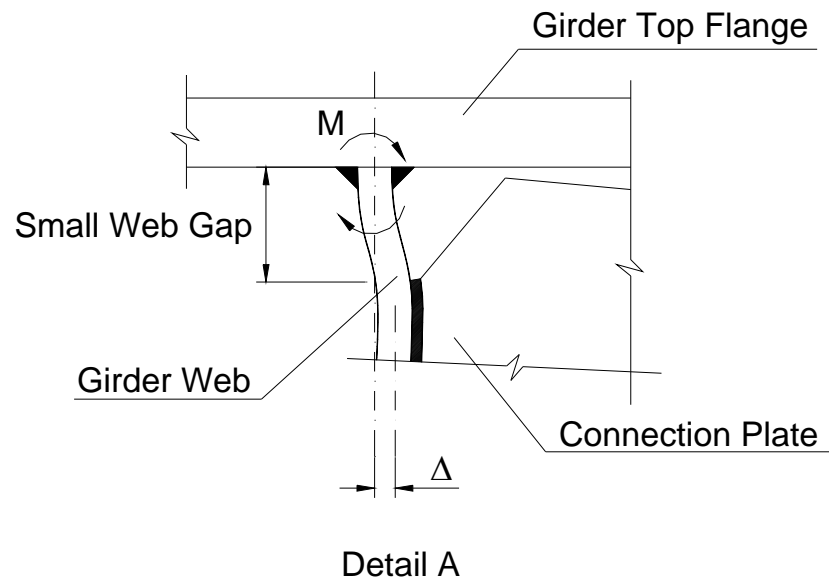
**Figure 2-1: Web-Gap Region**

The web gap region consisted of a 1"x 1" diagonal cut removed from the top and bottom of the stiffener as shown in Figures 2-1 and 2-2. This cut allowed the fillet weld between the web and flange to be continuous. This gap creates high stress concentrations in the web and creates the potential for fatigue cracks to propagate in this area. Two types of cracks that occurred in the upper web-gap region were designated as either weld tears or horizontal cracks. Figure 2-3 shows the two types of cracks, and Figure 2-4 presents a photograph of actual cracks.

The primary source of fatigue cracking in the Tuttle Creek Bridge was the lack of attachment between the top of the stiffener and the tension flange. The web-gap cracking was the result of differential deflection of the girders. Braces in the diaphragms created a tension force on the stiffener due to the difference in deflections between the two girders. This caused the web-gap to undergo double-curvature bending. Figure 2-5 shows the tension force created by the diaphragms. This type of detail is classified as a category C fatigue detail according to the 2004 AASHTO LFRD specifications.

A previous repair of the web-gap region was implemented in 1986. To repair the weld tears, the joint was “softened” by cutting the stiffeners 1 in. below the termination of the existing cracks. A 0.5-in. radius was placed at the end of the cut. Even though this was supposed to have repaired the problem, weld tears continued to

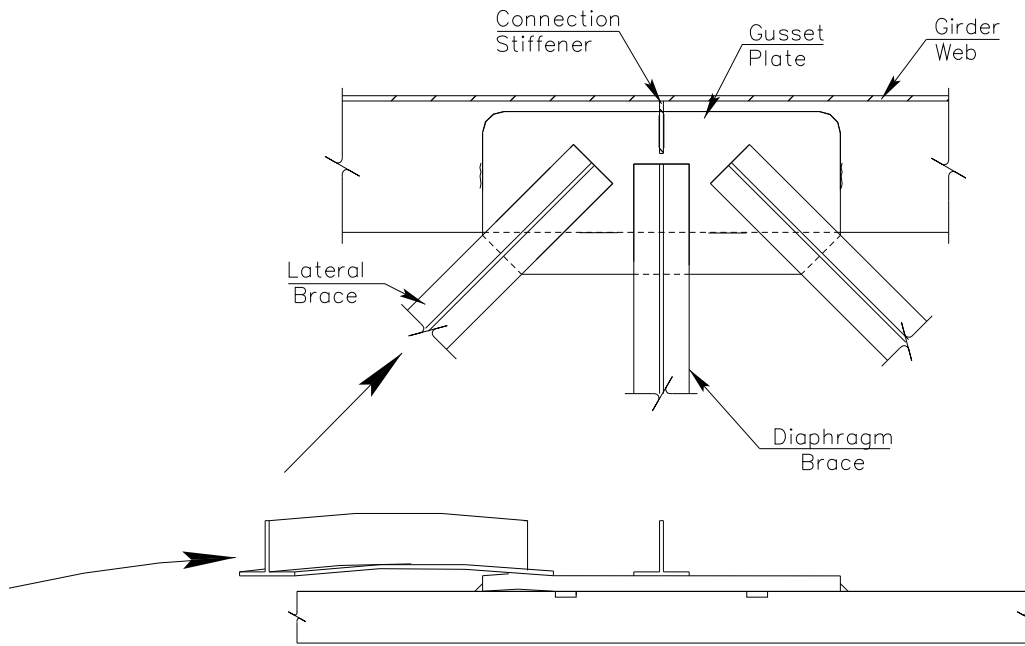
**Figure 2-9: Gusset Plate Cracking Source (Distortion of Lateral Brace)**

The source of the gusset plate cracks was not clearly defined. One theory was that cracks developed from the bending stress of the girder (Figure 2-8). Another possibility considered was that distortion of the girder caused high compressive stresses in the diagonal bracing. The lateral bracing could potentially buckle upward along its weak axis introducing a prying action on the gusset plate (Figure 2-9). Another theory considered racking of the gusset plate due to loads from the diagonal bracing. Twisting of the gusset plate would cause cracking to develop at the ends of the fillet weld (Figure 2-10). To help clarify this issue, strain gages were placed on the top and the bottom of the plate as shown in Figure 2-11.

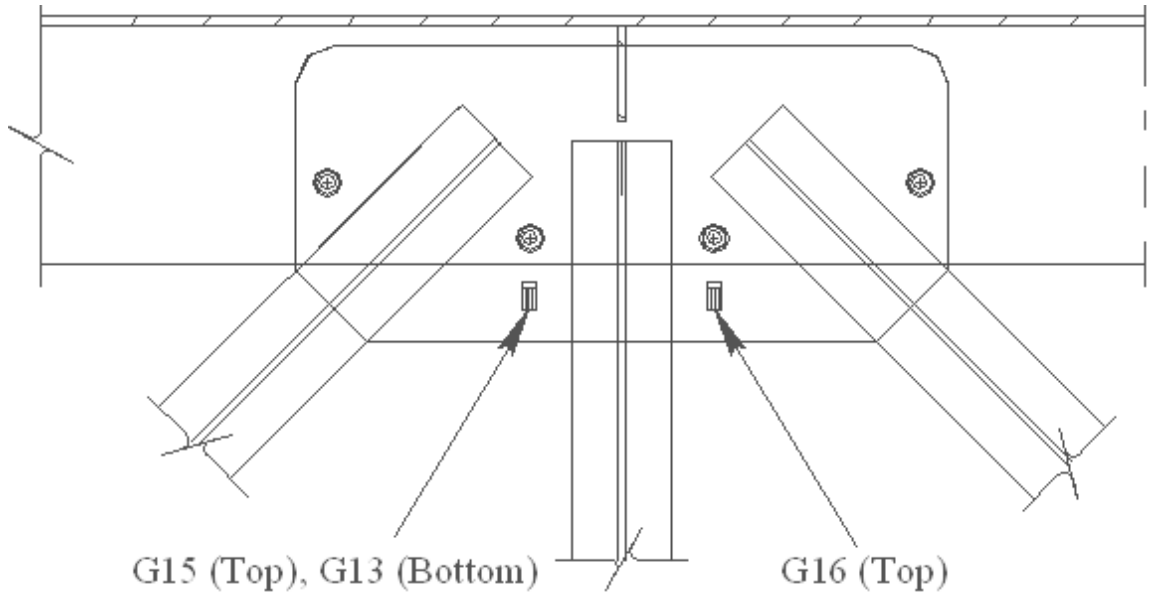
**Figure 6-4: Location of Relocated Gages**

The exact cause of cracking in the gusset plate was unknown after the first field investigation. In order to help determine why the cracking was occurring, three gages were moved to new locations on the gusset plate. Gage 13 was placed on the bottom side of the gusset plate with gage 15 placed directly above it on the top side. Gage 16 was placed in a similar location as gage 15 on the opposite side of the center brace. The locations are shown in Figure 6-4.

The stress over time for these gages is shown in Figures D-1 through D-11. The majority of the data supports the theory that there is bending force acting on the gusset plate during loading. This is illustrated when gage 13 experiences a stress that is opposite of the stress in gage 15. Gage 16 is also provided as a reference but is not directly related to the position of gage 13. Due to the majority of the tests exhibiting this relationship, prying action is occurring in the plate and is contributing to the formation of cracks.

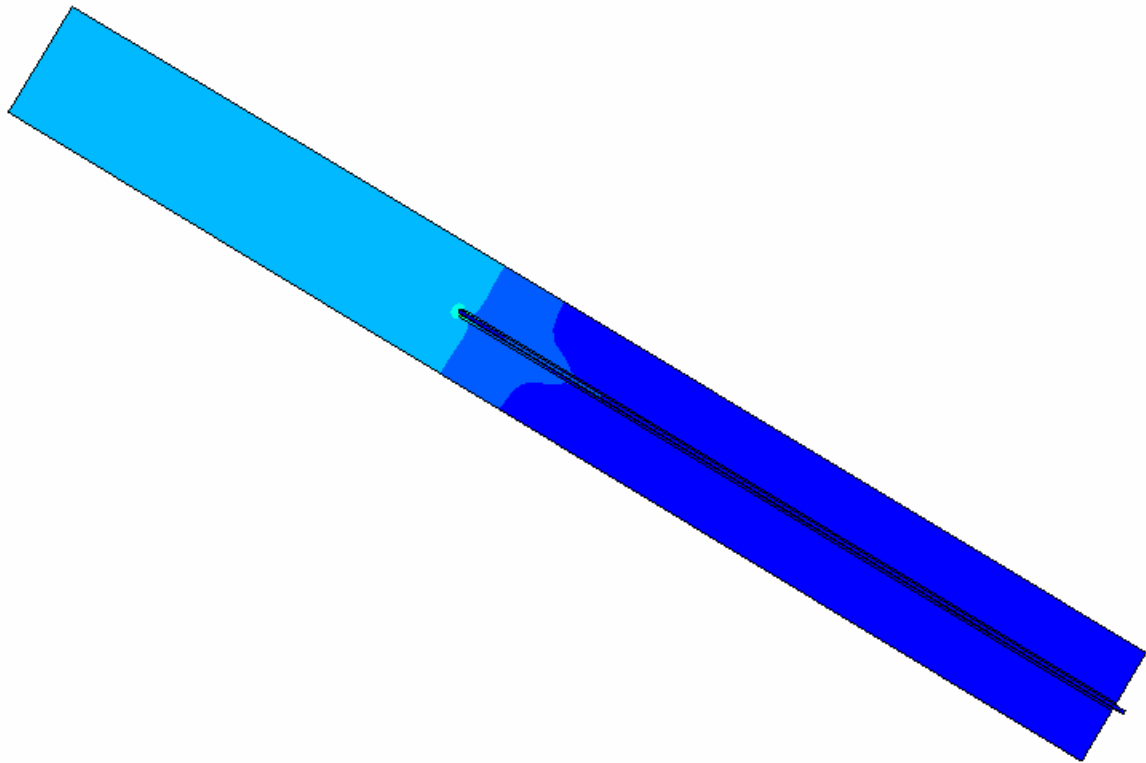
**Figure 12 - Girder web/stiffener (x-y) – before repair.**

Figures 12 and 13 show that reduction in the stresses along the girder web caused by the repair was not significant. Although stress concentrations were localized at the tip of the stiffener in both cases, the maximum stress decreased after the repair.

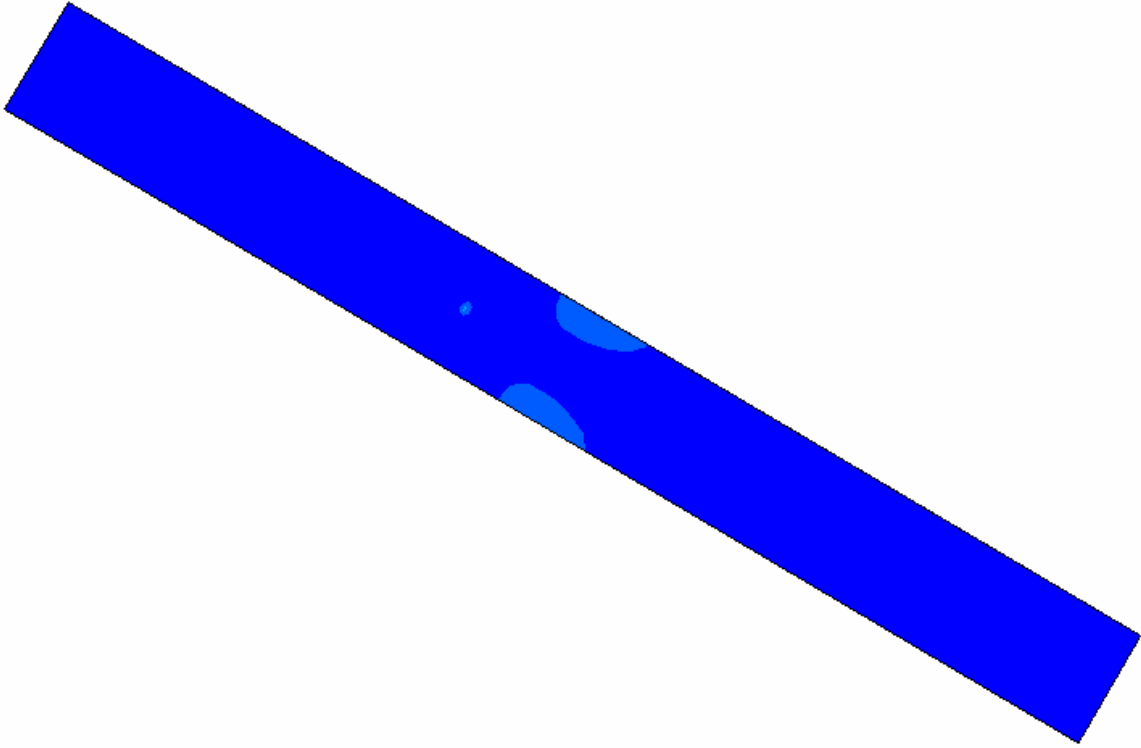
**Figure 14 - Girder web (x-y) - before repair.**

Figures 14 thru 17 show that on the side of the girder web opposite to the stiffener, stress concentrations were found right at the tip of the stiffener. However, the area over which these stress concentrations were present was very small. The implementation of the proposed repair did reduce the size of the region affected by stress concentrations. The FEM indicate that stress gradients at the sides of the model, near the tip of the stiffener, were eliminated by the repair (Figures 14 through 17).

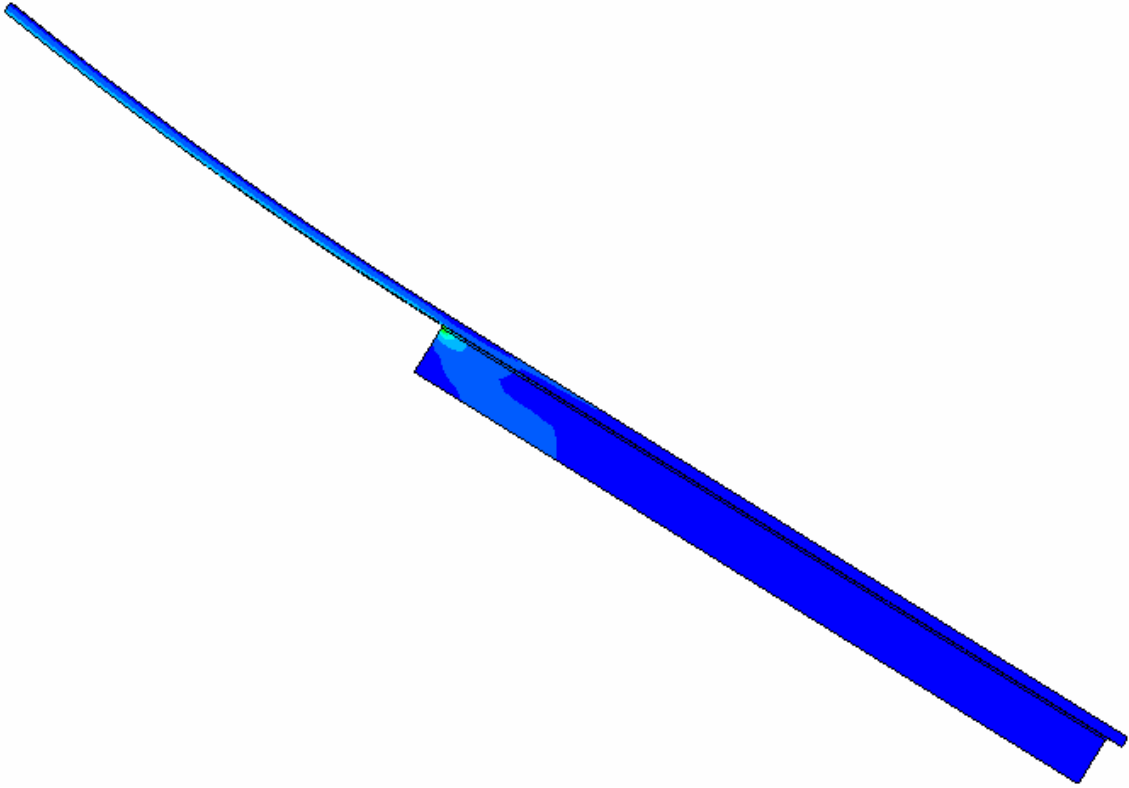
**Figure 18 - Stiffener (x-z) – before repair.**

Figures 18 through 25 show that the longitudinal stresses along the stiffener were similar in magnitude. After the repair, stresses propagated from the tip of the stiffener over a larger area along the stiffener. Also the stress distribution after the repair shows a much more gradual gradient. This can be observed in Figures 24 and 25 (detail 3), where areas with higher stresses are shown in yellow.

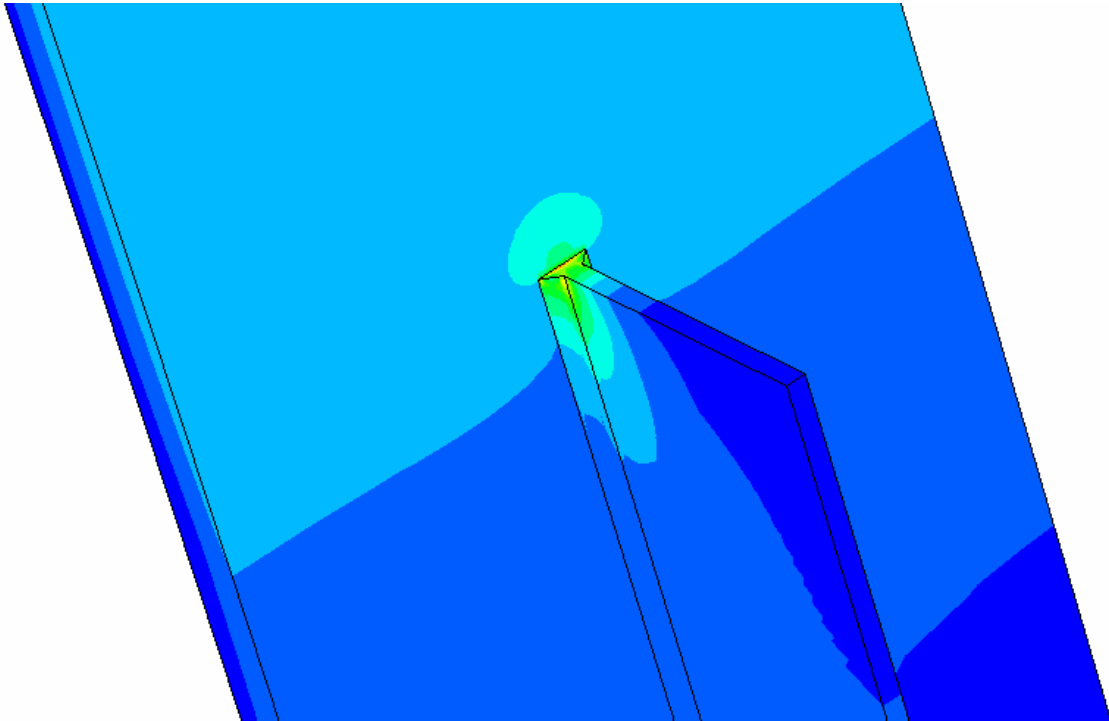
**Figure 26 – Tip of stiffener - detail 1- before repair.**

Figures 26 thru 31 show that the magnitude of the stresses (shown in increasing order of magnitude as yellow, orange and red) decreased with the repair. Figures 30 and 31 show that the front face of the stiffener within the fillet weld region was the area most affected by these stress concentrations. It was found by direct comparison of results from FEMs that after the repair the maximum stresses were reduced by approximately 25%, which would improve the fatigue life.
