# **Evaluation and Repair of Blast Damaged Reinforced Concrete Beams**

**Structural Engineering and Engineering Materials  
SL Report 05-1**

**UNIVERSITY OF KANSAS CENTER FOR RESEARCH, INC.  
LAWRENCE, KANSAS  
January 2005**

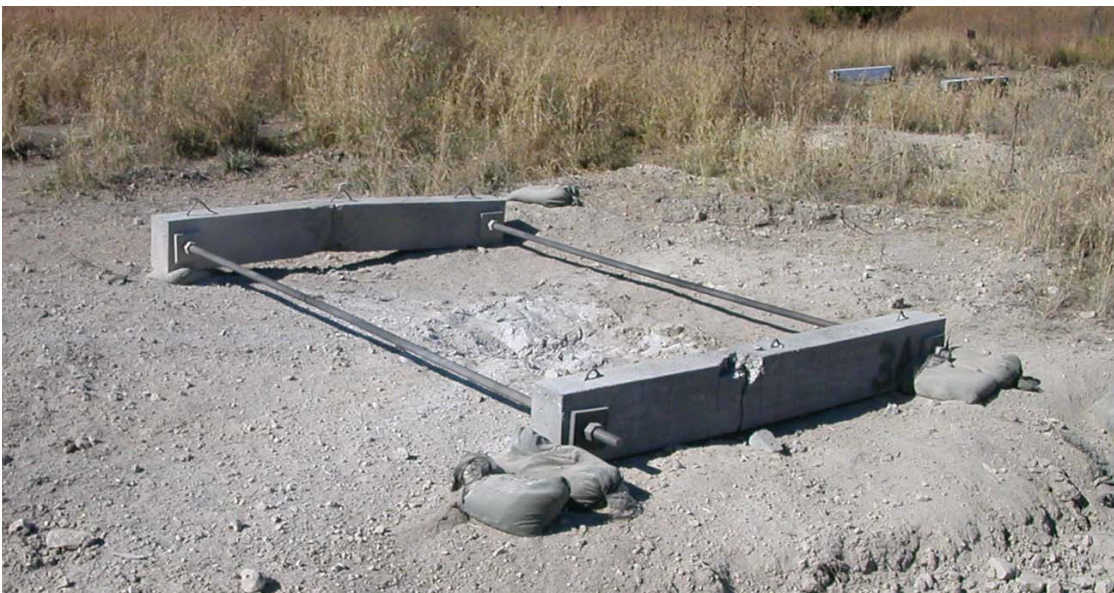
Figure A.14 –Set 3 following detonation of 15 lbs (6.80 kg) (12 blocks) of C-4

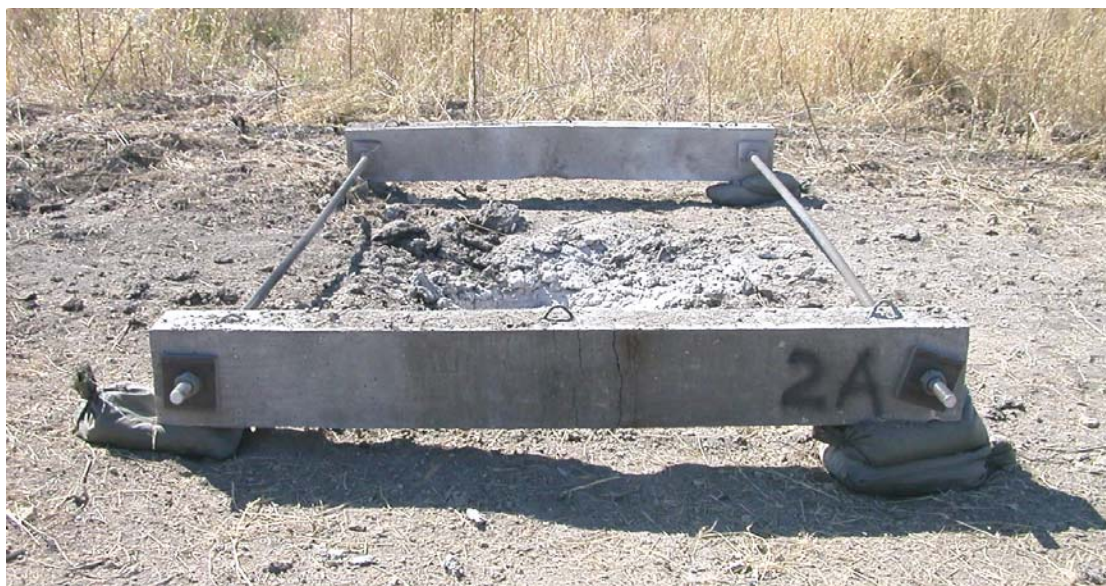
Figure A.17 –Set 2 following detonation of 11.25 lbs (5.10 kg) (9 blocks) of C-4

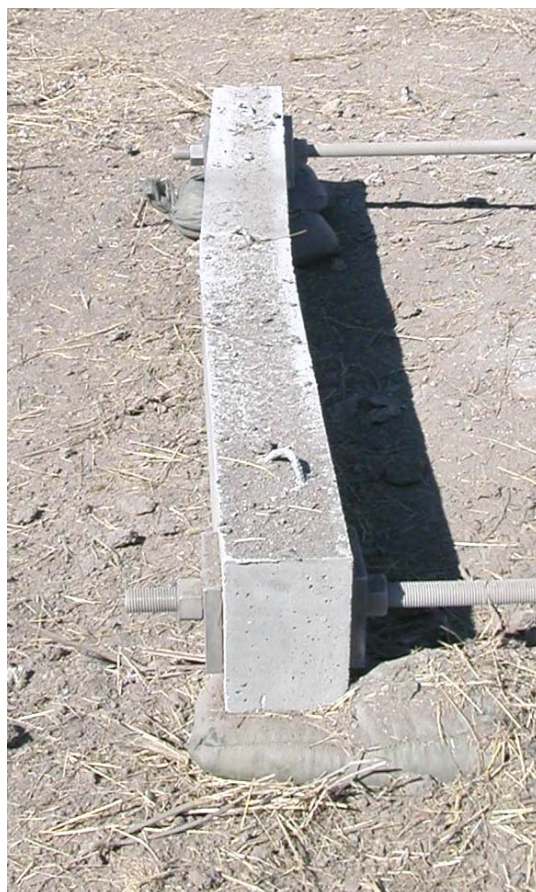
Figure A.18 – Beam 2B following detonation of 11.25 lbs (5.10 kg) of C-4. Note the outward bend due to the yielding of the concrete beams.

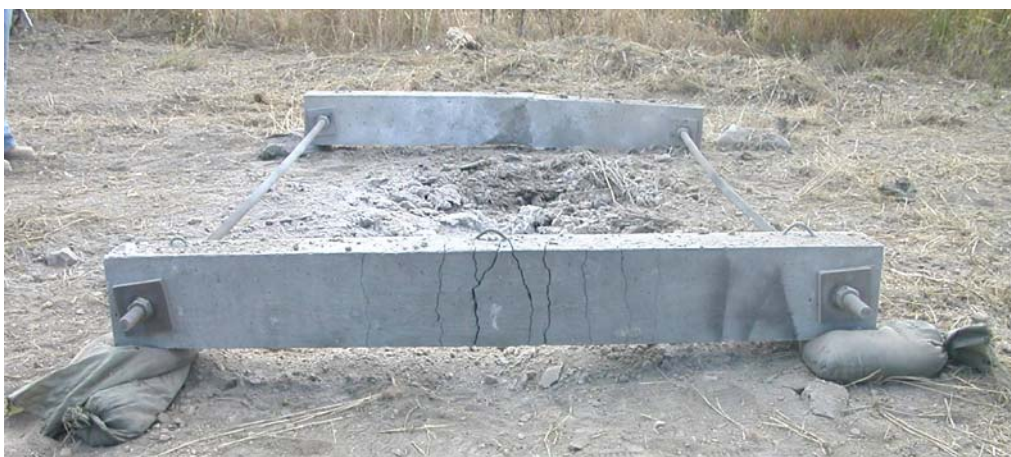
Figure A.19 –Set 1 following detonation of 10 lbs (4.54 kg) (8 blocks) of C-4

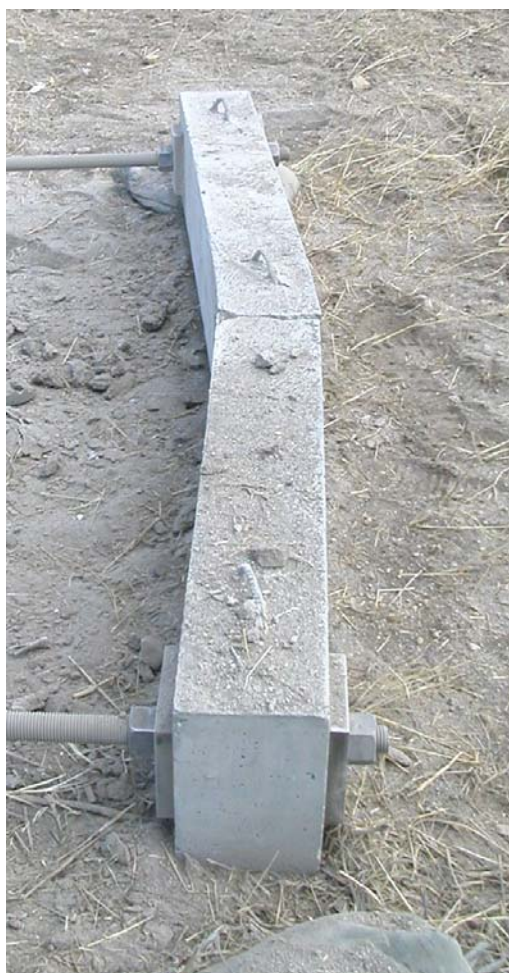
Figure A.20 – Beam 1B following detonation of 10 lbs (4.54 kg) of C-4. Note the outward bend due to the yielding of the concrete beams.

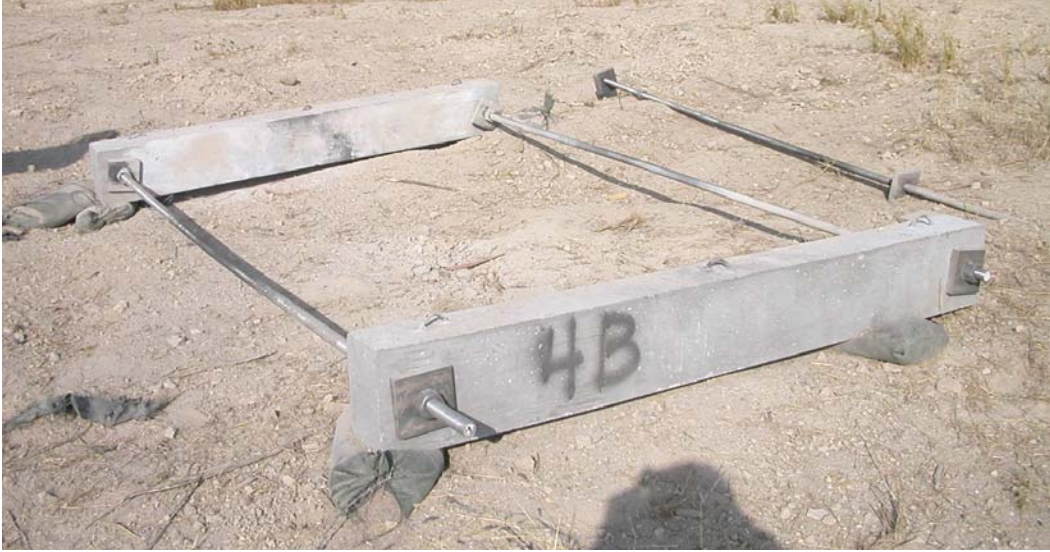
Figure A.21 –Set 4 following detonation of 6.25 lbs (2.83 kg) (5 blocks) of C-4

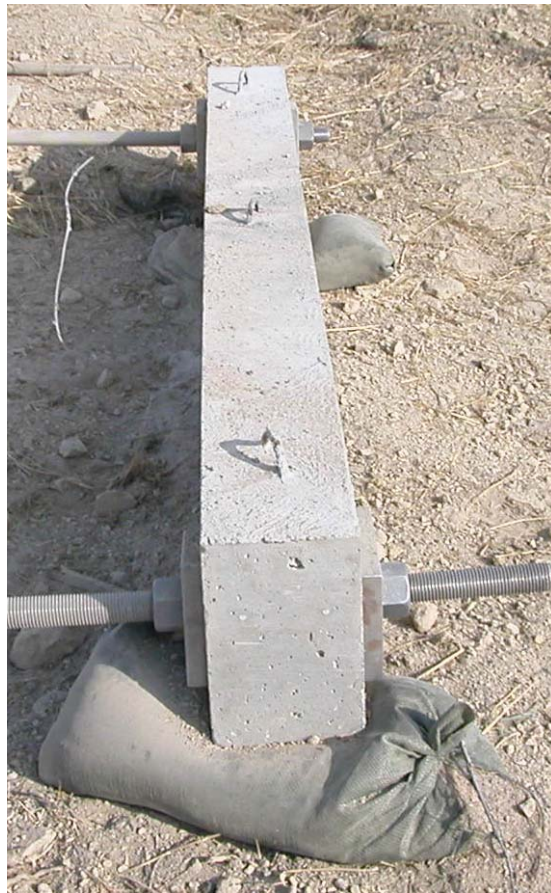
Figure A.22 – Beam 4B following detonation of 6.25 lbs (2.83 kg) of C-4. Note that the beam appears straight with no outward sign of yielding of the reinforcement within the beam.

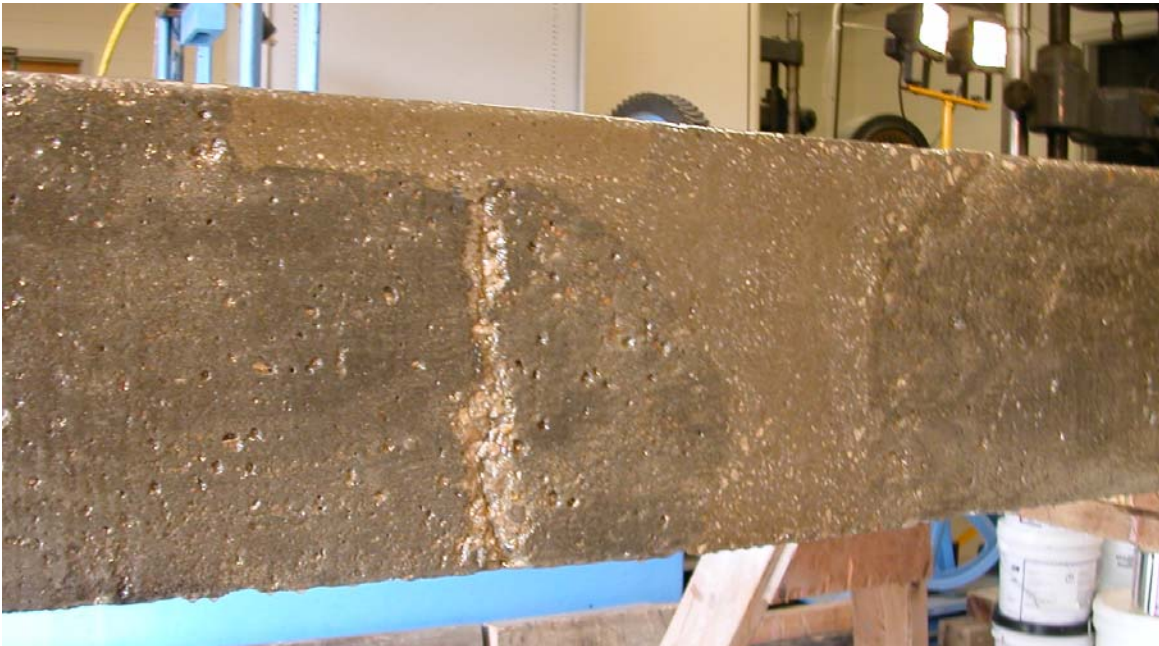
Figure A.40 – The repaired portion of beam 2A could be clearly seen after the primer coat was applied.

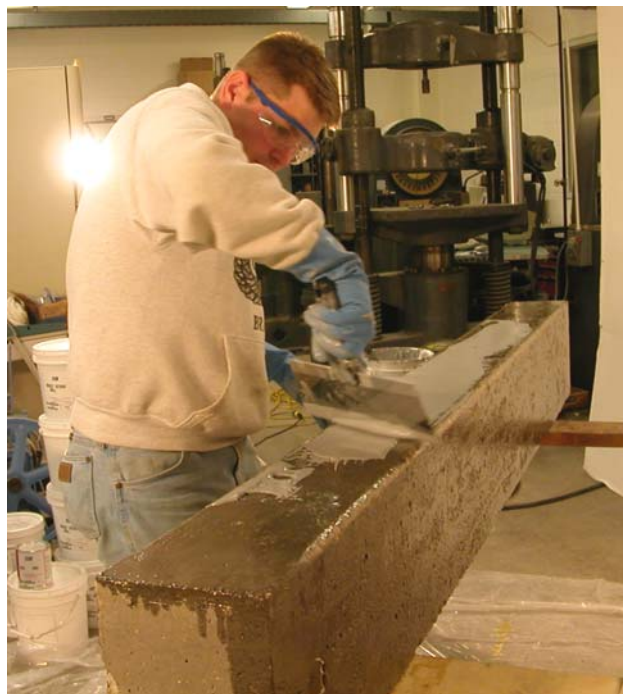
Figure A.42 – The MBRace Putty has a high viscosity and is applied using a steel trowel.

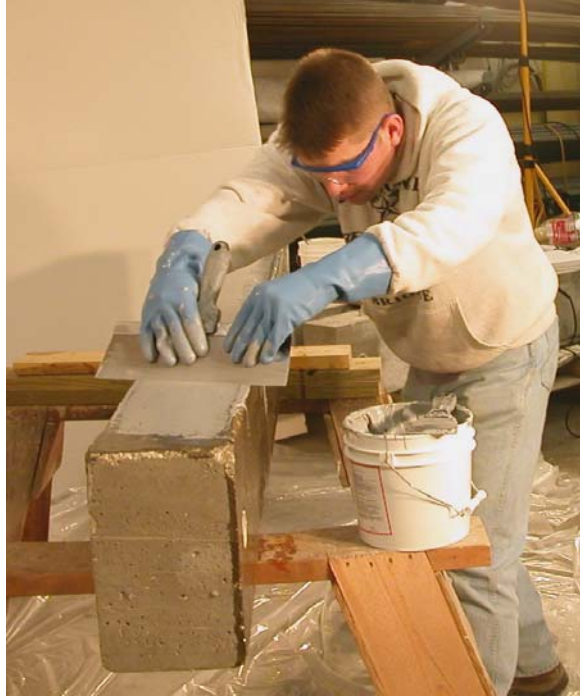
Figure A.43 – The MBrace Putty is applied in a thin coating to smooth the surface of the beam.

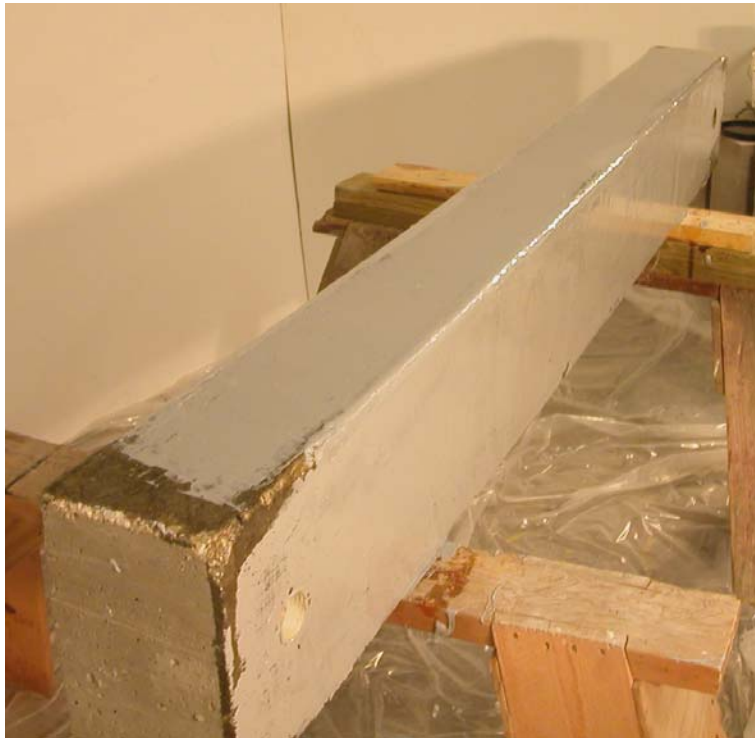
Figure A.44 – The MBrace Putty cured for approximately six hours before the saturant was applied.

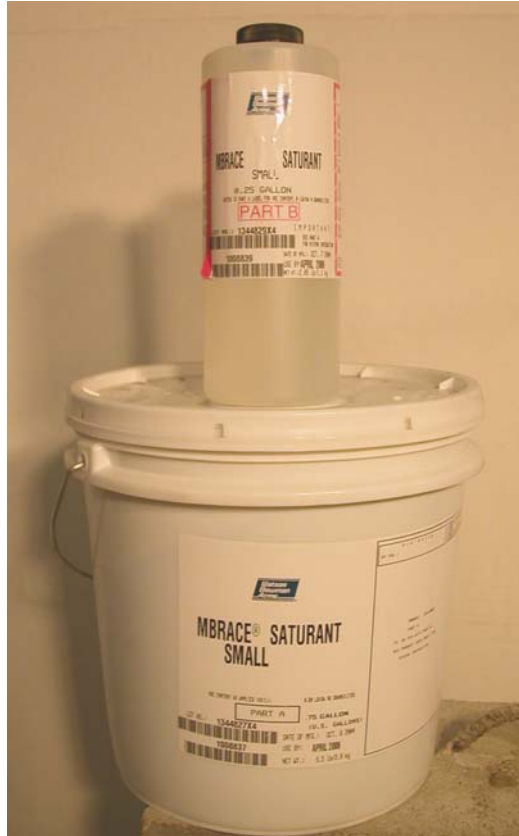
Figure A.45 – The MBrace Saturant comes in two parts that are mixed together just prior to use. Once mixed, there is about 45 minutes working time prior to setting.

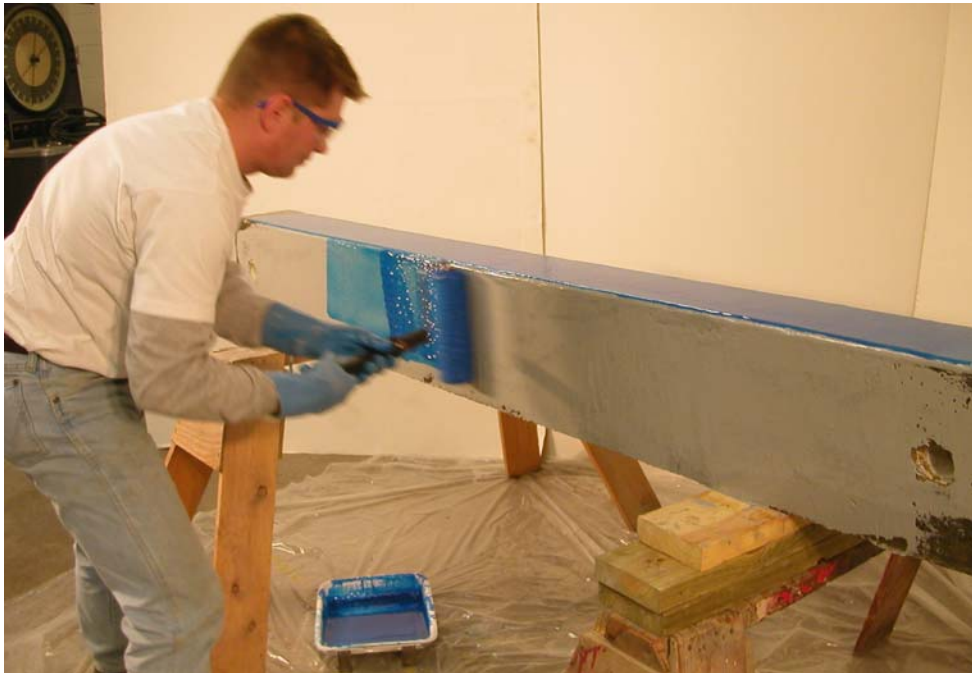
Figure A.46 –The MBrace Saturant was applied to each beam using a medium nap roller.

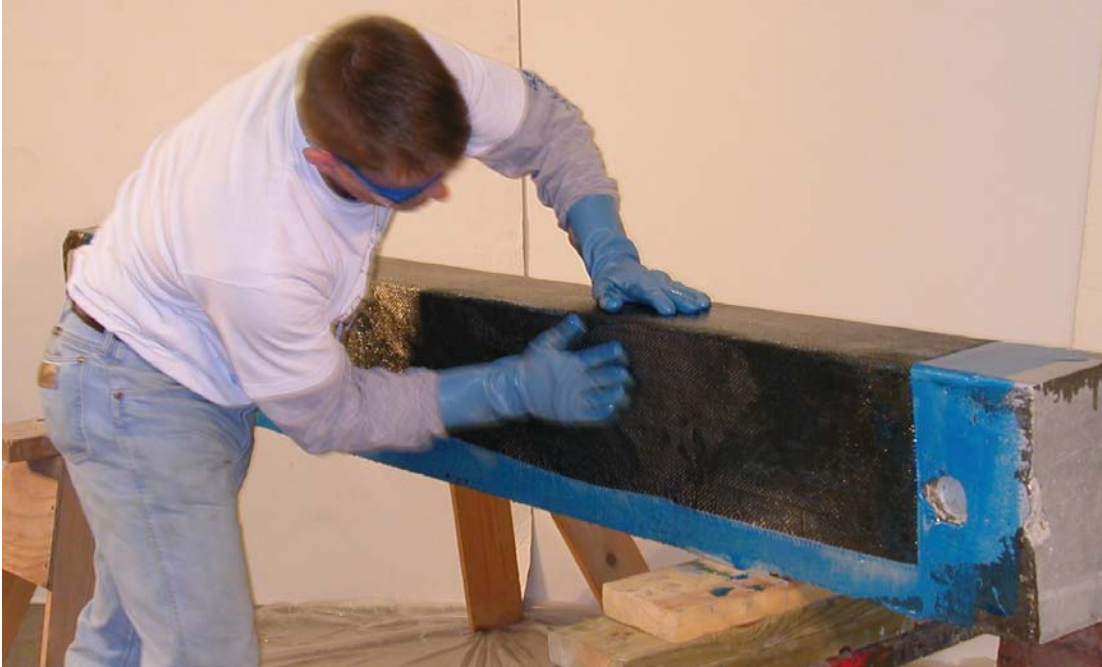
Figure A.47 –The first layer of carbon fiber fabric was applied running parallel to the beam’s primary axis. This layer of fabric provided tensile reinforcement to the beams.

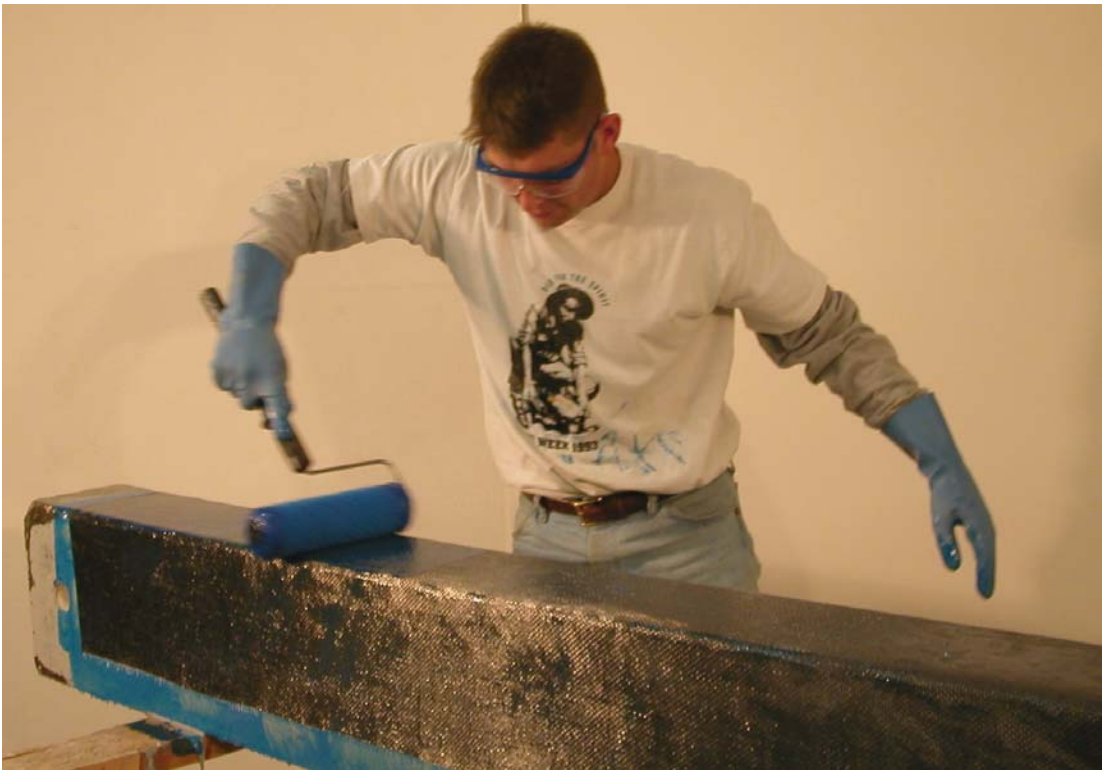
Figure A.48 –The MBrace Saturant was applied on top of the fabric using a medium nap roller. The saturant was applied generously to ensure that the fabric was fully saturated.

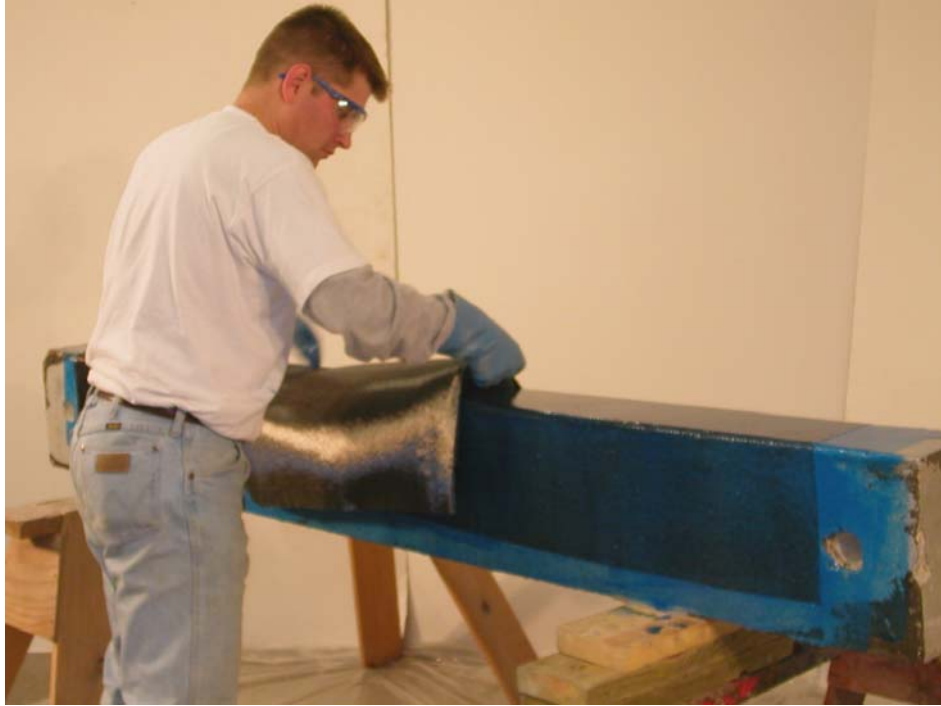
Figure A.49 – The second layer of carbon fiber fabric was applied on top of the fully saturated longitudinally oriented fabric. The second layer of fabric ran perpendicular to the beam's primary axis to provide shear reinforcement.

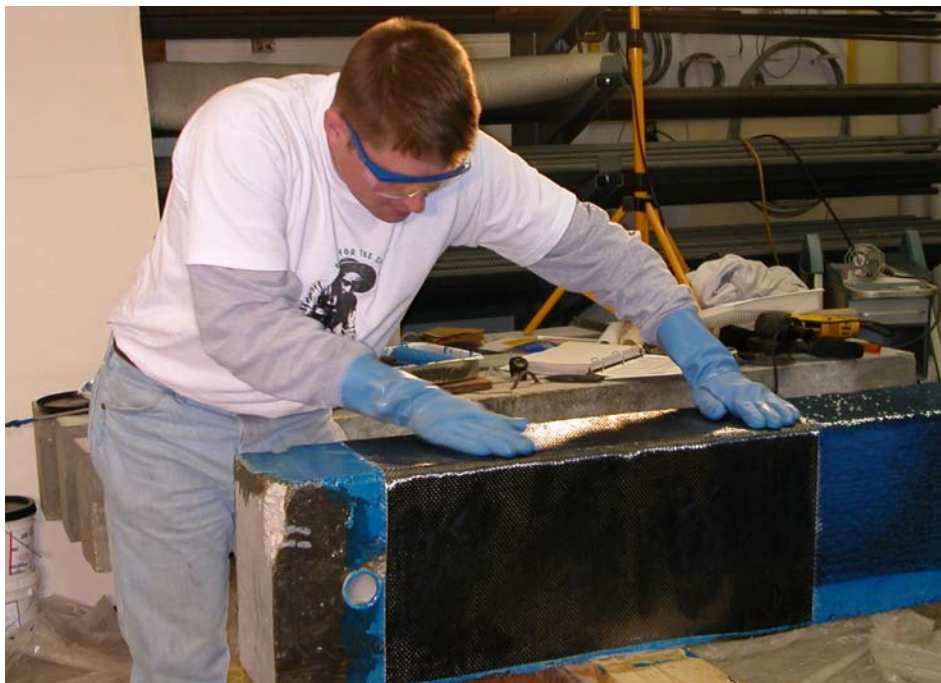
Figure A.50 – The fabric was smoothed to remove all air voids beneath it and the previous layers. Care was also taken to ensure the fibers in the fabric remained straight and properly oriented.

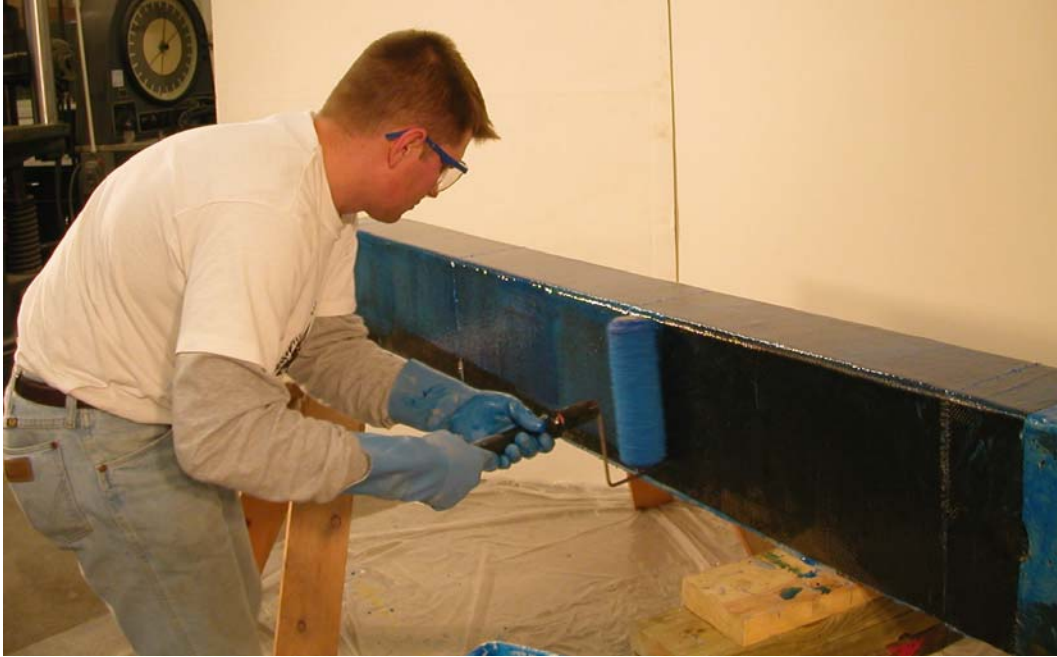
Figure A.51 – A final layer of saturant was applied to the beams on top of the shear reinforcement fabric. The saturant was applied generously to ensure the fabric was fully saturated.

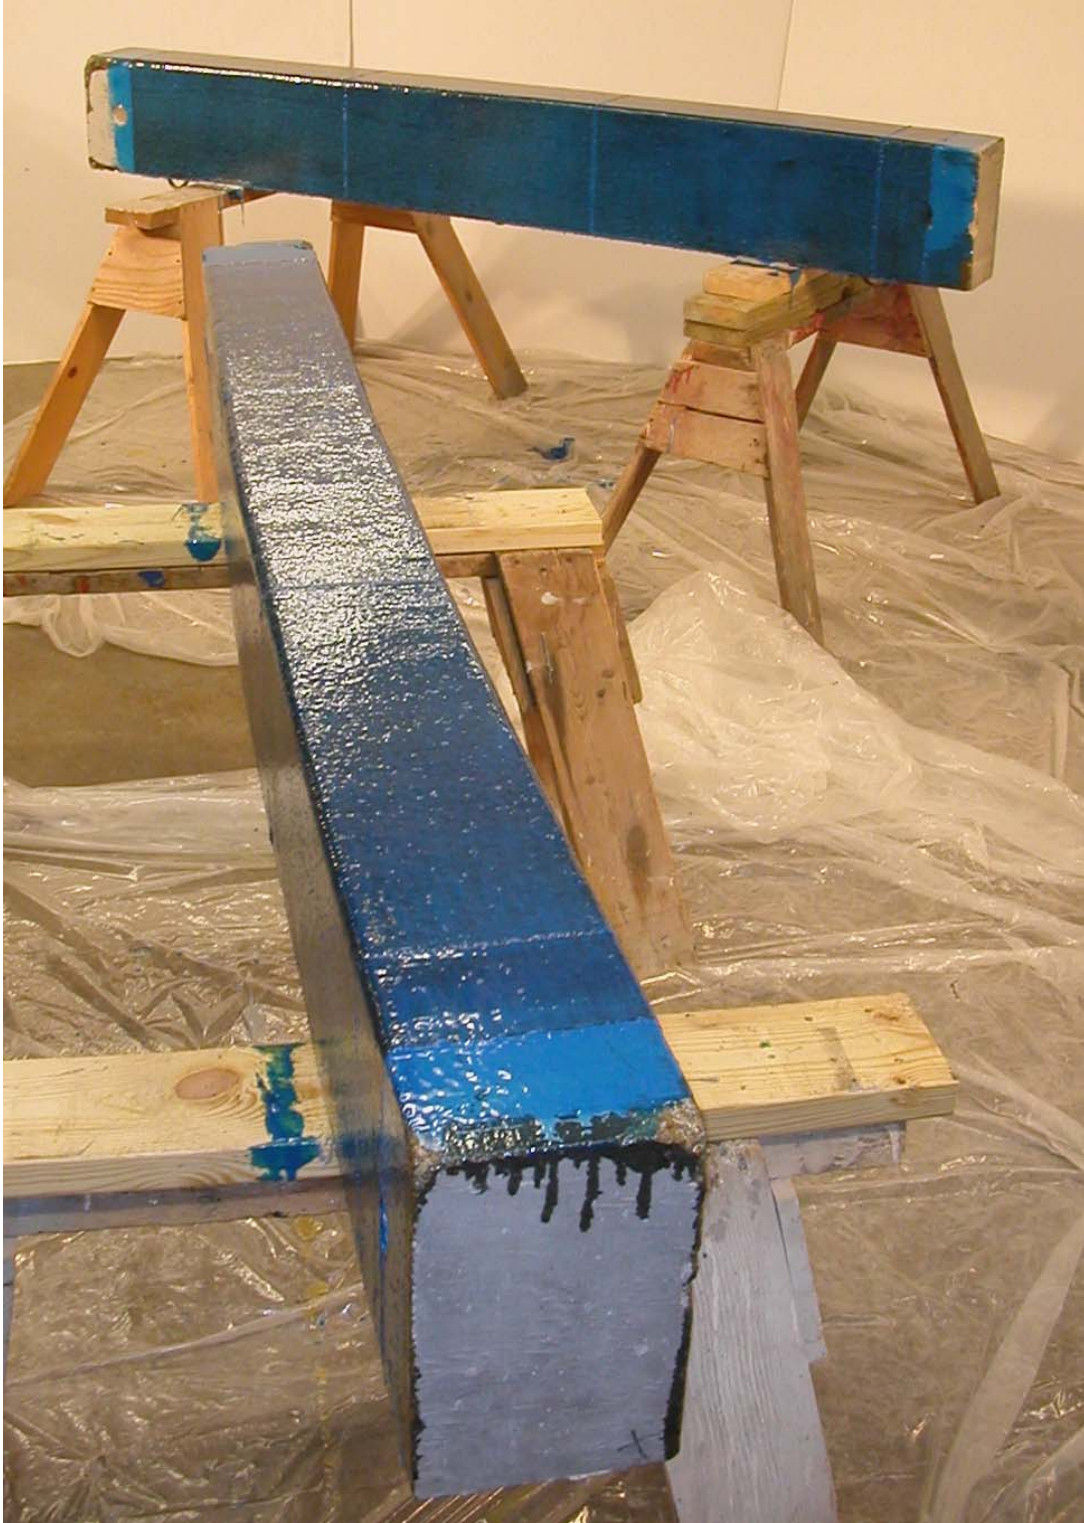
Figure A.52 – To apply the three layers of saturant and two layer of carbon fiber fabric took approximately 15 to 20 minutes per beam. After 24 hours the beams were still tacky and by 48 hours they were tack free. The FRP takes seven days to reach its full load carrying capacity according to the manufacturer but can begin receiving a load after just 24 hours.

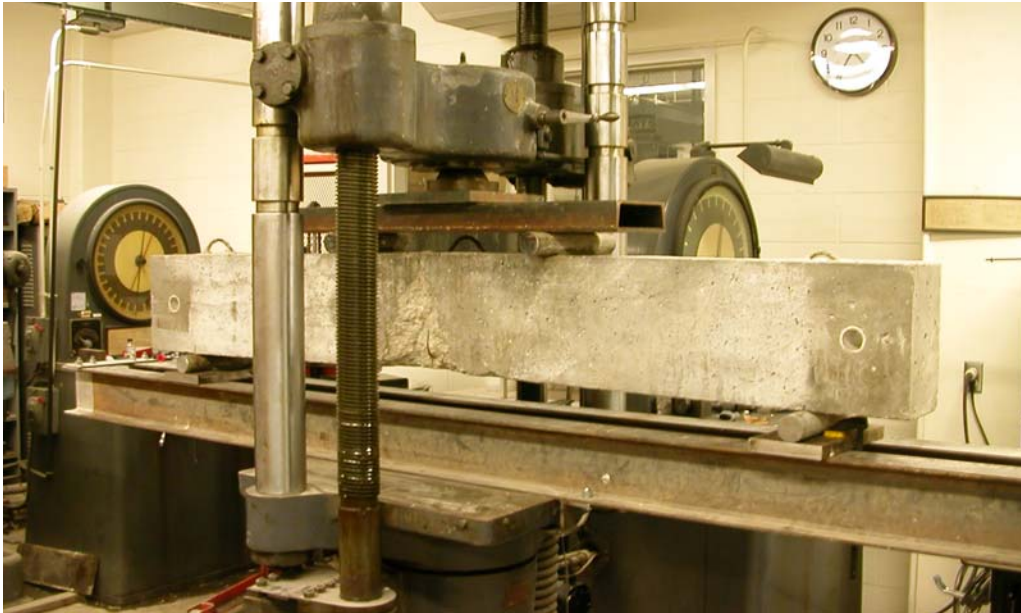
Figure A.53 – Beam 2A mounted in the third-point reaction from on the 120 kip (534 kN) Baldwin Universal Testing Machine.

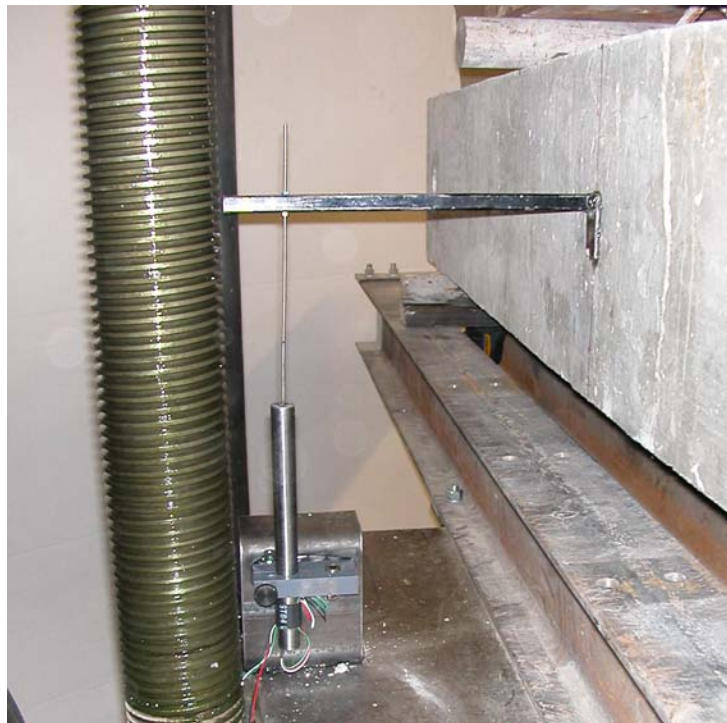
Figure A.54 – Displacement transducer measured the deflection of the centerline of the beam. The horizontal bar was epoxyed to the side of the beam and the transducer rod was firmly attached to the bar with two nuts. The transducer had a 2 in. (50 mm) displacement capacity.
