A LONGITUDINAL STUDY OF PLAYGROUND SURFACES TO EVALUATE ACCESSIBILITY

Final Report

October 2013

Project Team
Jennifer K. Skulski, CPSI, Principal Investigator
Dr. Sherril York, Executive Director

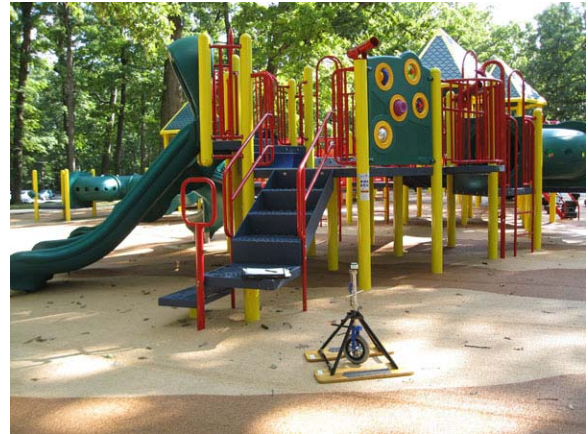
Photo 13: HYB surface system designed with outdoor carpet as top layer over engineered carpet pad base and infilled with silicone sand.
